# Seismic and Energy Performance Evaluation of Large-Scale Curtain Walls Subjected to Displacement Control Fasteners

**Abstract:** Glass façade curtain walls in buildings is the façade system of choice in modern architecture of mid- to high-rise buildings. This study investigates the seismic and thermal insulation performance of curtain wall systems through structural analysis using the finite element method (FEM) and LBNL Window&Therm insulation analysis. The aim was to optimize the capability of the curtain wall module system and the fastener element technology to respond to displacement and vibration caused by dynamic seismic waves. Using the structural analysis of the optimization process, a curtain wall system capable of withstanding earthquake waves of 0.4 Hz, displacement of  $\pm 150$  mm or more, and capable of responding to three-axis (*X*, *Y*, and *Z*-axis) dynamic earthquakes, was fabricated. Then, a curtain wall system that satisfies not only the evaluation of seismic performance, but also the desired airtightness, watertightness, wind pressure, and insulation, which are essential requirements for field applications, was verified through an experiment. Based on this

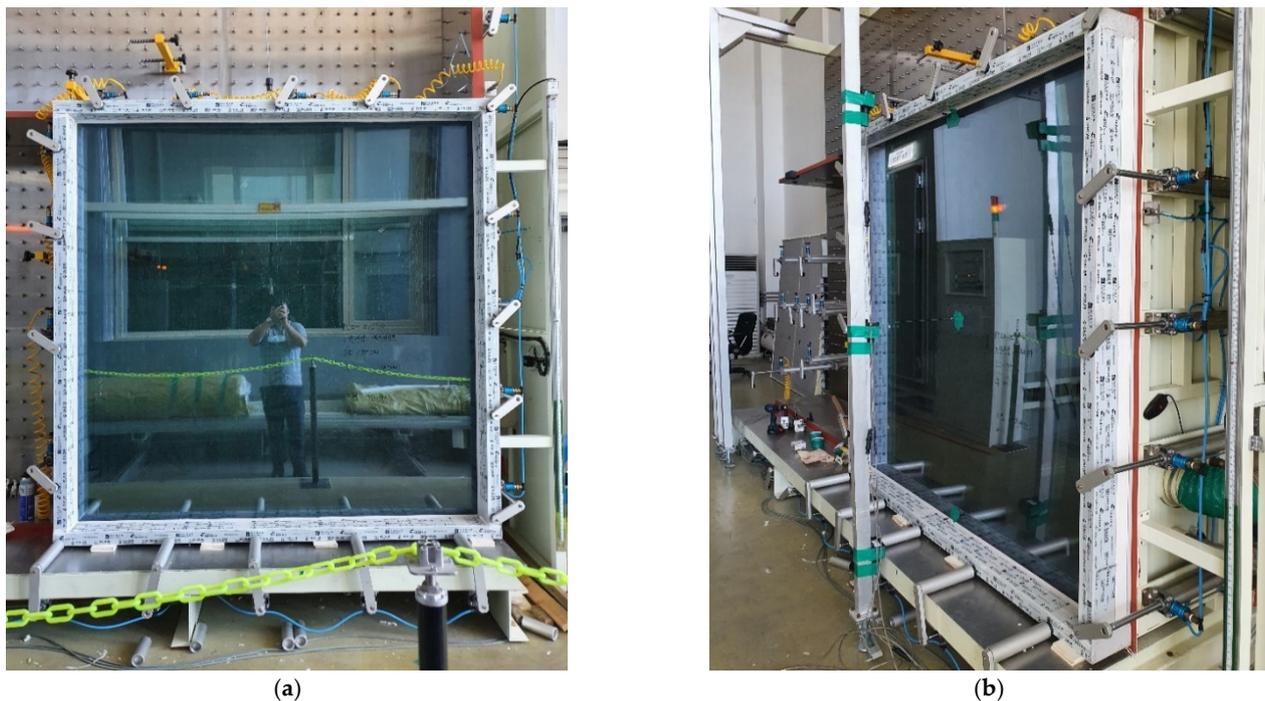
**Figure 39.** Specimens for evaluating watertightness and wind pressure performance: (a) watertightness performance evaluation specimen; (b) wind pressure performance evaluation specimen.

If watertightness is not achieved in terms of the usability of the curtain wall, it may result in a defect. Thus, performance must be ensured. In addition, curtain walls must be designed so that glass is not damaged by external forces such as typhoons, and wind pressure performance evaluation must therefore be undertaken. Evaluation of watertightness and wind pressure performance was performed, as shown in Figure 39.

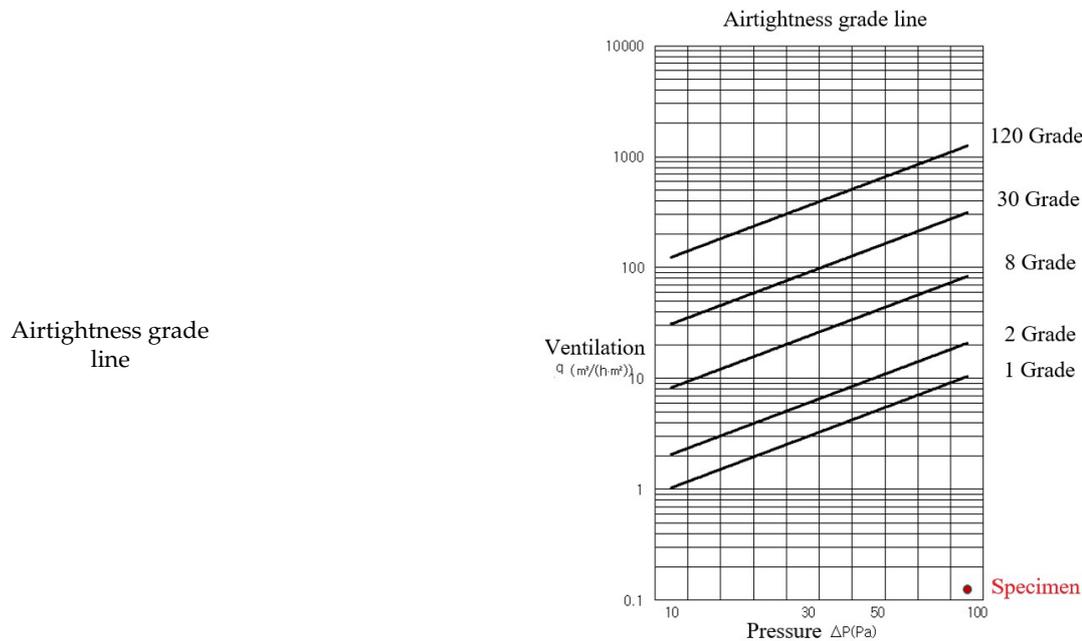
※ Because the ventilation volume at 10, 30, and 50 Pa pressure is 0.00 m<sup>3</sup>/(h·m<sup>2</sup>), it is not displayed on the airtightness rating line.

In this experiment, an air infiltration test was carried out according to KS F 2292, and the airflow rate was measured for each pressure difference based on 10, 30, 50, and 100 Pa, and the air infiltration rate was calculated. The air infiltration test results are shown in Table 14. At each pressurization, the air infiltration rate is expressed as the flow rate per hour (m<sup>3</sup>/h·m<sup>2</sup>) for the area of 1 m<sup>2</sup> of the specimens and converted using the formula. The results of the conversion are graphed and the performance is evaluated according to each classified class line. The general construction specification stipulates that it does not exceed the line of 120 grade. As a result of the air infiltration test, it was found to be 0.00 m<sup>3</sup>/(h·m<sup>2</sup>) at 10 Pa, 0.00 m<sup>3</sup>/(h·m<sup>2</sup>) at 30 Pa, 0.00 m<sup>3</sup>/(h·m<sup>2</sup>) at 50 Pa, and 0.00 m<sup>3</sup>/(h·m<sup>2</sup>) at 100 Pa. In addition, as each pressure difference falls below the 1st grade line, the airtightness grade was 1st grade. In terms of the airtight member, it was confirmed that the members responsible for tightness (gaskets, sealants) in the curtain wall unit were well constructed without any construction error, and sealant treatment of frame joints and inter-member connections was performed properly.
