Article

Reconstruction of Ancient Lake after Peat Excavation—A Case Study about Water Quality

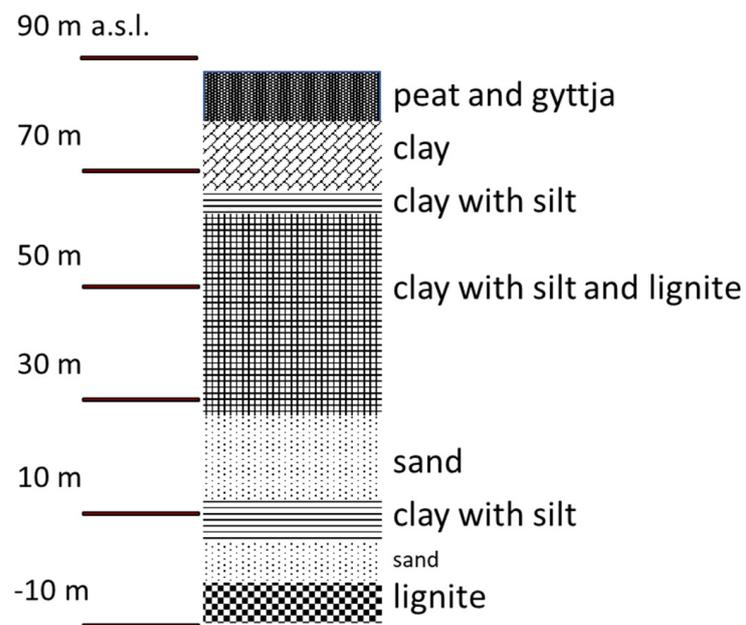
Figure 1. Stratigraphic column of Nienawiszcz reservoir before peat excavation.

Nienawiszcz is a village in the Wielkopolska (Greater Poland) region (Poland) with areas covered by forests, arable fields, meadows, waters and peat bogs. The peat-lake studied was localized at 52°40'31.6" N, 16°59'05.0" E southwest from the village and was constructed in consecutive steps. The geology of the watershed is the effect of Baltic ice deglaciation in the Holocene and in the site of an ancient lake, peat and gyttja developed. To the depth of about 120 m, there are tertiary and quaternary mineral deposits. The lowest are tertiary formations of silt and fine sands with lignite layers, which are the lowest parts of the Miocene deposit. Above them there is a layer of sands with a thickness of 10–20 m, locally overgrown with muddy sediments. These deposits are covered by a layer of clay and silt sediments with a coal layer of 10–30 m in thickness. Within it, there are local sandy layers—silty sands, sometimes sandstones. Another layer consists of Miocene and Pliocene clays with strongly differentiated thickness [18]. The subquaternary layer is strongly differentiated and is located at a height of approximately 30–70 m above sea level. The geology of study site is presented in Figure 1.

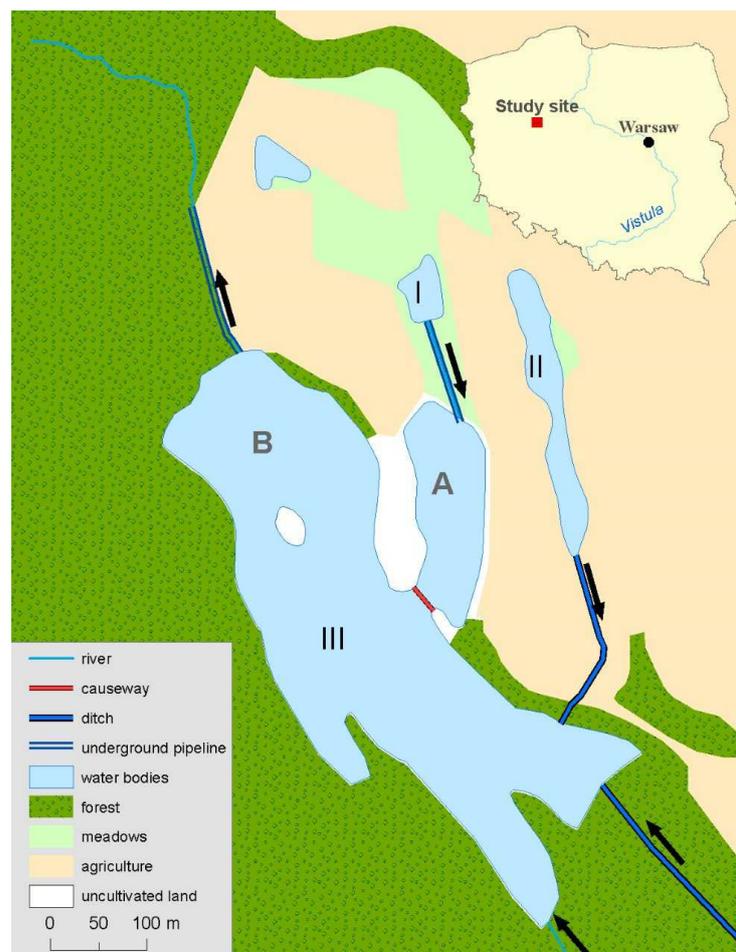
Figure 2. Sketch map of studied post-peat reservoir Nienawiszcz (III) after connection of both parts (A,B) and small post-peat reservoirs I and II, finished in years 1999 and 2000, respectively.

The construction of the studied reservoir (III) was carried out in several stages and was preceded by the construction of two smaller post-peat reservoirs I and II (Figure 2). After peat exploitation in the northeastern part, both parts of the reservoir were separated by a causeway and part A was flooded with water. The remaining part (B) was then drained by pumping out water in order to exploit the dry peat. After the extraction of the peat deposit, the reclamation work began, including the appropriate shaping of the surrounding area and bottom, levelling the banks and softening the slopes of the planned water reservoir and then, filling it with water. The reservoir is filling out a depression formerly occupied by lake and its banks are not reinforced in any part. Since the excavated deposit was formed as a result of the eutrophication of the former glacial lake, the construction of the water reservoir in this place was in a sense the reconstruction of an old, natural reservoir of glacial origin and contributed to the regulation of water conditions in this area.

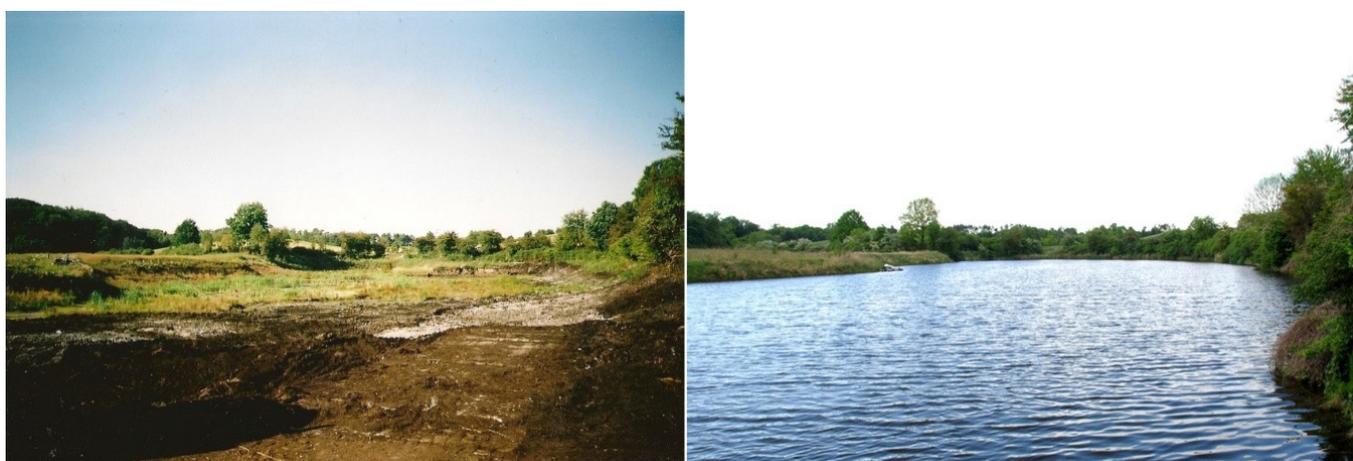
Figure 3. Part A of pit lake under construction (left) and one year after works (right).

After the peat deposit was excavated, a post-mining water reservoir was created (Figure 3). The average depth of post-peat lake was equal to 1.64 m and the maximum depth was 3.99 m. The length of the coastline was equal to 2425 m. The volume of reservoir was about 175,322 m³ and the area equal to 11 ha (including island) (Table 2). The total area of the water surface was equal to 10.71 ha. The maximum water level was determined by the lowest edge of the culvert positioned at 87.09 m above sea level. The reservoir has a diversified shoreline, covered with forests, meadows, and arable lands; it also has an island, bays of different depths and four peninsulas covered with grass.

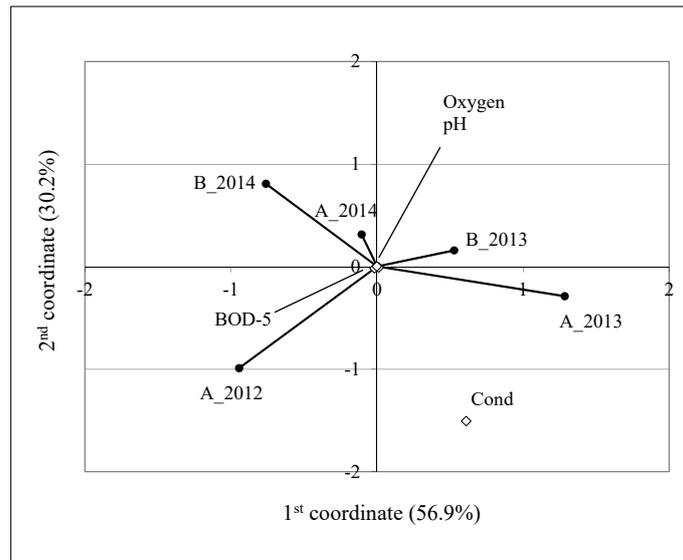
Figure 4. Position of experimental objects determined by conductivity, pH reaction, oxygen concentration and biochemical oxygen demand in the space of the first two canonical variates and the spacing of these parameters in the dual space.

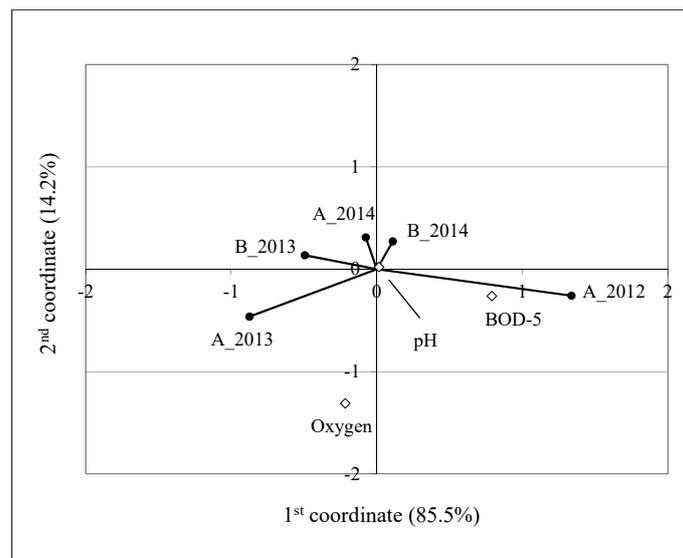
Figure 5. Position of experimental objects determined by pH reaction, oxygen concentration and biochemical oxygen demand in the space of the first two canonical variates and the spacing of these parameters in the dual space.

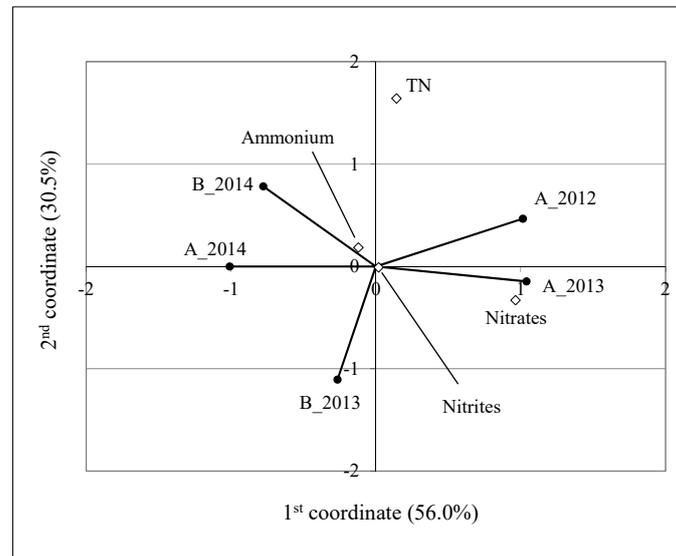
Figure 6. Position of experimental objects determined by different forms of nitrogen (ammonium, nitrates, nitrites and total nitrogen) in the space of the first two canonical variates and the spacing of these parameters in the dual space.

Positions of points representing objects A_2014 and B_2014 (Figure 6.) indicate that, after the connection of both parts, the water quality was stabilizing with a tendency to reduce nitrates concentration. Comparing the concentration of nitrogen compounds between experimental objects during the study period, it was found that the contents of nitrates and ammonium were the most important factors influencing the position of points representing experimental objects and the water quality (i.e., determining the similarity between the objects). It was found that part A of the reservoir in 2012 and 2013 was characterized by relatively high concentrations of nitrates and low concentrations of ammonium. In 2014 (after the connection), the opposite trend was observed for both parts of the reservoir (after connection). Both parts of the post-peat lake in 2014 were characterized by similar contents of analyzed nitrogen compounds. Additionally, the concentration of total phosphorus was found to be very low in the year 2013. Both parts of post-peat lake in 2013 were

characterized by the most similar values of examined nitrogen compounds. A comparable relationship between the parts of the reservoir was observed in 2014. This indicates that the variability of nitrates concentration in the water was much higher between the years than between the parts of the studied reservoir.
