Article

RCC Structural Deformation and Damage Quantification Using Unmanned Aerial Vehicle Image Correlation Technique

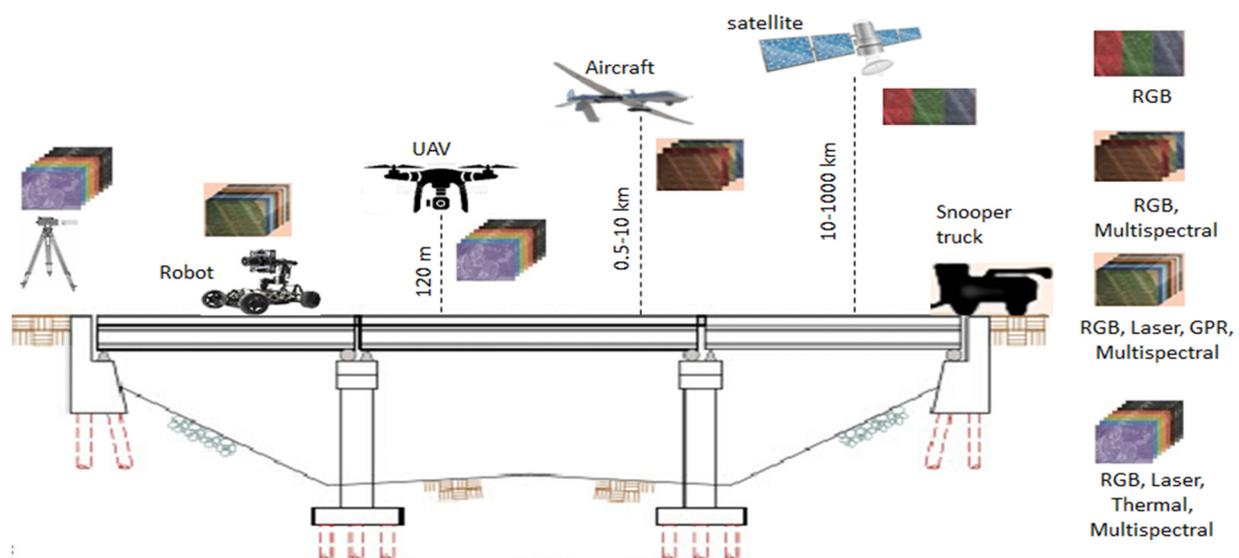
Figure 1. Different remote sensing platforms based on the operational altitudes and data sets produced.

The level of accuracy relies on the operational altitude of sensors and the resolution of imaging data. The data acquisition platforms as shown in Figure 1 are categorized based on high accuracy and low accuracy. Inspectors and engineers chose the data acquisition platform based on the type of monitoring, budget allocated and time span.

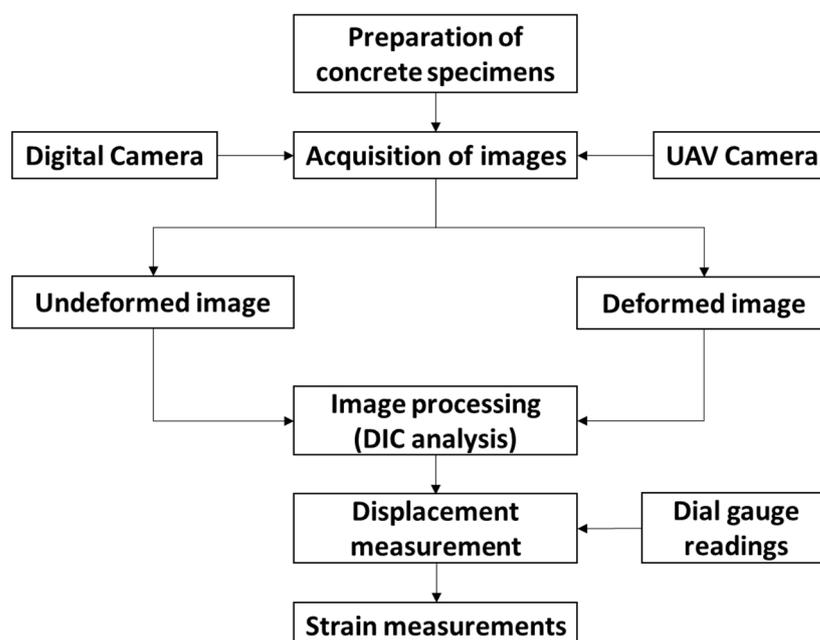
Figure 2. Flow chart showing the methodology.

The above Figure 2 depicts the flow chart of the methodology followed to perform the study.

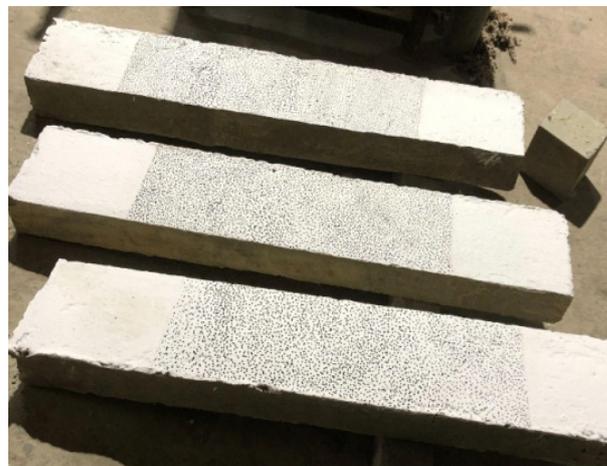
Figure 3. Specimens with random speckle pattern.

Three concrete specimens of M25 grade strength is casted for conducting the study. Three specimens are prepared by spraying white paint as a background for the application of random speckles with black paint on the surface at the centre portion of the beam as shown in Figure 3. To achieve accurate results, it is important to have a considerable quantity of black speckles with random shapes and sizes [28].

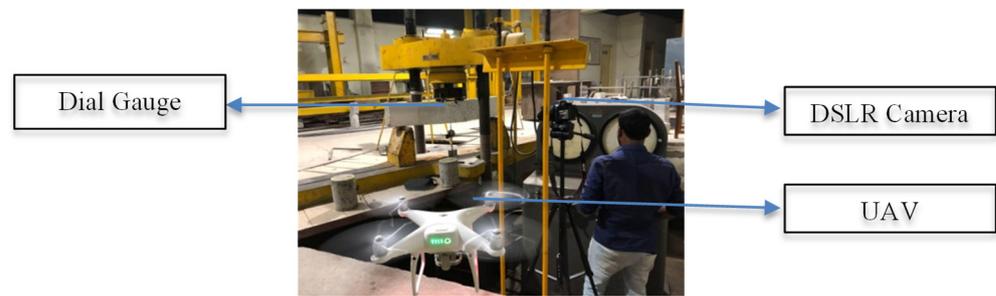
Figure 4. Image acquisition using DSLR camera and UAV during loading.

A series of digital images are acquired during load implications at different load levels to process in DIC [29]. Image acquisition during loading condition is done simultaneously with DSLR camera and drone camera as shown in Figure 4. Dial gauge is also placed prior to loading at the bottom centre of the beam to measure the deformation that occurred due to load implication. Similarly, images for the rest of the beams are also acquired at specific load levels. The camera images are acquired using a Nikon D5600 (Nikon, Tokyo, Japan) bearing a CMOS sensor of 24.2 MP with a focal length of 18 mm and 1920×1080 resolution, and it has 60 fps video recording capabilities. The drone image acquisition is achieved by employing DJI Phantom4 Pro V2.0 (DJI, Shenzhen, China) that is equipped with CMOS 20MP sensor with a focal length of 8.8 mm and resolution of 5472×3648 pixels, and it has 60 fps video recording capabilities. The UAV is a quadcopter with a designed flight time of 30 min and a maximum weight of 1375 g. It is a relatively cheaper and commonly used UAV in many engineering applications, due to its onboard sensor capabilities. Both the cameras are set at 3 m away from the target beam for imaging.

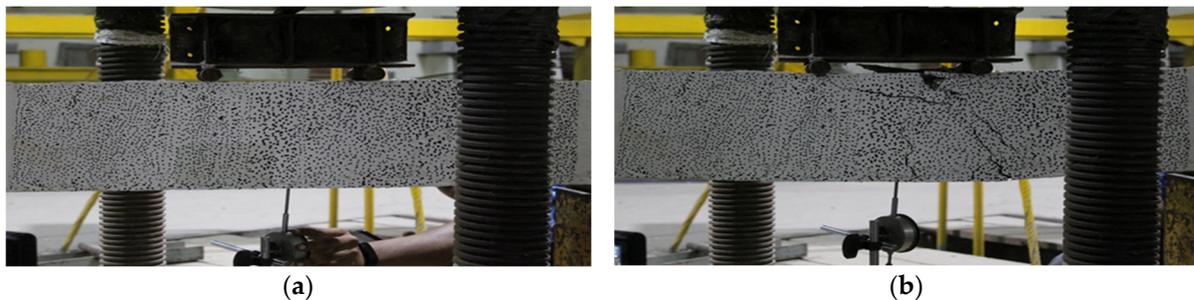
Figure 5. DSLR image acquisition (a) prior to application of load and (b) after application of load.

The reference image is the initial one taken before application of load as shown in Figure 5a, then the current image (deformed image) is uploaded as shown in Figure 5b. All the images should be in the same format as the reference image to minimize initial processing. Region of interest drawn on the surface for which displacements and strains are to be determined and minimizes computational time. The same image processing tools and algorithms were used for processing the images obtained from UAV as shown in Figure 6 prior to loading and after loading.

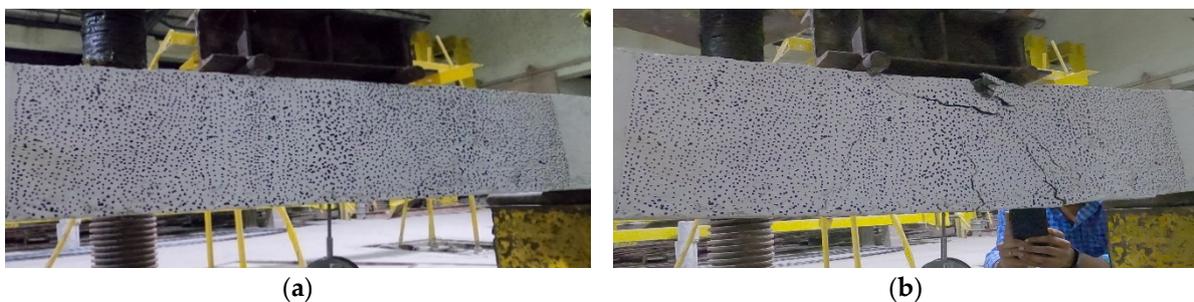
Figure 6. UAV image acquisition (a) prior to application of load and (b) after application of load.

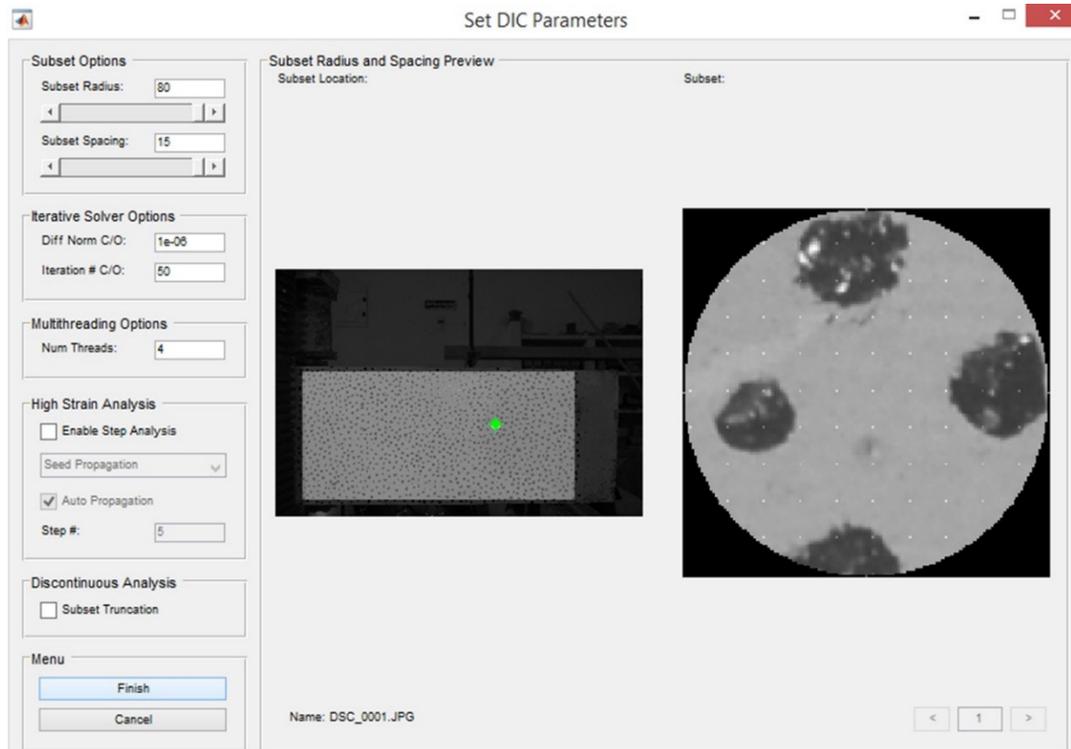
Figure 7. Setting DIC seed parameters and subset options.

pattern which should be small and at least covers more than 3 speckles that does not result in noisy displacement data as shown in Figure 7. Subset spacing is chosen in such a way that it should increase the computational speed. Multithreading is done for speeding up the computation and accurate results. In this study, an optimal subset size of 80, subset spacing of 15 and 4 number of threads are set as DIC parameters. Subset size ranges between 10 and 200. Subset spacing ranges between 0 and 20 are adopted.

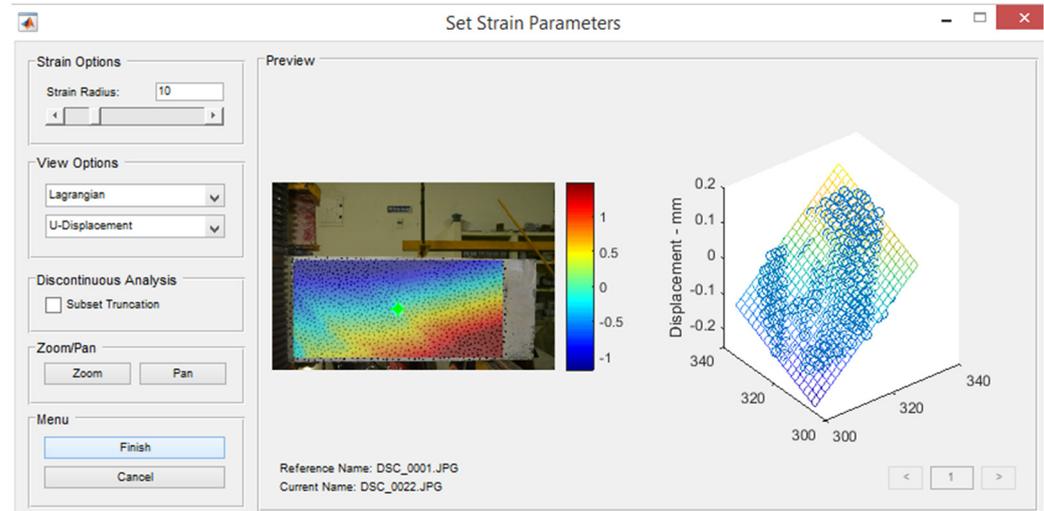
Figure 8. Setting strain parameters and strain radius.

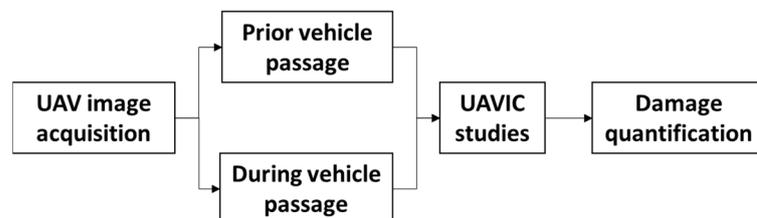
Figure 10. Flow chart showing UAVIC study on ROB.

Bridges are the most important RCC structures in the transportation system for connecting inaccessible locations. Due to its elevation, monitoring the bridges also became a herculean task in terms of safety and traffic mobility. The proposed and tested UAVIC is deployed to inspect the fully functional RCC Bridge available in the vicinity of the institution. The UAVIC study workflow on the bridge is given in Figure 10. The selected structure is rail over bridge (ROB) aged 21 years, with a length of 540 m and height 7 m and heavy weight freight on it. An automated process based on digital imaging and processing was used to determine structural damages of spalled concrete, crack initiation and propagation, crack width measurement and monitoring. Digital images of ROB are acquired by flying UAV on the center span and away from railway power lines. The span of the bridge deck is 11 m in length from center to center of support and 7 m in height. Images are obtained in the broad daylight under sunny conditions for detailed information of the bridge. There are two sets of reflective reference points attached on the supports of the bridge deck.

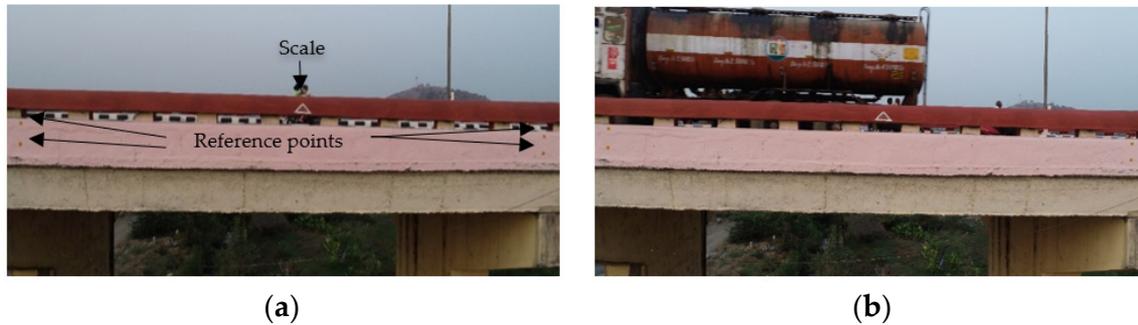
Figure 11. UAV images acquisition (a) prior to vehicle passage and (b) during vehicle passage.

A triangular scale at the center of the bridge deck is attached for reference length to perform DIC studies on the bridge. The irregularity and other dust particles on the surface of the bridge beam acted as a speckle pattern for conducting DIC studies. UAV images facing the center of the bridge deck prior to vehicle passage as shown in Figure 11a

and after vehicle passage are acquired as shown in Figure 11b. Similarly, different kinds of vehicles with varying loading condition images are acquired during the passage at a specified point.

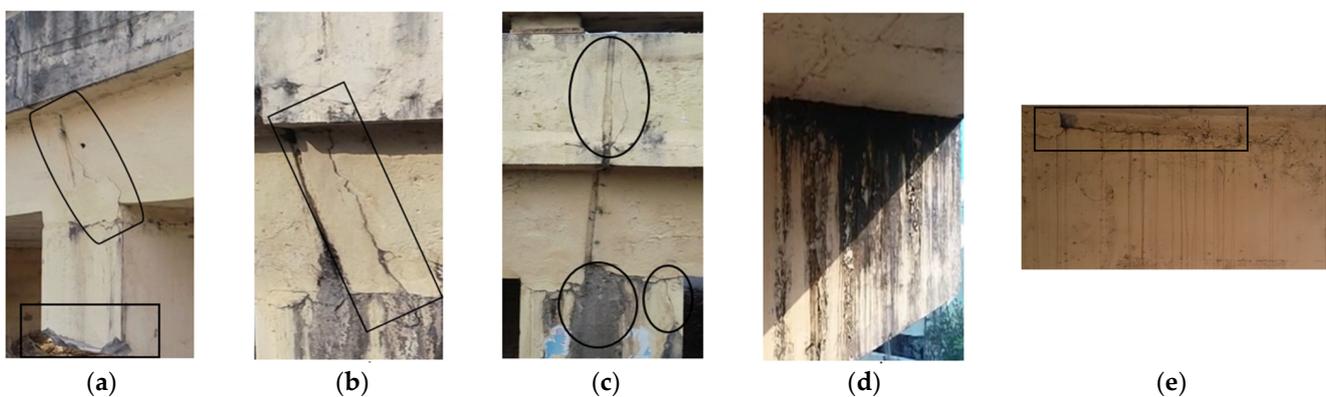
Figure 12. Images showing the structural damage investigations done through UAV: (a) crack in the joint and damage of beam, (b) crack in the deck of the bridge, (c) damage and crack in the pier, (d) spalling of beam and (e) crack in the beam and slab joint.

Damage analysis of the beam done by investigating the present structural condition of the bridge components. The entire stretch of the bridge is investigated for occurrence of cracks by flying the UAV. Crucial aspects, such as column and beam joints, beneath the deck slab, sides of the slab supporting beams and growth of organic matter are inspected. The damage structural images are analyzed for crack width and length investigations, and damage is ascertained by the results obtained. Few damaged portions of the bridge are shown in Figure 12 in alphabetical order and described: (a) crack in the joint and damage of beam, (b) crack in the deck of the bridge, (c) damage and crack in the pier, (d) spalling of beam and (e) crack in the beam and slab joint.

Excessive loading and poor maintenance of bridge structures causes cracking, which affects the structure's performance [31]. According to Sheerin [32], longitudinal and vertical cracks, which are commonly found in bridges, are classified as moderate or severe. The majority of the cracks detected in the study also fall into this category. In RCC constructions, fracture widths greater than 0.3mm cause rebar corrosion, expand the crack and cause structural damage. The maximum crack width allowed under service loads, as defined by several standard codes, is 0.3mm; any crack width greater than that should be treated [33]. The damage index is calculated based on the loading situation, crack width, and crack length [34,35]. The deterioration of bridge in terms of spalling and chemical attack is also considered for damage analysis [36,37].

The image analysis similar to beam crack properties investigations is carried out on the bridge element images acquired by UAV. A few damaged portions were put on to the show in the UAVIC studies in the previous section of damage quantification. The designated alphabetical order of damaged portions is investigated for crack properties and given in Table 3.

Bridge Component	Crack Width in mm	Crack Length in mm
(A) Crack in the joint and damage of beam	1.82	583
(B) Crack in the deck of the bridge	2.42	467
(C) Damage and crack in the pier	0.96	328
(E) Crack in the beam and slab joint	3.28	524

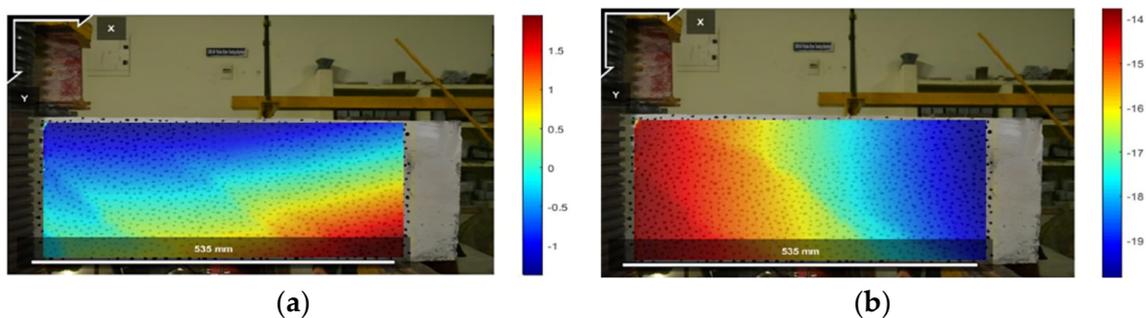
Figure 13. DSLR image Displacements in the (a) longitudinal direction and (b) lateral direction.

Results from RCC beam specimens tested for two-point bending have been evaluated. The image analysis performed on the DSLR images and UAV images of a single beam in the Ncorr V1.2 software is yielded with the below outputs. The maximum load has been recorded as 112 kN at which the failure has occurred. After the failure load, the displacement increases rapidly and the load decreases. Figure 13a depicts displacement at failure load in the longitudinal direction (U-Displacement) is 5.3640 mm, which indicates compression in the deformed image. The median value was found to be -0.0599 mm. The following Figure 13b depicts displacement at failure load in the lateral direction (V-Displacement) is -3.563 mm which is negative indicates tension. The median value has found to be -6.4953 mm. The results of the given beam are of a single deformed image, and each image yields different displacements according to the varying load values.

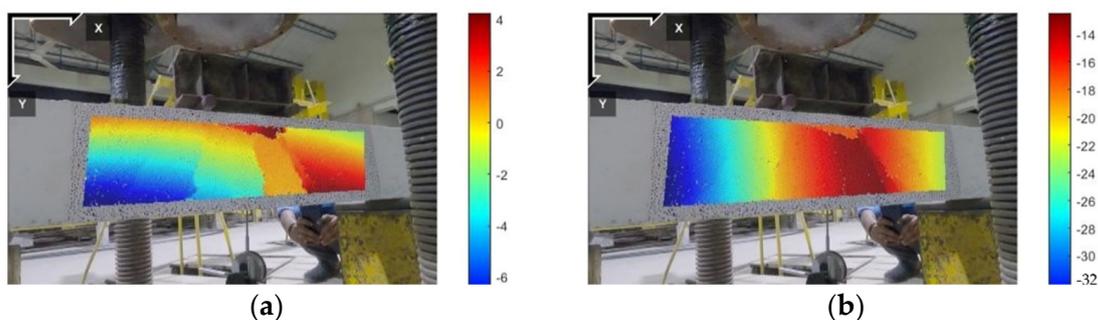
Figure 14. UAV image displacements in the (a) longitudinal direction and (b) lateral direction.

The following Figure 14a depicts displacement at failure load in the longitudinal direction (U-Displacement) is 5.8320, which indicates compression in the deformed image. The median value was found to be -0.0630 mm. The following Figure 14b depicts displacement at failure load in the lateral direction (V-Displacement) is -4.113 mm which is negative indicates tension. The median value has found to be -6.992 mm.

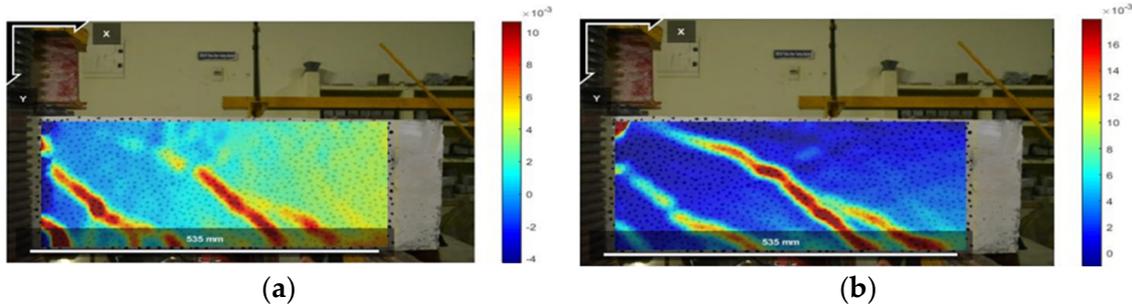
Figure 15. Strain in the (a) longitudinal direction and (b) lateral direction.

The DIC analysis also helps in determining the strains occurred with the beam. There are more strains in the longitudinal directions compared to the lateral directions. Figure 15a depicts strain in X-direction is 0.0126 mm. The median value has found to be 0.0025 mm. Figure 15b depicts strain in Y-direction is 0.1321 mm. The median value was found to be 0.0020 mm.

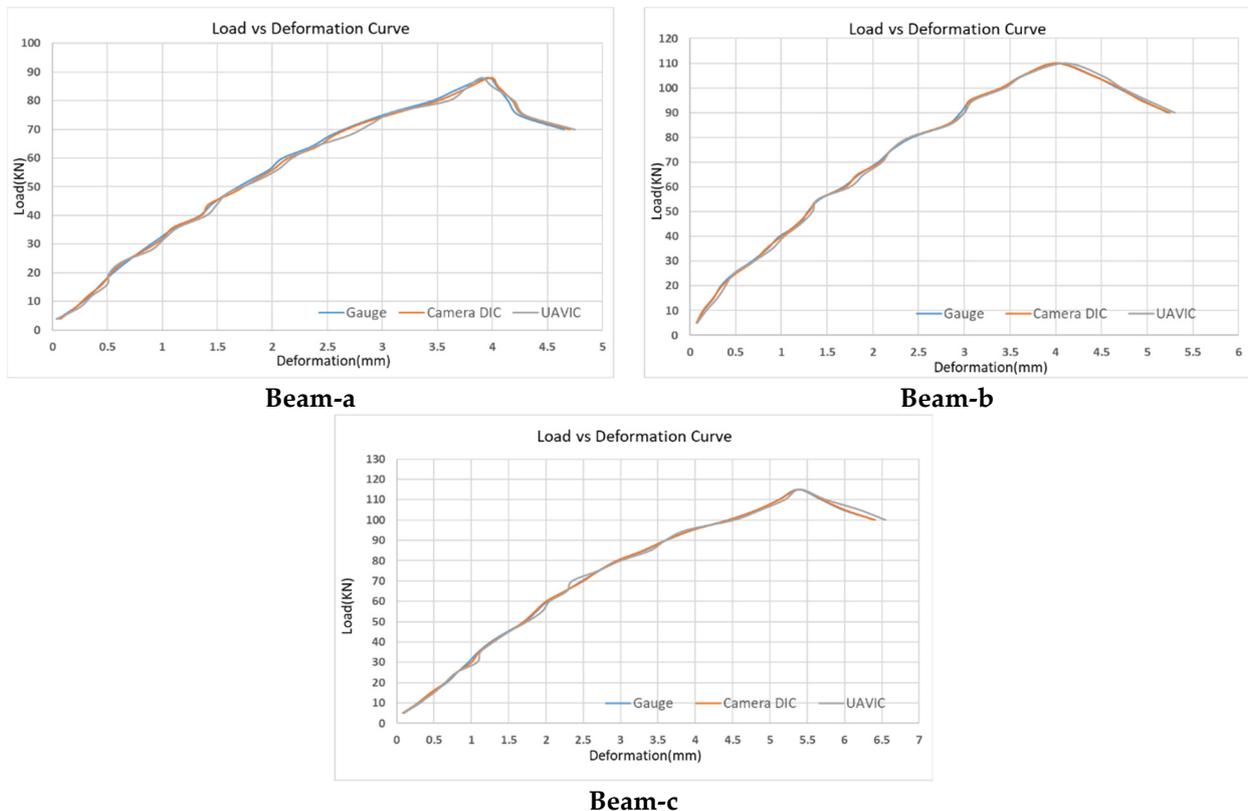
Figure 16. Load displacement plots of three RCC beams.

Displacements obtained from DIC analysis are compared with the experimentally recorded dial gauge values at varying load values. Displacement values of DSLR images are obtained separately from UAV images and plotted. Small variation in the investigations is observed in dial gauge to DSLR displacements, with an accuracy of 95%, whereas the variations are higher in investigations observed form dial gauge to UAV displacements, with an accuracy of 88%. A sudden spike is observed in UAVIC results at some intervals due to occurrence of vibrations and magnetic attractions in the drone. Figure 16a displays a load-displacement graph of beam-A with failure load as 88 kN and maximum displacement as 4.82 mm.

Similarly, beam-2 graph as shown in Figure 16b indicated failure load as 109 kN and maximum displacement as 5.35 mm, and beam-3 as shown in Figure 16c signifies failure load as 116 kN and maximum displacement as 6.45 mm, respectively. A good result has been observed between the two studies, with a deviation of 12% of experimental values.

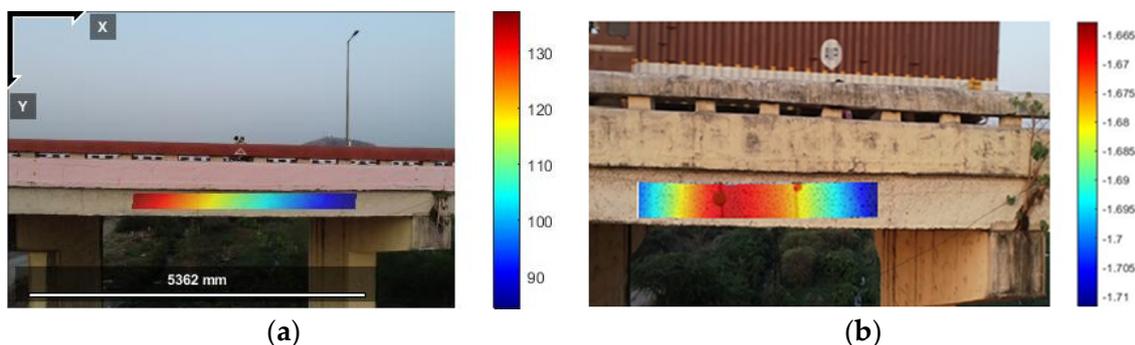
Figure 17. ROB displacement in the (a) longitudinal direction and (b) lateral direction.

Figure 17a depicts displacement at failure load in the longitudinal direction (U-Displacement) is 2.82 mm, which indicates compression in the deformed image. The median value was found to be -0.0519 mm. Figure 17b depicts that displacement at failure load in the lateral direction (V-Displacement) is -4.1928 mm, which indicates tension. The median value was found to be -3.2359 mm.
