# The Investigation of Detect Position of Partial Discharge in Cast-Resin Transformer Using High-Frequency Current Transformer Sensor and Acoustic Emission Sensor

**Abstract:** The lifetime of a cast-resin transformer mainly depends on the condition of insulation material. Partial discharge (PD) is an important reason for insulation deterioration in cast-resin transformers. Identifying the position of PD is very necessary for damage assessment while the transformer is still operating, and the transformer is covered by housing. This paper proposes the investigation of a cast-resin transformer using an AE sensor and HFCT sensor to specify the precise source of PD. In this study, four AE sensors were used to find PD sources, and the high-frequency current transducer (HFCT) technique was used to identify the PD source and the criteria level. The experiment, in the first two parts, identified the possibility of PD, which includes the position of PD. The final part of the experiment verified the position of the PD source of a cast-resin transformer and confirmed the inspection results. AE and HFCT sensors can be used to detect the location of PD sources, confirming the position of the P

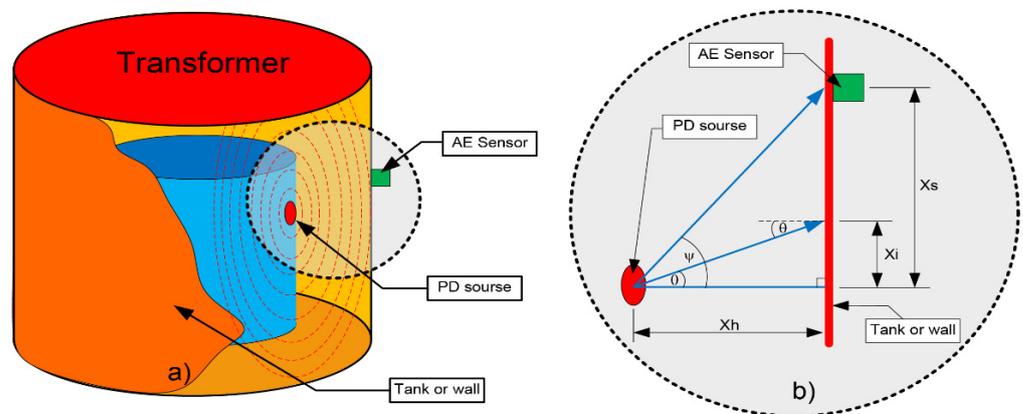
Figure 1 shows the relationship between the PD source and the AE sensor. Figure 1a shows the sound wave travel time is the passed time while the acoustic PD signal disseminates from its discharge location to an AE sensor. The PD signal disseminated was symmetrical in that the signal impacted the tank wall or case at the outside of the transformer. The tank wall of transformer was an AE sensor installation meant to receive signals from PD signals. Figure 1b shows the various parameters characterizing PD wave propagation paths. Nevertheless, a number of different dissemination paths could exist for sound waves traveling from the PD source to the sensor [7], as can be seen by Figure 1. The determination of the time of arrivals (TOAs) from the PD source to a number of AE sensors was used to be an acoustic emission (AE) measurement method to locate the PD source. The acoustic signal traveling distance from a PD source to an AE sensor as follows the Equation (1) [18]. All acoustic waves spread through the internal structure of a high voltage device until reaching the external surface.

**Figure 1.** The relationship between PD source and AE sensor. (a) Radical PD sound wave propagation patterns. (b) various parameters characterizing PD wave propagation paths [14].

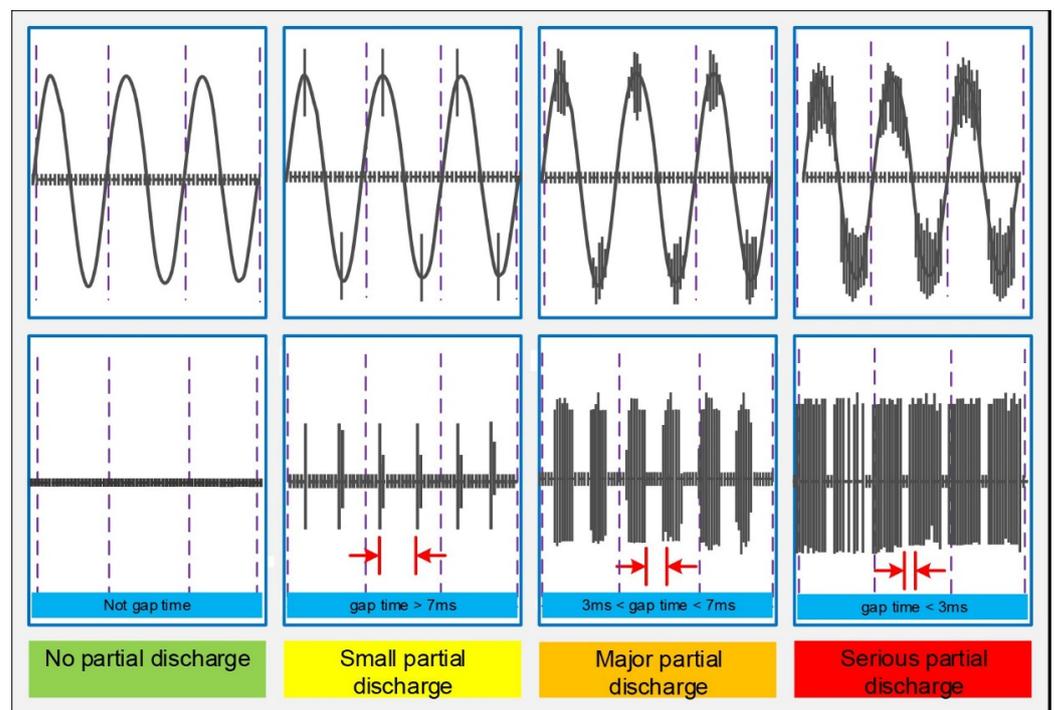
Figure 2 shown the relationship between electrical PD signal and acoustic PD signal which the acoustic PD signal was compared to the electrical PD signal which is based on the real PD signal from the transformer. The electrical signal from the PD is presented in the form of a unipolar pulse, by increasing the time, the unipolar pulse can be shown to the minimum of nanoseconds level. The increase in pulse at the point of origin depends on the type of discharge. The high frequencies are steadily reduced when the signal propagates through the transformer and the pulse shape will be modified because of multiple reflections and the exciting resonant frequency of the transformer components [2,19]. Furthermore, the severity criteria for partial discharge were called “Gap time” and the unit is in milliseconds. The gap time is a space between the end of one burst and the beginning of the next burst. If the gap time has not been generated it was found that a not partial discharge. When the gab time was observed in graph, and it had over 7 ms. which cause the partial discharge was found, but identifier was small partial discharge. The lower the gab time, the greater the partial discharge incidence is, the closer it dangerously becomes to 3 ms., clearly indicating that failure is imminent. Which, burst intervals are critical information in determining the severity of PD [20–22].

Figure 2. The severity criteria of partial discharge; Gap time.

Table 1 shows the risk level of PD according to the PowerPD reference; the gab time difference in level was presented in the results which it can confirm the determination of the condition level of PD difference. In addition, this table also recommended actions when the PD was generated. The minimum of PD condition level was acceptable when it had not been the gab time and the maximum of PD condition level was sinuous when the gab time was less 3 ms.

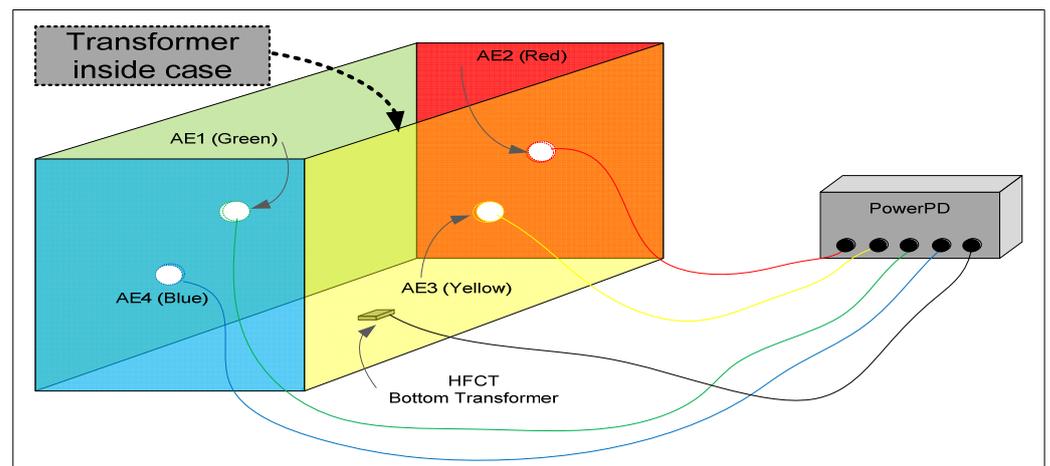
Figure 3 shows schematic diagram of experimental installation, in which four AE sensors were installed on the housing of the transformer. Moreover, the high-frequency current transducer (HFCT) was installed at the ground of the transformer [2,19]. However, all sensors (AE sensor and HFCT) were connected to PowerPD (PD-TP500A). The data storage device was used to view the results on a computer. Moreover, there was the special sensor, an acoustic emission sensor used that was a passive piezoelectric, with a frequency response featured by a peak at 150 kHz where it exhibited a resonance. The frequency range was fixed at 100 kHz to 450 kHz along with transformer function of 4.5–5.0 V/A. Except for disconnection, a split core ferrite was retrospectively allowed to fit in earth straps for HFCT. To provide RF shielding and improve performance in noisy environments, the HFCT was constructed with an aluminum body.

**Figure 3.** Schematic diagram of experimental installation.

When the AE sensor No.1 (Green color) was located on the HV side of the transformer. The AE sensor No.2 (Red color) was located at the next side, which was determined by clockwise direction on the bottom of the transformer. The AE sensor No.3 (Yellow color) was located by the LV side of the transformer, which was opposite to the AE sensor No.1. The AE sensor No.4 (Blue color) was located approximately opposite to the AE sensor No.2 on the bottom position of the transformer. At the beginning, the four AE sensors and HFCT sensor

As the first step, the four AE sensors (AE1 to AE4) were installed with housing of transformer as follows from Figure 3. for detected PD signal by PowerPD software. Figure 4 shows a real installation of Acoustic Emission Sensors with 4 positions. The PD signal from PowerPD software showed four signals with different colors (green, red, yellow, and blue) at the position of AE sensor was installed. Figure 5 shows the PD signal of each AE sensor detected with AE1, AE2, AE3, and AE4, in which it was found that the PD signal from PowerPD software was green, red, yellow, and blue color, respectively.

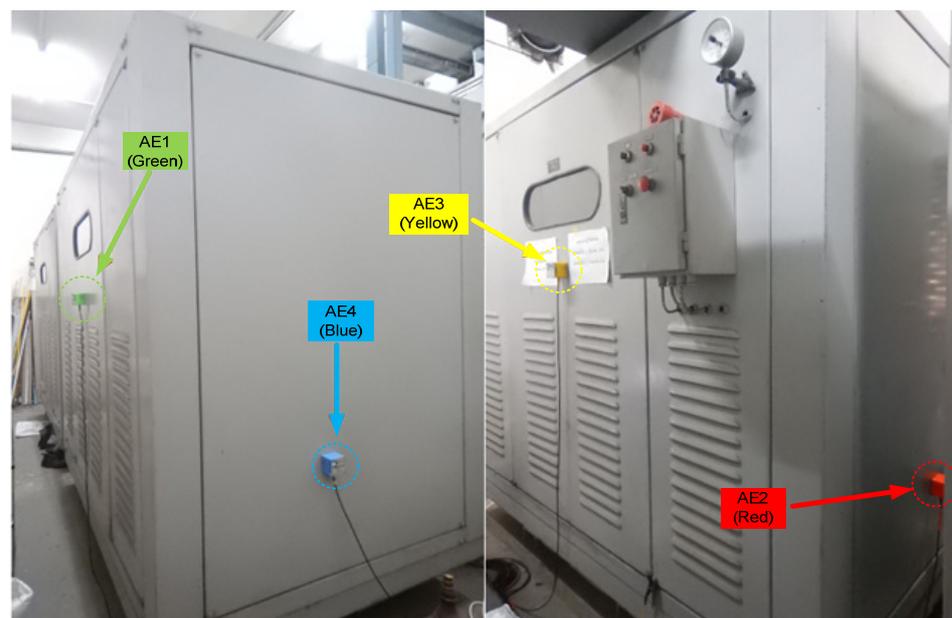
**Figure 4.** Installation of Acoustic Emission Sensor (AE1–AE4) with housing of transformer.

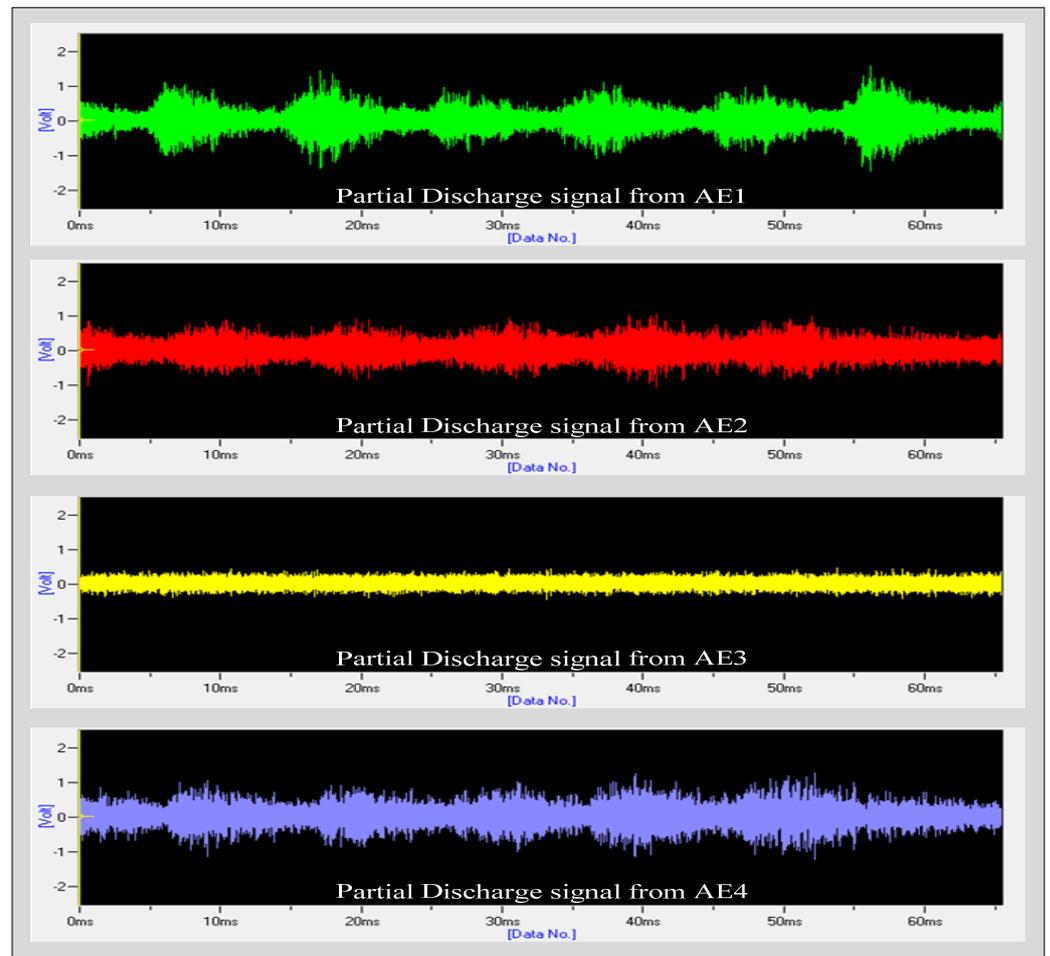
**Figure 5.** The PD signal waveform obtained from each sensor by four directions installation.

Figure 5 shows the PD signal waveforms obtained from each sensor in four directions of installation. Usually, the location of the PD by sound waves is successful only when the PD waveform has a strong amplitude and repetitive rate with the AE sensor detects at least three channels. It was observed that the PD signal by AE 3 (yellow color) was rather steady; ostensibly that, the amplitude of AE3 was minimum than AE1, AE2 and AE4. The amplitude of AE3 was minimum as the results of PD signal detection were low, which AE3 was installed with low side of this transformer and expected, the PD should not be caused from this side. It was found that the PD signal of AE1, AE2 and AE3 was unsteady, which when compared three signals, it was observed that the amplitude of AE 2 (red color) was lower than AE1 and AE4. The PD should not be caused from the AE2 installation side due to the PD signal was minimum. However, the PD signal of AE1 and AE4 cannot judge which signal was less than the others due to the fact that they have similar signals. Therefore, it is necessary to combine the signals into the same figure for easy analysis, which follows in Figure 6.

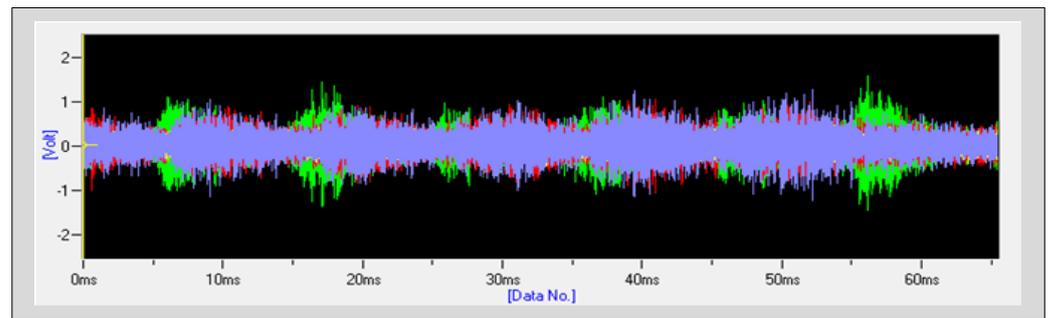
Figure 6 shows comparison of the PD signal waveform with AE1–AE4, it was observed that the PD signal by AE1 (green color) was higher than AE4 (blue color) from peak amplitude. The AE1 sensor was installed on the high side of transformer for detecting the PD signal in this experimental, while the AE4 sensor was installed on the left side of transformer when seen from high side of transformer. When the level of PD signal of AE1 was higher than AE4 with significance, thus, high possibility that the PD was generated from high side transformer which must be detail examined in next step.

**Figure 6.** The comparison PD signal waveform with AE1–AE4.

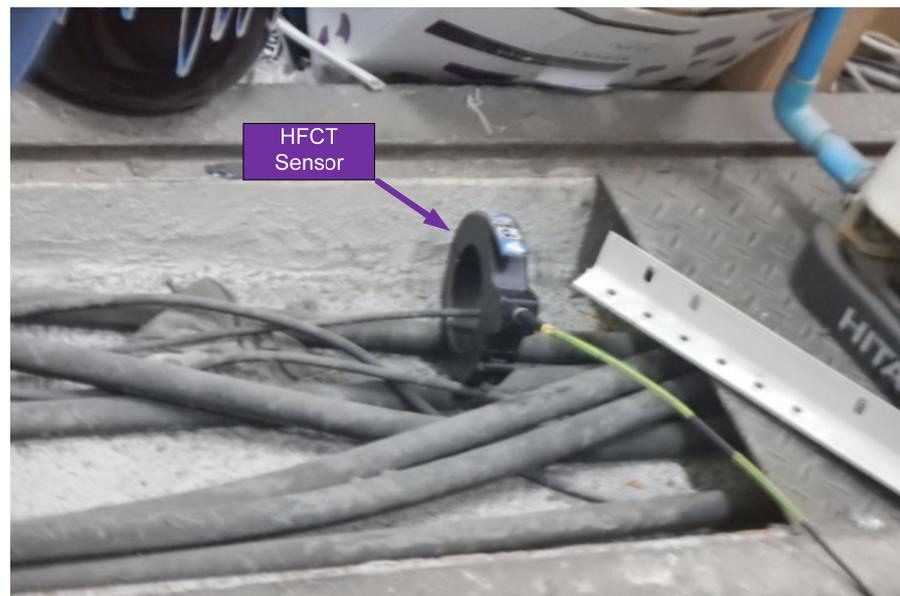
Figure 7 shows installation of HFCT at ground wire of cast-resin transformer, which the HFCT sensor was sensor number 5 at connect to PowerPD software for shown PD signal waveform. The HFCT sensor was connected to PowerPD due to it was easy to evaluate of condition level of PD with gab time can be easily seen. Figure 8 shows the PD signal waveform from HFCT sensor, it was observed that the gab time/dt was about 8 ms. Where, the signal was the electromagnetic wave signal when characterized by the discharge on the surface of the insulation (Surface Discharge) [11,23,24]. From Table 1, this data was evaluated for condition level at small PD due to gab time/dt > 7 ms. whereas this data must be examined in the next step when the AE sensor was moved to investigate the exact position of PD.

**Figure 7.** Installation of HFCT at ground wire of transformer.

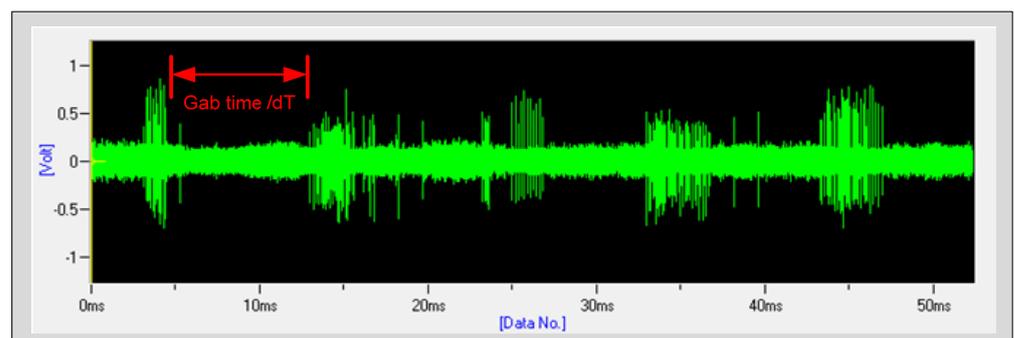
**Figure 8.** The PD signal waveform from HFCT sensor.

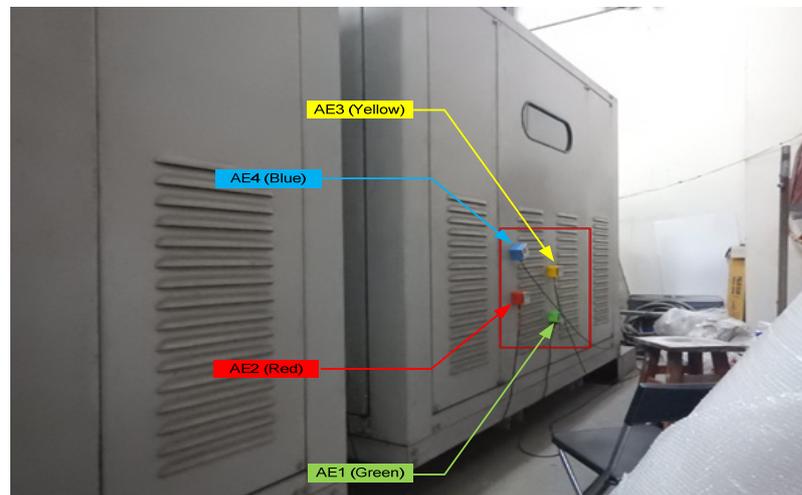
In the primary examination of partial discharge there was a PD signal from AE1 and HFCT sensor with significance which it has been, primary evaluation of condition level was small PD. However, cast-resin transformers must be insightful investigations of partial discharge for true evaluation of condition level of PD. It is well known that audio signals are considered direct path or longitudinal waves; thus, in order to identify of position of a PD source, therefore, it is necessary to signal detector as close as possible to the source. The PD signal have been a high-level signal from AE1 sensor which AE1 was installed on high side of transformer; thus, all AE sensor was moved to installation on high side of transformer in order to specify exact position from detected signal and true evaluation of PD. In Figure 5, the AE1 sensor was installed rather towards the top of the housing of the high side transformer, which usually was the part that was far from the electrical part of the transformer. Therefore, the insightful investigation of PD signal should installation of all AE sensor was near electrical part of transformer. Figure 9 shows the four AE sensor installation on housing of high side transformer which observed that AE sensor was group installation at center of housing transformer which near electrical part of transformer.

**Figure 9.** The four AE sensor installation on housing of high side transformer.

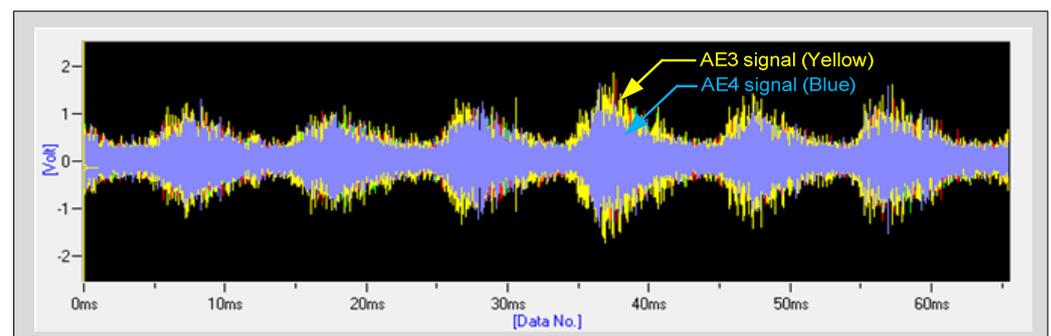
Figure 10 shows the comparison PD signal waveform when all AE sensor installation on housing of high side transformer. It was observed that PD signal form AE3 (Yellow color) was higher level than AE1 AE2 and AE4, with ostensibly where, AE4 (blue color) was a slightly lower PD signal level than AE3. It was confirmed that the position inside of cast-resin transformer at AE3 installation area had been partial discharge due to PD signal from PowerPD analysis. It was observed that all channels of PD waveform have a strong amplitude and repetitive rate which it confirmed that this location was PD source definitely.

**Figure 10.** The comparison PD signal waveform when all AE sensor installation on housing of high side transformer.

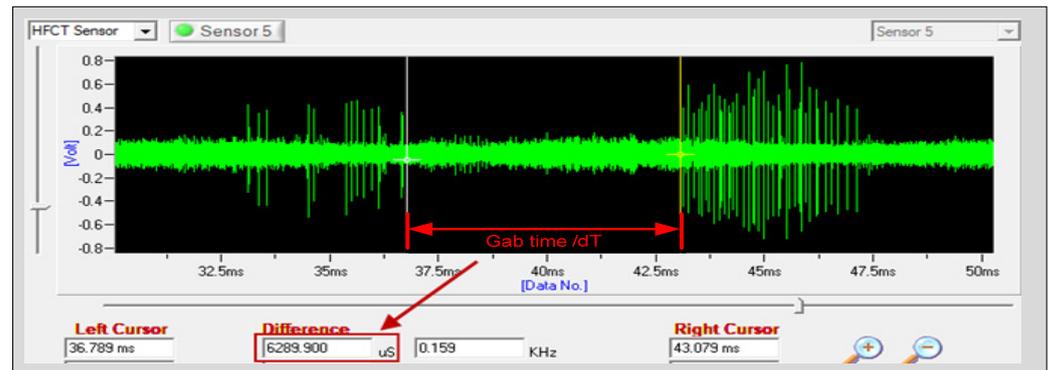
The HFCT sensor was still at ground wire of cast resin transformer (sensor number 5) and connected to PowerPD software for the shown PD signal waveform. Figure 11 shows the PD signal waveform from HFCT sensor when all AE sensor installation on housing of high side transformer. In addition, for accuracy of the evaluation, the cursor was pinned to both the left and right sides of the gab time in PowerPD software. When the value right cursor and left cursor was 43.079 ms and 36.789 ms, respectively, it was confirmed that the gab time/dt was 6.289 ms. From Table 1, The range of gab time/dt was between 3 ms to 7 ms as results of PD condition level was major PD which this PD level have been effect more than small PD from primary examination of PD.

**Figure 11.** The PD signal waveform from HFCT sensor when all AE sensor installation on housing of high side transformer.

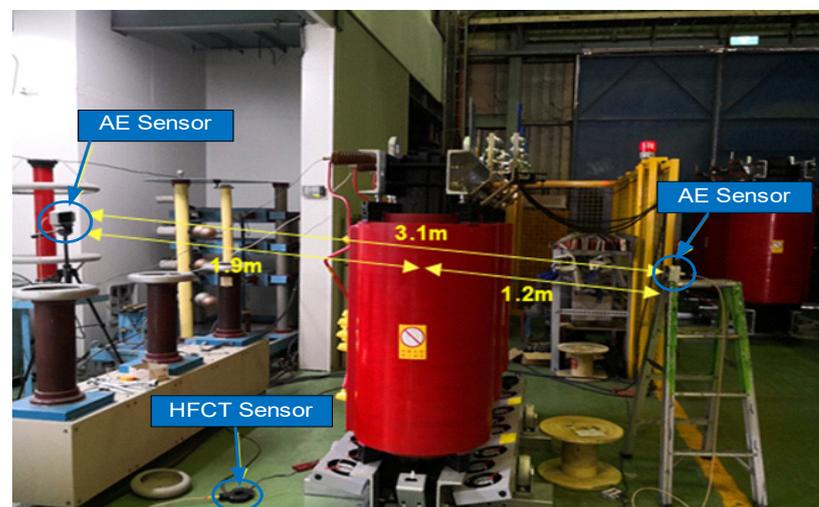
Verify the position of the PD source of cast-resin transformer to confirm the inspection results and analyze from AE sensor and HFCT sensor detection from the primary examination of partial discharge and the insightful examination of Partial Discharge. Figure 12 shows installation of AE sensor and HFCT sensor without housing of transformer. The cast-resin transformer has been removed housing, next, installation of two AE sensor and HFCT sensor. Since there is confirmation of the occurrence of partial discharge on the high-voltage side of cast-resin transformer. Thus, the 1st AE sensor was installed on the high-voltage side approximately 1.9 m from the center of the transformer. The 2nd AE sensor was installed in the opposite direction to the 1st AE sensor approximately 1.2 m from the center of the transformer on the low-voltage side. The two AE sensors have been located at approximately a distance of about 1.9 m. The HFCT sensor was installed at the ground wire of the cast-resin transformer.

**Figure 12.** Installation of AE sensor and HFCT sensor without housing of transformer.

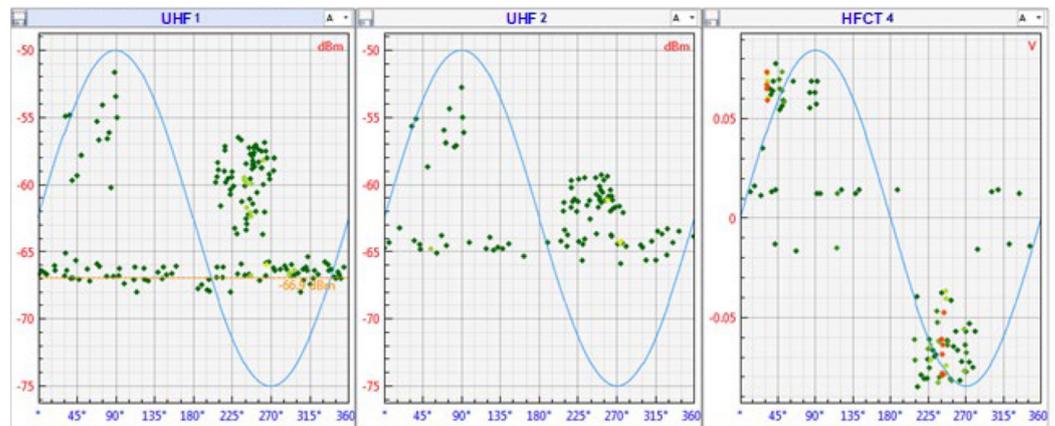
Figure 13 shows partial discharge when AE1, AE2 and HFCT sensor (UHF1, UHF2 and HFCT4, respectively) detection. The point in the graph was detection of partial discharge, which also shows a sinusoidal waveform for comparison. It was found that all sensors have detected PD, whereas the detection of AE1 sensor and AE2 sensor can have been more than HFCT sensor, which it was observed from point in graph. Furthermore, the distance of partial discharge calculation using the sensor input time difference (TDoA) method [25,26]. From the PD detection results to be processed to find the PD source, it was found that the distance between the PD source and the AE1 sensor was approximately 0.9 m.

Figure 13. Partial discharge when AE1, AE2 and HFCT sensor detection.

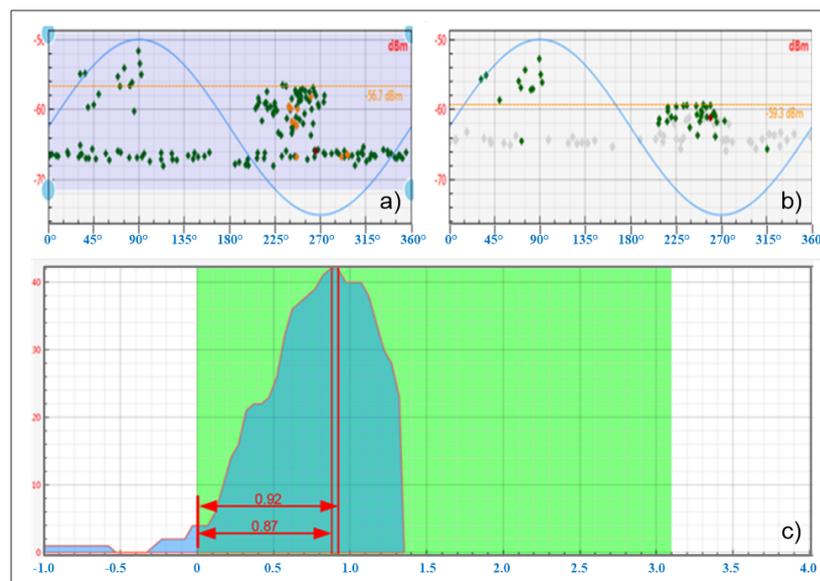
Figure 14 shows the distance of the PD source obtained from the two AE sensors. When using software analysis of PD distance, it was found that PD source distance was 0.87 to 0.92 m, which obviously that distance value between calculation with TDoA method and software analysis have been similar. It also confirmed the use of the AE sensor to accurately determine distance from the PD source. In addition, the AE sensor for PD detecting was able to accurately determine the location of the PD source even, in case of housing of transformer [27–29].

Figure 14. The distance of the PD source obtained from the two AE sensors. (a) partial discharge from AE1 (b) partial discharge from AE2 (c) distance of sensor detection.

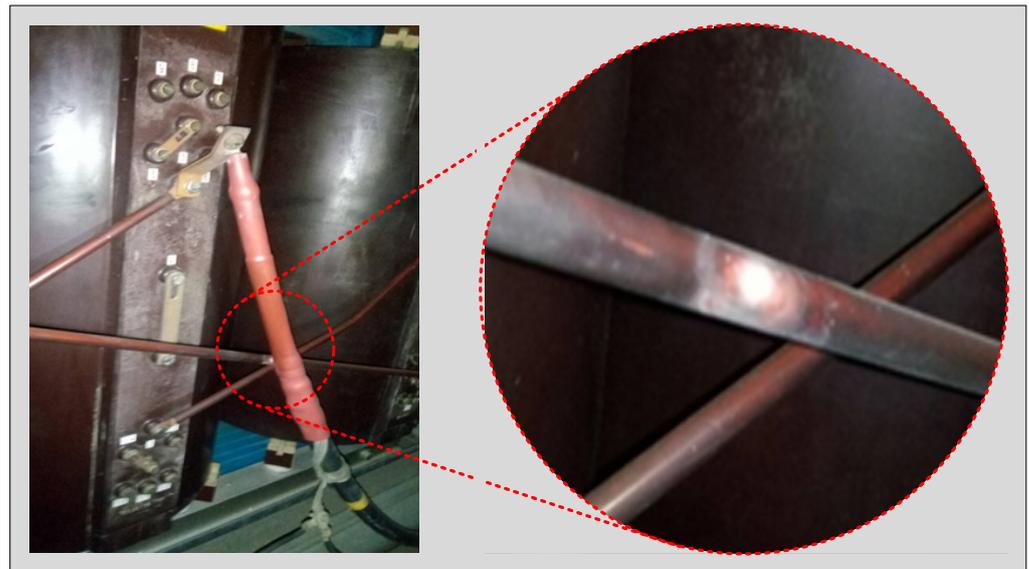
Figure 15 shows evidence of partial discharge on the insulator surface of the high-voltage side. From the primary and insightful examination of partial discharge using AE

sensor with HFCT sensor with housing or tank of transformer which it which could not see any vestige of damage from partial discharge. Therefore, in order to confirm that the AE sensor and HFCT sensor have been, an ability to located, the housing of transformer was removed. It was found that there is the PD on the surface of the insulation between the terminal of phase B and the high-voltage tap bar. Furthermore, it has been found that it was detected obviously of partial discharge on the surface and inside in the insulation of transformer; consequently, this is a significant effect on the result. Thus, the equipment would be immediately shut down, correction would be carried out, and the transformer would be put to normal use.

**Figure 15.** The evident of partial discharge on the insulator surface of high voltage side.

This research uses the AE and HFCT sensors to measure and determine the position of partial discharge in the transformers. The experimental has been three parts was the primary and insightful examination of partial discharge, for Identify the possibility of partial discharge, which includes the position of partial discharge in first part and second part. The final part was the position examination of partial discharge source which it was the verify the position of the PD source of cast-resin transformer to confirm the inspection results and analyze from AE sensor and HFCT sensor detection in the first two parts. The AE and HFCT sensors could certainly be used for detecting the location of the PD source, which confirmed by calculation using TDoA method and software analysis, have been 0.9 m and 0.87–0.92 m, respectively. In addition, the evident partial discharge on the insulator surface of the high-voltage side could also confirm this very well.
