Article

Mechanical Properties and Failure Mechanism of Granite with Maximum Free Water Absorption under Triaxial Compression

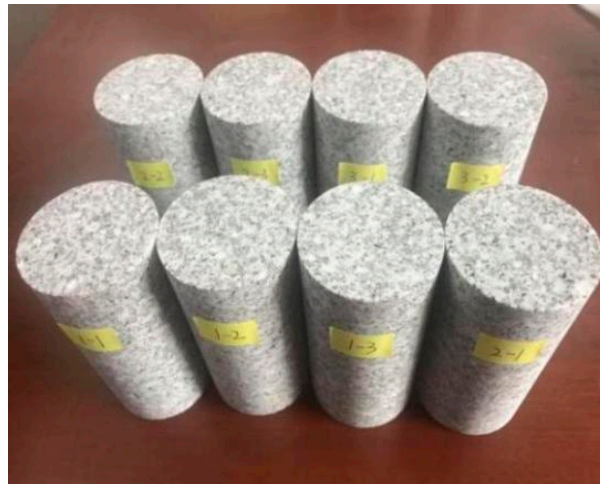
Figure 1. Demonstration photographs of some samples.

A complete crack-free granite block was extracted from an underground water-sealed storage cavern in Shandong province, China, and cylindrical rock samples with a diameter of 50 mm and an aspect ratio of 2 were obtained from this material. Some of the samples are shown in Figure 1. The stipulations of the *Standards for Engineering Rock Mass Test Methods* [34] were followed to ensure the representativeness and accuracy of each sample after processing.

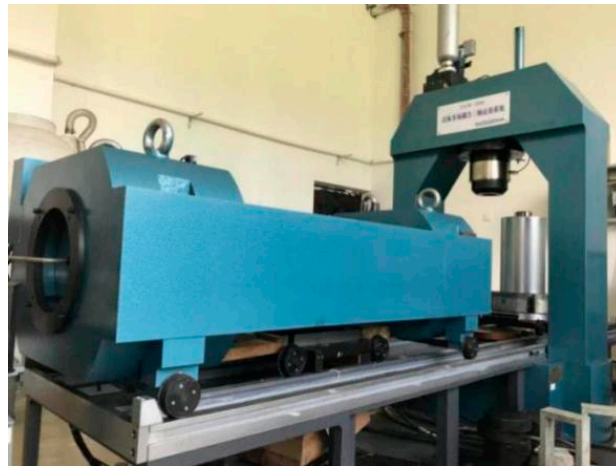
A total of 15 samples were selected for triaxial compression test research and divided into five groups according to different confining pressures, with three samples in each group. The instrument used in the triaxial compression test was a TAJW-2000 rock mass multi-field coupling triaxial test system (Figure 4). The stress control method was used to increase the confining pressure at a rate of 0.05 MPa/s until the specified confining pressure [34]. After the confining pressure was stabilized, the specimen was loaded to failure at a displacement rate of 0.003 mm/s.

Figure 4. TAJW-2000 rock mass multi-field coupling triaxial test system.

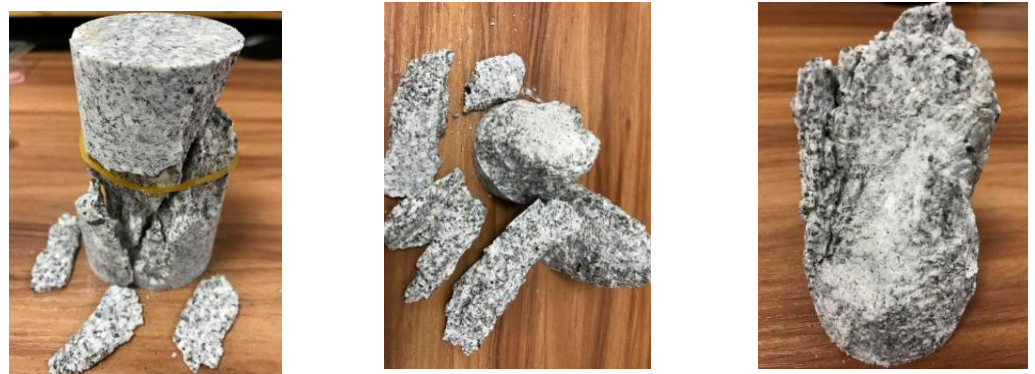
Figure 9. Cont.

The failure diagram with confining pressure at 0 MPa, is shown in Figure 9. There was no phenomenon in the sample for a long time. With continuous application of the load, microcracks were gradually generated and then the clear and brittle sound of the rock sample cracking could be heard; however, the surface of the rock sample was not destroyed, but particle ejection occurred at the corner of the rock sample, producing flake spalling debris. With continuous loading, the microcracks continued to extend from both ends to the middle. Finally, the microcracks became interconnected; the rock sample lost its bearing capacity instantly and collapsed loudly.

Figure 9. Test results and failure modes of granite with confining pressure at 0 MPa.

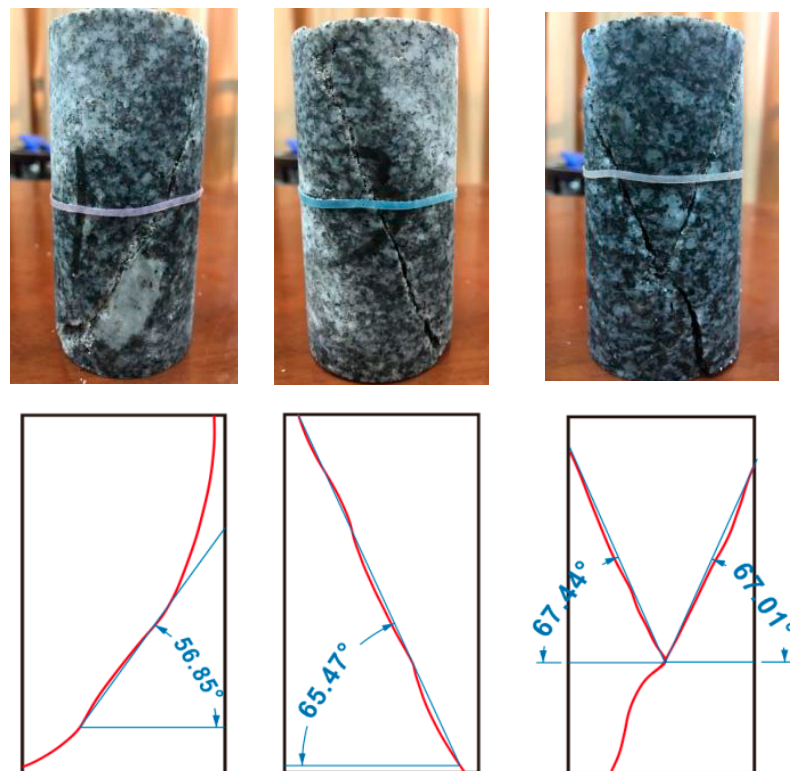
Figure 12 shows the failure diagrams when the confining pressure was 15 MPa. A further increase in the confining pressure further limited the lateral deformation of the specimen, and the specimen after failure remained complete. The fracture surface of the specimen was inclined, and the inclination angle of the fracture surface was 56–68°. It was found that conjugate inclined fracture surfaces formed in some samples with the inclination angles of the two fracture surfaces being approximately the same.

Figure 12. Test results and failure modes of granite with confining pressure at 15 MPa.

Through a study on the failure characteristics and fracture surface morphology of granite under triaxial compression with different confining pressures, it was found that the vertical fracture surface was dominant under low confining pressures, the inclined fracture surface was dominant under medium and high confining pressures, and the dip angle of the fracture surface decreased with the increase in confining pressure. The average angle of the fracture surface decreased from 66° (10 MPa) to 65° (15 MPa) to 63° (20 MPa).
