# Assessment of Rainwater Quality Regarding Its Use in the Roztocze National Park (Poland)—Case Study

**Abstract:** The aim of this study was to determine the quality of rainwater and the possibility of using it for various purposes in the Roztocze National Park (RNP), Poland. This study was carried out in 2021–2022. Samples of rainwater that drained from the roofs of farm buildings in the RNP were tested for their organoleptic, physicochemical and microbiological qualities. The organoleptic tests were run to evaluate the water for a foreign odour and the threshold odour number. The physical and chemical tests included turbidity; colour; pH; conductivity; concentrations of ammonium ions, nitrates, nitrites, manganese, iron and chlorides; and general hardness. The microbiological tests included total microbial counts at 36 °C and 22 °C, coliform bacteria, *Escherichia coli*, intestinal enterococci and *Pseudomonas aeruginosa*. The rainwater quality results were compared with the quality parameters of surface water collected from the River Świerszcz, as well as with the Polish drinking water standards. The findings indicated that rainwater collected in the RNP had good organoleptic,

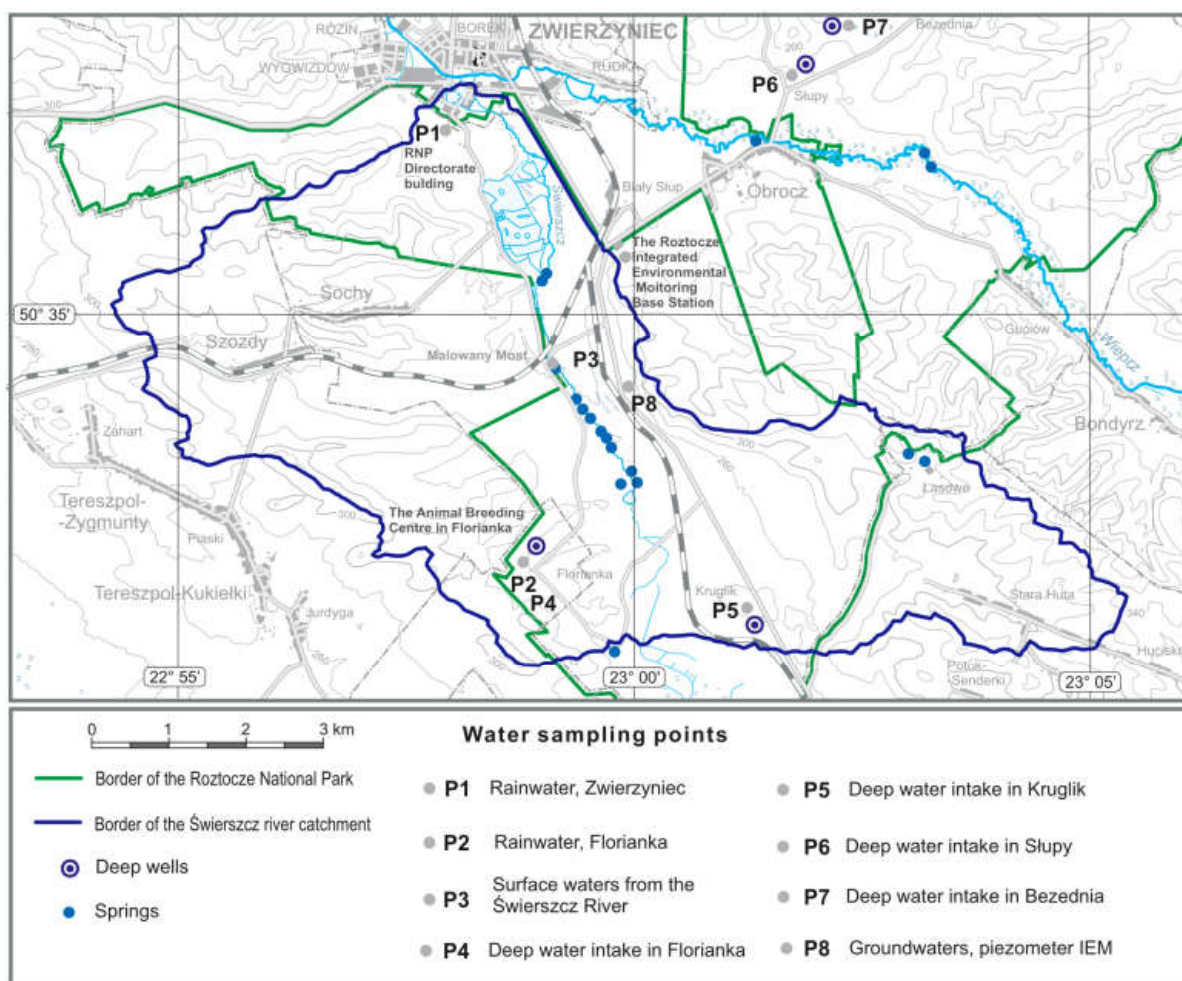
**Figure 1.** Location of water-sampling points in the Świerszcz river catchment. Own elaboration.

located the rainwater, surface water and groundwater sampling points from which water was collected for the physicochemical, organoleptic and microbiological tests reported in the present study (Figure 1).

from deep wells in the RNP's forest settlements of Florianka, Kruglik, Słupy and Bezednia, respectively (Figure 1).

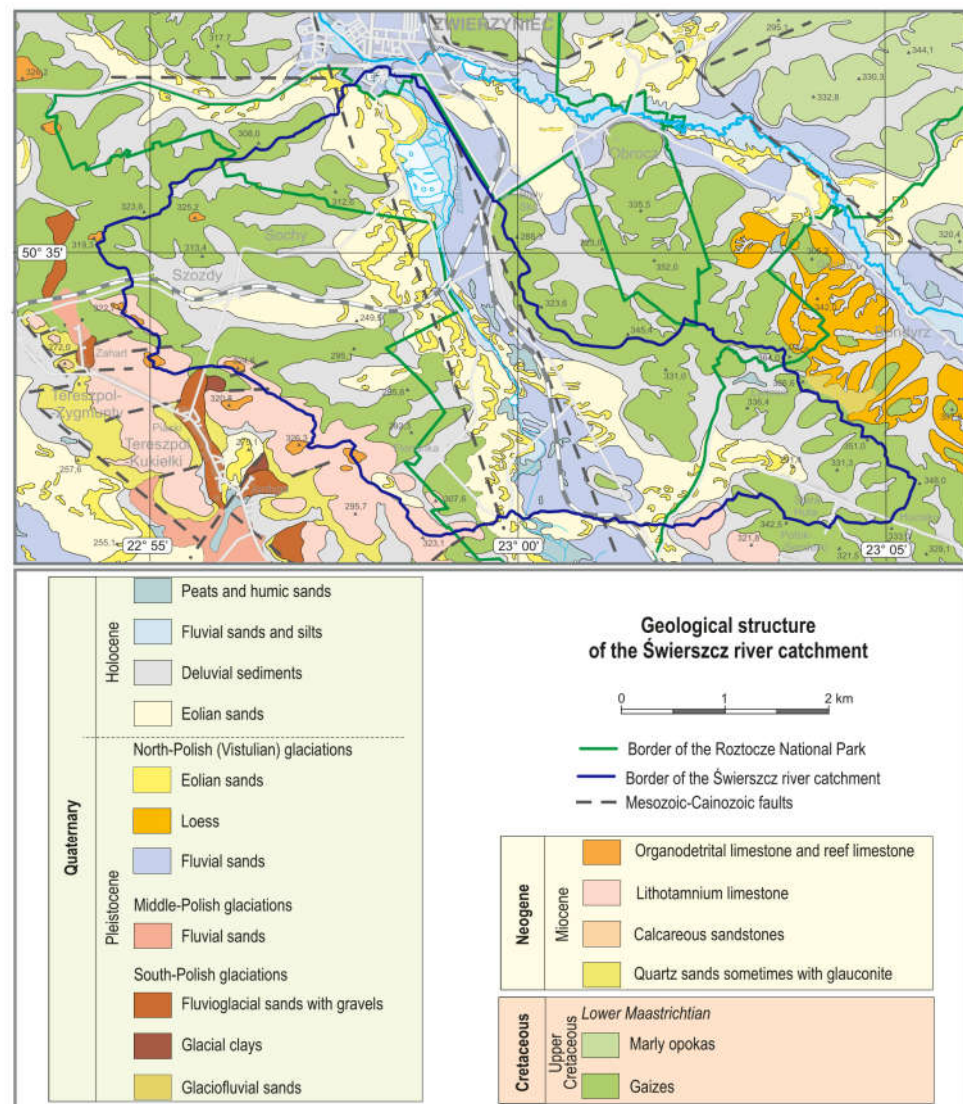
**Figure 2.** Geological structure of the River Świerszcz catchment. Own elaboration based on [26].

The catchment of the River Świerszcz is part of two subregions: Roztocze Szczebrzeszyńskie and Roztocze Tomaszowskie [25]. The catchment is crossed from NE to SW by the valley of the Świerszcz stream and is lined with river and aeolian sands, forming dune ridges and dunes. The eastern and western parts of the catchment are covered with Upper Cretaceous gaizes, marls and opokas [26] (Figure 2).

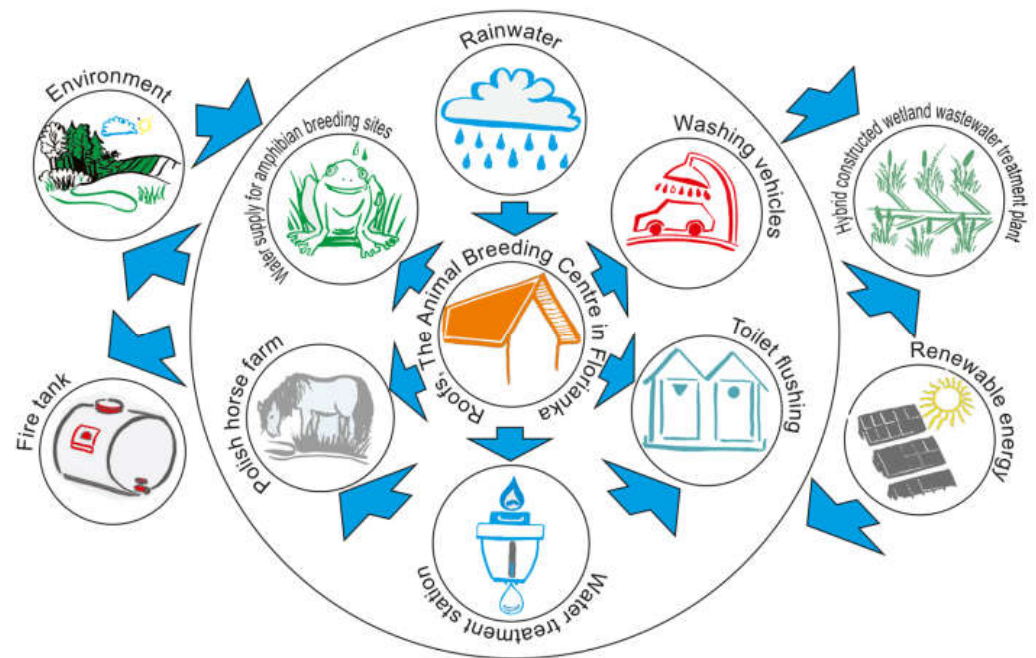
**Figure 3.** Schematic model of the rainwater applications in the designed RWHS.

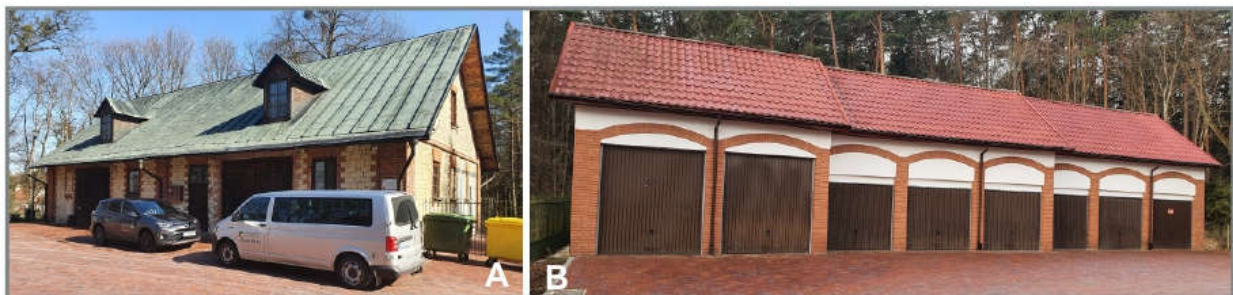
**Figure 4.** RNP directorate area: (A) historic farm building and (B) garages.

Water quality tests for this study were carried out in the RNP in the years 2021–2022. They included the determination of selected microbiological, organoleptic and physico-chemical properties of rainwater, surface water and groundwater. The analysis covered (1) P1—the quality of rainwater collected from the roofs of two farm buildings located close to the RNP Directorate building in Zwierzyniec, which was stored in a concrete tank with a capacity of 20 m<sup>3</sup> (Figure 4); (2) P2—the quality of rainwater harvested from two roofs of farm buildings located in the Animal Breeding Centre in Florianka (Figure 5); (3) P3—the quality of surface water sampled from the River Świerszcz in the so-called “Malowany most” profile (Figure 6); and (4) P4, P5, P6 and P7—the quality of groundwater sampled

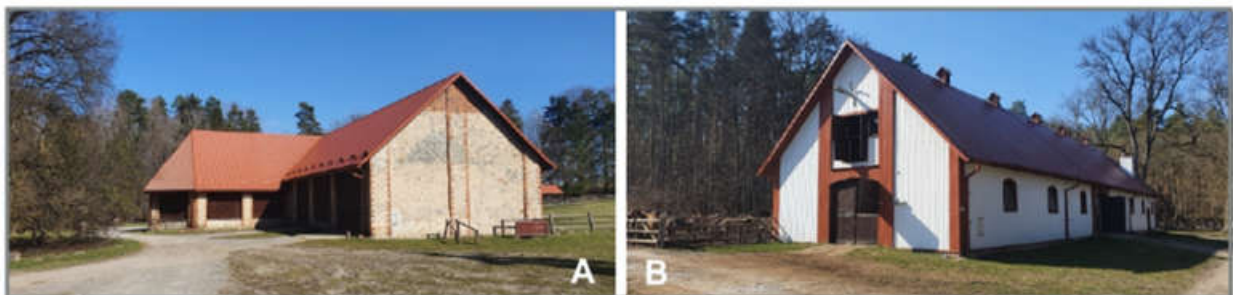
**Figure 5.** The Animal Breeding Centre in Florianka: (A) barn and (B) horse stables.

The ongoing climate change and the increasing demand for water lead, among other issues, to the lowering of the groundwater level and a decrease in well efficiency. This phenomenon was observed in Florianka, which is a unique settlement on the map of the RNP. Florianka is home to the Animal Breeding Center devoted to the conservation of the Polish konik horse, which is the official symbol of the park, and primitive cattle and sheep breeds: white-back cows, red cows and Uhruska sheep. There is also a field base for educational and tourist activities called Izba Leśna (Forest Room). Approx. 35,000 tourists visit this place every year. In the lower section of the River Świerszcz, there is a “sanctuary” of the Polish konik horse. A herd of up to 25 horses lives here throughout the year, grazing in an area of approx. 260 ha.

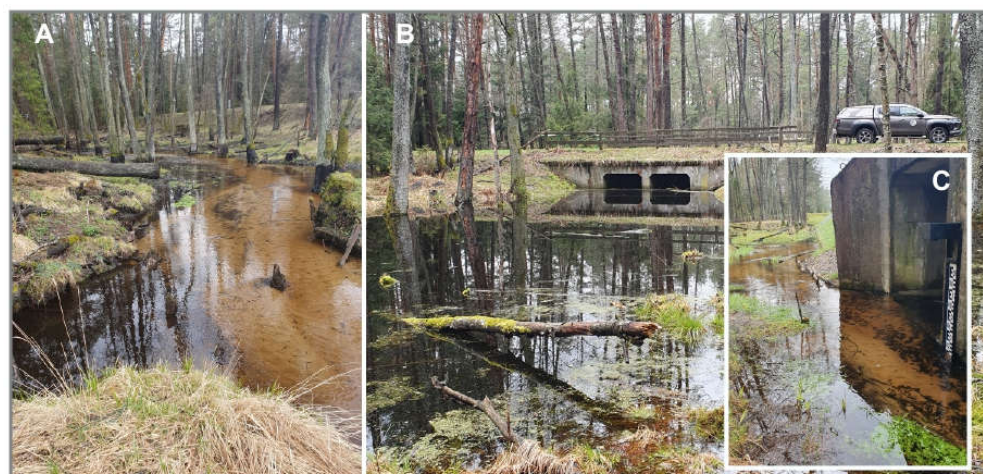
**Figure 6.** The River Świerszcz in the “Malowany most” profile: (A) riverbed, (B) view on the bridge and (C) sampling point (P3).

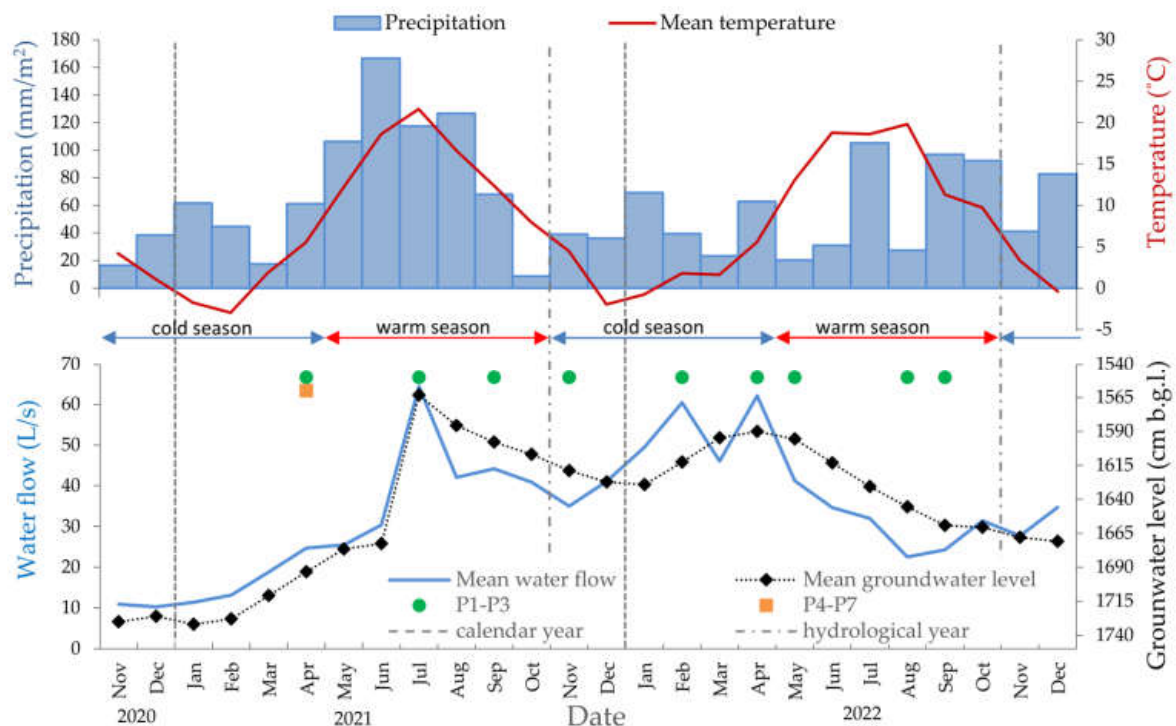
**Figure 7.** Hydrometeorological conditions in the test period and water sampling dates: P1–P3 (rainwater and flowing water) and P4–P7 (groundwater).

As stated in the previous section, the quality tests of various types of water from the catchment of the River Świerszcz were carried out in the years 2021–2022. In order to determine the quantitative background for the waters tested, we also analysed the meteorological (temperatures and precipitation) and hydrological (water flow and groundwater levels) conditions in the catchment of the River Świerszcz recorded for the same period (Figure 7).

and winter months (October to March) (Figure 7). As the data show, the distribution of precipitation in the hydrological year 2020/2021 was similar to that observed in the years 2001–2020 [32]; however, the total precipitation in the spring and summer months of 2020/2021 was much higher than in the 20-year period. A different situation was observed in 2021/2022, with similar total monthly precipitation levels across the year (Figure 7), which was favourable from the point of view of nature. Although the total rainfall in July 2022 was high at 105 mm, June and August of that year received only 31 and 27 mm of rain, respectively, making it a very dry summer. Furthermore, the possibility of harvesting and storing rainwater in this period was very limited. Fortunately, higher precipitation levels in the autumn and winter months of the hydrological year 2021/2022 recharged the groundwater table and increased the flow rates of the River Świerszcz (Figure 7).

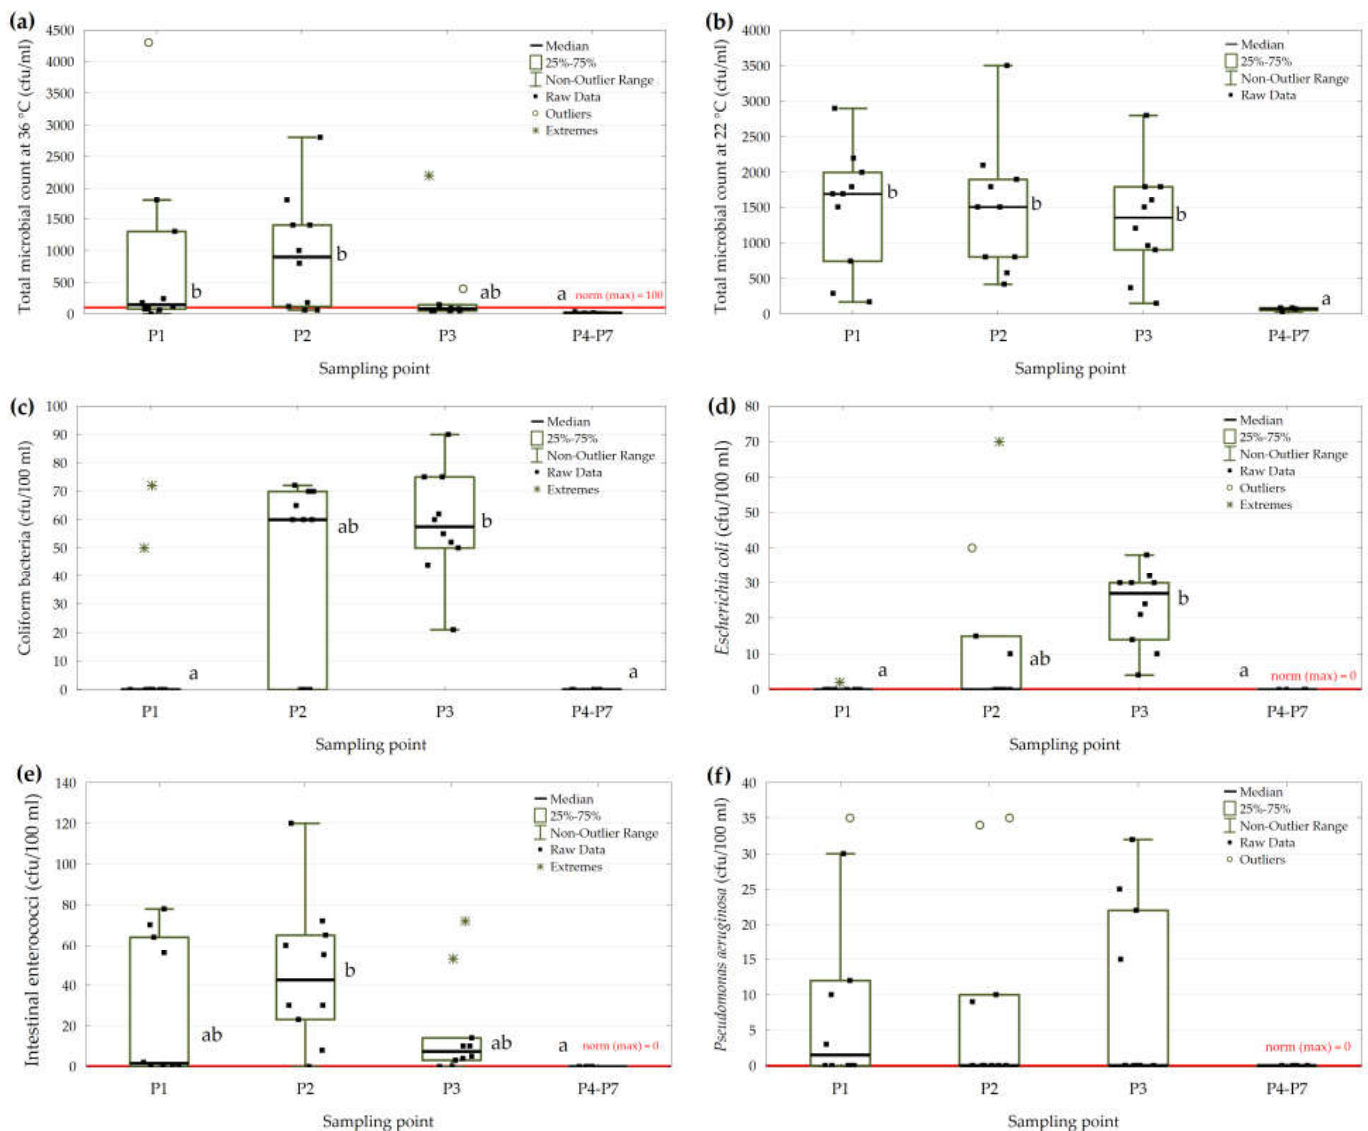
**Figure 8.** Boxplots for microbiological parameters of the investigated water types. A comparison of the quality of rainwater (P1, P2), river water (P3) and water from deep wells (P4–P7) with drinking water standards. <sup>ab</sup> Distributions of results in groups not containing the same letter differed significantly at  $\alpha = 0.05$  (Kruskal–Wallis test). Boxplots for: (a) total microbial counts at 36 °C, (b) total microbial counts at 22 °C, (c) coliform bacteria, (d) *Escherichia coli*, (e) intestinal enterococci, (f) *Pseudomonas aeruginosa*.

Statistically significant differences were found in the distribution of the total microbial counts at  $22\text{ }^{\circ}\text{C}$  (Kruskal–Wallis  $H = 10.67$ ,  $p = 0.014$ ). The rainwater collected at points P1 and P2 contained significantly more bacteria than the water sampled from deep wells, but no significant differences were found relative to the flowing water at P3 (Figure 8b).

Relationships similar to those for coliform counts were found for *Escherichia coli* (Kruskal–Wallis  $H = 19.06$ ,  $p < 0.001$ ) (Figure 8d). Again, the deep waters (P4–P7) were the only ones to comply with the drinking water standard [36]. In rainwater collected at sampling point P1, *Escherichia coli* was found only once, namely, in July 2021, and its count exceeded the drinking water limit (Table 3). Compliance with drinking water standards for rainwater was 90% and 40% for P1 and P2, respectively. The largest counts of *Escherichia coli* were found in water coming from the River Świerszcz.

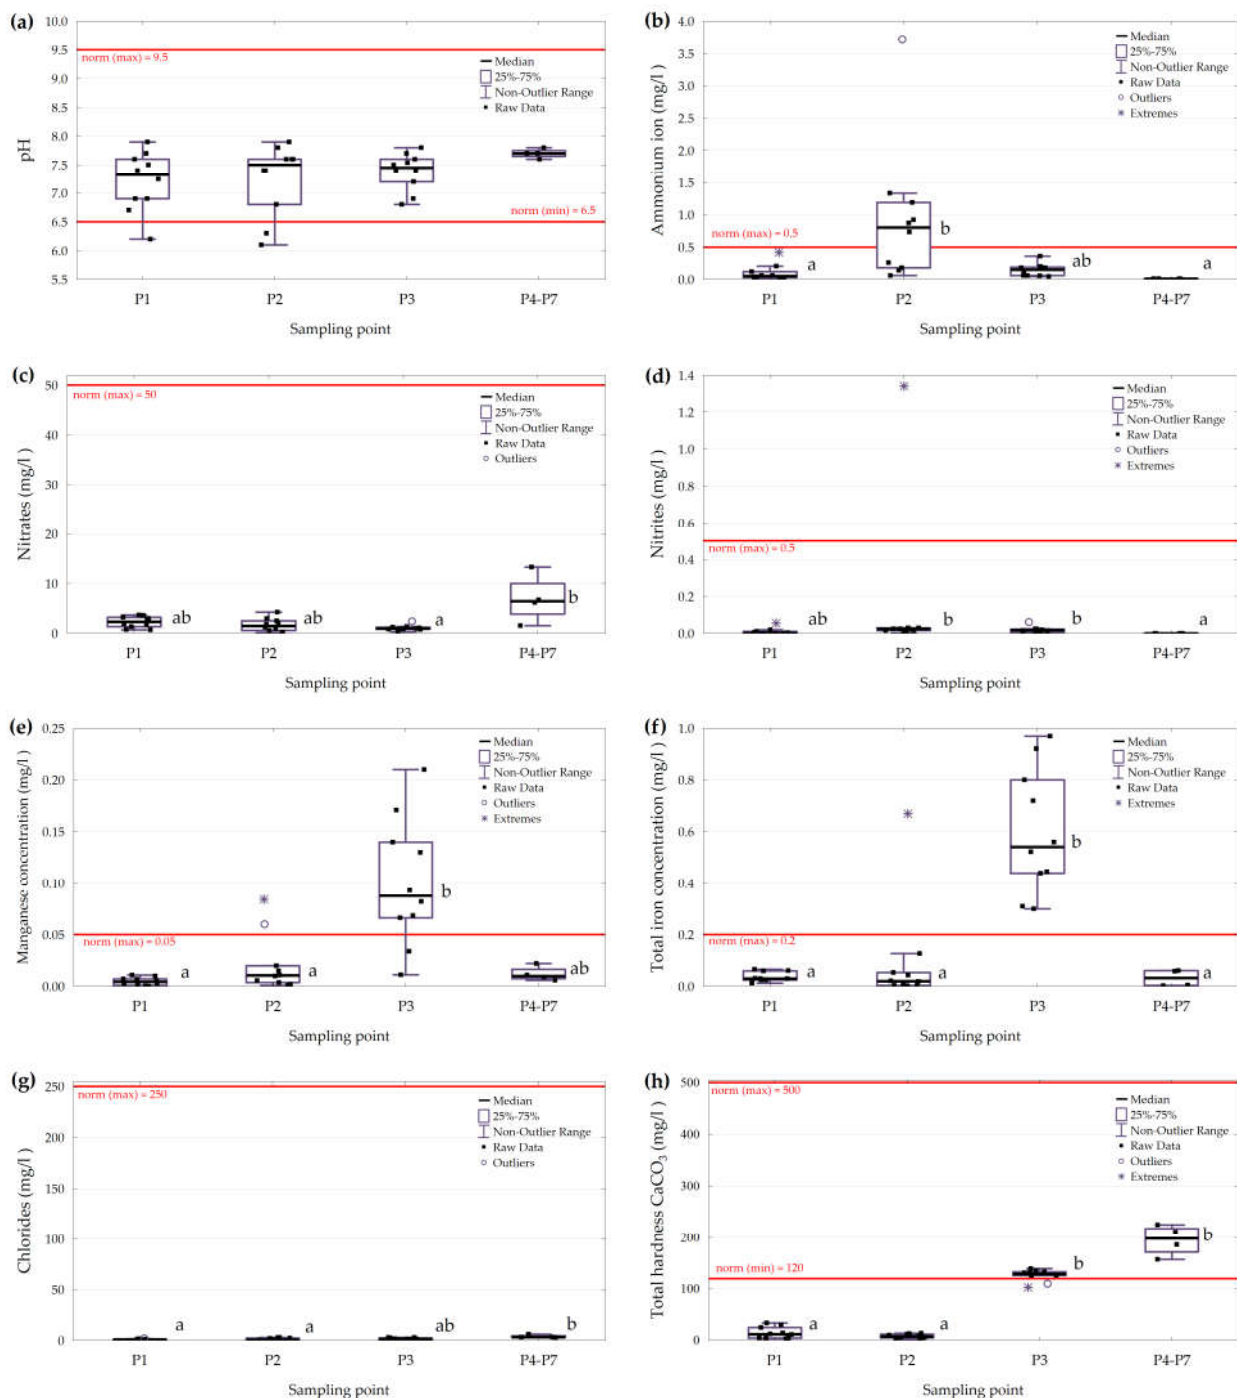
**Figure 10.** Boxplots of the chemical parameters of the tested water groups. A comparison of the quality of rainwater (P1, P2), river water (P3) and water from the deep wells (P4–P7) with the corresponding drinking water standards. <sup>ab</sup> Distributions of results in the groups not containing the same letter differed significantly at  $\alpha = 0.05$  (Kruskal–Wallis test). Boxplots for: (a) pH, (b) ammonium ion, (c) nitrates, (d) nitrites, (e) manganese, (f) total iron, (g) chlorides, (h) total hardness  $\text{CaCO}_3$ .

In the case of chlorides, the drinking water standard of 250 mg/L was not exceeded in any of the measurement points (Figure 10g). The lowest content of chlorides was found in rainwater (P1 and P2) and the highest was found in groundwater (P4–P7).
