# Degradation of Hydraulic System due to Wear Particles or Medium Test Dust

**Abstract:** Contamination in hydraulic systems is the cause of 70% of failures. This study highlights the performance degradation caused by solid particle contamination of hydraulic components: hydraulic gear pump, 4/3 valve, and orbital motor. Experimental durability tests of components with wear particles and test dust are used to investigate the effects of accelerated wear caused by these two types of contaminants. Results show that oil contaminated with wear particles reduces the volumetric efficiency of the gear pump by 18% and the hydraulic valve by only 0.8%, while oil contaminated with test dust reduces the efficiency of the pump by 76% and the hydraulic valve by 0.9%. This research provides insights for accelerating hydraulic component testing to improve system reliability and longevity.

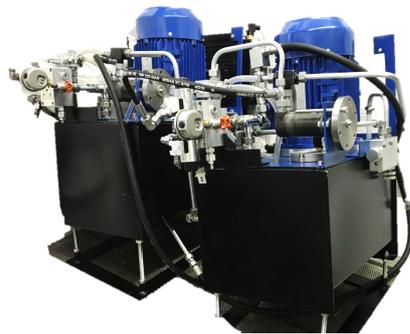
**Figure 1.** Two identical hydraulic system durability test rigs with wear particles (right, front) and test dust (MTD) (left, rear).

Two identical hydraulic test rigs were set up in our laboratory. The effect of oil cleanliness in the hydraulic system on the durability of the system itself was tested, and the effect of wear particles or test dust (MTD) was compared. Figure 1 shows both test rigs, with wear particles added to the first test rig (right) and test dust added to the second test rig (left). Initially, 30 L of hydraulic oil ISO VG 46 was added to both units. Flow through the 2SP A06 D 10-G gear pump was measured at a displacement of 6 cm<sup>3</sup>/rev and a pressure of up to 270 bar. Internal leakage was measured on a 4/3 directional control valve with a solenoid model DS3-S1/11-N-D24K1. In the zero position of the directional control valve, all ports were closed (P, T, A, B). The oil temperature in the tank was about 65 °C. The thermostat, which switched the oil cooling on or off, was set to 60 °C. The directional control valve was switched with a frequency of 5 Hz.

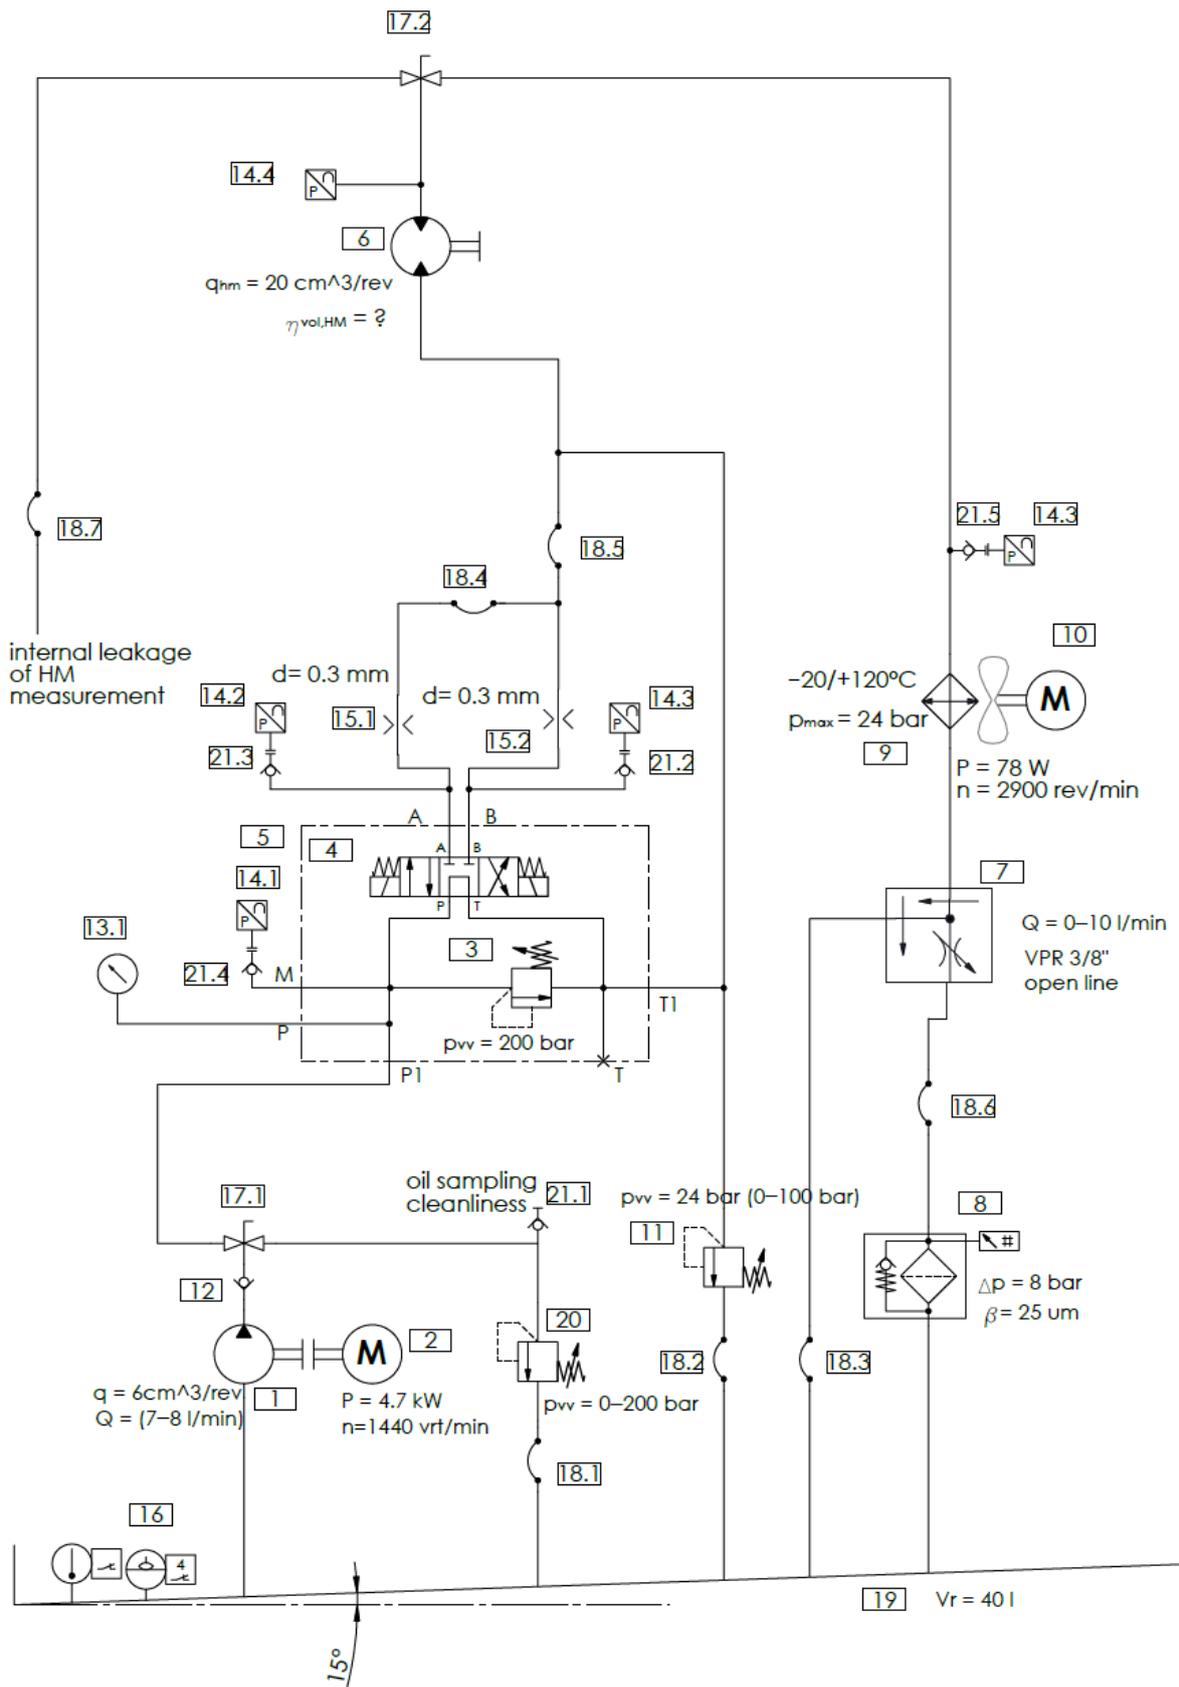
Figure 2. Hydraulic scheme for durability test of hydraulic gear pump.

The pump (pos. 1, Figure 2) sucked the oil from the tank (pos. 19, Figure 2), which was inclined at an angle of 15° (to prevent particles from settling, the suction pipe was located at the lowest point (corner) of the tank), and pushed the oil through the check valve (pos. 12, Figure 2) to directional 4/3 valve with solenoid (pos. 4, Figure 2). During the parallel or diagonal positions of the valve, the oil flowed through working lines A or B, the orifices (pos. 15, Figure 2), hydraulic motor (pos. 6, Figure 2), manually operated 3/2 valve (pos. 17, Figure 2), cooler (pos. 9, Figure 2), priority valve (pos. 7, Figure 2), filter (pos. 8, Figure 2), and back to the reservoir (pos. 19, Figure 2). The priority valve can be set to an adjustable pressure differential so that it can divert the oil flow around the filter into reservoir. In this way, the oil can be filtered and the cleanliness level is consequently

The volumetric efficiency of the gear pump was measured with an additional pressure relief valve by switching the manually operated 3/2 ball valve (pos. 17.1, Figure 2), which returned the oil to the tank through the pressure relief valve (pos. 20, Figure 2). Measurements were made at four different pressures: 0 bar, 100 bar, 150 bar, and 200 bar. Then, flow rates were measured with a stopwatch and a weight scale, weighing the oil volume in graduated cylinder. From the density of the oil and the weight of the oil, the volume of the oil and thus the flow rate, according to Equation (1), were indirectly determined:

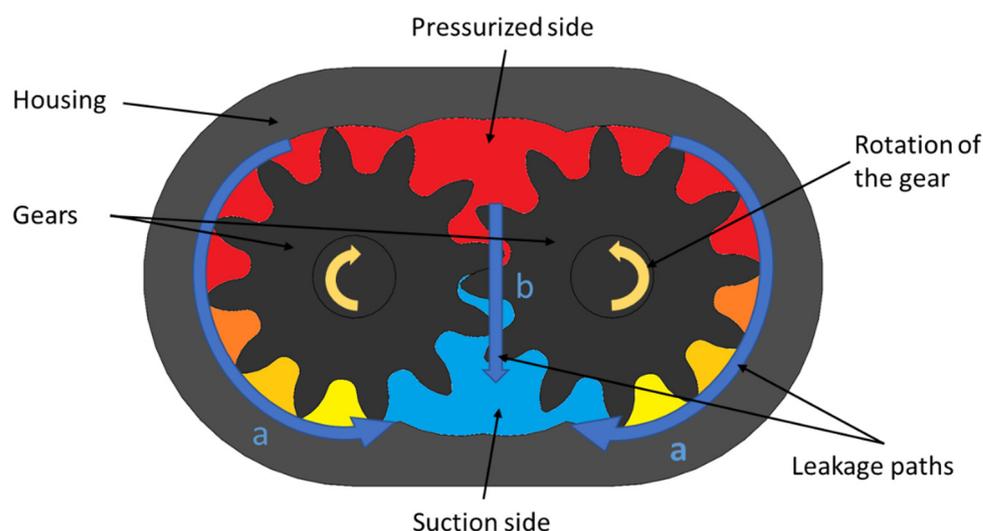
**Figure 3.** Schematic representation of leakage paths: (a) between the gear and housing and (b) between the two gears.

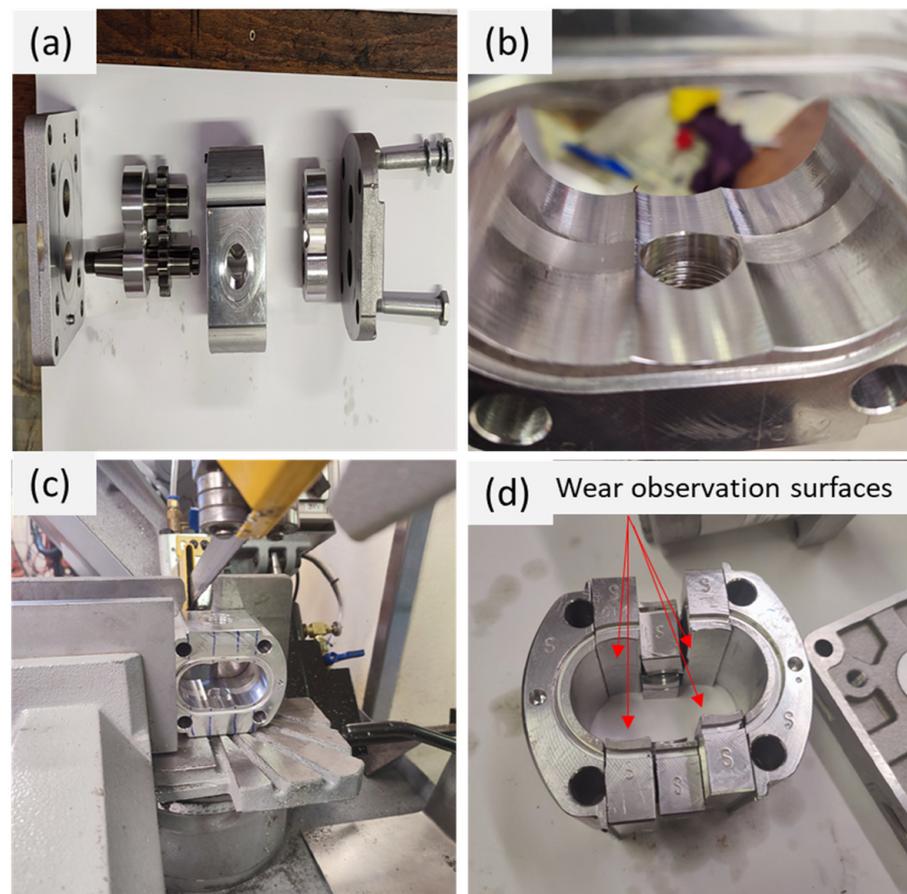
**Figure 4.** (a) Disassembled gear pump, (b) wear of pump housing, and (c,d) cutting the pump housing and observing the wear on housing with digital microscope.

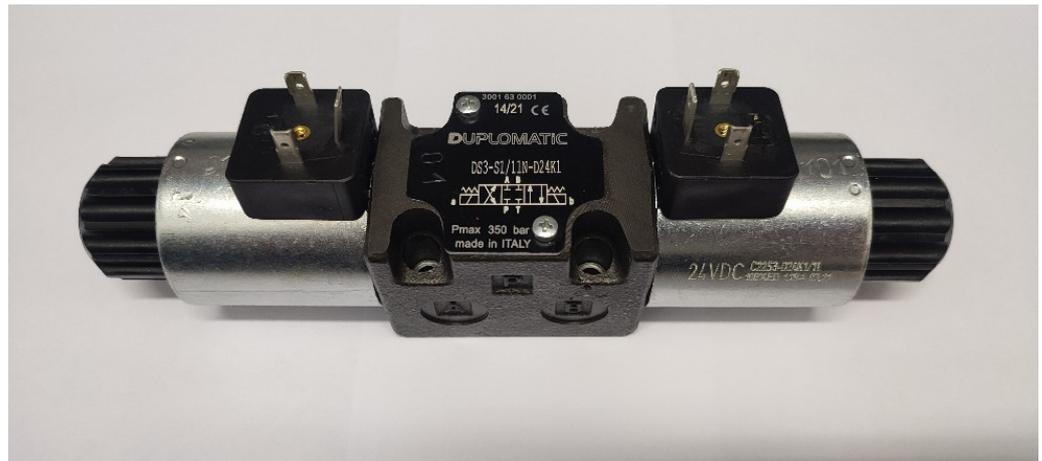
**Figure 5.** Hydraulic directional 4/3 valve DS3-S1/11 N-D24 K1 with A, B, T, and P ports closed in neutral position.

The hydraulic directional 4/3 valve in Figure 5 was used to perform durability tests. The internal leakage of the directional 4/3 valve was measured at ports A and B when the valve was in the zero position, the pressure in the P line was 200 bar, and the T line was continuously relieved. The valve code was DS3-S1/11-N-D24K1 and was intended for controlling the direction of the flow. The valve had static mineral oil-resistant seals, 24 V solenoids controlling the spool in the housing, and standard electrical control connections (DIN 43650).

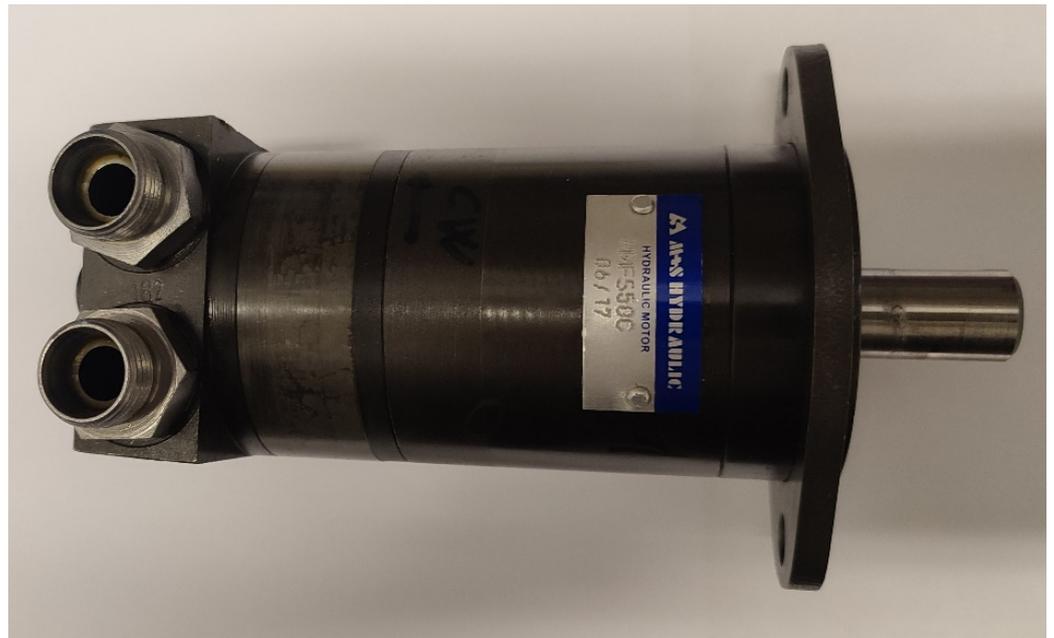
**Figure 6.** Hydraulic motor type MMFS50C.

The hydraulic motor manufactured by M+S Hydraulic (Figure 6), type MMFS50C, has a displacement of  $50\text{ cm}^3/\text{rev}$  and a maximum rotation speed of 400 rpm. The maximum continuous torque that can be achieved is 45 Nm, and the maximum output power is 3.2 kW. The maximum pressure difference between inlet and outlet pressures can be 105 bar, and the maximum flow rate can be 25 L/min. The minimum rotation speed is 20 rpm. For the motor to work, the fluid must be mineral oil based. The working temperature of the fluid should be in the range between  $-40$  and  $+140\text{ }^{\circ}\text{C}$ , and the optimum viscosity of the fluid is between  $20\text{ mm}^2/\text{s}$  and  $75\text{ mm}^2/\text{s}$ . The required cleanliness of the fluid for the operation of the hydraulic motor is 18/16/13 according to the standard ISO 4406.

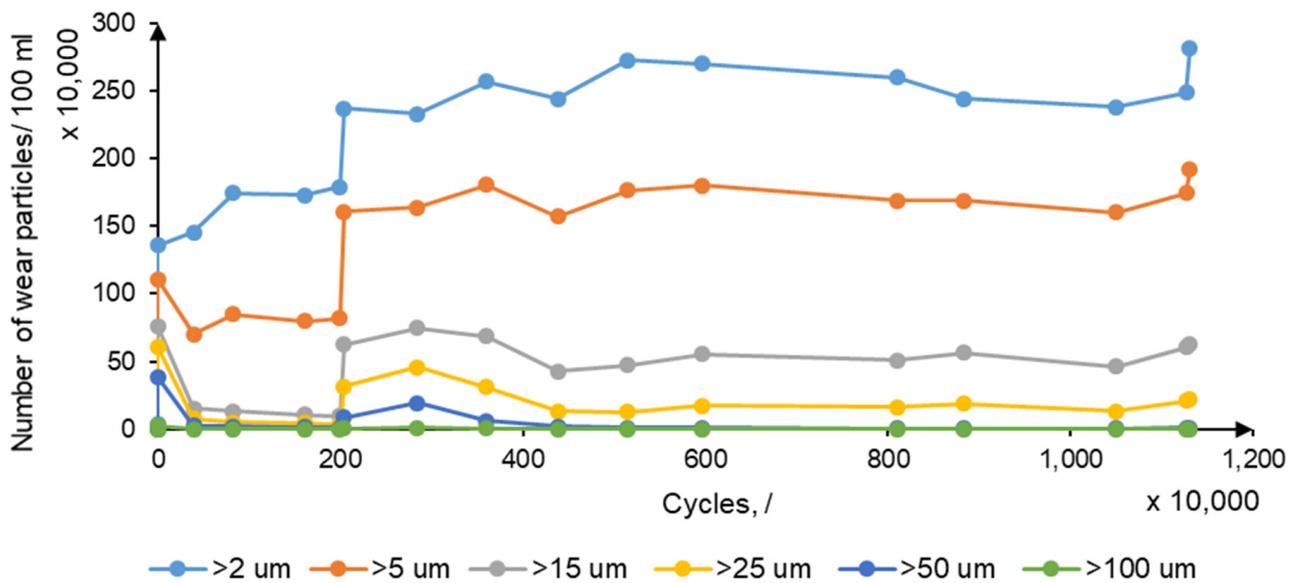
Figure 7. Cleanliness level of oil contaminated with wear particles during long-term test.

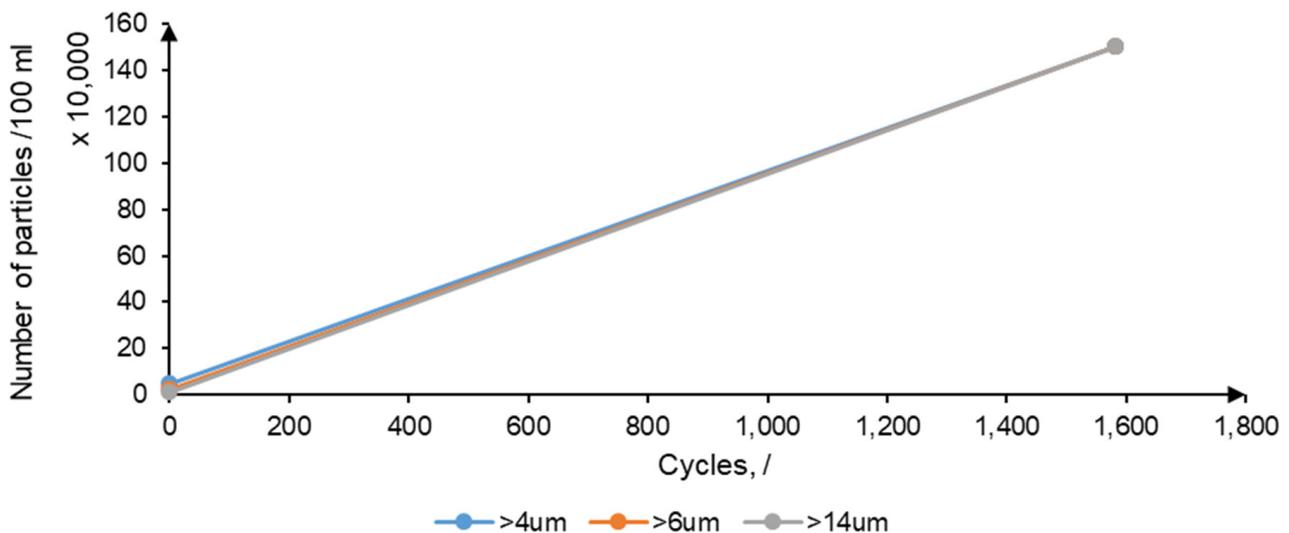
Figure 8. Cleanliness level of oil contaminated with medium test dust during long-term test.

On the test rig contaminated with test dust, the initial cleanliness after filtration was 16/15/13 (48,000 particles were larger than 4  $\mu\text{m}$ , 24,000 particles were larger than 6  $\mu\text{m}$ , and 12,000 particles were larger than 14  $\mu\text{m}$ ) and then, 5 g of test dust was added. After that, the cleanliness was 21/21/21 (1,500,000 were larger than 4  $\mu\text{m}$ , 6  $\mu\text{m}$ , and also 14  $\mu\text{m}$ ). After 1581 cycles (after 5.3 min), the pump was worn out and the test was terminated (Figure 8).

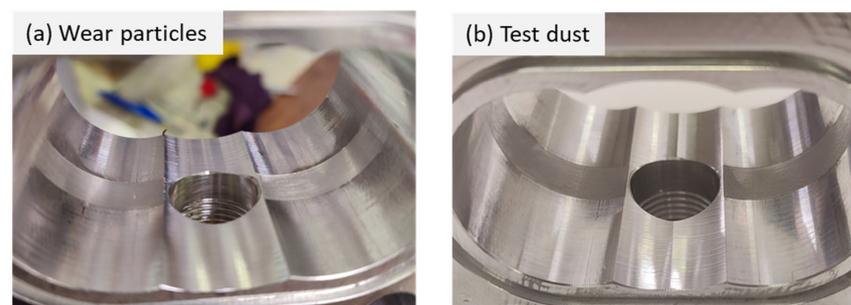
**Figure 10.** Wear of the housing on the suction side of (a) pump tested with wear particles and (b) pump tested with medium test dust.

Wear on three gear pump housings from a production series was studied. The first was a new pump that was examined. The second pump was tested for 624 h of operation with wear particles. The third pump was tested for 5.3 min with medium test dust. The hardness of the pump housing, which was a type of aluminum alloy, was measured between a minimum of 67 HV<sub>0.5</sub> and a maximum of 85 HV<sub>0.5</sub> for all three housings. Internal leakage was present where there were gaps between the pressurized and unpressurized (suction) sections. Wear of the pump housing was observed on the pressurized and suction sides. Figure 10 shows the wear of the housing on the suction side where the gear was in contact with the housing. The width of the worn band was measured as  $9.55 \pm 0.05$  mm. The width of the gear that was in contact was  $10.00 \pm 0.05$  mm.

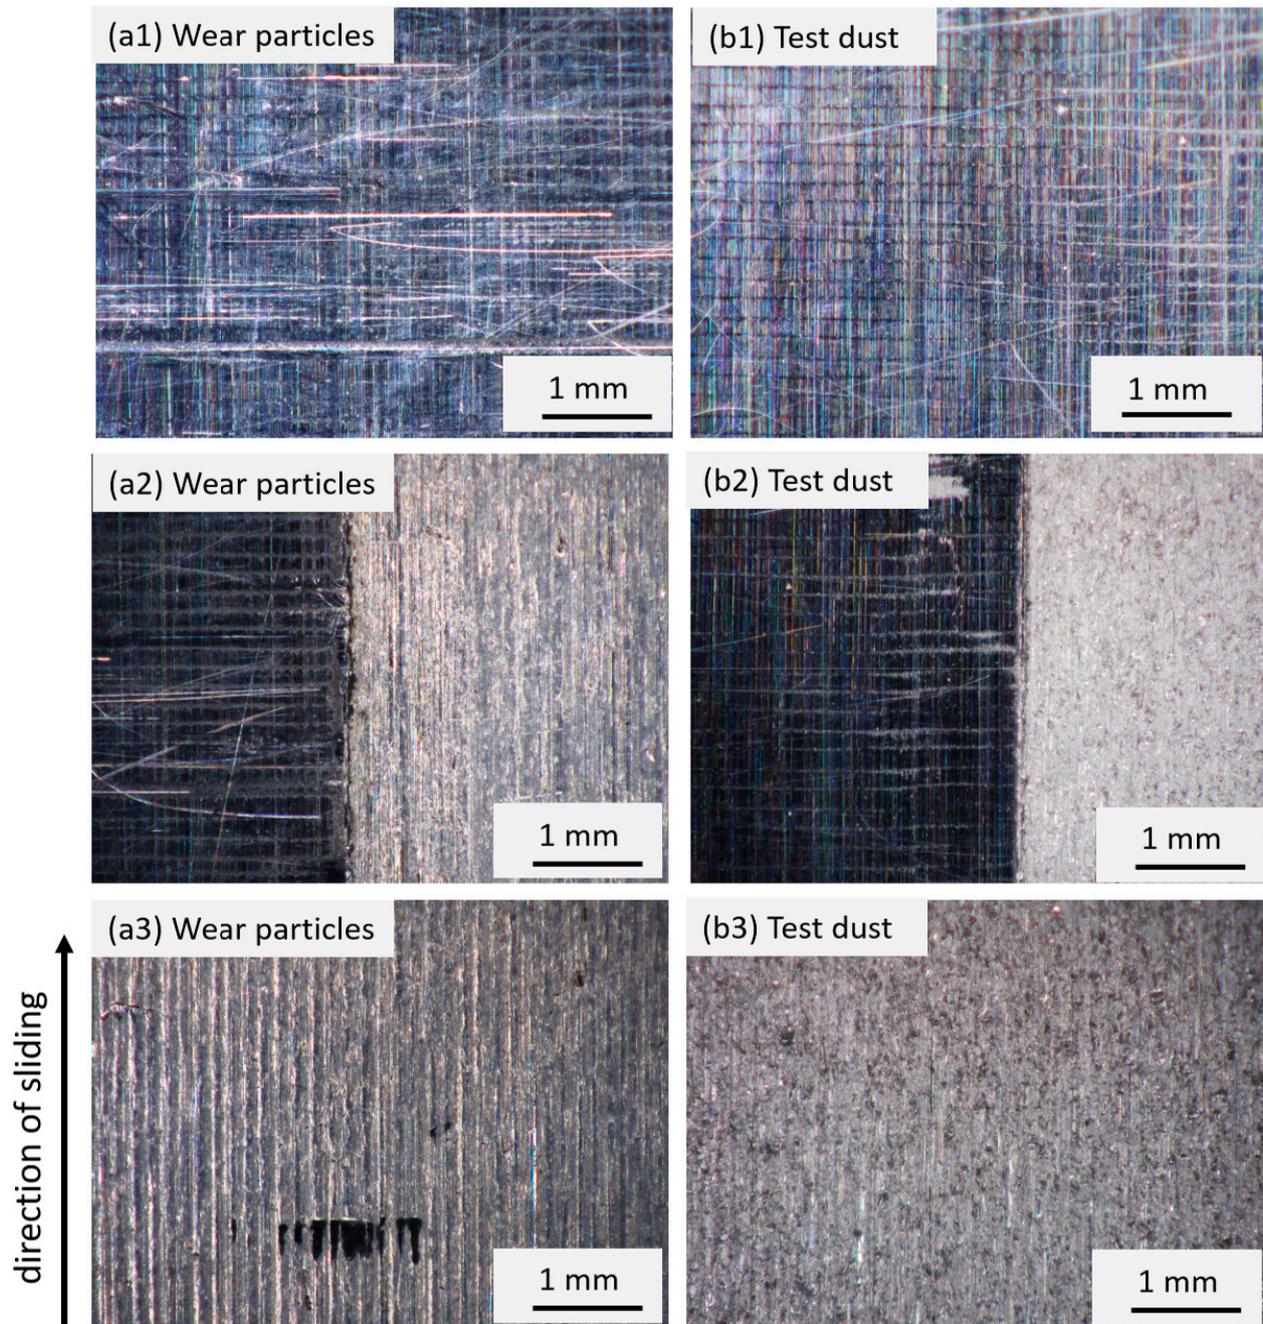
**Figure 11.** Suction side of the pump housing: (a1,b1) unworn surface, (a2,b2) border between unworn and worn surfaces, and (a3,b3) worn surface.

The undamaged surface of the pump on the suction side tested with wear particles is shown in Figure 11(a1) and the surface tested with test dust is shown in Figure 11(b1). Figure 11(a1,a2) show the undamaged surface and the boundary between worn and undamaged surfaces of the housing tested with wear particles. There are some horizontal scratches perpendicular to the sliding direction due to wear particles caught between the housing and the side plate (Figure 11(a1,a2)). These particles erode the surface due to the pressure difference. No such horizontal scratches can be seen on the unworn surface of the housing

tested with test dust (Figure 11(b1,b2)) since the test was very short (5.3 min). On the worn surface (Figure 11(a3)), scratches can be seen in the same direction as during sliding, indicating a two-body abrasion where the gear abraded the housing. In Figure 11(b3), there are more scratches in random directions, indicating a three-body abrasion mechanism. The particles that are moving with the fluid are as small, or smaller, as the clearance between the gear and the housing. These are critical size particles, which provide the most damage [18]. Particles also have the ability to get stuck in the softer material (in this case, housing) and then abrade the counter part of the tribological pair, which, in this case, are the gears. Mechanisms such as micro-cutting, micro-ploughing, and micro-rolling occurred.

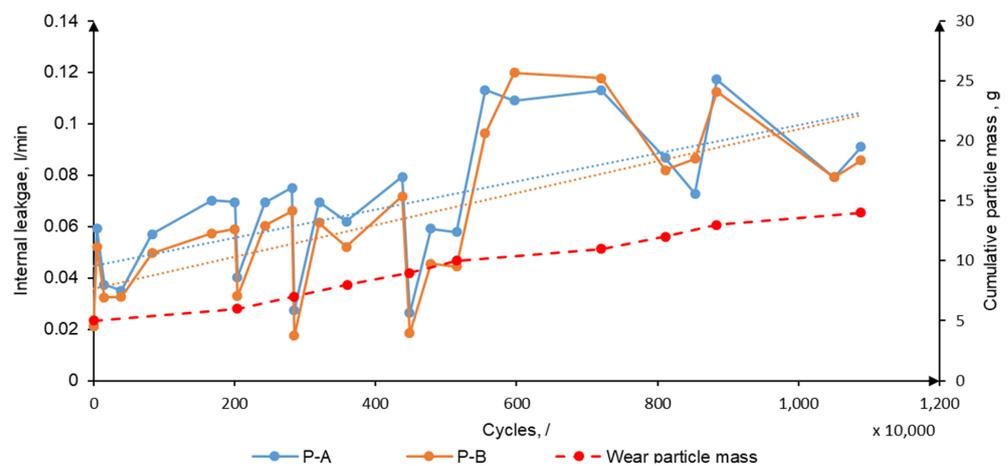
**Figure 12.** Directional 4/3 valve internal leakage measured at ports A and B during durability test with wear particles.

The internal leakage of the directional 4/3 valve was measured at ports A and B when the valve was in the zero position, the pressure at port P was 200 bar, and port T was continuously relieved. The results of internal leakage from port P to port A and from port P to port B are shown in Figure 12. Overall, a linear increase in leakage can be seen. At the beginning, the leakage from port P to port A was 0.02 L/min and from port P to port B was also 0.02 L/min. For the presentation of the results, only the path from port A to port P is described below. At about 8.5 million cycles, the leakage increased to a maximum value of 0.12 L/min, but at the end, the leakage decreased to 0.09 L/min. Not all measurements are consistent with a linear increase in leakage. The reason is the change in position of the control spool in the valve housing. When switching over, the control spool in the valve can rotate uncontrollably, which would lead to deviations from the measurements. The cumulative mass of wear particles is introduced on the secondary axis because additional wear particles during the test were added.

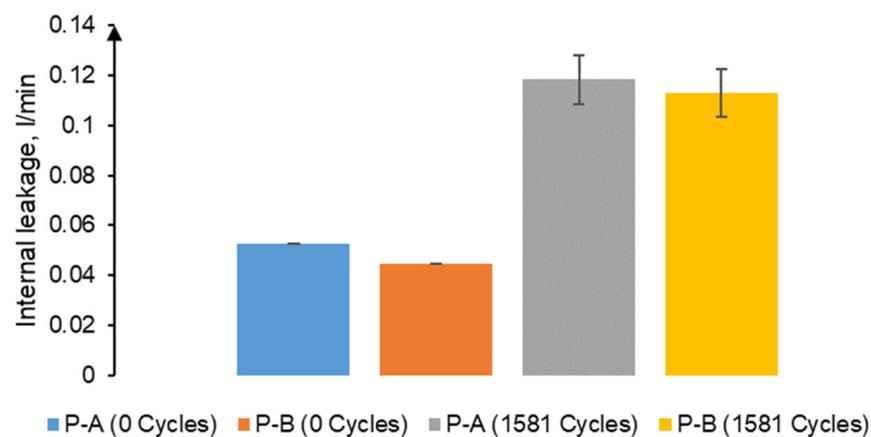
**Figure 13.** Internal leakage of directional 4/3 valve at A and B ports, tested with medium test dust at the beginning of the test and at the end of the test at the additional test rig.

Measurements of the leakage of the directional 4/3 valve tested with test dust were made at the beginning of the test. A first measurement was made at 200 bar. It was 0.05 L/min at port A and 0.04 L/min at port B. At the end of the test, the valve leakage was 0.12 L/min at port A and 0.11 L/min at port B and the leakage increased by a factor of three (Figure 13).

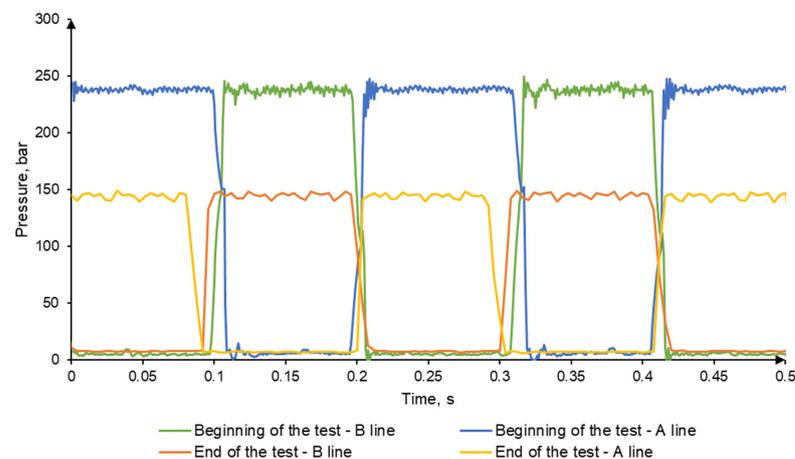
**Figure 14.** Comparison of pressures on A and B lines during operation with wear particles at the beginning and end of the test on pressure ports A and B on directional 4/3 valve.

Figure 14 shows the pressure conditions on lines A and B at the beginning of the test and at the end of the test (11.27 million cycles) with wear particles over a period of 0.5 s. At the beginning, the system was able to maintain the pressure at 247 bar, but later it was lowered because the system overheated and the safety temperature switch installed in the tank shut down the motor and pump at 70 °C. On site, the temperatures were even higher. The directional 4/3 valve was switched at a frequency of 5 Hz so that the pressure on both line A and line B changed from 247 bar to 1 bar and back to 247 bar on the lines at the beginning of the test. At the end of the test, due to excessive wear on the pump, the system only reached a pressure of 149 bar, as one can see in Figure 14. Thus, the system pressure dropped from the original 247 bar to 149 bar, which corresponds to a pressure drop of 48 bar from the beginning to the end of the operation. Zhang et al. [21] commented on worn sharp edges of spool in an electro-hydraulic spool valve which lead to degradation in leakage flow and degradation in pressure gain (pressure change). At the end of the test, the pressure changes from 149 bar to 1 bar and back to 149 bar with the same frequency of 5 Hz.

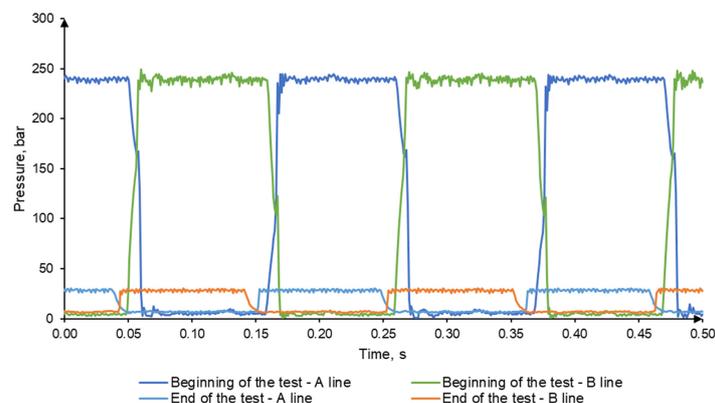
**Figure 15.** Comparison of pressures on A and B lines during operation with test dust at the beginning and end of the test on pressure ports A and B on directional 4/3 valve.

The pressure conditions on the A and B lines were measured at the beginning of the test and at the end of the test with the test dust over a period of 0.5 s. Figure 15 shows the pressure on the A and B lines, where the system reached 247 bar. At the end of the test (after 5.3 min of operation of the system), pressure in the previously mentioned lines dropped to 27 bar, as it was not possible for the system to reach a higher pressure due to the wear of the pump.

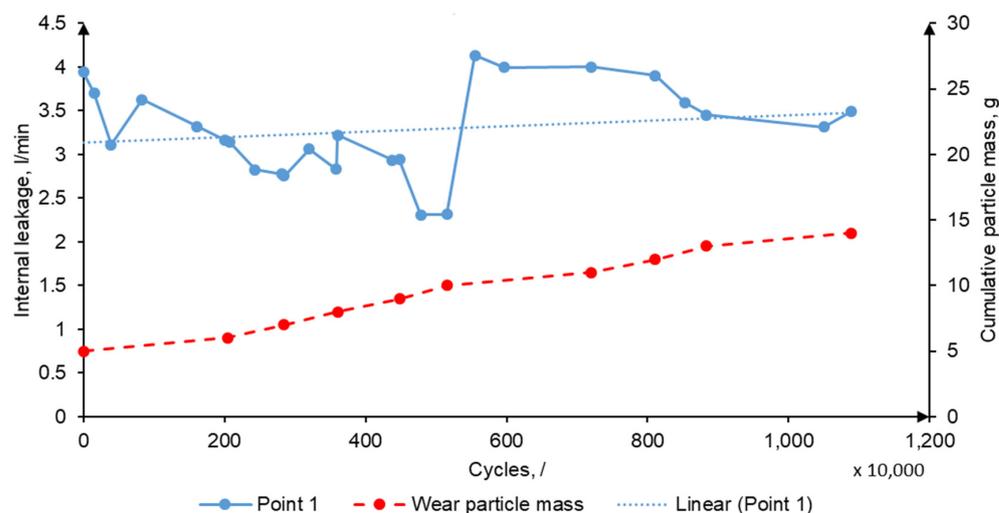
**Figure 16.** Measured internal leakage of a hydraulic motor tested at attachment point 1—test with wear particles.

Figure 16 shows the results of the measurements of the internal leakage of the tested hydraulic motor in attachment point 1. The internal leakage increased slightly during the test with wear particles (Figure 16). The leakage at the beginning of the test was 3.94 L/min and at the end it was 3.49 L/min. Since the hydraulic motor was not loaded and ran freely, the wear particles had little effect on the evolution of wear and thus on the increase in leakage. Leakage was also high due to the design (valve plate, gear, and housing) and operating conditions of the orbital hydraulic motor. Probably, the heat accumulation in the hydraulic motor was so large that the internal leakage increased due to the local heating of the oil.

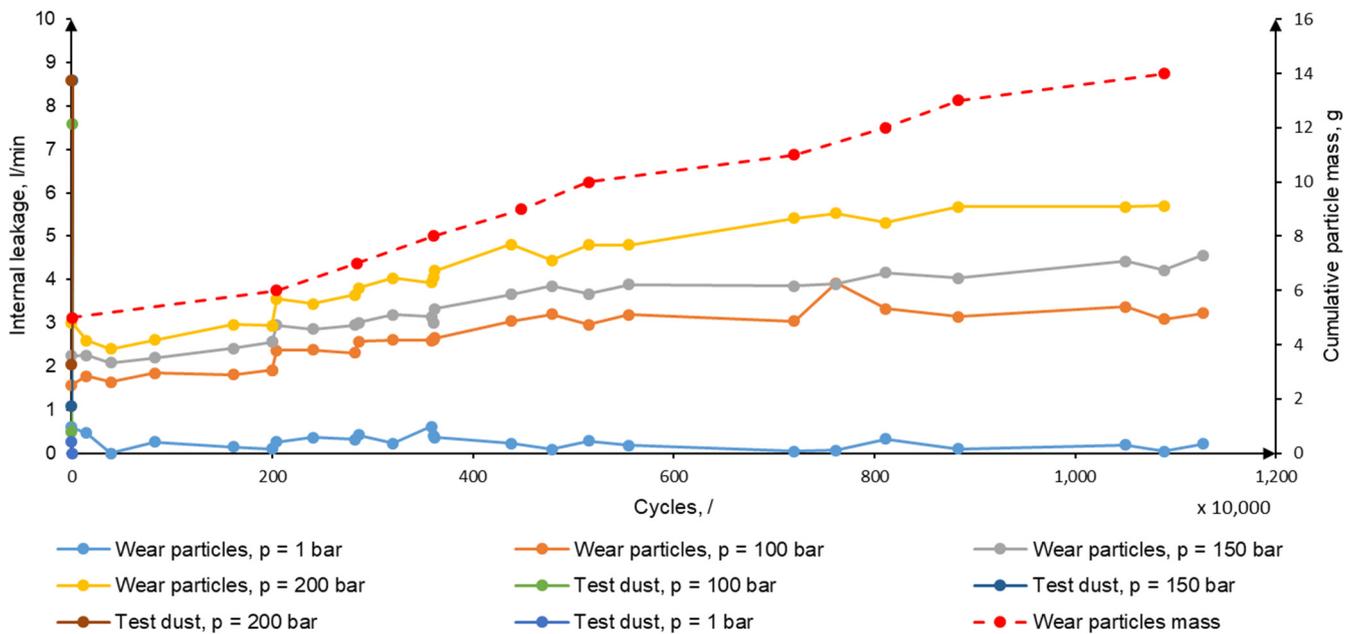
**Figure 17.** Comparison of volumetric efficiencies of hydraulic pump at different operating pressure points (0 bar, 100 bar, 150 bar, and 200 bar), tested with test dust (far left) and wear particles.

Initially, a test with wear particles at cleanliness level 22/21/19 and a test at cleanliness level 21/21/21 with MTD was performed. A comparison of the volumetric efficiencies of the pumps shows that the hydraulic system tested with medium test dust failed significantly faster than the hydraulic system tested with wear particles (Figure 17). The flow rates on the far left of Figure 17 show the internal leakage of the pump tested with test dust at four different pressures, and the rest of the figure shows the measured flow rates at four different pressures of the pump tested with wear particles. From the measurements, although the oil cleanliness was better when tested with test dust, the pump wore out much faster. Particles when trapped between two relative moving surfaces cause three-body abrasion which can be further divided into micro-ploughing, micro-rolling, and micro-cutting wear mechanisms [8]. The hardness of particles plays a crucial role because wear particles found in real hydraulic systems have lower hardness than the test dust, which is intended for testing hydraulic components [20–23].

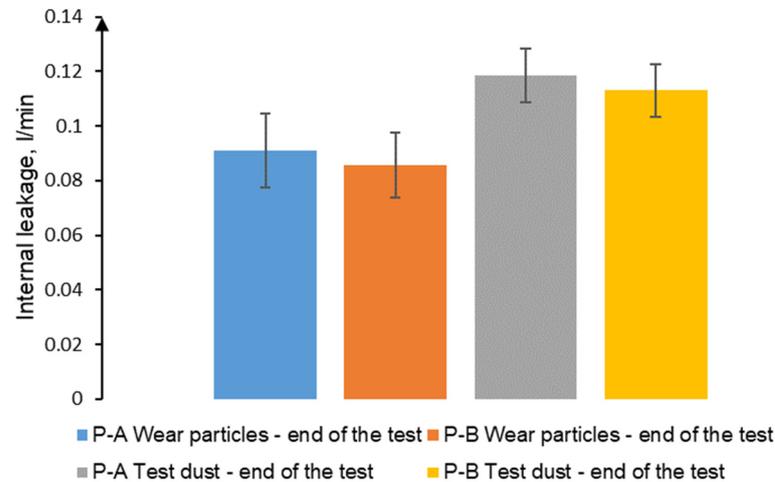
**Figure 18.** Comparison of internal leakage on directional 4/3 valve, tested with wear particles and test dust after the end of the test.

The endurance test of the hydraulic directional 4/3 valve revealed a minor internal leakage, which can be seen in Figure 18, when tested with wear particles and when tested with test dust. It should be pointed out that the valve tested with wear particles was less worn than the one tested with test dust, even though it was in operation for 624 h longer. It can be seen from Figure 12 that the leakage measurements are scattered. One possible explanation for such variation could be the position of the control spool with respect to rotation. If the housing and control spool are in a position where both worn surfaces are in contact, increased leakage may occur.

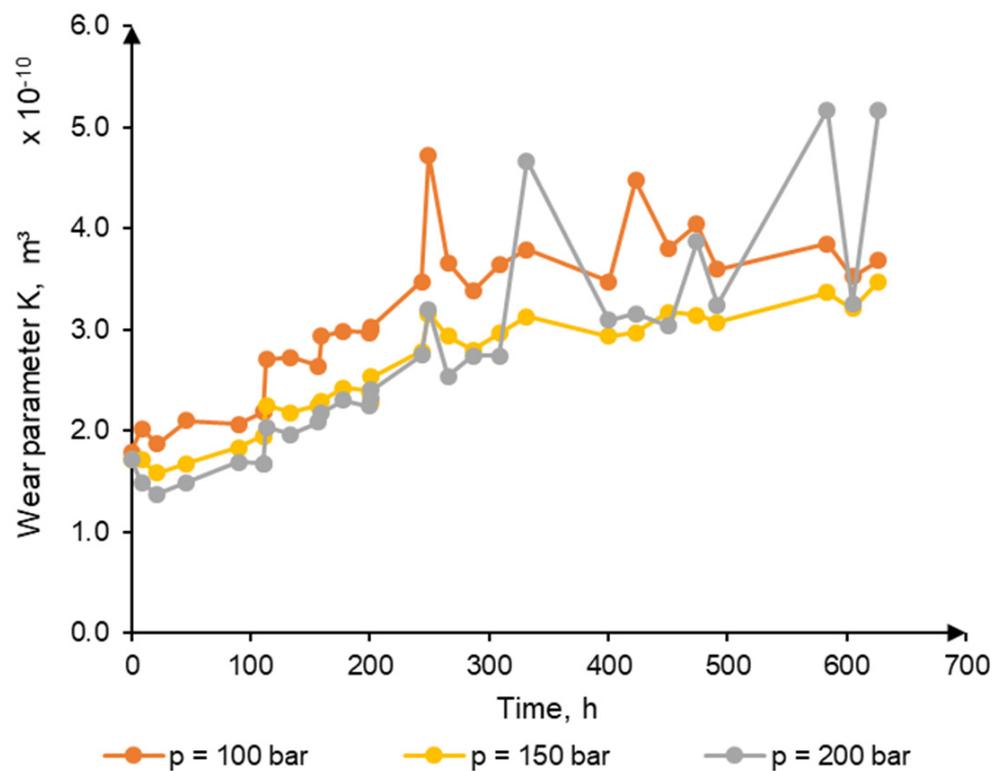
Figure 19. Wear parameter  $K$  depending on the time operation of the pump.

In this way, the wear parameter can be determined, which should be the same regardless of the pressure at which the internal leakage was measured. In Figure 19, the curves overlap well enough at 100 bar, 150 bar, and 200 bar. Researchers from the University of Tulsa and the University of Petroleum-Beijing studied the degradation and wear of an electric submersible pump (ESP) with gas–liquid–solid flow: experiments and a mechanical model [33]. When the increase in the gap in the water pump with the addition of air and sand is compared to the increase in the gap of gear pump housing, a similar wear trend, as in the case of Figure 19, occurs.
