Corrosion Damage Detection in Headrace Tunnel Using YOLOv7 with Continuous Wall Images

Abstract: Infrastructure that was constructed during the high economic growth period of Japan is starting to deteriorate; thus, there is a need for the maintenance and management of these structures. The basis of maintenance and management is the inspection process, which involves finding and recording damage. However, in headrace tunnels, the water supply is interrupted during inspection; thus, it is desirable to comprehensively photograph and record the tunnel wall and detect damage using the captured images to significantly reduce the water supply interruption time. Given this background, the aim of this study is to establish an investigation and assessment system for deformation points in the inner walls of headrace tunnels and to perform efficient maintenance and management of the tunnels. First, we develop a mobile headrace photography device that photographs the walls of the headrace tunnel with a charge-coupled device line camera. Next, we develop a method using YOLOv7 for detecting chalk marks at the damage locations made during cleaning of the tunnel walls that were photographed by the

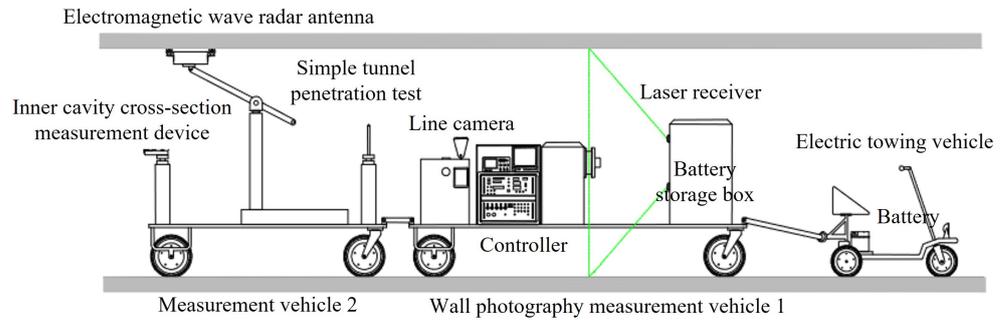
Figure 1. Nondestructive continuous digital scanning system for water canals.

In this study, we developed a device that can comprehensively capture wall images in headrace tunnels such as that shown in Figure 1 to record chalking positions, which are damage markers, and detect them using AI. The device is equipped with a charge-coupled device (CCD) line camera, and it constructs a continuous wall image by connecting long and narrow images captured by the CCD camera at regular intervals and recording and saving them as high-precision digitally developed images. Figure 2 shows an overview of the equipment used for continuous nondestructive surveys of the headrace tunnel in this study, as well as a photograph of the actual equipment, and the state of the survey using this equipment. The device was made with a focus on miniaturization and unitization so that it could be applied to headrace tunnels with a diameter of ≥ 1.3 m. Furthermore, the measurement speed is 1.0 km/h, allowing efficient operation, and the device can be used even during short water supply interruption periods. For example, if the images are captured from a distance of 2.5 m, the size of one pixel is 1 mm \times 1 mm, which is sufficient performance for capturing chalking positions. Furthermore, the images are 8-bit for each RGB color, with a total of 16,277,216 colors.

An innovation of this device is the identification of the camera shooting position. The CCD line camera collects the acceleration data while driving, converts them into a displacement, and corrects the camera shooting position. However, there is a risk that errors will accumulate when shooting from long distances using only acceleration data correction; thus, the system was designed to conduct software correction using the joint

position of the tunnel, which is known in advance. Aperture adjustments are also required. In the device, an illuminometer was installed on the upper part of the CCD line camera, and a function to automatically adjust the aperture according to the value of the illuminometer was incorporated. The left side of Figure 3 presents a continuous image of the wall surface that was used in this study as an example. From top to bottom, the upper left, lower left, lower right, and upper right are shown as seen from the direction of travel in the tunnel. As indicated by the figure, the entire wall surface was photographed.

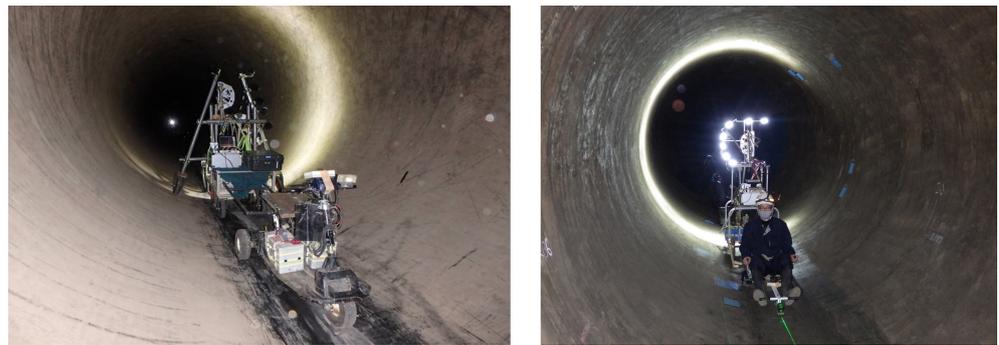
Figure 2. Photography equipment used (left) and shooting conditions inside the headrace tunnel (right).

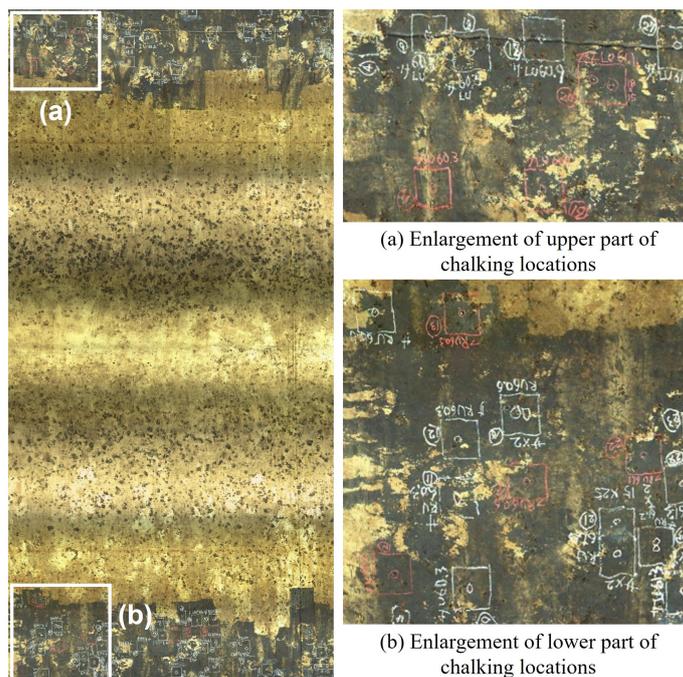
Figure 3. Example of the images used as training and validation data (inner wall).

As mentioned previously, in the present study, we aimed to detect the chalked areas of damage. Figure 3 shows an example of the photograph data used for training. We created a dataset for training and validation using a total of 3125 images of actual tunnels captured in 2016, 2017, and 2020. As shown in Figure 4, photographs were taken of the Fusa shield section No. 1 route (first headrace) in 2016, the underground pipe section (second headrace) in 2017, and the Fusa shield section No. 2 route (first headrace) in 2020. Therefore, the images were captured at different locations. Additionally, as shown in Figure 3, some images had multiple chalking positions. The total amount of data for each type of label used as training and validation data is presented in Table 1. No previous studies have involved the detection of chalked areas in headrace tunnels; however, in previous studies involving the detection of cracks in concrete structures, the number of data used for learning and validation ranged from several hundred to several tens of thousands [11,12,14,15]. Moreover, a wide variety of detection methods were employed, such as CNNs, encoder–decoder networks, segmentation, and object detection [7,8,11]. In this study, YOLOv7—the object-detection method described above—was employed because the area marked with chalk was rectangular, and in contrast to cracks, the object to be detected was not continuous.

The target of this study was the North Chiba Headrace (Figure 4), which is being inspected and repaired as part of a life extension plan. At this headrace, we examined the validity and applicability of the proposed method. The North Chiba Headrace is approximately 28.5 km long and plays a role in removing inland water during floods, supplying city water to Tokyo and purifying nearby rivers and swamps such as the Saka River and Tega Swamp. It has been over 20 years since the start of its operations in 2000, and the deterioration of the water pipes has become apparent, necessitating periodic inspection and repair. Therefore, we formulated a maintenance plan for the headrace and started inspection and repair in each section. The first round of inspection and repair was conducted from 2013 to 2017, and the second round of inspection started in 2018. However, owing to the role played by headrace tunnels, a long water supply interruption period is impossible, and this applies to the North Chiba Headrace. Therefore, when deformities, which need to be removed, are found when removing mussels clinging to the wall (Figure 7), they are circled with chalk. The chalk color depends on the type of deterioration; white chalk is used in the case of corrosion, and red chalk is used in cases of blistering (Figure 3, right).

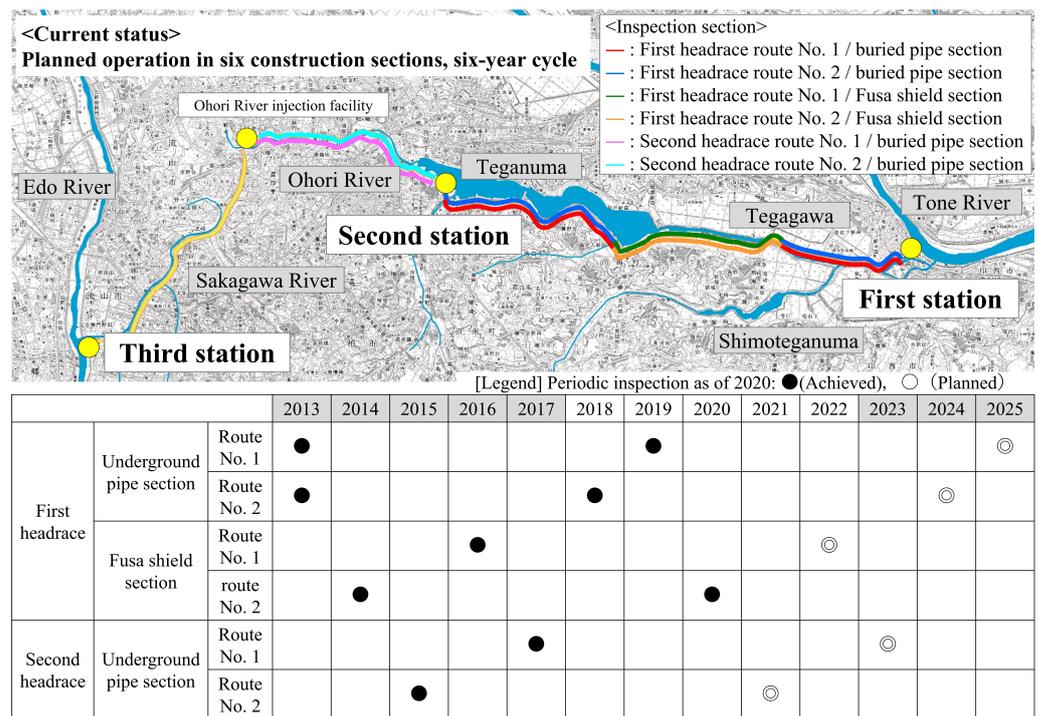
Figure 4. Outline of the plan for extending the service life of the Kita-Chiba headrace tunnel.

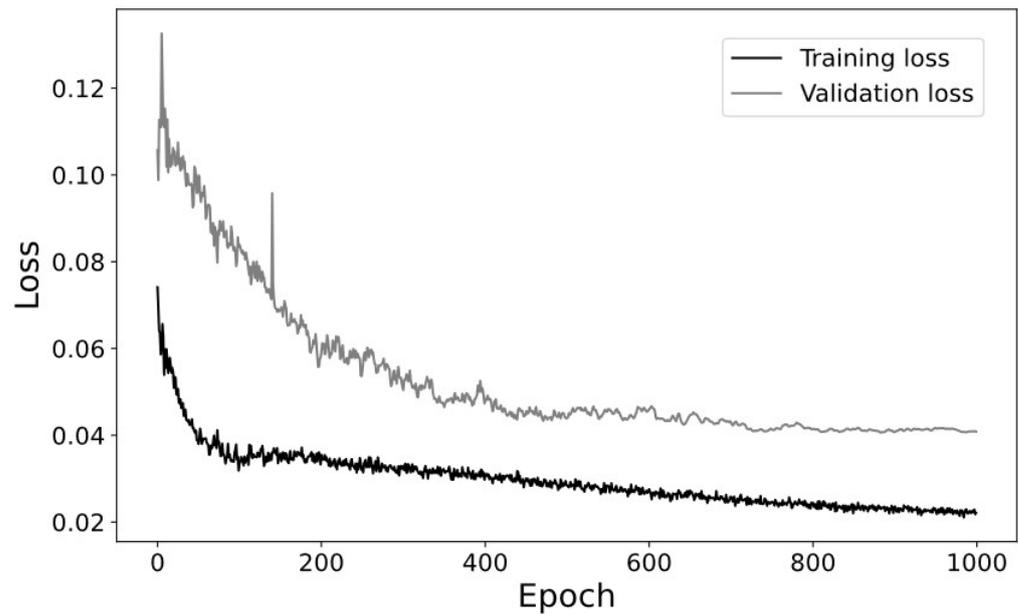
Figure 5. Losses for the training and validation of the chalking detection model.

The data generated in this manner were used to train YOLOv7. In the present study, of the 3125 chalking positions, 2479 positions—80% of the total, excluding the test data—were used as the training data, and the other 20%—totaling 614 positions—were used as the validation data. The corresponding numbers of images were 415 and 145, respectively. The image size was 2528 pixels × 2528 pixels. An Nvidia GeForce RTX 3060 graphics processing unit was used for the training. The learning rate was set to 0.01, and stochastic gradient descent was adopted as the optimization method. The batch size was set to 2, and the amount of training data per epoch was set to be the same as the number of training data prepared. A total of 1000 training epochs were conducted. Figure 5 presents the losses of training data and validation data for each epoch. As shown, the loss decreased as the training progressed. If the number of training data is too small or the number of epochs is too large, overtraining may occur. When overtraining occurs, the loss of validation data often increases. As indicated by Figure 5, the training conducted in this study did not show signs of overtraining, and the training was conducted appropriately.

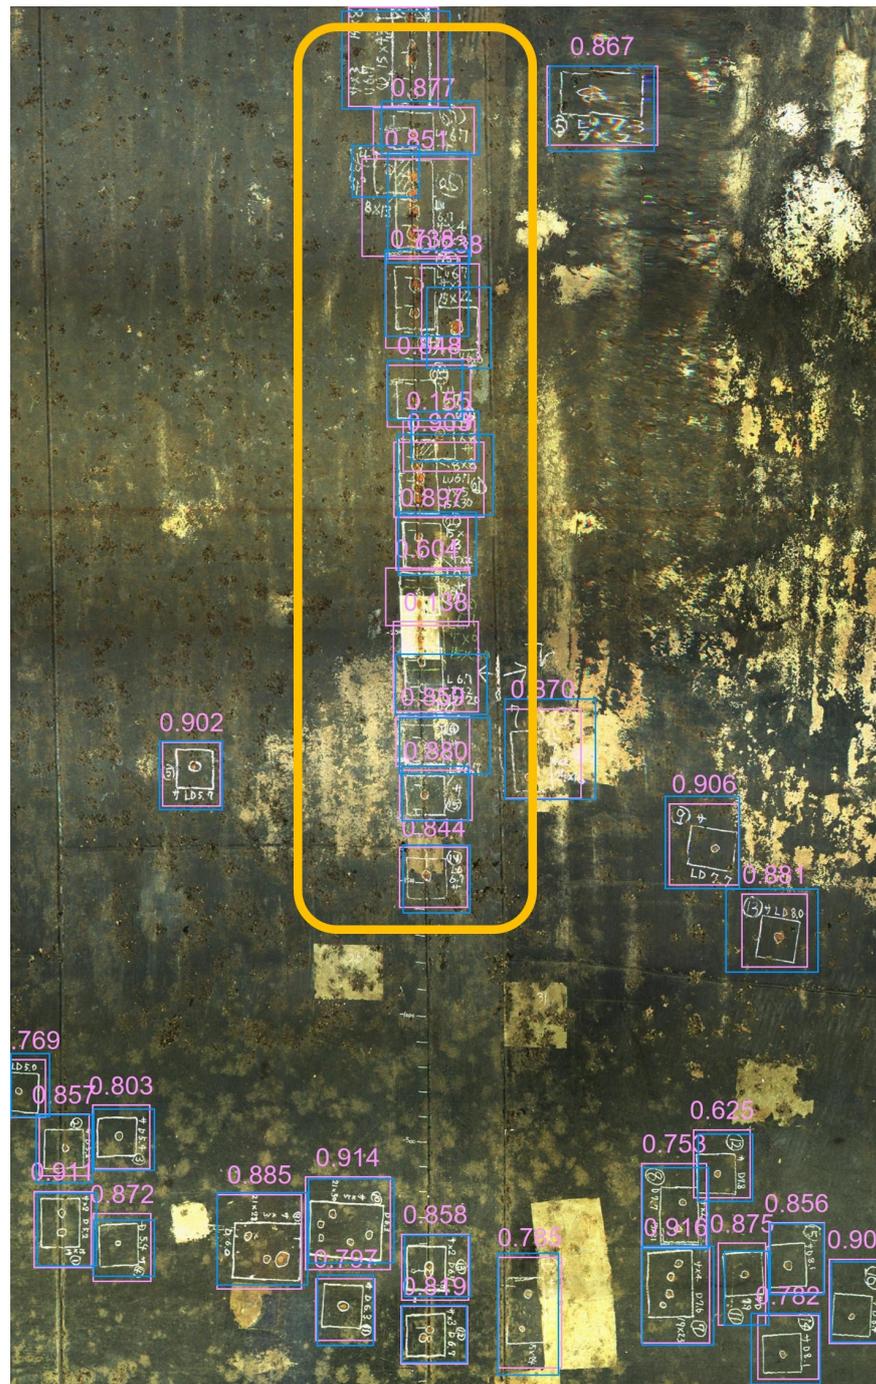
Figure 6. Example of detection results. In the lower part of the image, the chalking positions are separated from each other; thus, many positions were detected with high confidence. Meanwhile, in the upper center part of the image, there is a large amount of chalking overlap, and although some of the positions had low confidence, most of them were detected.

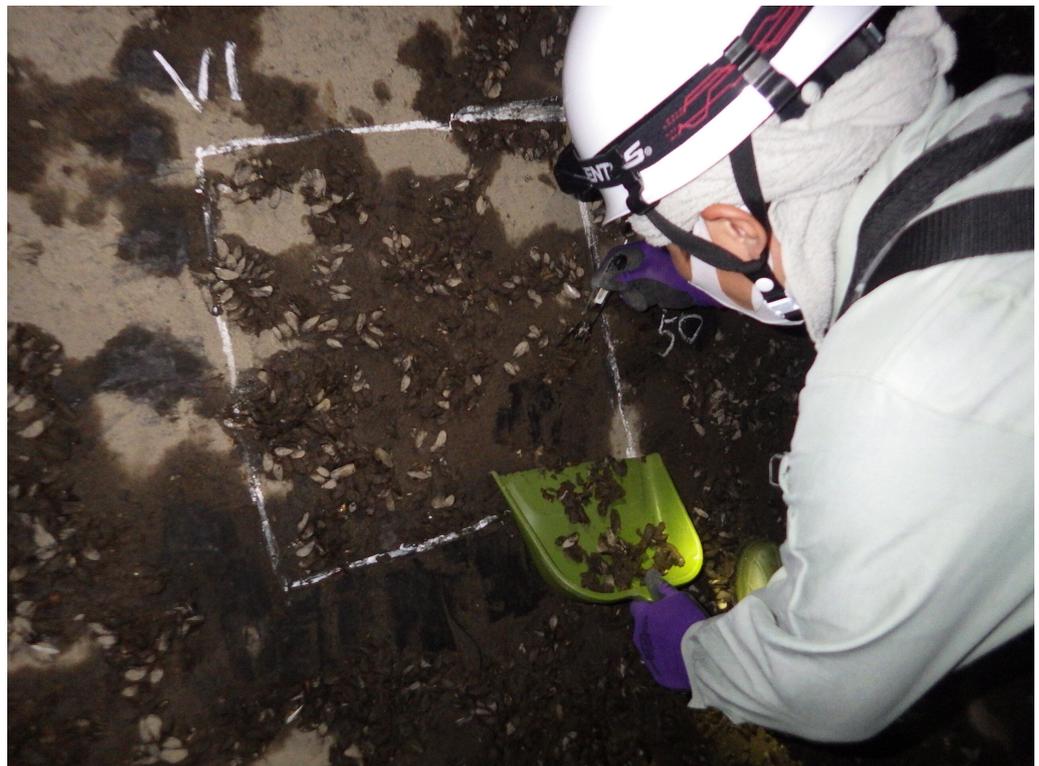
Figure 7. Removing mussels.

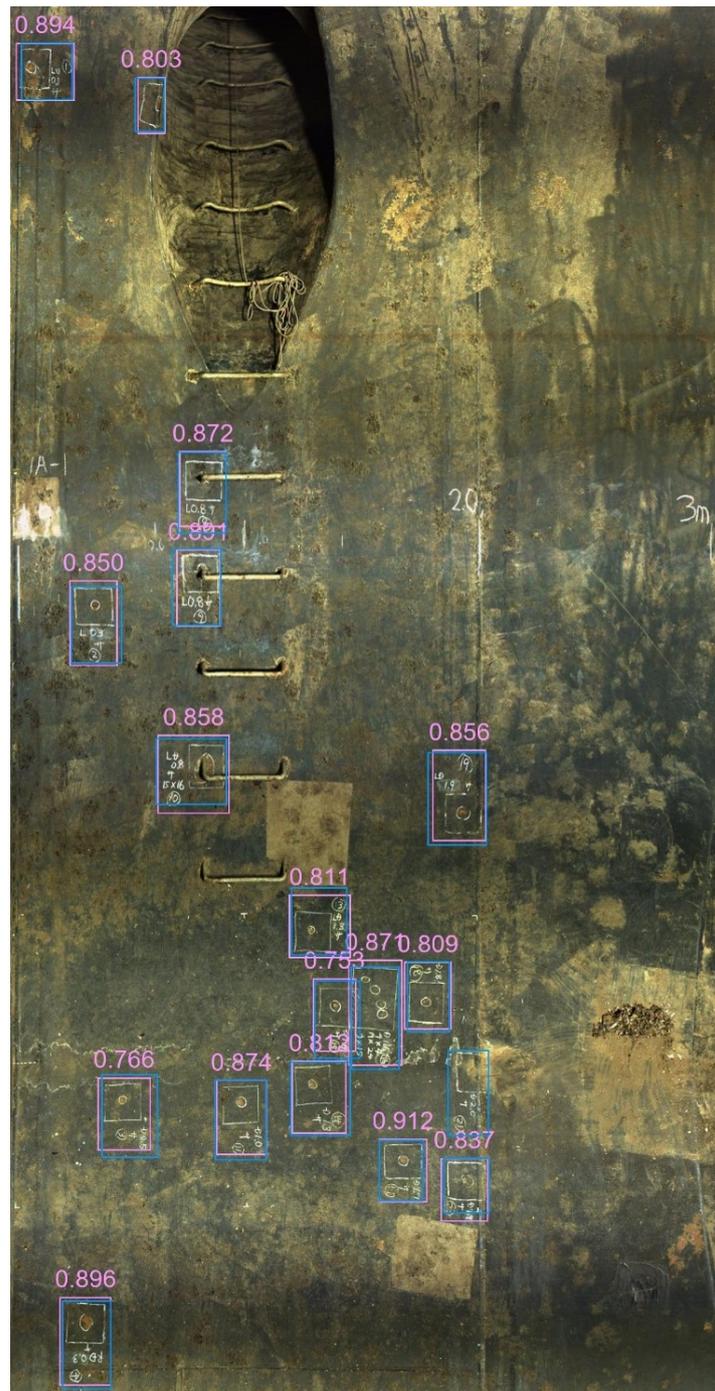
Figure 8. Example of chalking detection results. The blue frames indicate the annotation results, the pink frames indicate the detection results, and the pink numbers indicate the confidence scores at the time of each detection. Almost all the chalking positions were detected with high confidence scores.

Figure 8 shows an example of detection near a ladder. Almost all the chalking positions were detected, and the confidence score was high, with an average value of 0.845. The detection results (pink frames) had almost the same shape as the blue frames indicating the annotation positions, and both the rectangular areas surrounding the deterioration positions and the characters indicating the information could be detected. In the upper part of Figure 8, there is a ladder on the wall, and only half of the chalked area is visible in the upper left part of this ladder. However, the confidence score is as high as 0.803, and the IoU is as high as 0.866. The IoU, which is described in detail later in the paper, indicates the degree of overlap of the regions and is expressed as a value between 0 and 1. A value

closer to 1 indicates a higher accuracy. As shown in Figure 8, almost all chalked areas were detected without significant deviations. This was confirmed by the fact that the mean IoU (mIoU), i.e., the average value of the IoU in Figure 8, was 0.840.

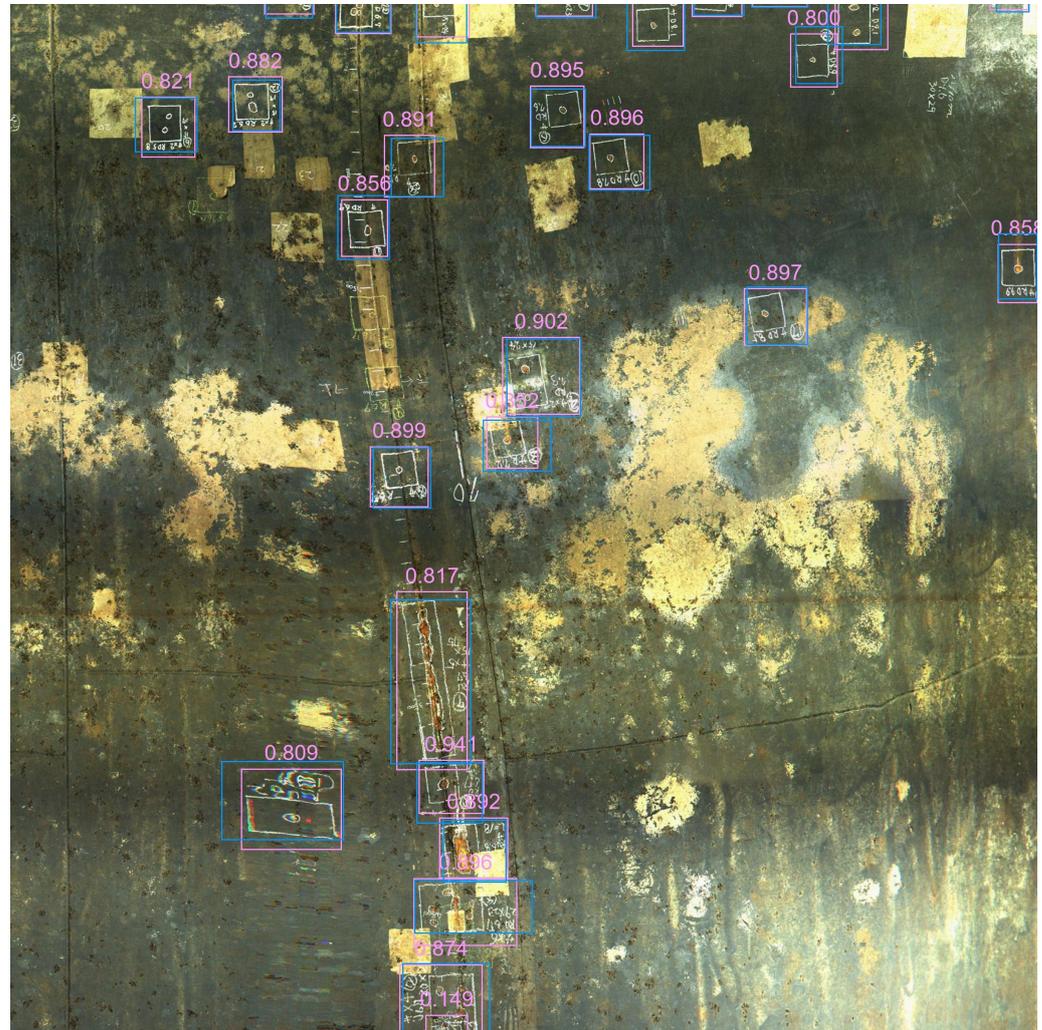
Figure 9. Example of chalking detection results. The blue frames indicate the annotation results, the pink frames indicate the detection results, and the pink numbers indicate the confidence scores at the time of each detection. Detection was achieved for not only chalking positions with square-shaped areas having similar aspect ratios but also shapes that did not exist in large numbers, such as vertically or horizontally long shapes. The yellow chalked area in the upper center part was not detected, and it can be said that the color was recognized.

Similarly, in Figure 9, most of the damage positions were detected, and the confidence score was high, with an average value of 0.871. However, at one position near the bottom of Figure 9, the confidence score was 0.149. Most of the chalking positions in this study had square-like shapes with similar aspect ratios, but there were a few chalking positions with a vertically long rectangular shape located at the center of Figure 9. This chalking point has not only a high confidence score of 0.817 but also a high IoU of 0.826. The developed model detected these few characteristic points with a high confidence score and IoU. Similarly, the mIoU in Figure 9 was as high as 0.739. In Figure 9, there are two yellow chalking points slightly above the aforementioned vertical chalking points. The accuracy was increased by the fact that the yellow chalked areas were not detected incorrectly, because only the white chalked area was the target in this study.

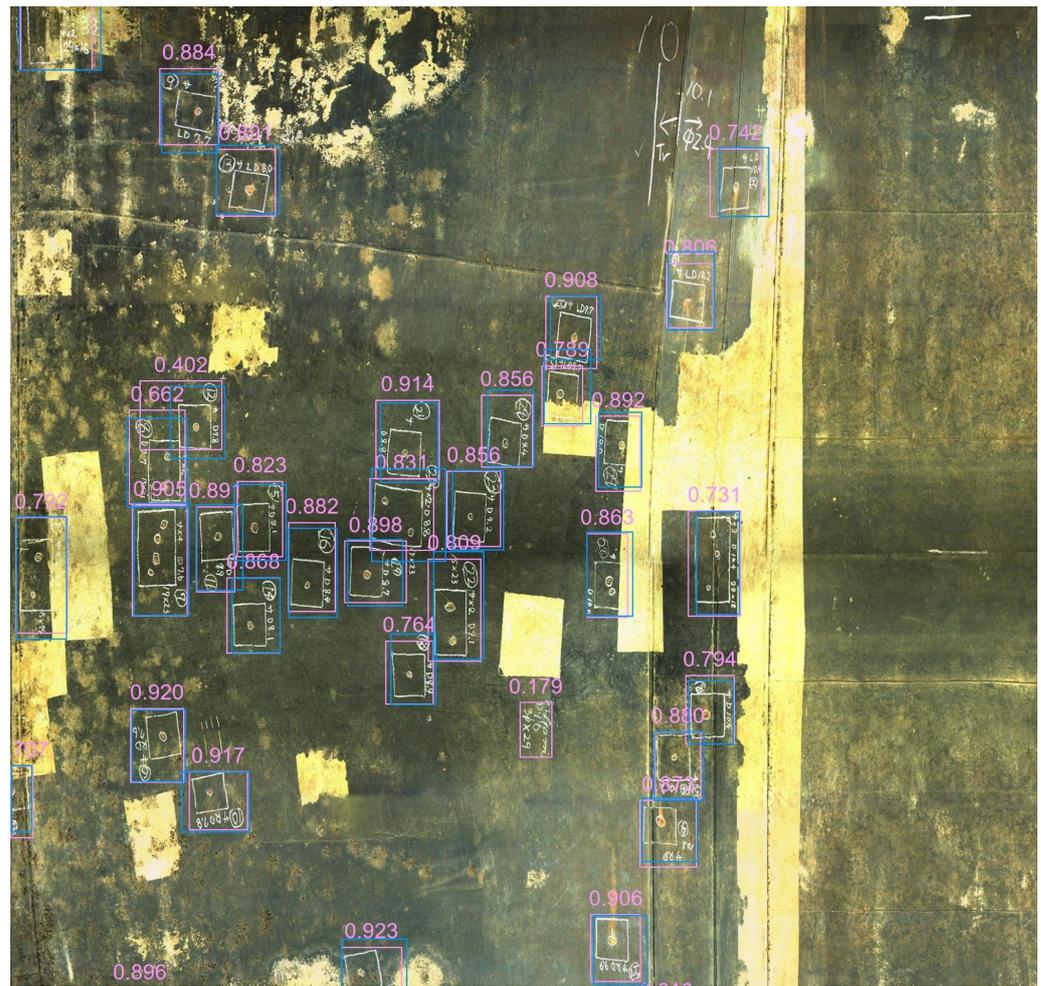
Figure 10. Example of chalking detection results. The blue frames indicate the annotation results, the pink frames indicate the detection results, and the pink numbers indicate the confidence scores at the time of each detection. As in Figure 7, even vertical chalking positions were detected. However, some of the positions where numbers and symbols were written in white chalk were incorrectly detected.

In the case of Figure 10, similar to Figures 8 and 9, the positions were detected with high accuracy, but there were positions where only the numbers and symbols that were chalked were detected incorrectly. These numbers and symbols were written using the same chalk as those in the annotations, and their sizes were very similar; thus, it is possible that such misdetection occurred. However, these detection results had very low confidence scores, with values of 0.173 and 0.179, as shown in Figure 10. Herein, all the results are presented, regardless of the confidence score; thus, there are false positives such as this. We consider that setting a threshold for the confidence score will increase the accuracy. However, even with these false detections, the mIoU was as high as 0.756, indicating that the detection was highly accurate.

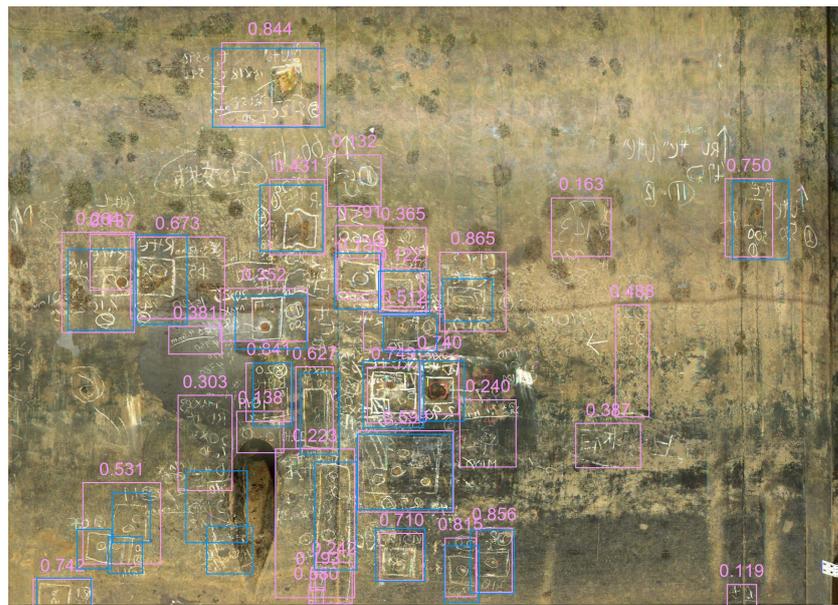
Figure 11. Example of chalking detection results. The blue frames indicate the annotation results, the pink frames indicate the detection results, and the pink numbers indicate the confidence scores at the time of each detection. When there were not only many rectangular chalking positions but also many cases with notes such as numbers or symbols, multiple detections were conducted for a single annotation position. Most annotation areas contained both rectangles and numbers; thus, locations with only numbers and symbols written were also detected.

Figure 11 shows a very large amount of chalking, with many symbols and characters around it. Although they were detected, the confidence score was low, or only positions with characters were detected, and the detection was not very accurate. The mIoU was 0.611, for the case where the chalking was dense or there were many letters and numbers outside the rectangular area, as shown in Figure 11. Distinguishing such characters and symbols from annotation positions is difficult even for humans; thus, when conducting chalking, there is probably a need to color-code corrosion positions to be detected along with symbols and characters.

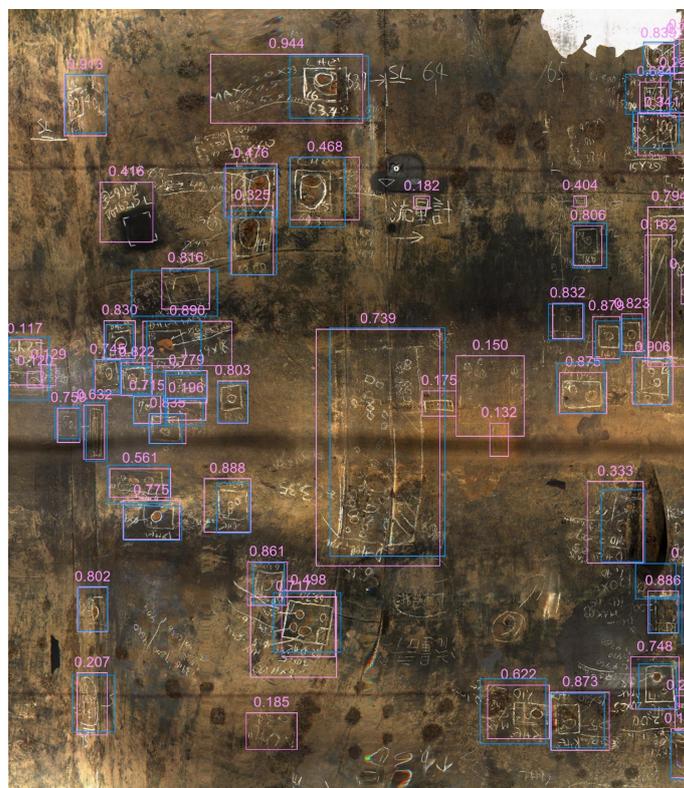
Figure 12. Example of chalking detection results. The blue frames indicate the annotation results, the pink frames indicate the detection results, and the pink numbers indicate the confidence scores at the time of each detection. The large chalked area in the center of this figure was detected accurately as well, although it is different from the usual chalked area. The lower left detection area in this figure has a high IoU, although the image is distorted, resulting in a low confidence score.

Furthermore, there are areas that were detected accurately and areas that were not detected accurately in the same region in Figure 12. The large chalked area in the center of the image was detected accurately, with a confidence score of 0.739 and an IoU of 0.816. The small chalked areas to the left and right of the chalked area were also generally detected accurately, because the chalked rectangle area was clear. However, the disappearing chalked area overlapping on the right side of the large chalked area in the center of the image was detected incorrectly. Because this chalking point is where deterioration has appeared in the past, it is necessary to consider whether such a chalked area should be detected. The chalked area in the lower left of Figure 12 was detected accurately but with a low confidence score (0.207). This is because the image was a planar rendering of a curved tunnel wall surface, which caused distortions; consequently, the chalk markings were distorted. Although there were many such distorted areas, only a few were not detected. The confidence score of the disappearing chalked area ranged from approximately 0.132 to 0.175, whereas the confidence score of the distorted area was 0.207. Therefore, it is better not to detect chalked areas when the confidence score is <0.200 . In the case of the densely chalked areas shown in Figure 11, some false detections have a confidence score of 0.300–0.500; however, the confidence score of the false-detection area in Figure 10 is 0.179. Thus, setting a threshold value is effective for increasing the detection accuracy.

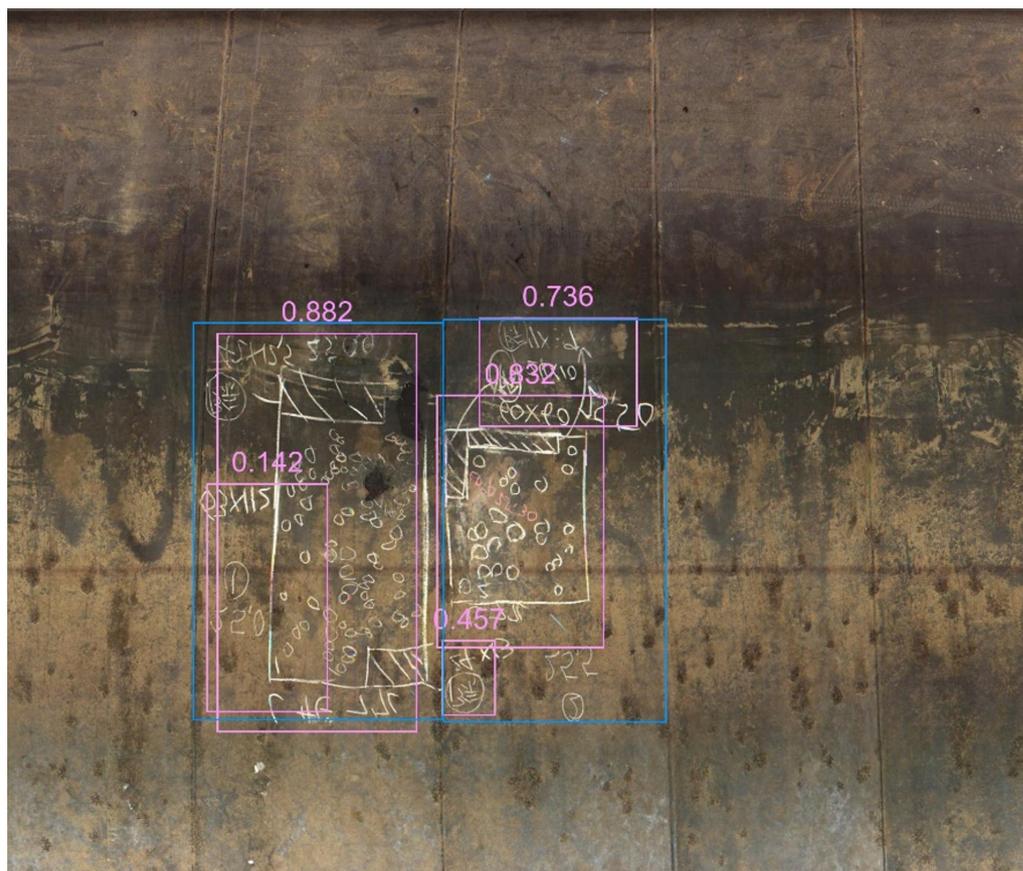
Figure 13. Example of chalking detection results. The blue frames indicate the annotation results, the pink frames indicate the detection results, and the pink numbers indicate the confidence scores at the time of each detection. Although only two large areas on the left and right were considered as chalking points during annotation, two chalked areas were detected in the left area and three chalked areas were detected in the right area. Since these large areas contain many deteriorated areas (circled areas within a rectangular area), it is not necessarily a mistake to detect more than the annotated data.

Finally, Figure 13 shows the detection results for chalking points larger than those in Figure 12. In this case, two large chalking points were annotated as the left and right areas, and the detection results indicated that there were two chalking points in the left area

and three in the right area. For the two areas with confidence scores exceeding 0.800, the rectangular area indicated by the chalk was detected, but for the other areas, only the text was detected. Such large areas include many deteriorated areas (Figure 13, circled areas within chalked areas), and whether the area should be divided into one or two rectangles depends on the judgment of the individual. Therefore, the distribution of the chalked areas should not be judged solely according to the number of chalked areas; rather, the size of the chalked areas should be considered to obtain an accurate grasp of the deterioration status.

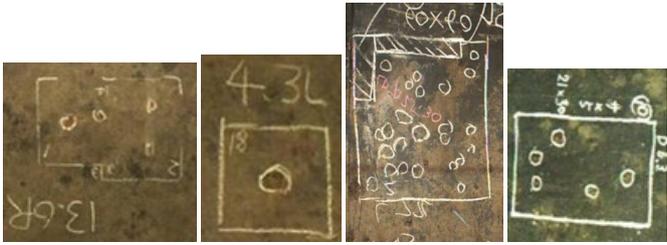
False Negative (FN)

Examples of Detectable/Not Detectable	
True Positive (TP)

Table 3 presents a breakdown of the detection results, and Table 4 presents each detected and undetected case. As shown in Table 3, there were 609 positions where chalking was detected accurately. As indicated by the first row of Table 4, there were cases of singular and multiple corrosion positions, and these positions were detected even when the shapes were slightly different, e.g., when the rectangular area surrounding them was larger than usual. Only six positions were not detected, and as indicated by the second row of Table 4, these included cases where chalking was performed at seams and dents and where the chalk color was faded. Thus, the results indicated that the proposed model can generally detect objects that are clearly chalked on a flat surface. The number of incorrectly detected positions was 146 and as indicated by the third row in Table 4, there were examples of positions that were chalked in red or yellow and where some numbers or symbols were detected. However, approximately 86% of these were positions where parts of chalking positions or numbers/symbols were detected; thus, it can be said that “locations with chalking” were generally captured. The results suggested that the damage positions were generally detected well. Excluding the false detection results, the number of chalking positions detected was 608 out of 614, indicating that the positions were detected with an extremely high accuracy.

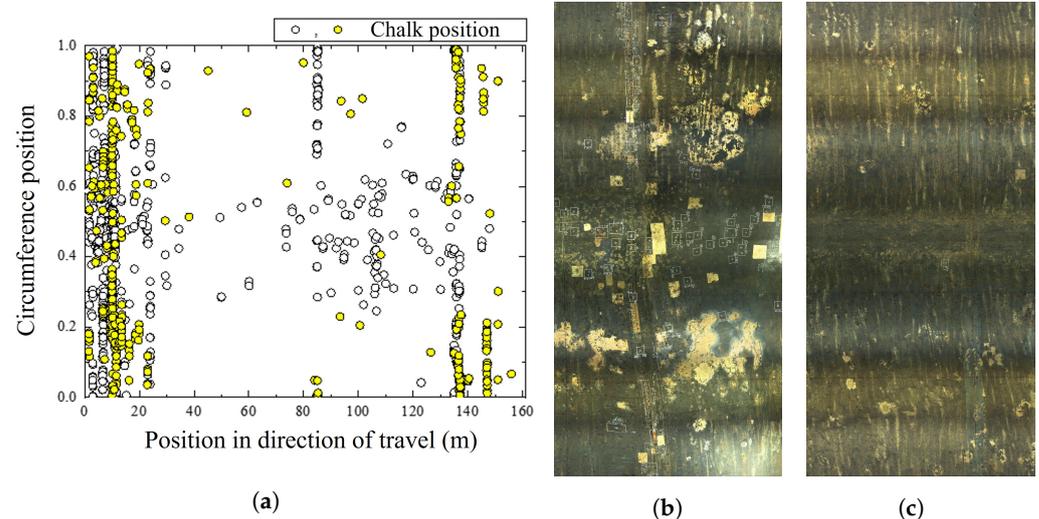
Figure 14. Plot of chalking positions in the headrace tunnel. (a) Plot of positions where chalking was detected from the analysis results; there were many detections near the entrance (positions of 0–20 m in direction of travel). Meanwhile, there were few detections near 40–80 m. (b) Image of the wall 5–10 m from the entrance. As indicated by the detection results in (a), there were many chalking positions here. (c) Image of the wall 60–65 m from the entrance. As indicated by the detection results in (a), there were relatively few chalking positions here.

To efficiently detect deformation positions on the inner wall of the headrace tunnel, in the proposed system, we made it possible to visualize the damage positions in the entire tunnel, as shown in Figure 14a, according to the positional information of the tunnel provided by the captured continuous images of the walls and the chalking-position detection results. This is based on the fact that YOLO can derive the bounding box of the detected damage, and here, the central point of the bounding box was used as the representative point. As shown in Figure 14a, there were many detections near the entrance (positions of 0–20 m in the direction of travel), but there were very few chalking positions after approximately 40–80 m. Figure 14b,c present continuous images of the wall 5–10 m and 60–65 m from the entrance, respectively. In Figure 14b, there are many chalking positions, whereas in Figure 14c, there are hardly any; thus, the detection result is considered to be

valid. Additionally, for example, there was considerable damage at approximately 10 m, but this was a joint part, and the damage is attributed to the scattering of spatter during fabrication, which made leakage more likely, promoting corrosion. Thus, detecting the chalking positions throughout the tunnel made it possible to determine the distribution of damage locations and their tendencies, which will be useful for future maintenance and management.
