Archaeoseismological Evidence of Seismic Damage at Medina Azahara (Córdoba, Spain) from the Early 11th Century

Abstract: The “Caliphal City of Medina Azahara” was built in 936–937 CE or 940–941 CE (depending on the source) by the first Caliph of al-Andalus Abd al-Rahman III, being recently inscribed (2018) on the UNESCO World Heritage List. The abandonment and destruction of the city have been traditionally related to the civil war (“*fitna*”) that started between 1009 and 1010 CE. However, we cannot rule out other causes for the rapid depopulation and plundering of the city just a few decades after its foundation. The archaeoseismological study provides the first clues on the possible role played by an earthquake in the sudden abandonment and ruin of the city. Eleven different types of Earthquake Archaeological Effects (EAEs) have been identified, such as dropped key stones in arches, tilted walls, conjugated fractures in brick-made walls, conjugated fractures and folds in regular pavements and dipping broken corners in columns, among others. Besides that, 163 structural measures on EAEs were surveyed resulting in a mean ground movement direction of N140°–160° E. This geological

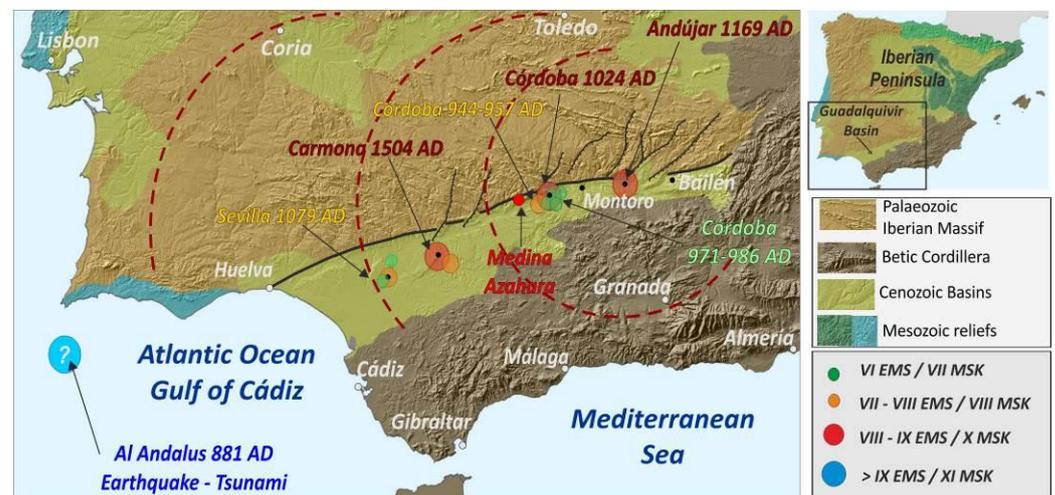
Figure 1. Geological setting of the Caliphal City of Medina Azahara in the framework of the Guadalquivir Basin (SW Spain). Main faults and macroseismic epicenters of the most important historical earthquakes occurred in Al-Andalus between the years 940 CE and 1504 CE are showed (see Appendix A for seismic details).

The ancient city of Medina Azahara is located in southern Spain (Andalusia), close to the city of Córdoba, on the boundary between the Paleozoic reliefs of Sierra Morena and the Neogene Guadalquivir sedimentary basin (Figure 1).

The Guadalquivir Neogene Basin corresponds to the foreland basin of the Betic Cordillera (Figure 1) and is filled by a thick sedimentary succession (c. 1.5 km) of Miocene to Pliocene marine deposits and olisthostromic units from the last c. 15.5 Ma [16]. To the south olisthostrome melange is imbricated and overridden by the proximal tectonic wedges formed by Triassic to Paleogene materials along the Betic thrust-front [17]. Tectonic loading along the Betic front and continuous sedimentation from 10.5 to 5.5 Ma caused significant lithospheric overloading triggering isostatic forebulging along the northern margin of the basin and the adjacent Paleozoic materials of the Iberian massif [17,18] (Figure 2A). Following these authors, Pliocene to Quaternary isostatic forebulging propagated to the North into the Iberian massif giving rise to flexural upfolding in the Paleozoic materials and relief generation (i.e., Sierra Morena). Upfolding also affected to the Miocene calcarenites along the northern margin of the Guadalquivir Depression facilitating its deformation and subaerial erosion. Nowadays, isolated patches of these eroded and uplifted Miocene materials lying unconformably on the metamorphic substratum provide evidence of the process (Figure 2B). Tectonic relief rejuvenation processes of the northern edge of the Guadalquivir basin have been described using geomorphological indexes and associated with the seismic activity of this fault [19–22]. As illustrated in Figure 1, NNE-SSW to nearly N-S normal faults segment the trace of the NE-SW border of the Guadalquivir Basin, a complex erosive-mechanical contact historically known as the “Great Betic Fault” or the Guadalquivir Fault Zone (GFZ) [21,22]. The GFZ is a large fault-flexure fragmented (split) in multiple subparallel inducing the bending and upfolding of the Paleozoic basement for about 1500 m beneath the central sector of the basin to the northern reliefs of Sierra Morena [23]. This tectonic flexure induced the uplift of Sierra Morena which marks the southern end of the Iberian Paleozoic plateau generating an important topographic step and the uplift of the overlying Late Neogene materials [24]. Cartographic and geophysical data indicate that the uplift of the late Neogene calcarenites within the Sierra Morena range reach up to 420–450 m for the last c.a. 5 M.a. [17,24]. This accumulated uplift will indicate uplift rates of about 0.09–0.1 mm/year, sufficient to explain the seismicity of the zone [17,22]. Crustal bending promoted and assisted brittle deformation at upper crustal levels (<30 km) resulting in NNE-SSW to NE-SW normal faulting in the backbulge zone [18,25] delineating the northern border of the basin (Figure 2). Following these authors, these normal faults are the responsible of the instrumental seismicity along the northern border of the Guadalquivir basin (Figure 2A), but buried reverse faulting is also responsible of the variety of seismic series and swarms instrumentally recorded in the southern zone of the basin since the early 20th century [18,25,26].

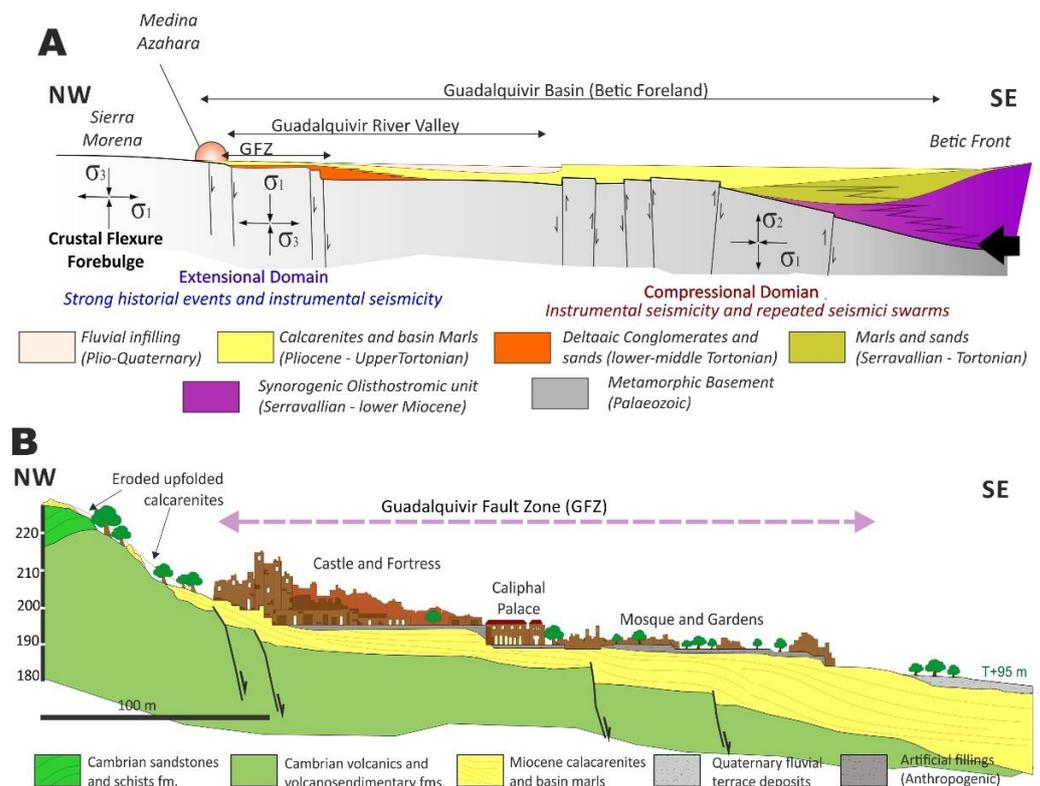
Figure 2. Geologic and Geodynamic setting of the Archaeological site of Medina Azahara. (A): General sketch showing the lithospheric structure of the Betic foreland basin, flexural processes and related seismicity. Based in data from [17,18] (not scaled). The cross-section displays the buried faults and stress tensors (σ_1 – σ_2 – σ_3) deduced for recent focal solutions related with ongoing flexural process throughout the basin in the northern zone of the basin [18] (B): Geological cross-section displaying the structural arrangement of Paleozoic and Cenozoic materials beneath Medina Azahara. Based in the geological map of the zone [28] Vertical Exaggeration $\times 4$.

In detail, as mapped in the 1:50,000 geological chart of the zone [28], Medina Azahara is just located on the trace of the mentioned Guadalquivir Fault Zone (GFZ), which comprises several subparallel minor faults stepping the Late Neogene sediments basin wards (Figure 2A). These faults are subvertical and affect to the gently dipping (10–15° SE) Late Miocene calcarenites and marls overlapping the Paleozoic materials of Sierra Morena (Figure 2B). Normal faulting affects the Paleozoic basement and Late Neogene materials across the northern margin of the basin but there are no surface faulting elements. For this reason, these faults are considered as late Neogene faults [28], but instrumental seismicity ($m_b < 4.5$) with normal faulting focal solutions is common along the northern margin of the basin [18,27] (Figure 2A). In the same way, important instrumental seismic swarms are recorded towards the southern margin of the basin, which are related to subsurface reverse faulting affecting the Paleozoic basement [18] (Figure 2A).

Paleozoic materials in the area are mainly constituted by variably metamorphosed volcanic and volcanoclastic formations of the Lower Cambrian to Ordovician age [29,30]. Regarding the Neogene materials, they are littoral and marine sediments filling the sedimentary trough and overlapping the northern Paleozoic materials. In the studied zone, these are mainly biocalcarenes, algae limestones and interbedded sands and yellow silts [28]. The substratum of the area has an upper Tortonian to Messinian age, but to the south (Carmona–Sevilla) these facies reach a Late Pliocene age following the progressive filling of the foreland basin during the Late Neogene [16]. In detail, the Neogene biocalcarenes and limestones from local quarries were the main construction materials in Medina Azahara, although other Paleozoic lithologies such as marbles, schists, gabbros, granites and other valuable exotic rocks were also used [31]. Overlapping the Neogene materials outcrops, the extensive formation of Quaternary alluvial deposits of the Guadalquivir River develop (Figure 2).

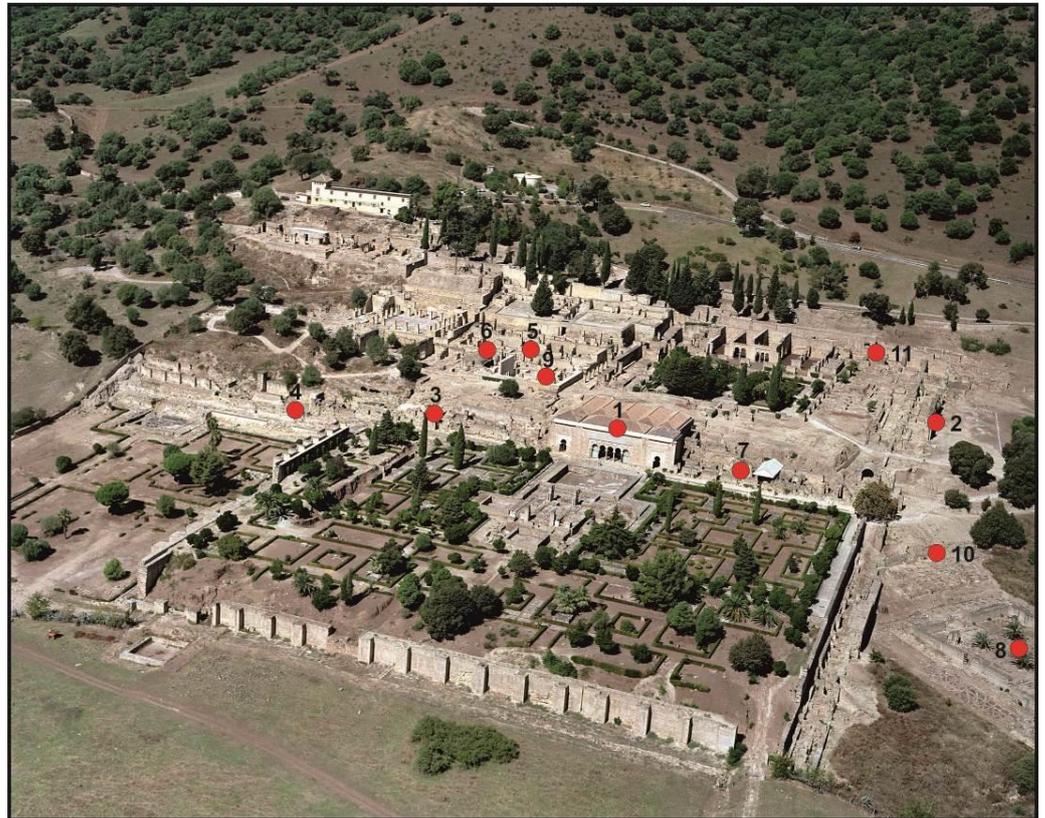
Figure 4. Aerial view of the archaeological site of Medina Azahara. The red dots are the location of the measurement of strain structures: 1—Abderraman III Saloon; 2—Porticos Entrance; 3—Ronda Way (Patrol Path); 4—Sewer of the patrol path; 5—The Oriental Service House (Oven); 6—Corridor of the Alberca House; 7—Attached Rooms to the Abderraman III Saloon; 8—Mosque; 9—Ya’far House; 10—Houses in the front of the Mosque; 11—defensive wall.

All the studied deformations are within the existing EAEs classification [41], and therefore subject to the proposed geological analyses. Eleven (11) different types of EAEs have been identified in this study: Collapsed key stones in arches (CKY), dropped key stones (DKY), directionally displaced columns (DDC), Block Extrusions in Walls (BEX), impact block marks (IBM), deformed and displaced vaults (DDV), tilted or folded walls (TFL), conjugated fractures in bricks-made walls (XFW), conjugated fractures on regular pavements (XFP), folds on regular pavements (FPV) and dipping broken corners in columns (DBC). These are distributed in 11 different sectors or buildings (Figure 4) and complete a dataset of 163 measured EAEs.

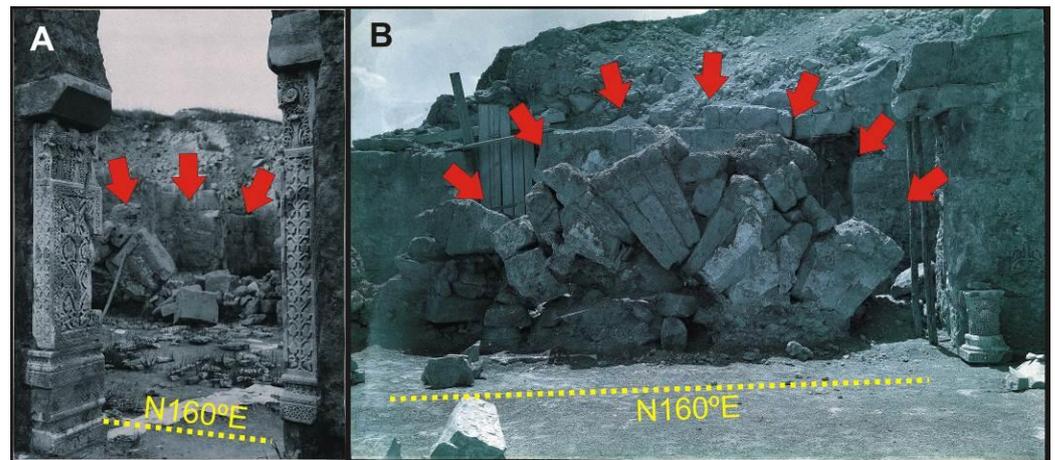
Figure 5. In situ collapsed arches in the Abderraman III Saloon. (A,B) interpretational sketches over the original photos from the excavations of the archaeologist Felix Hernández in 1943 (unpublished photographs). Red arrows indicate the collapsed and dropped keystones.

Most of the original information from Medina Azahara has been lost, mainly because its ruins were quarried for centuries, but also because former archaeological methods of excavation were more extractive than conservative. However, we have been able to analyse some photographs from the early excavations (beginning of the 20th century) and recover some of this lost information. Two photographs of the Abderraman III Saloon (Figure 5) from the excavations carried out by the archaeologist Félix Hernández in the year 1943 [5] show collapsed arches clearly parallel to the walls that contained them, in a $N160^\circ E$ direction.

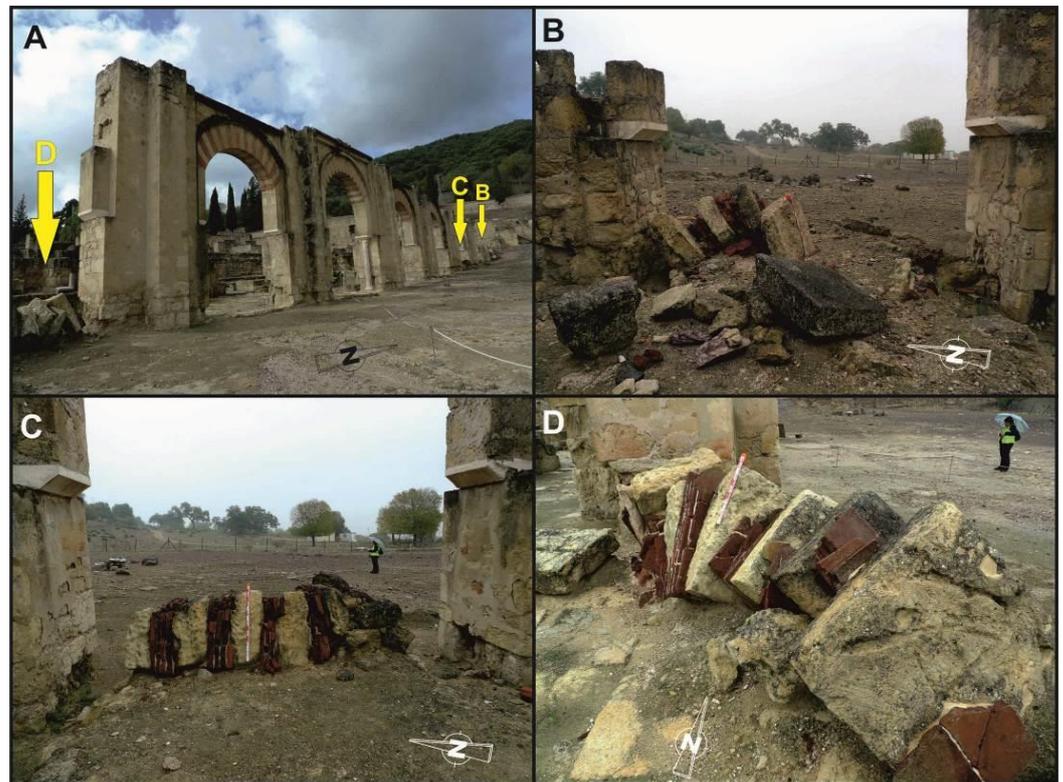
Figure 6. Collapsed arches in the Portico Zone: (A) General view of the arches, the yellow arrows mark the location of the collapsed arches in situ; (B) Collapsed arch marked like “B” in the (A) sketch; (C) Collapsed arch marked like “C” in the (A) sketch; (D) Collapsed arch marked like “D” in the (A) sketch.

The same feature can be observed in the site called “Los Pórticos” (Figures 4 and 6), where three in situ collapsed arches present the same $N160^\circ E$ orientation (Figure 6B,C) as in the Abderraman III Saloon. The southernmost arch (Figure 6D) shows a dextraltwist in the sequence of key stones generated after the collapse, which could have been produced by the proper fall down of the arch or by a movement relative movement of the ground in NW-SE direction.

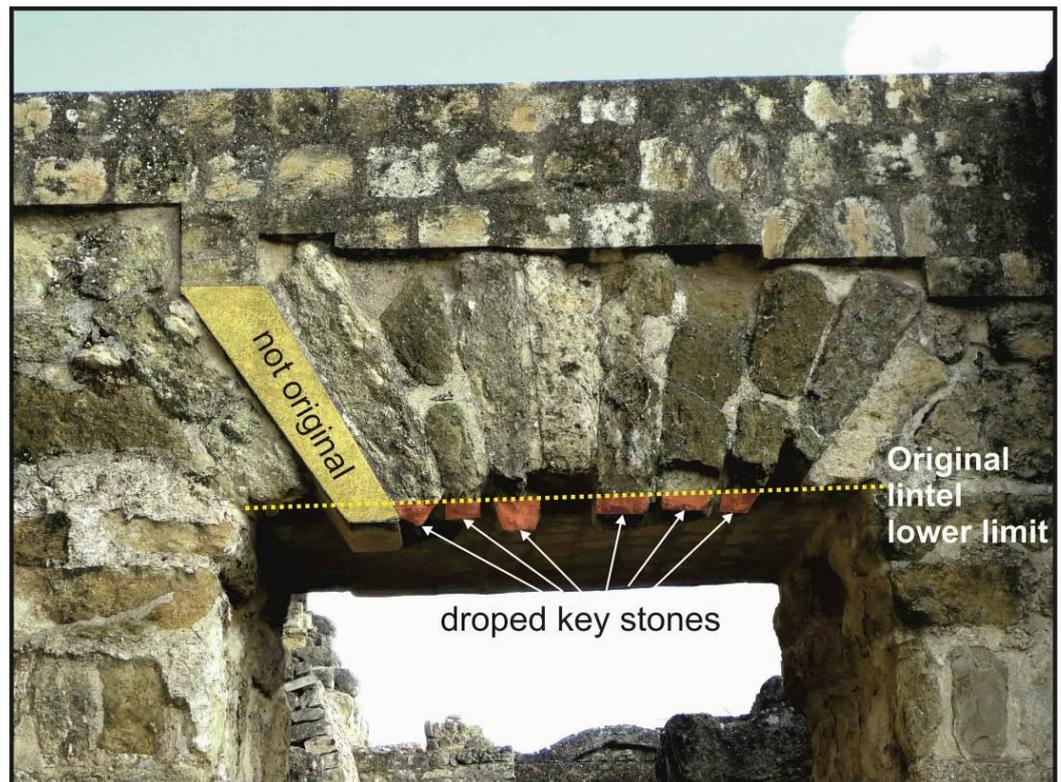
Figure 7. Dropped key stones in the Ronda Way zone. The direction of the wall that contain the arch is $N160^\circ E$.

Both dropped (Figure 7) and horizontally displaced (Figure 8) keystones are also recorded in the site. They are located at the end of the patrol path and in one of the sewers drains of the lower garden area (Figure 4). In the first case, the direction of the movement needed to generate the fall of the keystone should be $N163^\circ E$ (Figure 7), compatible with the direction of horizontal movement of the drainage arch (Figure 8). This horizontal displacement even extruded up to 10–12 cm the mortar joining these arch keystones, showing also horizontal striations generated by the movement of the key (Figure 8B). This is a very good example of how two arches, perpendicular each other, behave under a same directional seismic shacking triggered by surface waves, giving in both cases the same average direction of ground movement.

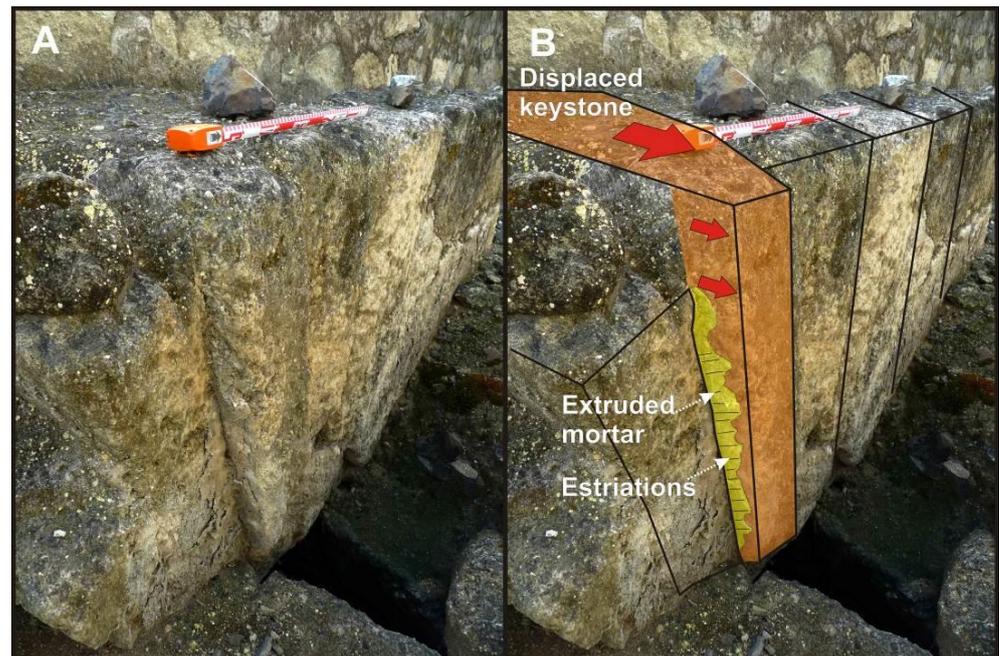
Figure 8. Horizontal displacement of key stones in a sewer at the Patrol Path zone: (A) perspective of the displaced key stone; (B) interpretative sketch, the displaced key stone is painted in orange (red arrow marks the direction of movement) and the yellow zone represents the extruded mortar from its original position.

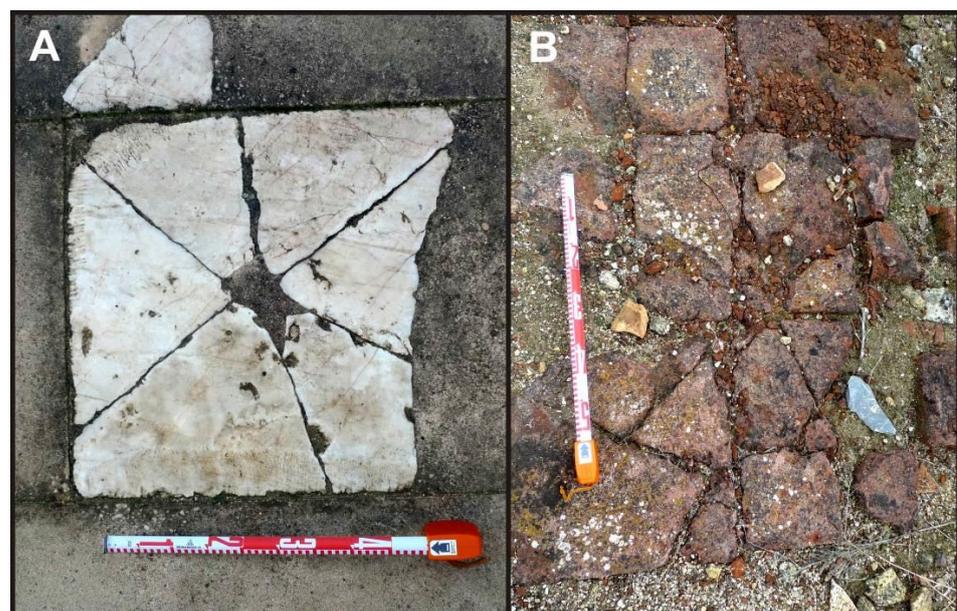
Figure 9. Impact marks: (A) Marble flagstone in the Ya'far House; (B) Terracotta flagstone in the Mosque.

The impact marks can indicate the direction and sense of the collapse of architectural elements that impact the pavements generating radial fractures [40,43,44,49]. This type of deformations can be observed around the Ya'far House (Figure 4) with regular marble pavement (Figure 9A) and in the Mosque with terracotta flagstones (Figure 9B). Unfortunately, the absence of the architectural elements that impacted the paved areas does not allow to determine the direction and sense of collapse. For this reason, these impact marks have been documented but cannot be used for geological structural analysis.

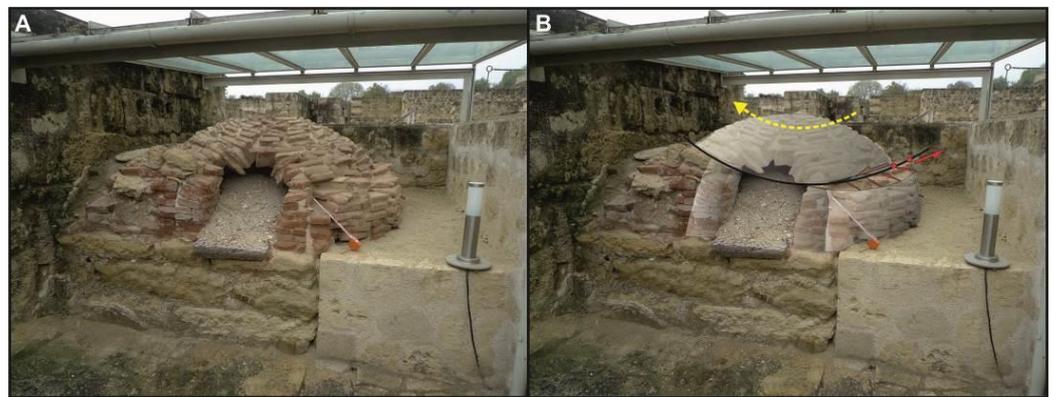
Figure 10. (A) Deformed oven in the Oriental Service House and (B) interpretative sketch of the deformation structures (displaced vault). Arrows show the relative sense of rotation of the own elements.

A very common EAE that affect the cultural heritage during earthquakes is the deformation, and eventual collapse, of vaults [50]. For example, the 2011 Lorca earthquake (Spain) generated a horizontal fracture with a 10–15 cm long displacement in the cross vault of the San Francisco Church coinciding with the direction of the arrival of surface seismic waves [49]. In Medina Azahara, the only preserved vaults are those of kitchen ovens, as the one preserved in the Eastern service house (Figures 4 and 10). The upper half of the brick vault of this oven is noticeably affected by a 10 to 16 cm horizontal displacement towards N135° E, making the structure too unstable to remove the archaeological filling of the oven to prevent its collapse (Figure 10A). As illustrated in Figure 10B, during seismic shaking, the circular ground base of the oven rotated in a counter-clockwise sense (towards the SE), triggering the visible twist of the oven vault. These kinds of rotations in circular elements without anisotropy, as orthogonal walls could be, are indicative of permanent ground deformation since the base of the structure rotates, but not its upper part [1,2]. Therefore, this EAE is an excellent indicator of the direction of maximum horizontal deformation (i.e., SHmax trajectories) [44,45].

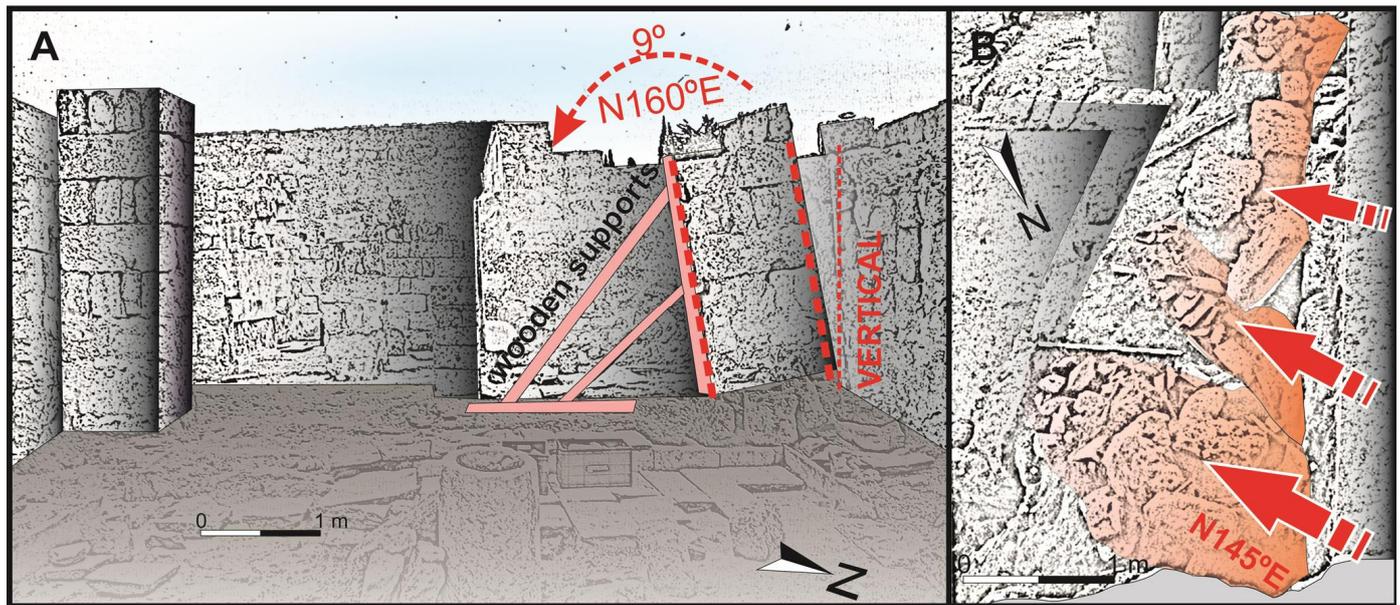
Figure 11. Tilted and collapsed walls: (A) tilted walls in the sector of the service houses. Photograph taken during the excavations of 1992–1997 (schematic shecht based on [52]) (B) collapsed walls in the houses in front of the Mosque (schematic shecht based on [37]).

This EAE is one of the most common effects observed in any urban area after an earthquake [44,51]. Tilted walls can be seen in photographs from former excavations, such as those carried out during the period 1992–1997 in this site [52]. These tilted walls were restored after the excavations, so we can only study them by using the old photographs (Figure 11). The best example of tilted wall is in the sector of the service houses (Figure 11A), where the main walls are tilted 9 degrees towards N160° E. On the other hand, oriented collapsed walls were excavated in several houses in front of the Mosque [37], where the collapse followed a N145° E direction (Figure 11B).

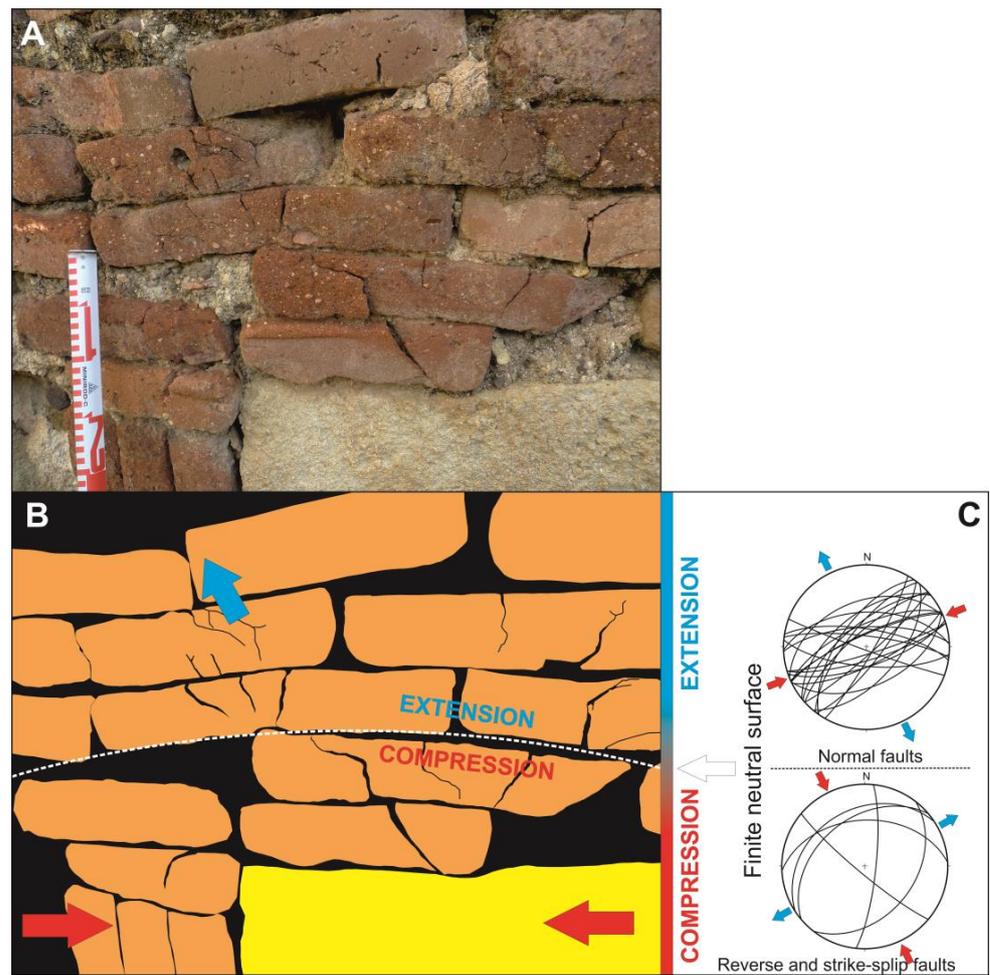
Figure 12. Deformed brick-made walls in the corridor of the Alberca House: (A) Fractures in bricks-made walls; (B) interpretative sketch of the deformation structures in bricks (orange) and masonry block (yellow); the red arrows represent the maximum horizontal strain, and the dashed line is the finite neutral surface; (C) stereonet of reverse and strike-slip faults generated under the finite neutral surface (compression) and normal faults over the finite neutral surface (extension).

Cyclic shear movements generated by earthquakes in walls that are parallel to the direction of ground motion can generate conjugate fractures (X-fractures), which are a very common seismic effect in buildings deformed by earthquakes [43,44,50,53]. In Medina Azahara, most walls are masonry walls made up with blocks of carbonate sandstone (calcarenites) with different weathering degree that makes it very difficult to discern whether fractures were generated by an earthquake, or they were inherited from the original rock. In many cases, all traces of possible seismic deformation structures such as fractures (XFP) or dipping broken corners (DBC), have been erased by the weathering of the walls. However, conjugated fractures have been observed in the better-preserved brick walls, with the most interesting case in the corridor of the Alberca House (Figure 4).

The wall in this corridor is essentially made up of bricks with a mixed base of bricks and masonry blocks. Although this wall is affected by conjugated fractures, the most interesting phenomena is the development of “micro-fractures” in the bricks that behave fragile to deformation, while the mortar that joins them has a ductile-fragile behavior, which allows some inter-brick displacement. The horizontal movement of masonry blocks at the base of the walls by the cyclic shearing generated during seismic shaking, produce a compressive effect on the bricks beside and on the top of them (Figure 12A). Horizontal thrusting causes folding of the upper wall zone, generating compressional fractures (reverse faults) in the lower part and extensional fractures (normal faults) in the upper part (Figure 12B). A total of 6 reverse faults and 24 normal faults have been measured, congruent with a single horizontal shortening direction N155° E (Figure 12C). This phenomenon is common in the development of folds, where this type of deformation, compression in the lower part and extension in the upper part, is separated by the finite neutral surface (Figure 13). Conjugated compressive fractures follow Anderson’s classical fracture models, while extensional features follow the Slip Model [54]. In both cases, the three deformation axes remain parallel to each other, exchanging the axis of maximum shortening from the horizontal, in the case of compressional stresses, and to the vertical in the case of extensional ones, thus being a coaxial deformation compatible with a unique direction of maximum horizontal shortening (SHmax), N155° E in the studied case (Figure 13).

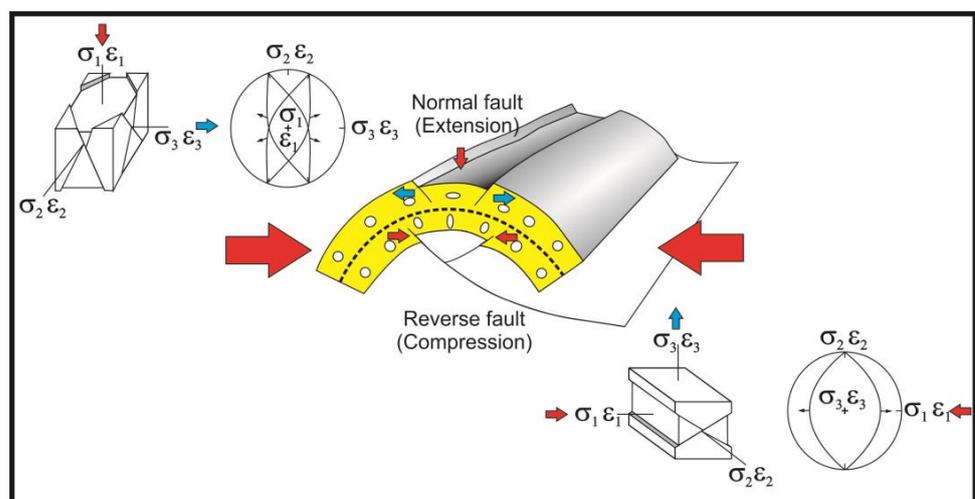
Figure 13. Structural sketch of brittle deformation generated in a fold. This interpretation is used for the explanation of the conjugated fractures in brick-made walls. Red arrows represent compression and blue ones extension; the dashed line is the finite neutral surface.

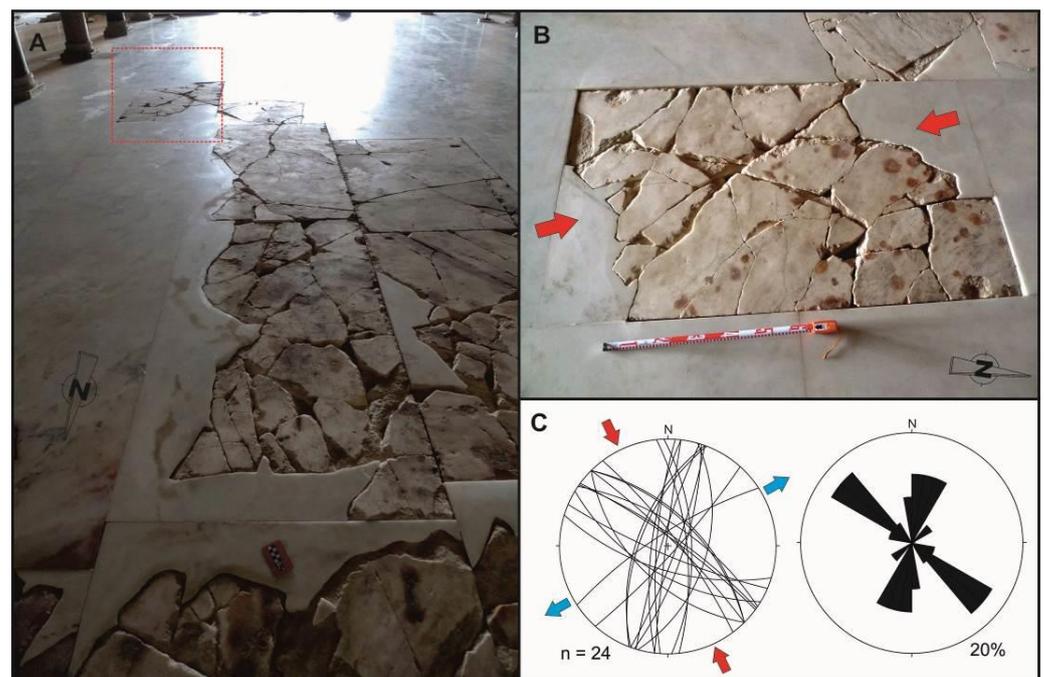
Figure 14. Conjugated fractures in the in the Abderraman III Saloon: (A) reconstructed original marble flagstone; (B) close view of a marble flagstone with conjugated fractures (marked with a red dashed line in (A)); (C) stereonet and rose diagram of conjugated fractures (red arrows: compression; blue arrows: extension).

The two most interesting areas are the Abderraman III Saloon (Figures 4 and 14) and its attached rooms (Figures 4 and 15). A total of 24 fractures (12 pairs of conjugated fractures) have been measured within the Abderraman III Saloon (Figure 14C). The direction of maximum horizontal shortening is in the bisector of the acute angle formed by the conjugated fracture systems, which in this case is in a N156° E direction. In the sector of the Attached Rooms, 16 fractures (8 pairs of conjugated fractures) were measured, obtaining a similar result that in the previous site, with an average direction of maximum horizontal shortening of N164° E (Figure 15C).

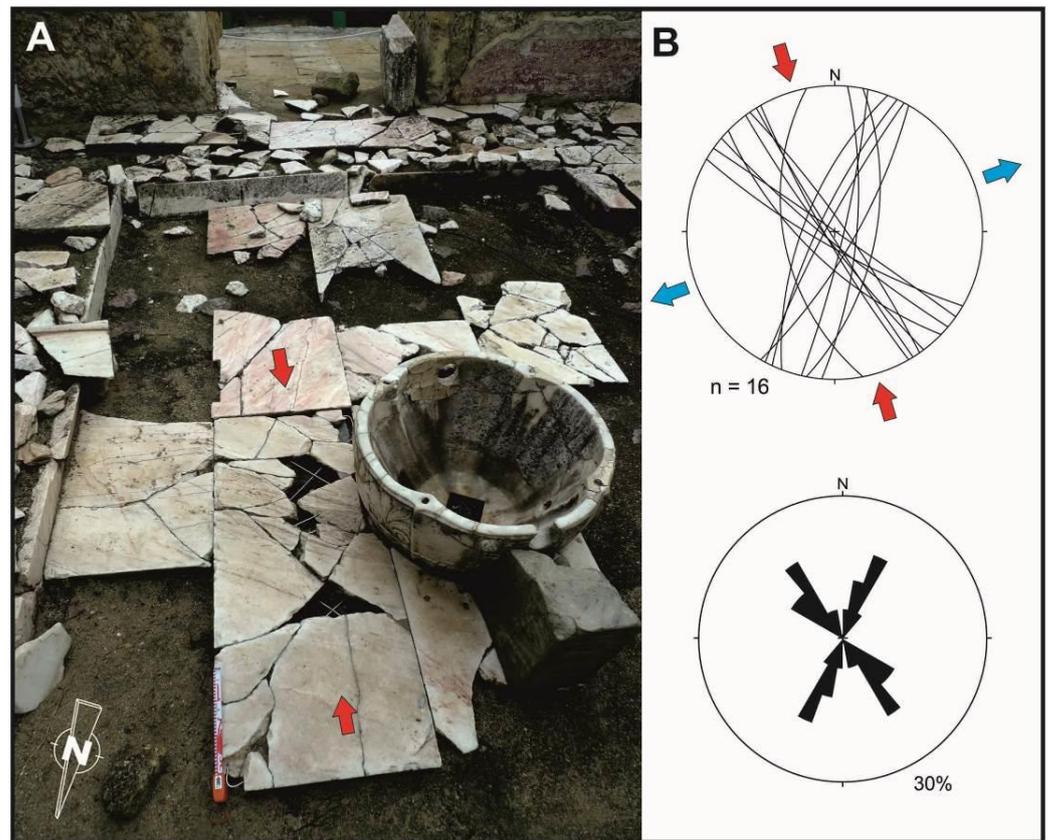
Figure 15. Conjugated fractures in the in the Attached Rooms to the Abderraman III Saloon: (A) reconstructed original marble flagstones; (B) stereonet and rose diagram of conjugated fractures (red arrows: compression; blue arrows: extension).

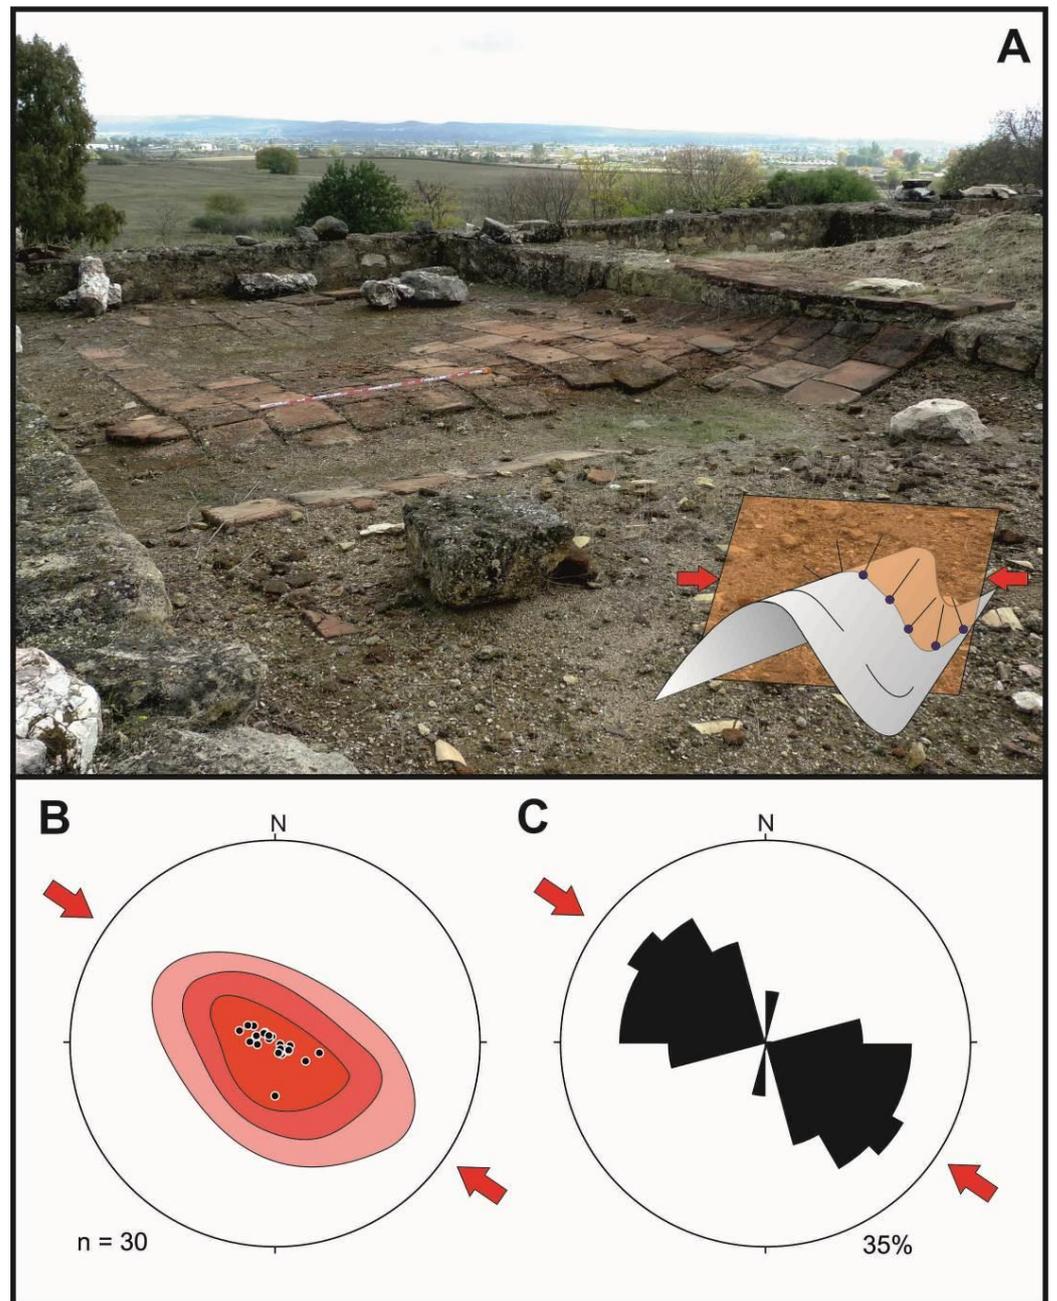
Figure 16. (A) Folds in terracotta regular pavement in the mosque; (B) density diagram of pole representation of flagstones; (C) rose diagram of the poles of the flagstones. Red arrows represent the maximum horizontal strain.

This classical geological method to characterize the folds has been used in the folded pavement of the Mosque (Figures 4 and 16A) to obtain the SHmax orientation from the deformed pavement. The floor of the mosque, consisting of terracotta tiles (80 cm × 90 cm), shows folds with a wavelength of 1.5–2.3 m. The orientation of the tiles was determined measuring perpendicular sections to the fold axes and obtaining average orientations of the direction of the plane containing the poles of these planes, in this case with an orientation N125° E (Figure 16B,C).

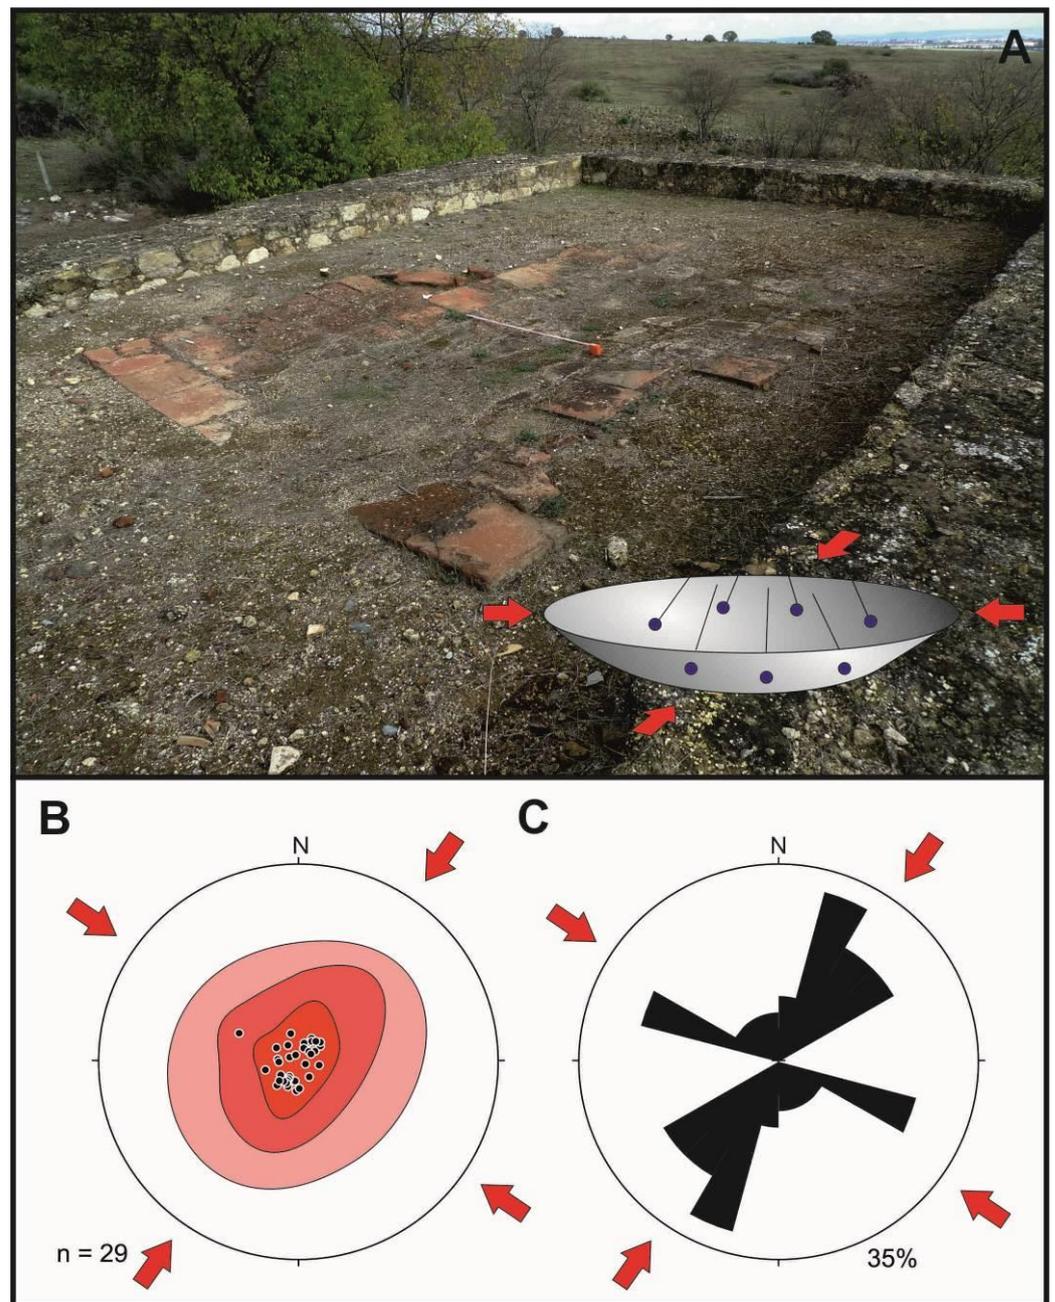
Figure 17. (A) Interference of folds in terracotta regular pavement in the Mosque, the fold has an interference figure Type 1 (egg box pattern); (B) density diagram of measured flagstone poles; (C) rose diagram of the deformed flagstone poles. Red arrows represent the maximum horizontal strain (SHmax).

In addition to folds, the floor of the mosque shows differential compaction of the ground. The Mosque was built on the same hillside (slope) as the rest of the city, so half the floor of the building had to be terraced and the other half rests on the infilling extracted from the terracing, being this artificial filling where the main compaction phenomena occur. As a present-day example, during the 2011 Lorca earthquake (Spain), differential compaction triggering pavement deformations was documented in anthropic fillings [49]. The cyclic shear movements generated by the Lorca earthquake caused the internal reorganization of the particles of the artificial fillings inducing an increase of packing and a decrease of porosity, inducing differential compaction and folding of the overlaying elements of the pavement. A similar phenomenon has been observed in Medina Azahara Mosque, where the vertical compaction of the ground surface reaches more than 30 cm (Figures 16 and 17). Therefore, in this case, in addition to the horizontal deformation, a complementary vertical deformation took place because of differential compaction of the ground. The sum of both deformations produced a fold interference figure with a “egg box” pattern, known in structural geology as Type 1 interference structure [57]. This phenomenon can be observed at the SE end of the northernmost nave of the Mosque (Figure 17A), where the two dominant directions of folding are N034° E and N125° E (Figure 17B,C), the first one related to the seismic wave deformation (which would be perpendicular to it, N124° E) and the second one to the effects of ground compaction.

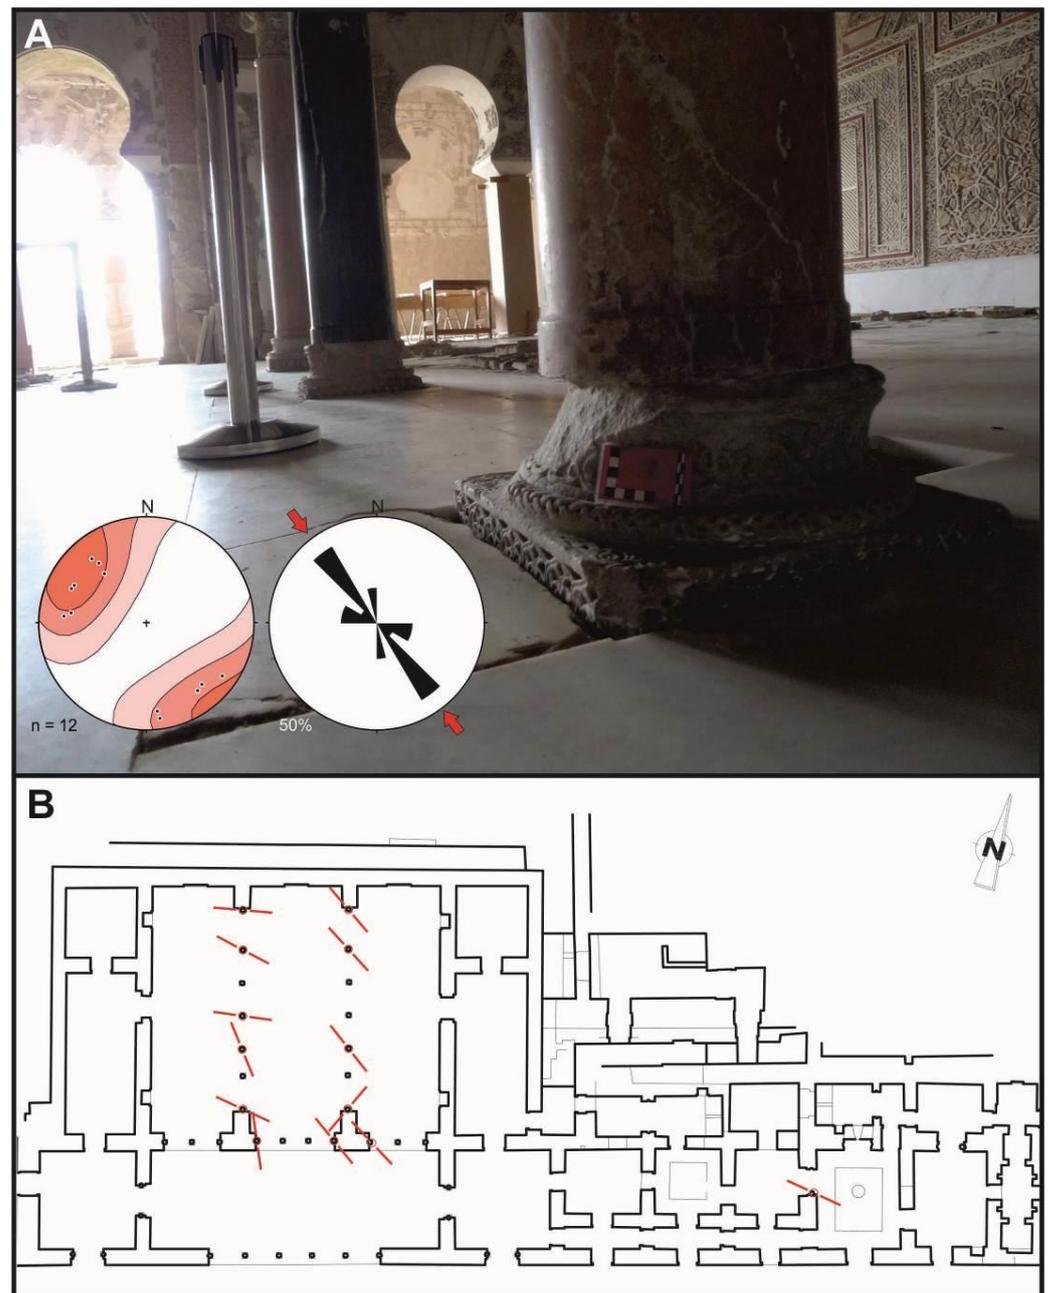
Figure 18. Dipping broken corners in the base of columns in the Abderraman III Saloon; (A) Close up view of a dipping broken corner in the base of a column and density and rose diagram of the poles of the fractures; (B) Map of the Abderraman III Saloon and Attached Rooms (red lines is the horizontal projection of the dipping broken corners poles).

The building that presents the best examples of columns with circular section is the Abderraman III Saloon (Figure 4). The reception hall of the lounge has a set of 24 marble columns, 12 of which display fractures at the edge of their bases (Figure 18). Only the original bases were used to take measures, as some of them have been replaced by new drums during the restoration works. The average orientation of the poles of the fracture planes is N145° E, and the measurements are very homogeneous (Figure 18A). Another fractured base has been identified around the attached rooms to the saloon (Figure 18B).

Regarding the preserved remains, the probable seismically induced destruction of rich buildings (i.e., Abderramman III Saloon; Figure 18) may have allowed the preservation of many of their luxurious decorative architectural elements (cooper, marbles, etc.) under the rubble, saving them from early robbery and centuries of plundering. Otherwise, these valuable elements would have been stolen, miss-sold and reused in former medieval buildings in Cordoba, the Islamic Iberia, or the entire Maghreb [63]. Collapse levels by earthquake damage would facilitate the preservation of valuable elements under the ruins of the historical heritage from the ancient Al-Andalus, allowing their recovery by the archaeological excavations carried out in Medina Azahara from the early 20th century [5].

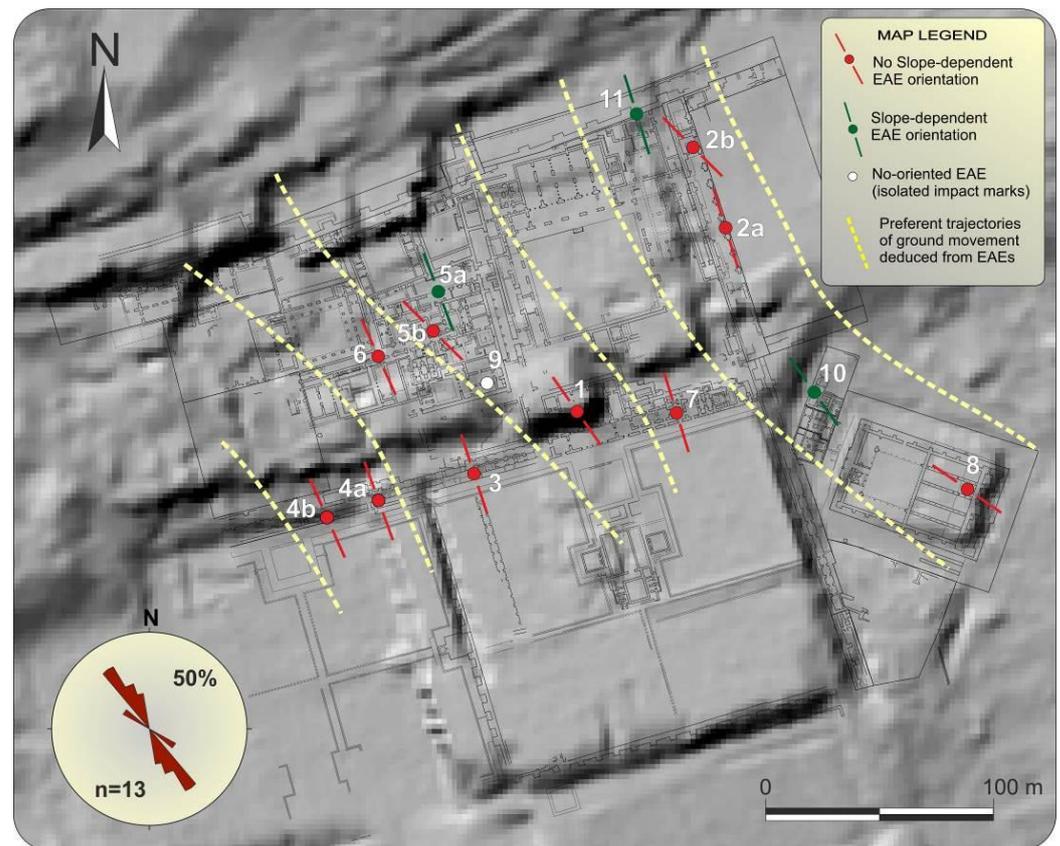
Figure 19. Map of the Caliphal City of Medina Azahara showing the average trajectories of maximum horizontal strain (yellow dashed lines) obtained from the geological structural analysis of EAEs. Number codes refer to surveyed sites referenced in Figure 4 (Section 5). The urban map of the archaeological site is showed on the Digital Terrain Model (2 m/pixel) obtained from Lidar data of the PNOA database (IGN): <https://pnoa.ign.es/el-proyecto-pnoa-lidar> (accessed on 20 February 2022).

Some of the analyzed EAEs are subparallel to the overall ground slope of the site (Figure 19) so they could be attributed to directional collapses by slope process before or during the earlier burial stages of the abandoned city (i.e., some tilted and wall collapses; Figures 11 and 19). Other EAEs can only be related to building-oriented damage (BOD) of seismic origin. This is the case of dropped or displaced keystones (Figures 6–8), rotation of structural elements (Figure 10), conjugated fractures in pavements (Figures 14 and 15), folded pavements (Figures 16 and 17), impact marks in clean pavements (Figure 9) and dipping broken corners in the base of columns in the Abderraman III Saloon (Figure 18). Some of the modern archaeological excavations indicate that the site was early buried after its abandonment. In the houses attached to the mosque (sector 10 in Figure 4) there are collapsed walls and roofs that directly impacted on the old pavement, with piles of ceiling tiles oriented in a NW–SE direction coming from the south, i.e., counter-slope collapses [37]. This author indicates that this destruction horizon contains dark clayey levels with animal bones and pottery fragments of a clear caliphal chronology (≤ 1009 CE) which was rapidly buried by a thick pile of debris-slope deposits incorporating many elements, blocks and pottery fragments of the ruined city. These upper debris levels contain Hispano-Muslim rounded pottery fragments of post-caliphal age, sandy levels as well as rubble and stucco horizons from the medieval plundering of the ruins [37].

(Figure 19) indicates that the oriented damage recorded in Medina Azahara can be certainly related with a damaging earthquake (\geq VII MSK) that contributed to the destruction and ruin of the city. Similar oriented patterns have been observed during recent instrumental earthquakes being possible to relate them to the primary arrival direction of surface seismic waves and earthquake source parameters [43,46,47].
