# Application of Failure Mode Effects Analysis for Maintenance of Turnout System on Serviced Urban Rapid Transit

**Abstract:** Over the past 25 years, maintenance processes for the wooden sleeper turnouts of sleeper floating tracks (known as STEDEF) have been insufficient, lacking accurate maintenance history and failure cause analyses. Currently, damaged parts are repeatedly replaced without an analysis of the cause of their failure. Therefore, it has been difficult to predict potential damages due to the lack of maintenance history data on the replaced items and the timing of the turnout component. This study proposes a turnout maintenance plan using the failure mode and effects analysis (FMEA) technique to analyze the turnout maintenance history data for a period spanning 10 years. The maintenance damage type of the turnout was classified to confirm the cause of damage and the damage frequency. Additionally, components that could lower the occurrence score were selected based on a risk analysis of the turnover. Therefore, it was possible to reduce the risk occurrence score by improving the size of the turnout top plate and the number of bolts.

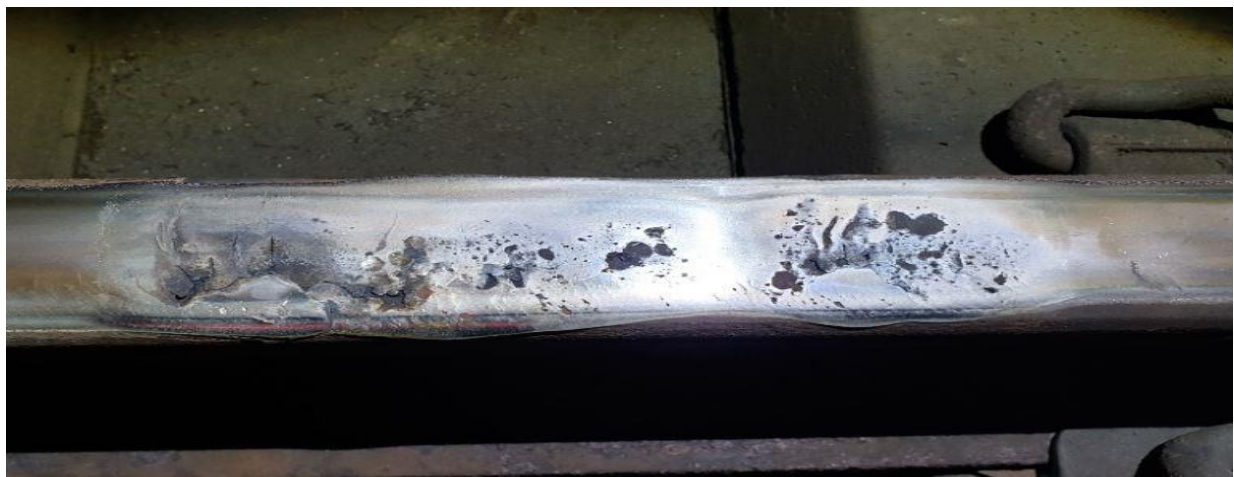
**Figure 6.** Squat.

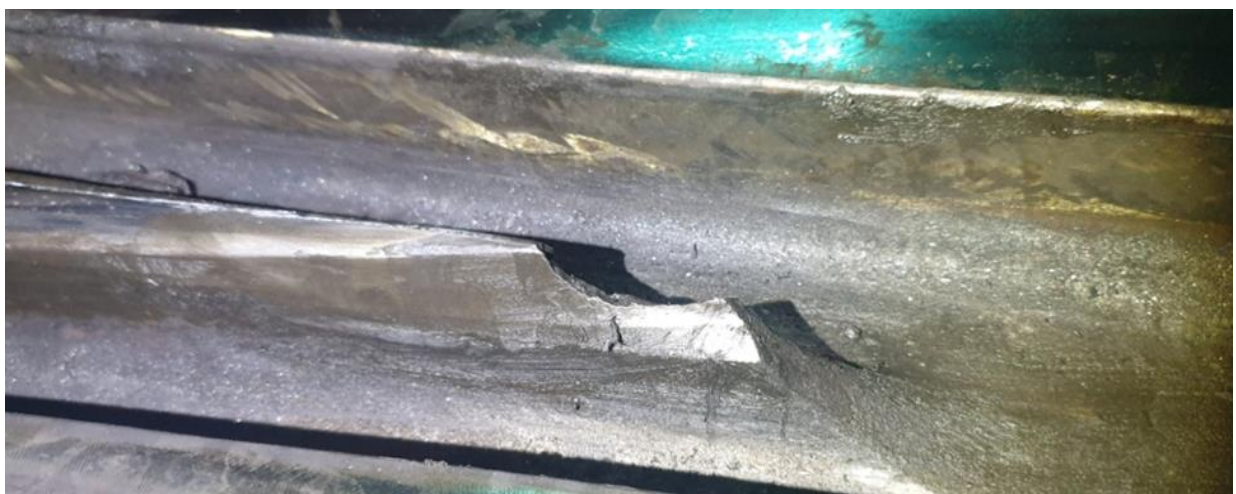
**Figure 7.** Partial fracture of the nose.

Meanwhile, seven different damage occurrences from the past seven years were observed on the closure panel. Rail wear was the primary type of damage. The status in terms of damage occurrence was determined based on the turnout numbers; these were 3, 2, and 2 for F8, F10, and F12, respectively, thereby indicating that more damage occurred in turnouts with shorter lengths. In the closure rail, as shown in Figures 5 and 6, the main types of damage were head check, squat, and side wear, which are forms of rolling contact fatigue damage. In addition, wear and partial fracture also occurred on the crossing nose, which bears the highest level of repetitively applied impact loads among the turnout components, as shown in Figure 7.
