# A Study on Development of New Type Rubber Boot for Sleeper Floating Track System (STEDEF): Materials and Shapes

**Abstract:** Urban railway sleeper floating track (STEDEF) reduces the block vibration transmitted to the subgrade structure by structurally separating the sleeper and the concrete bed, using a rubber boot and a resilient pad. Recently, the replacement of rubber boot material (SBR) after long-term wear and tear has become of utmost importance because of durability problems such as deformation, tearing, and abrasion. This study investigates rubber boots—a component of the urban railway sleeper floating track—to resolve these concerns and proposes the material and shape of a novel rubber boot. The proposed rubber boot reduces the maximum displacement and strain by more than 83% and 90%, respectively, compared with the existing rubber boots. In addition, the results of numerical analysis and indoor tests show that type 3 rubber boots can prevent displacement and stress generation in rubber boots.

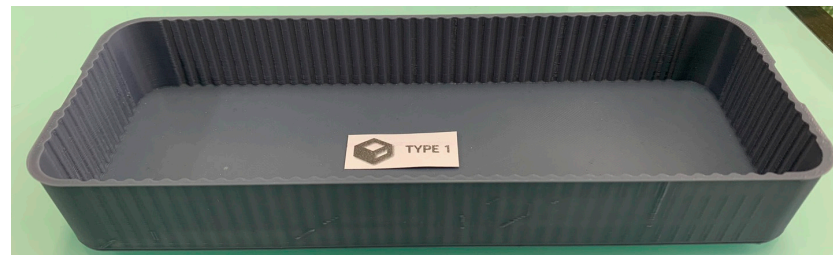
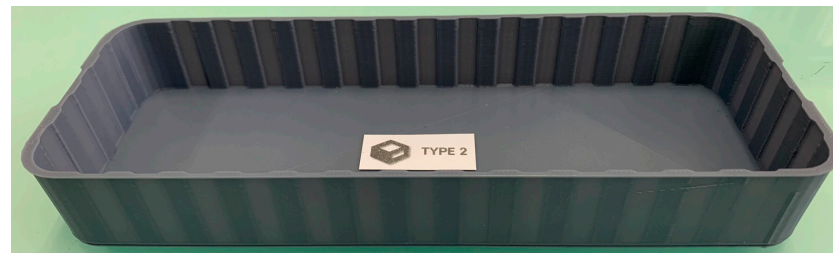
In this study, after designing all the possible rubber boot shapes (draft), the products were manufactured in a small size using a 3D printer, as shown in Figure 13.

**Figure 13.** Rubber boot 3D-printed models (draft). (a) type 1; (b) type 2; (c) type 3; (d) type 4.

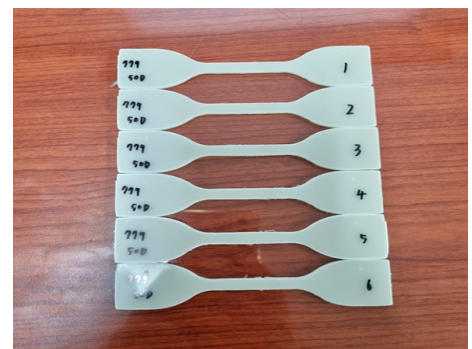
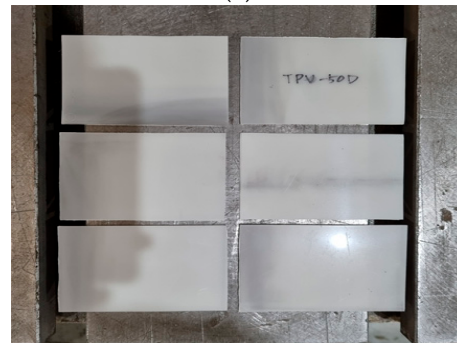
To select the optimal material for the new eco-friendly rubber boot, the physical properties of various EP materials, as shown in Table 3, were examined, and the priority of the optimal material was determined based on the indoor test. Correspondingly, a total of five seat-type prototypes for indoor testing were produced. Figure 17a–d show the indoor test specimens.

**Figure 17.** Rubber boot indoor test specimen (example): (a) hardness; (b) tensile strength; (c) shear; (d) static/dynamic compression.
