# Experimental Investigation on Innovative Stress Sensors for Existing Masonry Structures Monitoring

**Abstract:** Historical masonry structures often suffer gradual deterioration that in many cases can compromise the safety levels and the operating conditions of the buildings. In this context, Structural Health Monitoring (SHM) is an effective tool for the prediction of the structural behaviour and the state of conservation of buildings. Although many monitoring systems have recently been proposed, there is a lack of practical application of low-cost systems. This paper presents an experimental study based on the use of two innovative stress sensors—capacitive stress sensor and ceramic stress sensor—for the monitoring of existing masonry elements. In order to reproduce the actual conditions of onsite masonry, sensors are post-installed in the mortar joints of two series of pre-stressed specimens made of calcarenite stone masonry and clay brick masonry. The best practice of post-installation of the two sensors is investigated. The reliability of the proposed sensors is evaluated through comparison with data recorded from classical measurement devices.

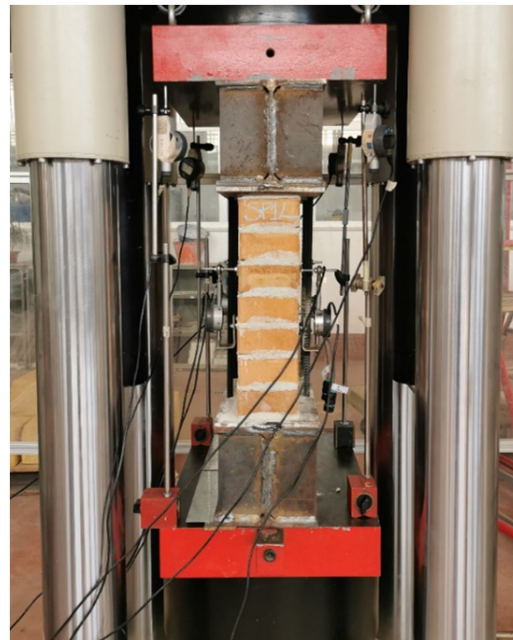
**Figure 8.** Test setup.

The specimens were tested in compression by using a Zwick–Roell testing machine with capacitance of 4000 kN, Figure 8. Tests were performed in a displacement controlled mode, assuming a rate equal to 0.2 mm/min. Preliminary, two pre-load cycles were carried out ranging between 20 and 100 kN for assessing a suitable contact between the testing machine and the specimen.

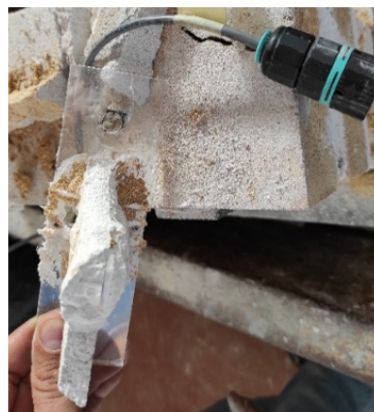
**Figure 17.** Sensor fully embedded after the test.
