Article

Mechanism of Time-Dependent Instability of Deep Soft-Rock Roadway and Crack-Filling Reinforcement Technology

Mechanism of Time-Dependent Instability of Deep Soft-Rock Roadway and Crack-Filling Reinforcement Technology. *Appl. Sci.* **2023**, *13*, 4641. <https://doi.org/10.3390/app13074641>

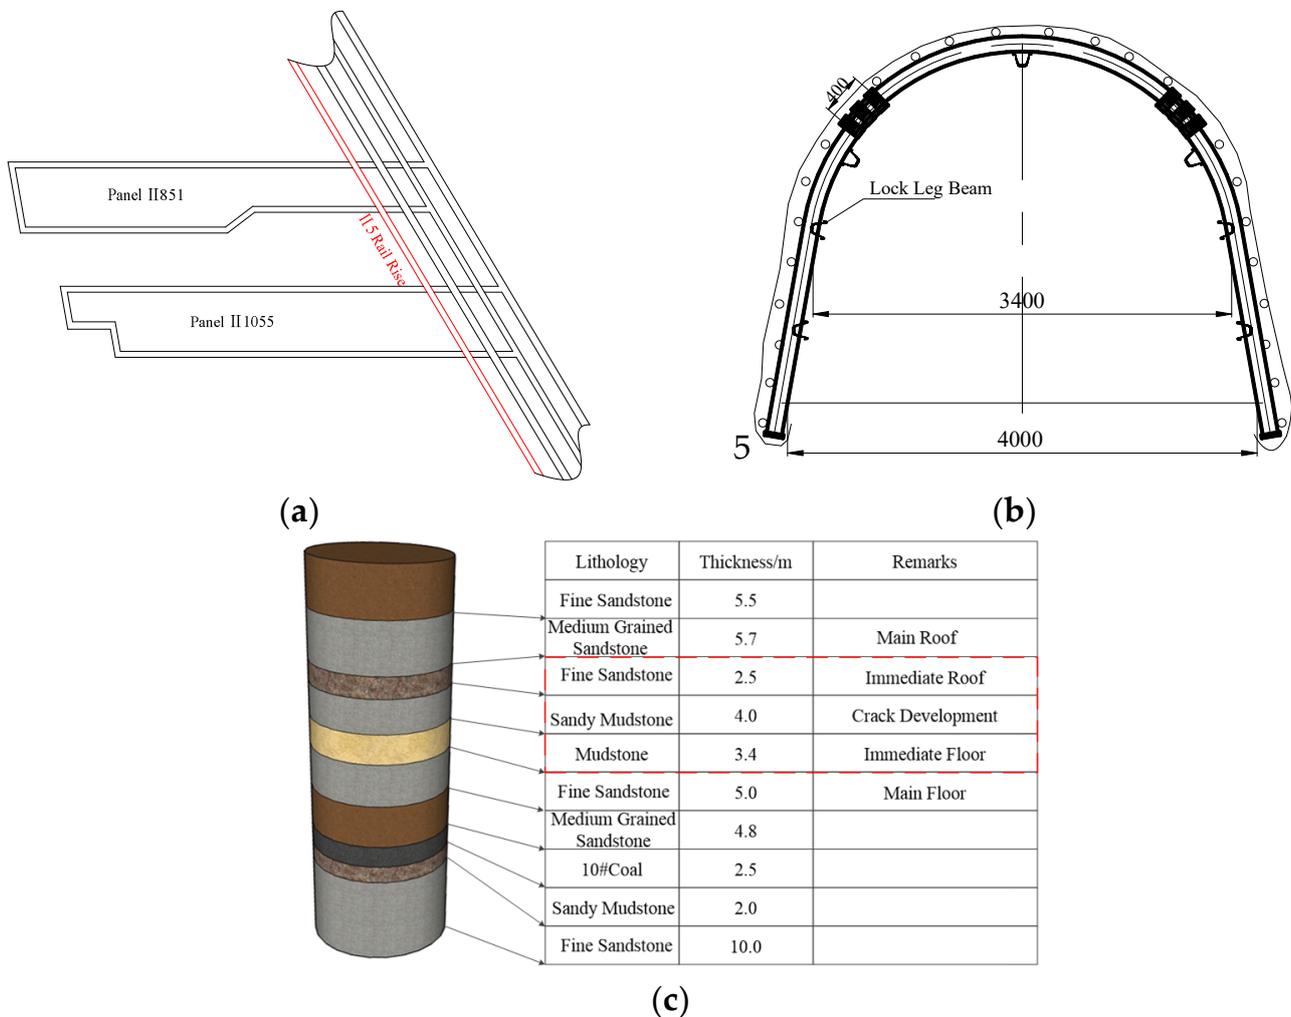
Figure 1. Basic information of the roadway. (a) Layout plan of the II5 Rail Rise; (b) Initial support of the roadway; (c) Geological histogram.

Zhuxianzhuang Coal Mine is located in Suzhou City, Anhui Province, China. The II5 Rail Rise of this mine is a roadway with straight walls and a semicircular arch (4.0 m width \times 3.4 m height). The straight walls are 1.4 m in height and 450–678 m in buried depth (Figure 1a). The selected roadway, 600 m in buried depth, is located in sandy mudstone where internal cracks are developed and the range of the test loose circle exceeds 2.0 m. Therefore, the surrounding rock is weak, broken, and of poor integrity. The roof and floor are 2.5 m thick fine sandstone and 3.4 m thick mudstone, respectively. Figure 1c shows the comprehensive geological histogram. According to Figure 1c, initially, the II5 Rail Rise adopts the U29-type shed symmetrical support, in which the overlapping length of the beam legs is 400 mm; the tightening torque of nuts is not less than 300 mm; and the spacing of the sheds is 500 mm.

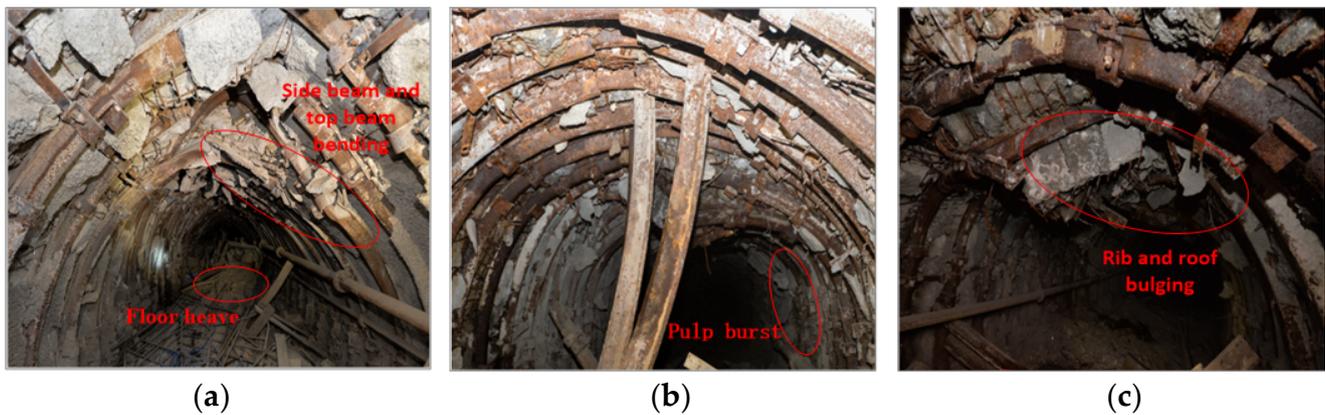
Figure 2. Roadway damage in test section. (a) Floor heave and side-beam and top-beam bending; (b) Pulp burst; (c) Rib and roof bulging.

As can be observed from the photos of roadway damage in the test section given in Figure 2, the soft and broken surrounding rock of the roadway displays serious asymmetric

deformation and support failure phenomena under the long-term action of deep high-ground stress, including floor heave, side-beam and top-beam bending, twisting, kneeling leg, pulp burst, rib and roof bulge, etc. The monitored data of the roadway surface displacement show that the rib-to-rib displacement is 1000–1500 mm and the floor heave is 800–1200 mm, which threatens the safety of coal mining.

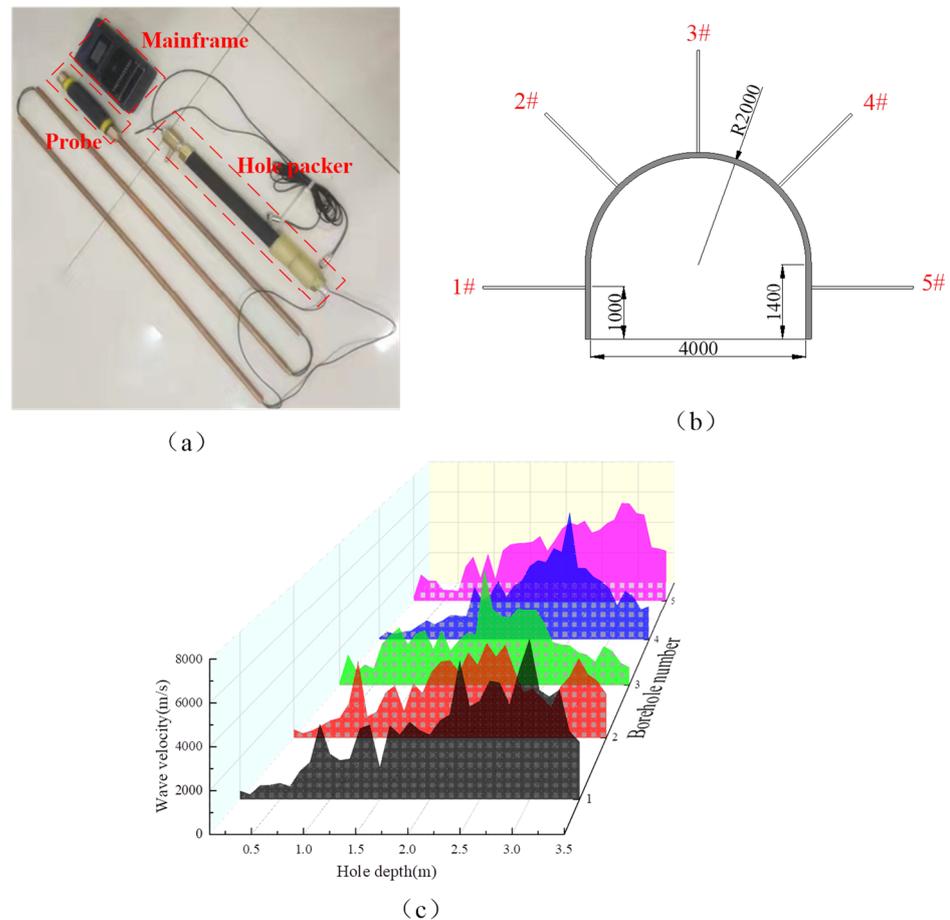
Figure 3. Surrounding rock loose circle test. (a) CT2 mine ultrasonic surrounding rock crack detector; (b) test borehole arrangement; (c) test results.

The boundary of the loose circle was measured using the single-borehole method with the aid of the CT2 ultrasonic surrounding rock crack detector (Figure 3a). Considering the serious overall roadway damage, test boreholes were arranged in the full section of the tested roadway (Figure 3b). Boreholes 1#–5# were located at the left rib, the left 45° shoulder corner, the midpoint of the roof, the right 45° shoulder corner, and the right rib of the roadway, respectively. Since sound waves propagate more slowly in the fracture zone than in the original rock mass, the wave velocity fluctuated obviously at the periphery of the loose circle. Hence, the abrupt change point of the sound velocity was taken as the boundary of the loose circle. Figure 3c shows the relationship between the wave velocity and the borehole depth. It can be seen that with the increase in the borehole depth, the wave velocity curves of the five boreholes rose gradually, then reached their peaks at the critical points, and finally tended to stabilize. The test results show that the average sizes of the loose circle corresponding to boreholes 1#–5# were 3.0 m, 2.2 m, 1.8 m, 2.5 m, and 2.9 m, respectively. The large sizes of the loose circle at the roadway left rib (borehole 1#) and the right shoulder corner (borehole 4#) are indicative of serious breakage and internal crack development in the surrounding rock at these two positions. Therefore, the real range of the loose circle obtained in this test was about 3.0 m, and it was difficult to effectively control the deformation of the roadway surrounding rock with merely the shed support.

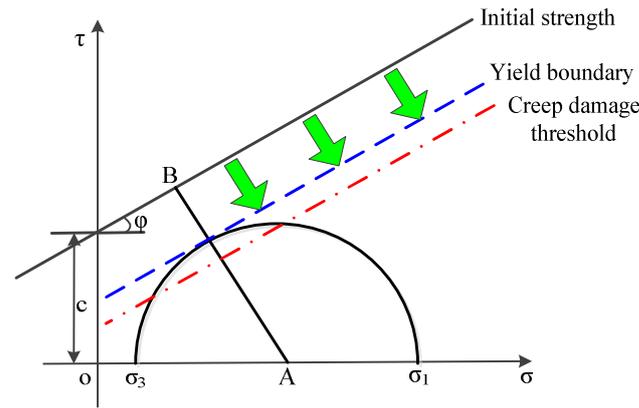
Figure 4. Schematic diagram of block strength attenuation.

In the discrete element software Universal Distinct Element Code (UDEC), the deformation and damage of a rock block are jointly controlled by the block and the contact surface. UDEC merely provides a rheological model for the block, yet fails to offer a rheological model for the contact surface [22]. Based on the GBM-TtoF creep model developed by Wang et al. [23], in this study, a rheological model based on the strength attenuation of the contact surface was established. The ideas of these two models are basically consistent. That is, the relationship between the block strength variation with time is established first and then converted into the strength attenuation of the contact surface through the coefficient. A schematic diagram of the block strength attenuation of the two models is illustrated in Figure 4. The models assume that the crack damage threshold is equal to the rheological damage threshold. By lowering the position of the strength line, rock damage under a static load that is lower than the ultimate strength is described. The ultimate strength of rock is the distance of AB:

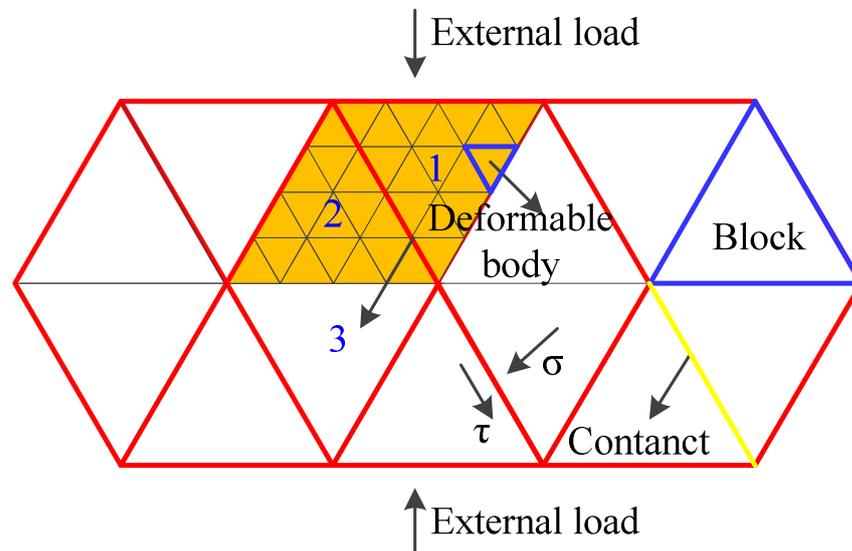
Figure 5. Mechanism of contact strength attenuation.

The strength attenuation of blocks can be transformed into the strength attenuation of the contact surface through the conversion coefficient K . The conversion coefficient of the GBM-TtoF creep model is the defined damage coefficient, but the model in this study defines the conversion coefficient K based on the crack static fatigue failure mechanism [27] and software characteristics. The mechanism of the strength attenuation of the contact surface is illustrated in Figure 5. The contact surface between blocks 1 and 2 is called contact surface 3. Since the strength attenuation of contact surface 3 is jointly controlled by the strength attenuation of blocks 1 and 2, the strengths of the blocks can be applied to the strength of the contact surface through strength conversion. In fact, many deformable bodies exist in a block, and they also follow the law of strength attenuation. The stress states of deformable bodies in the block differed as a result of stress concentration. Therefore, we could monitor the stress states of deformable bodies inside the block using the FISH function and record the number of deformable bodies exceeding the rheological damage threshold; afterwards, through dividing this number by the total number of deformable bodies inside the block, the conversion coefficient K was obtained:

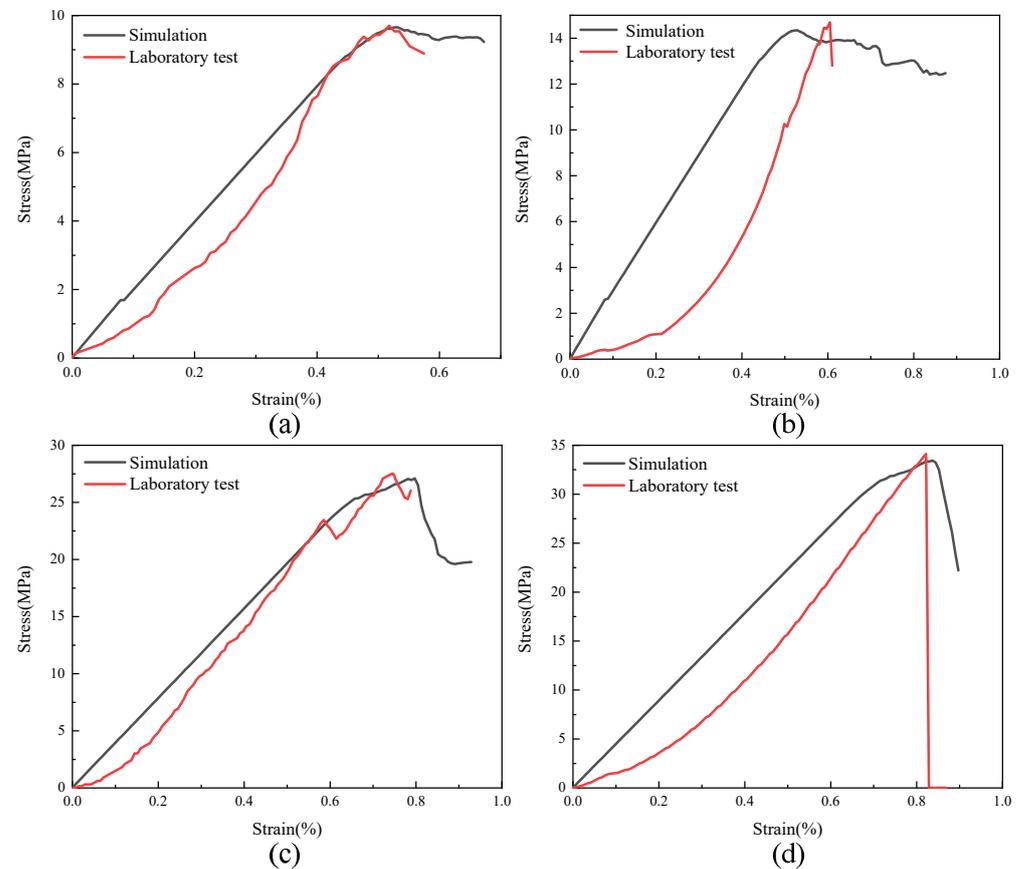
Figure 6. Comparison of uniaxial compression simulation curves and laboratory test curves. (a) coal; (b) mudstone; (c) medium-grained sandstone; (d) fine sandstone.

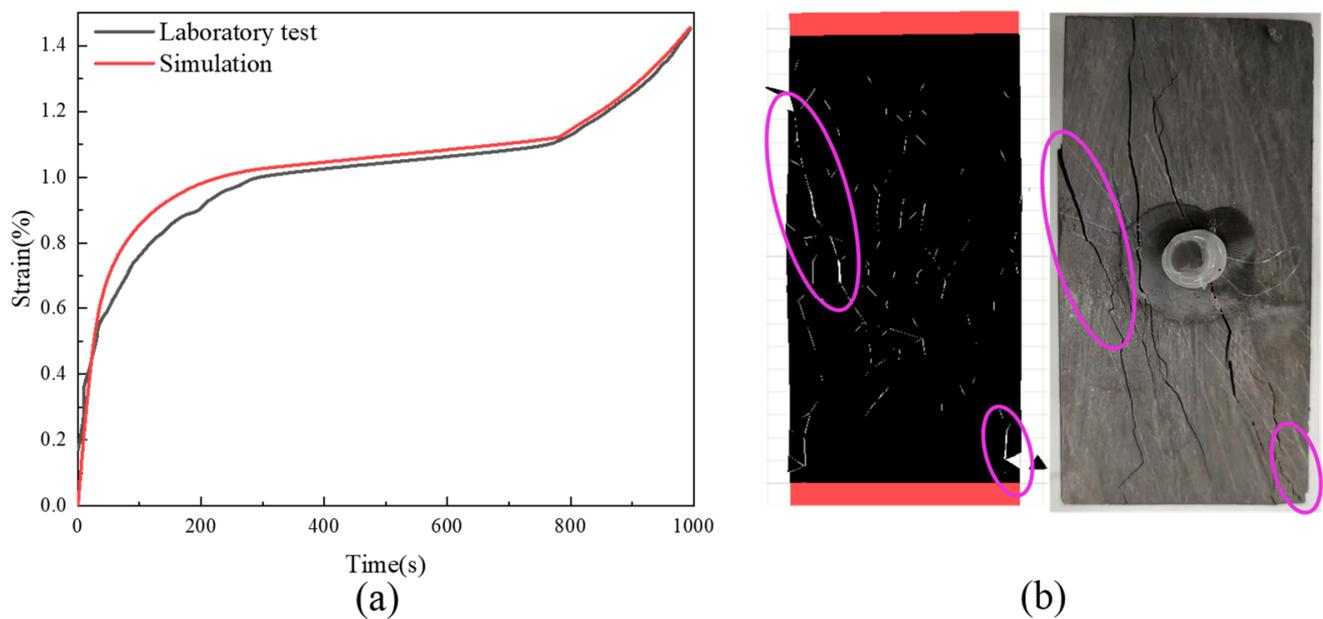
Figure 7. Rheological parameter calibration. (a) matching between simulated and test curves; (b) matching between simulation and test damage results.

During rheological parameter calibration, the block used the CVISC rheological model, and the contact surface used the strength attenuation model. The basic calibration steps included: the parameter calibration of single blocks, the parameter combined calibration of the contact surface block, and the completion of parameter calibration. Table 3 shows the calibrated rheological parameters of sandy mudstone. Figure 7 contrasts the rheological simulation and test results of sandy mudstone. It can be found that these two results share basically the same macroscopic crack distribution characteristics. The simulation results

are more accurate in capturing the fracturing damage at the upper left and lower right corners of the sample, and they well describe the three stages of the rheology of sandy mudstone. The simulation results of accelerated rheology time and final deformation are basically consistent with the test results.

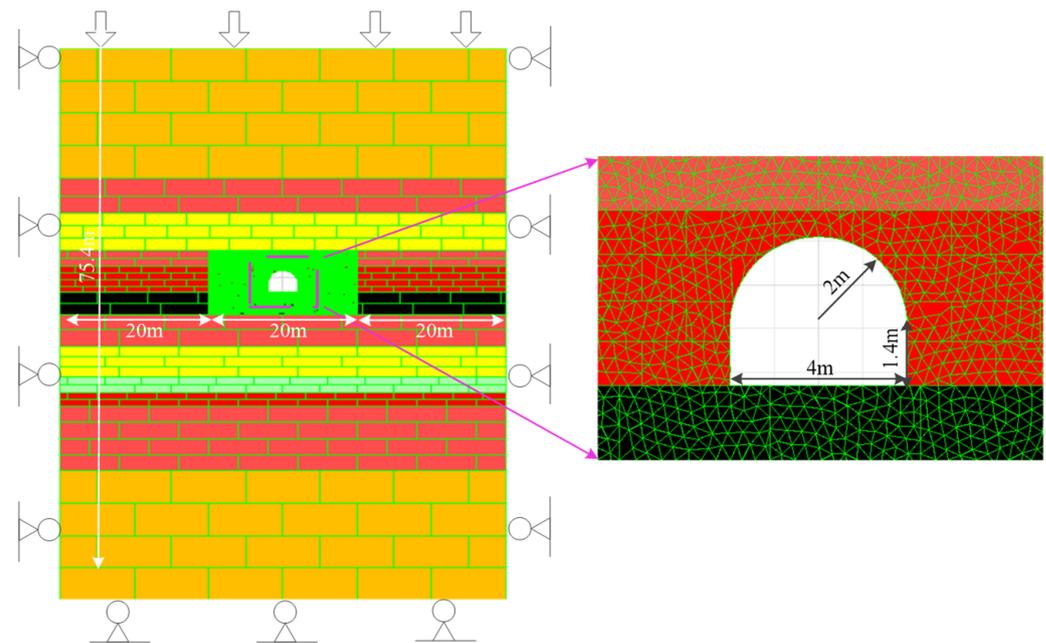
Figure 8. Numerical calculation model of II5 Rail Rise.

Based on the above calibrated rock stratum parameters and the geological conditions of the mine, a model of the II5 Rail Rise in Zhuxianzhuang Coal Mine was established. The model is 60 m long, 75.4 m high, and the roadway cross-section is in the shape of a semicircular arch (4.0 m \times 3.4 m, wide and high) and straight walls (1.4 m high) (Figure 8). The models and parameters for each rock stratum were consistent with the calibrated values. To improve the calculation efficiency, triangular block division was carried out only in the area whose four sides were 8 m above the roof, 8 m below the floor, and 8 m away from the left and right sides of the roadway center, respectively. The horizontal displacement constraint was set on the left and right boundaries of the model, and the vertical displacement constraint was set on the floor boundary of the model. A 20 m long area was reserved on the left and right sides of the model to avoid the boundary effect. A 1.885 MPa equivalent load of overlying strata was applied to the upper boundary of the model. Based on the roadway buried depth, the vertical stress was 15 MPa and the vertical stress gradient was 0.025 MPa/m. According to the recorded data, the lateral pressure coefficient of Zhuxianzhuang Coal Mine is 1.6. Therefore, the horizontal stress was 27.016 MPa and the horizontal stress gradient was 0.04 MPa/m in the model. The simulation procedure was as follows: (1) a model based on the geological histogram was established, and calibrated parameters were assigned to each rock stratum; (2) the initial state of gravity-induced ground stress was calculated; (3) the II5 Rail Rise was excavated and supported; (4) the parameters of the roadway support were changed. Finally, the deformation and crack evolution of the roadway surrounding rock under different support parameters were analyzed.

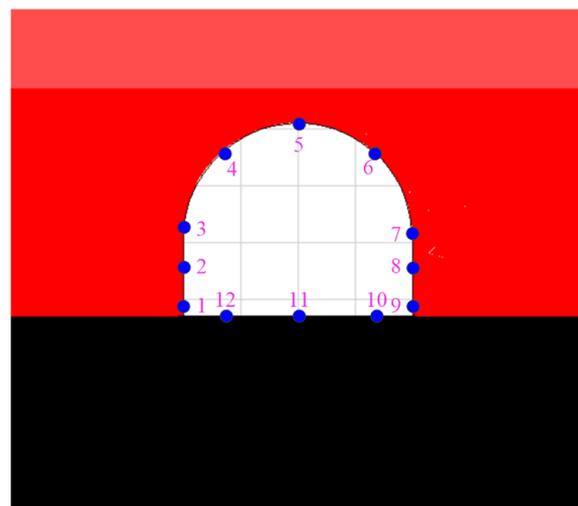
Figure 9. Layout of displacement measuring points.

To analyze the deformation characteristics of the roadway surrounding rock, the horizontal displacement and vertical displacement of the roadway were analyzed through the displacement nephogram and measuring point data. With reference to the analysis results, twelve measuring points were set on the roadway surface to measure the displacement of the ribs, the roof, and the floor. The locations of the measuring points are given in Figure 9.

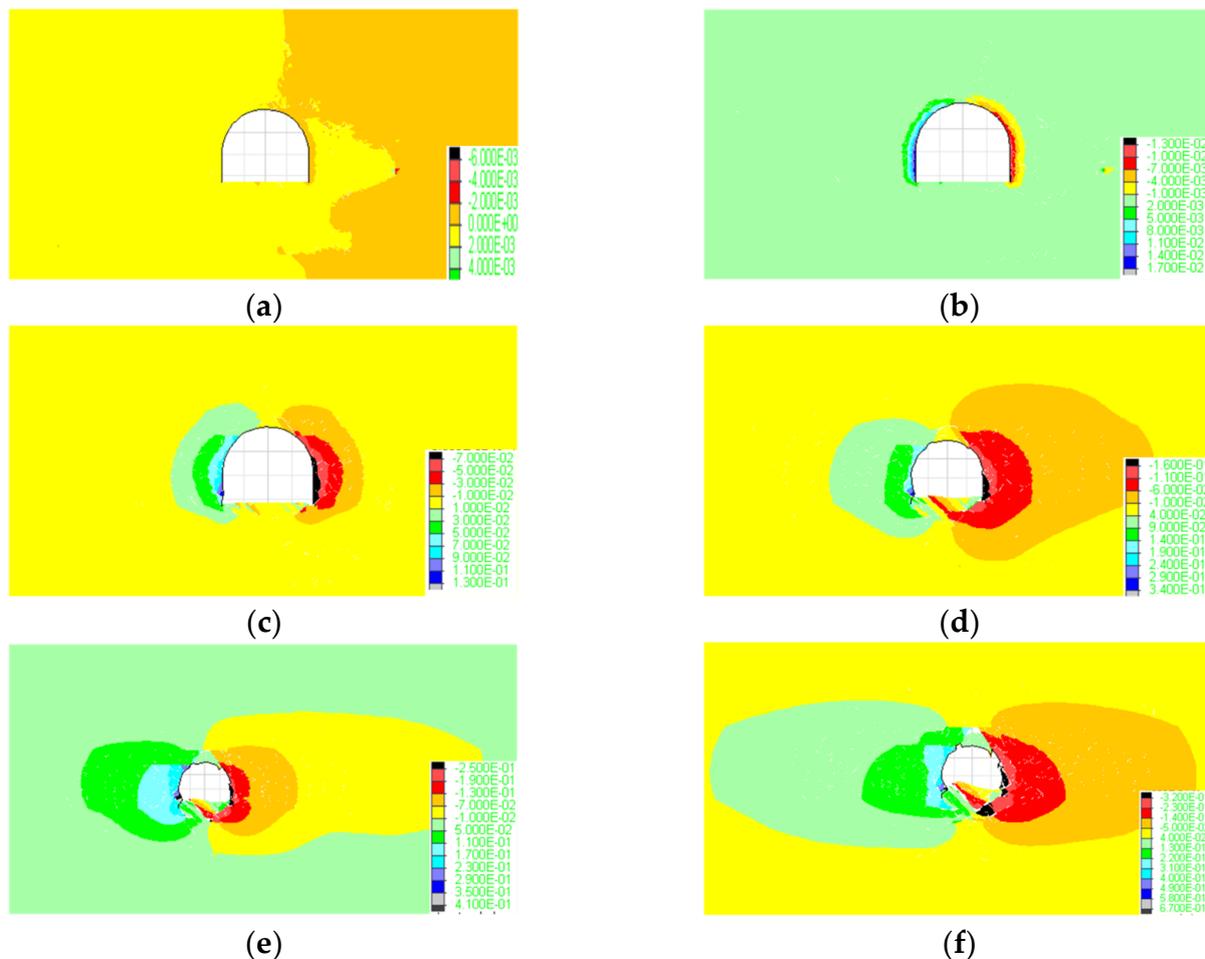
Figure 10. Horizontal displacement nephograms of roadway on different days. (a) 1st d; (b) 5th d; (c) 50th d; (d) 200th d; (e) 250th d; (f) 300th d.

Figure 10 shows the horizontal displacement nephograms of the roadway under the original support. After the completion of the roadway excavation (the 1st day), the horizontal displacement was small, and the displacement of two ribs was within 2 mm. Within a short time (the 5th day), the roadway cross-section displayed overall shrinkage, with the displacement being within 20 mm. The two ribs started to present asymmetric deformation, and the displacements of the left and right ribs were 17 mm and 13 mm,

respectively. On the 50th day, the roadway cross-section kept shrinking overall, and the asymmetric deformation of the two ribs further expanded. The displacement of most of the left rib was 90 mm, the displacement of the bulge position at the bottom corner was up to 130 mm, and the displacement of the right rib was 70 mm. From the 50th day to the 250th day, the two ribs continued to deform, and the influence area of roadway deformation continued to expand. On the 250th day, the maximum displacement of the left rib reached 410 mm, while that of the right rib reached 250 mm. On the 300th day, the overall displacements of the left and right ribs reached 447 mm and 341 mm, respectively, displaying serious roadway section shrinkage and deformation.

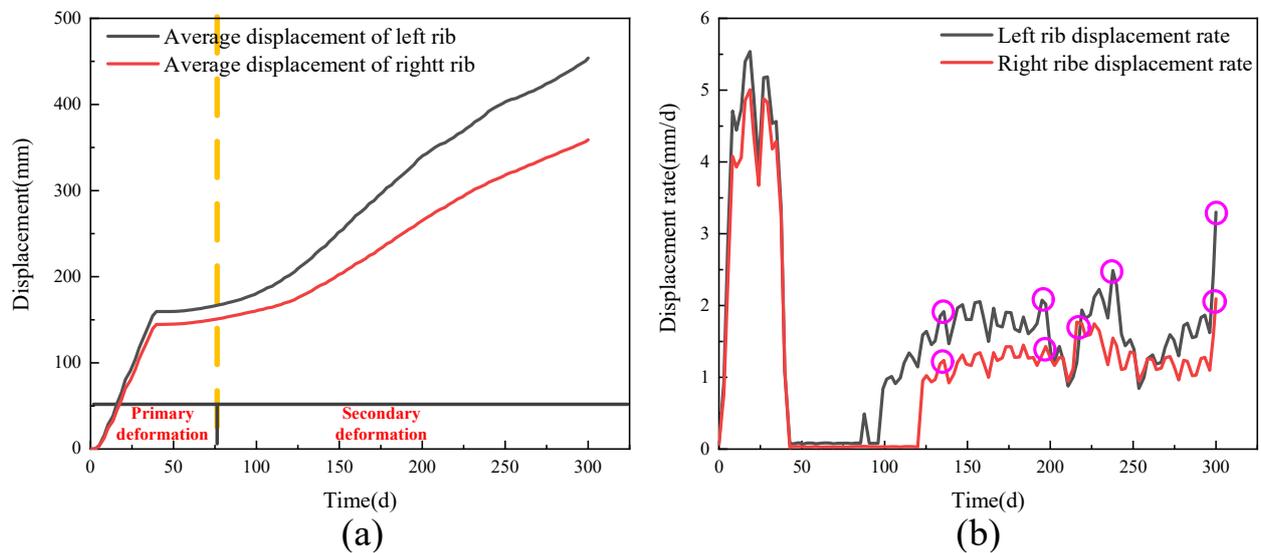
Figure 11. Average displacement and displacement rate of two ribs of roadway. (a) average displacement; (b) average displacement rate.

Figure 11 gives the average deformation amount and rate of the two ribs. The average deformation data of the two ribs were taken from the average values of the measured data. The displacement of the left rib was significantly greater than that of the right rib, showing asymmetric deformation. Both ribs presented obvious rheological characteristics. The deformation rate was derived from the displacement curve. The deformation rate of the left rib was significantly greater than that of the right rib. The maximum deformation rates of the left and right ribs appeared on the 18th day: 5.5 mm/d and 5.0 mm/d, respectively. In the secondary deformation stage, the deformation rate increased in fluctuations. With the displacement rate of the left rib as an example, there were four obvious increases: on the 135th day (1.8 mm/d), the 197th day (2.1 mm/d), the 237th day (2.5 mm/d), and the 300th day (3.3 mm/d), respectively, and this displacement tended to keep rising. The time intervals of the four accelerations were 62 days, 40 days, and 63 days, respectively (average

value: 55 days); the deformation accelerated by 16.7%, 19.0%, and 28.6%, respectively (average value: 21.4%). These statistics indicate that in the absence of further control measures, the deformation of the roadway surrounding rock accelerated by 21.4% every 55 days on average after it entered into the accelerated deformation stage.

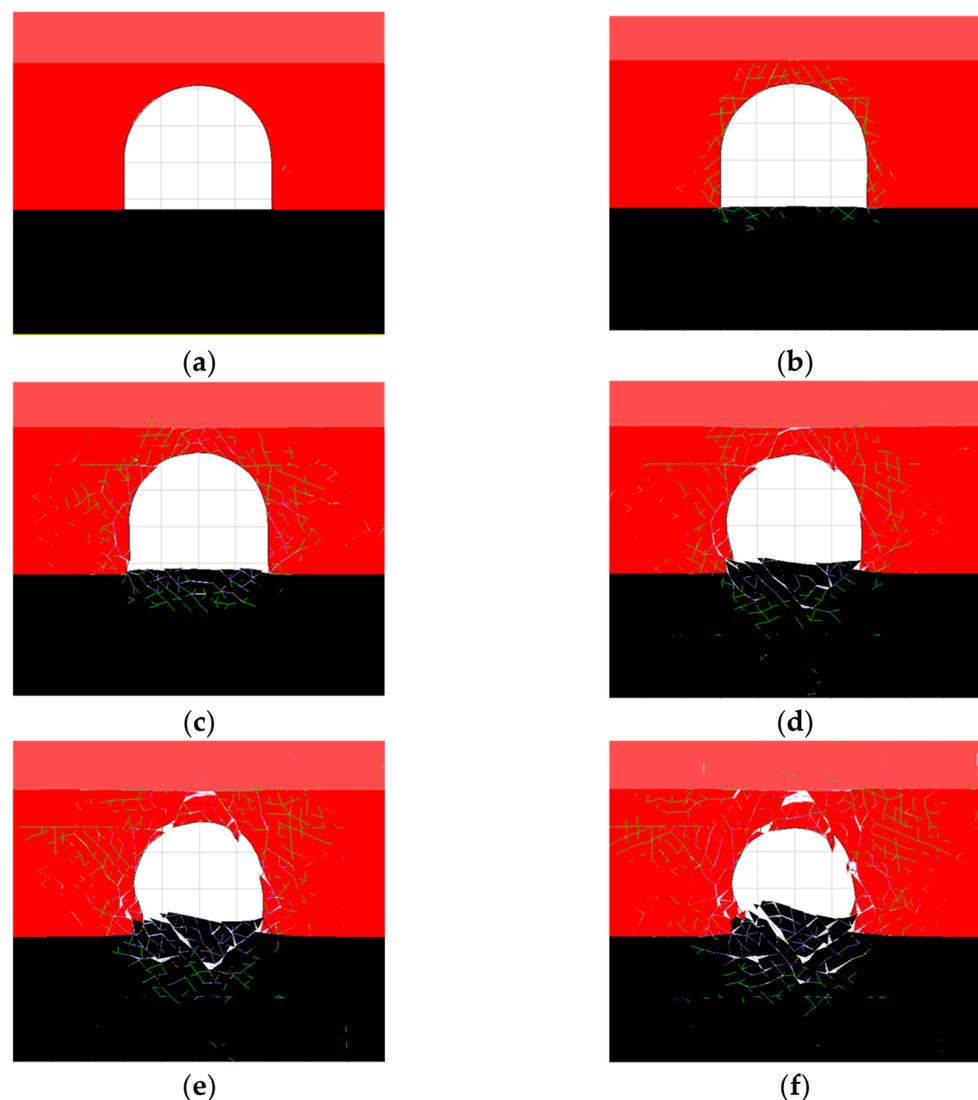
Figure 12. Distribution characteristics of cracks in roadway surrounding rock with the passage of time. (a) 1st d; (b) 5th d; (c) 50th d; (d) 200th d; (e) 250th d; (f) 300th d.

According to Figure 12, in the initial stage (e.g., on the 5th day), there were few cracks around the roadway surrounding rock, with merely shear cracks distributed on the surrounding rock surface, and the cracks at the roof and shoulder corners were more significant than those at the roadway ribs and floor. These cracks were mainly caused by the instantaneous deformation of the roadway. On the 50th day, shallow cracks in the ribs extended to the deep area; tensile cracks appeared on the floor; and the roadway section shrank overall, accompanied by rib bulge on the fault side (left rib) and floor heave. With the passage of time, the total number of cracks and the number of tensile cracks at the roadway left rib, the floor, and the shoulder corner increased continuously. On the 200th day, the deep cracks began to expand, and the left rib had been transformed from a straight wall shape to an arc shape. On the 300th day, the roadway presented obvious asymmetric damage. Cracks at the left and right ribs extended to a depth of 3 m and 2.5 m into the ribs, respectively. Severe tensile damage occurred at the roof on the left side where the blocks extruded upward, and the floor on the left side deformed more significantly than that on the right side. Massive tensile cracks were also distributed at the roof shoulder corners, resulting in slight separation at the junction of sandy mudstone and fine sandstone, the stripping of blocks in the middle of the roof, as well as the protruding and falling of blocks at the shoulder corners. Figure 13 contrasts the on-site damage characteristics with the simulated damage characteristics of the roadway. Clearly, these two are basically consistent.

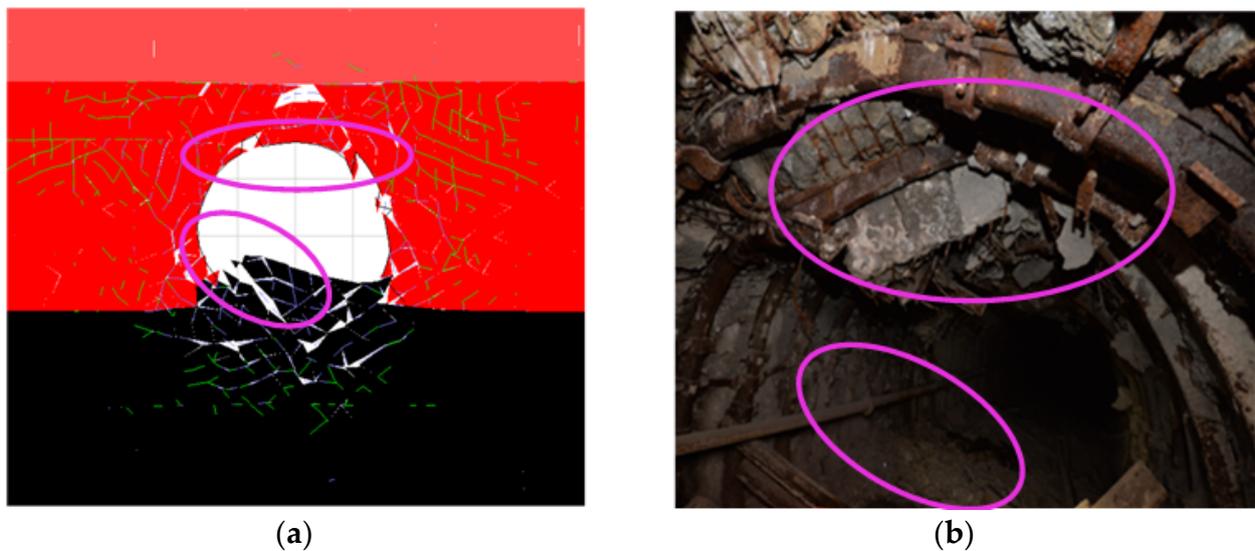
Figure 13. Comparison between on-site damage characteristics and simulated damage characteristics of the roadway. (a) simulated damage characteristics; (b) on-site damage characteristics.

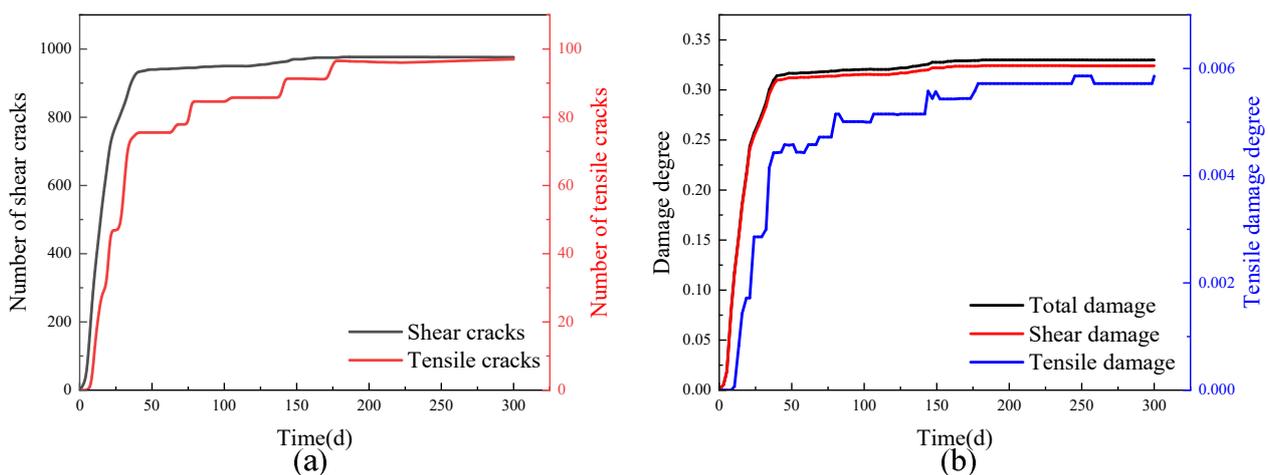
Figure 14. Evolutions of number of cracks and damage degree with time in the surrounding rock. (a) number of cracks; (b) damage degree.

Figure 14 shows the evolutions of the number of cracks and damage degree over time in the monitored area. In the simulation, the total length of the contact surface of the surrounding rock in the monitored area was counted using FISH. The shear crack length and tensile crack length generated during the rheological process were monitored, and the damage degree of the test sample was defined by the ratio of the crack length to the total length of the contact surface. The development of shear cracks, the total damage, and the shear damage displayed obvious rheological characteristics. With reference to the development of shear cracks and tensile cracks, the whole process can be divided into three stages. In Stage I (0–40th day), i.e., the decelerated deformation stage of rheology, massive

shear cracks were generated. The damage of the surrounding rock was mainly caused by shear damage. The shear damage curve and total damage curve coincided greatly. In Stage II (40th–125th day), i.e., the constant-rate deformation stage of rheology, shear cracks increased at a constant rate first; then, as the cracks expanded to the deep area, the shear cracks grew faster, and the number and damage of tensile cracks jumped. In Stage III (125th–300th day), i.e., the accelerated deformation stage of rheology, the number of shear cracks and the corresponding damage continued to increase at basically the same rate as that in Stage II, and the number of tensile cracks and the corresponding damage rose notably, causing obvious roadway destruction. On the 300th day, the number of cracks totaled 2002, including 1765 shear cracks (accounting for 88.2%) and 237 tensile cracks (accounting for 11.8%). It can be seen that the cracks in the surrounding rock were mainly shear ones. The cumulative number of shear cracks in Stages I and II is 1331, accounting for 75.4% of the total number of shear cracks. In Stage III, the number of new shear cracks is 434, accounting for 24.6% of the total number of shear cracks. In Stages I and II, the cumulative number of tensile cracks was 83, accounting for 35% of the total number of tensile cracks. In Stage III, 154 new tensile cracks occurred, accounting for 65% of the total number of tensile cracks. Shear cracks mainly appeared before Stage III, while tensile cracks mainly grew in Stage III.

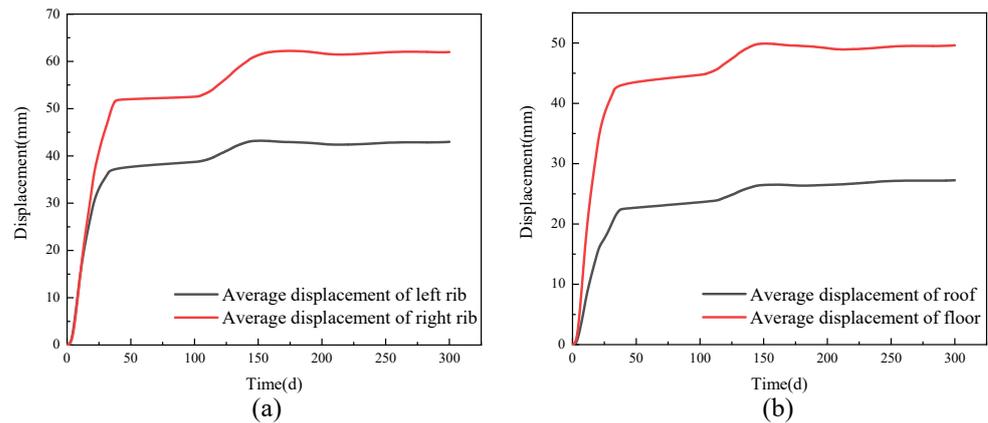
Figure 15. Average displacement of two ribs, roof, and floor of the roadway. (a) ribs; (b) roof and floor.

Figure 15a exhibits the average deformation of the two ribs of the controlled roadway. Although the displacement of the right rib was greater than that of the left rib, their deformations differed by merely 20 mm after stabilization. Both ribs experienced secondary deformation and displayed obvious rheological deformation properties during the secondary deformation. The amount and duration of the decelerated deformation of the right rib were greater than those of the left rib in the secondary deformation, but the final stabilized deformation amounts of both ribs were relatively small. Figure 15b presents the average deformation of the roof and floor of the controlled roadway. Although the roof and floor experienced secondary deformation, the deformation amounts were both less than 10 mm. The roof and floor entered the stabilized deformation period on the 150th day, during which the displacement rate fluctuated at around 0.01 mm/d, with slight surround-

ing rock deformation. After the roadway was controlled by high-preload bolt + deep and shallow crack filling, the displacement amount and rate of the roadway further decreased. This technology effectively restrains the rheology of the deep surrounding rock and ensures the long-term stability of the roadway. Different parts of the roadway completed the main deformation on around the 50th day. The deformation adjustment period was from the 50th day to the 150th day, and the stabilized deformation period started after the 150th day. The roadway deformation was limited, and no severe deformation trend was found on the 300th day.

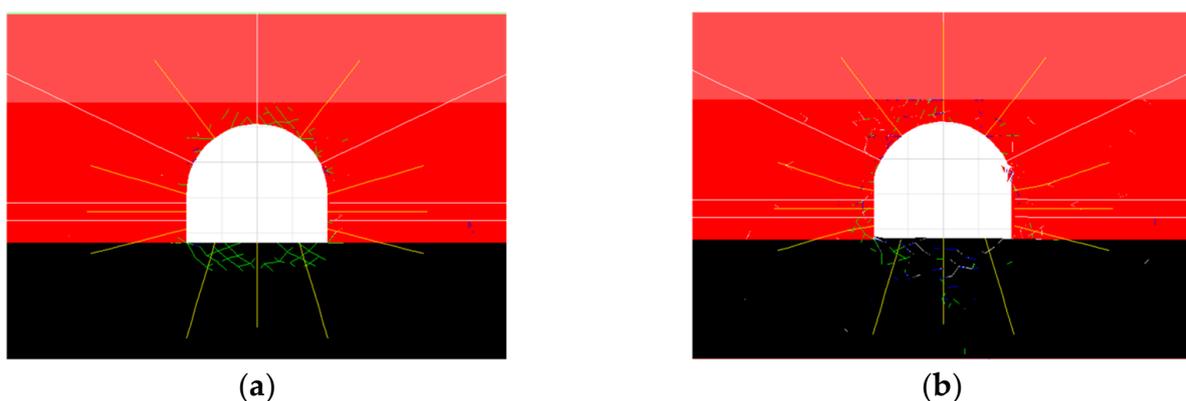
Figure 16. Crack distribution of the improved support. (a) 5th d; (b) 300th d.

As can be observed from Figure 16, in the initial stage, only a few shear cracks caused by instantaneous deformation appeared in the roadway surrounding rock. On the 300th day, the anchor bolts at the shoulder corners and the bottom corners of the ribs bent slightly without breakage. The ribs shared consistent damage characteristics, and only a few cracks were distributed on the roadway surface, while almost no cracks appeared in the deep surrounding rock. On the roadway floor, there were merely tensile cracks on the surface; the central block of the roof no longer moved, and the surrounding rock of the roof was relatively integrated.

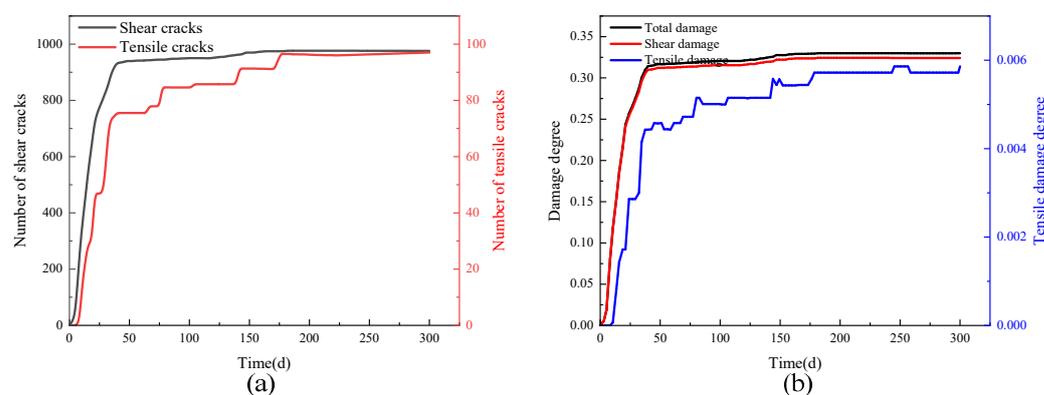
Figure 17. Evolutions of number of cracks and damage degree with time after support optimization. (a) number of cracks; (b) damage degree.

As can be observed from Figure 17, on the 300th day, the total number of cracks in the surrounding rock was 1073, including 976 shear cracks (accounting for 91%) and 97 tensile cracks (accounting for 9%). Compared with those in the original support method, the total number of cracks decreased by 46.4%; the number of shear cracks fell by 44.7%; and the number of tensile cracks declined by 37%. In the primary deformation stage, the cumulative number of shear cracks was 950, accounting for 97% of the total number of shear cracks. In the secondary deformation stage, 26 new shear cracks appeared, accounting for 3% of

the total number of shear cracks. The cumulative number of tensile cracks in the primary deformation stage was 86, accounting for 89% of the total number of tensile cracks, and 11 new tensile cracks occurred in the secondary deformation stage, accounting for 11% of the total number of tensile cracks. Both shear and tensile cracks mainly appeared in the primary deformation stage. According to the overall roadway damage characteristics, after the support optimization, the shear cracks exerted smaller damage to the roadway surrounding rock, while the tensile cracks did not cause bolt breakage or floor bulge due to their small number. In the primary deformation stage, the total damage was 31.5%, and it increased to 32.9% in the secondary deformation stage. It can be seen that the control technology of high-preload bolt + deep and shallow crack filling could well inhibit the shallow crack propagation and the rheological deformation of the deep surrounding rock and prevent secondary damage to the roadway.

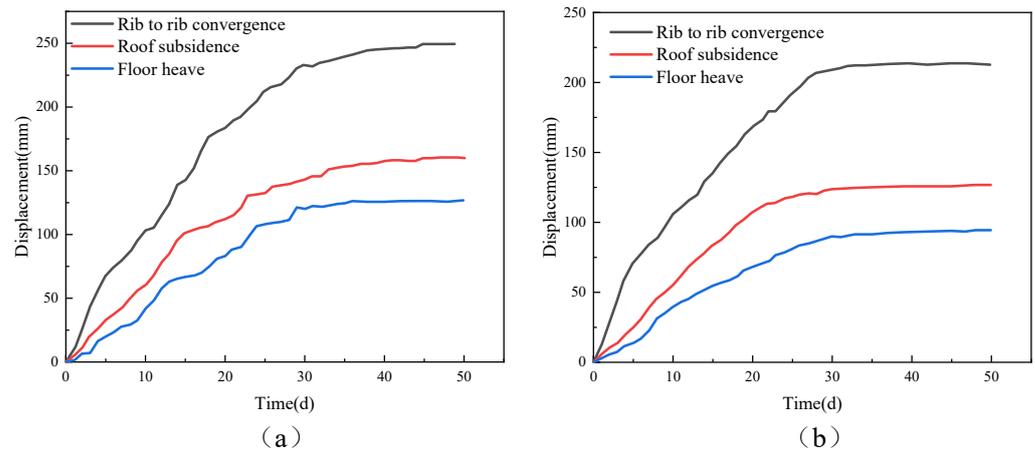
Figure 18. Roadway surface displacement monitoring. (a) station 1; (b) station 2.

Figure 18 shows the monitored results of roadway surrounding rock surface displacement. It can be seen that from the 25th day to the 30th day after the support, the roadway deformation slowed down. The two groups of observation stations found that the maximum subsidence of the roof was 143.5 mm, the maximum displacement of the two ribs was 232 mm, and the maximum floor heave was 110.5 mm on average. Therefore, the roadway deformation was effectively controlled by this support scheme overall to ensure the safety and stability of the roadway.

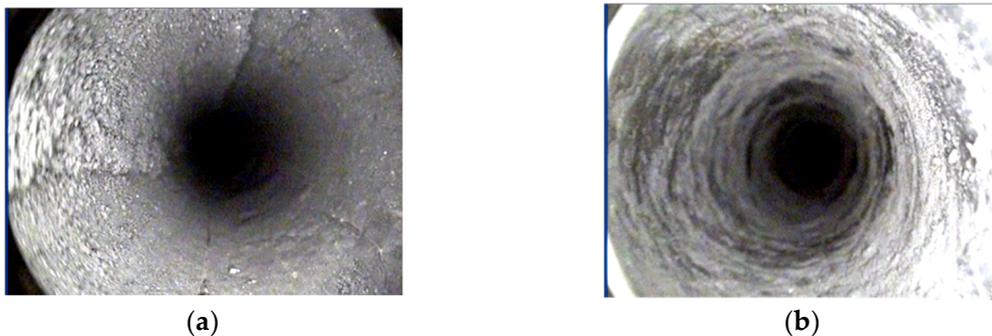
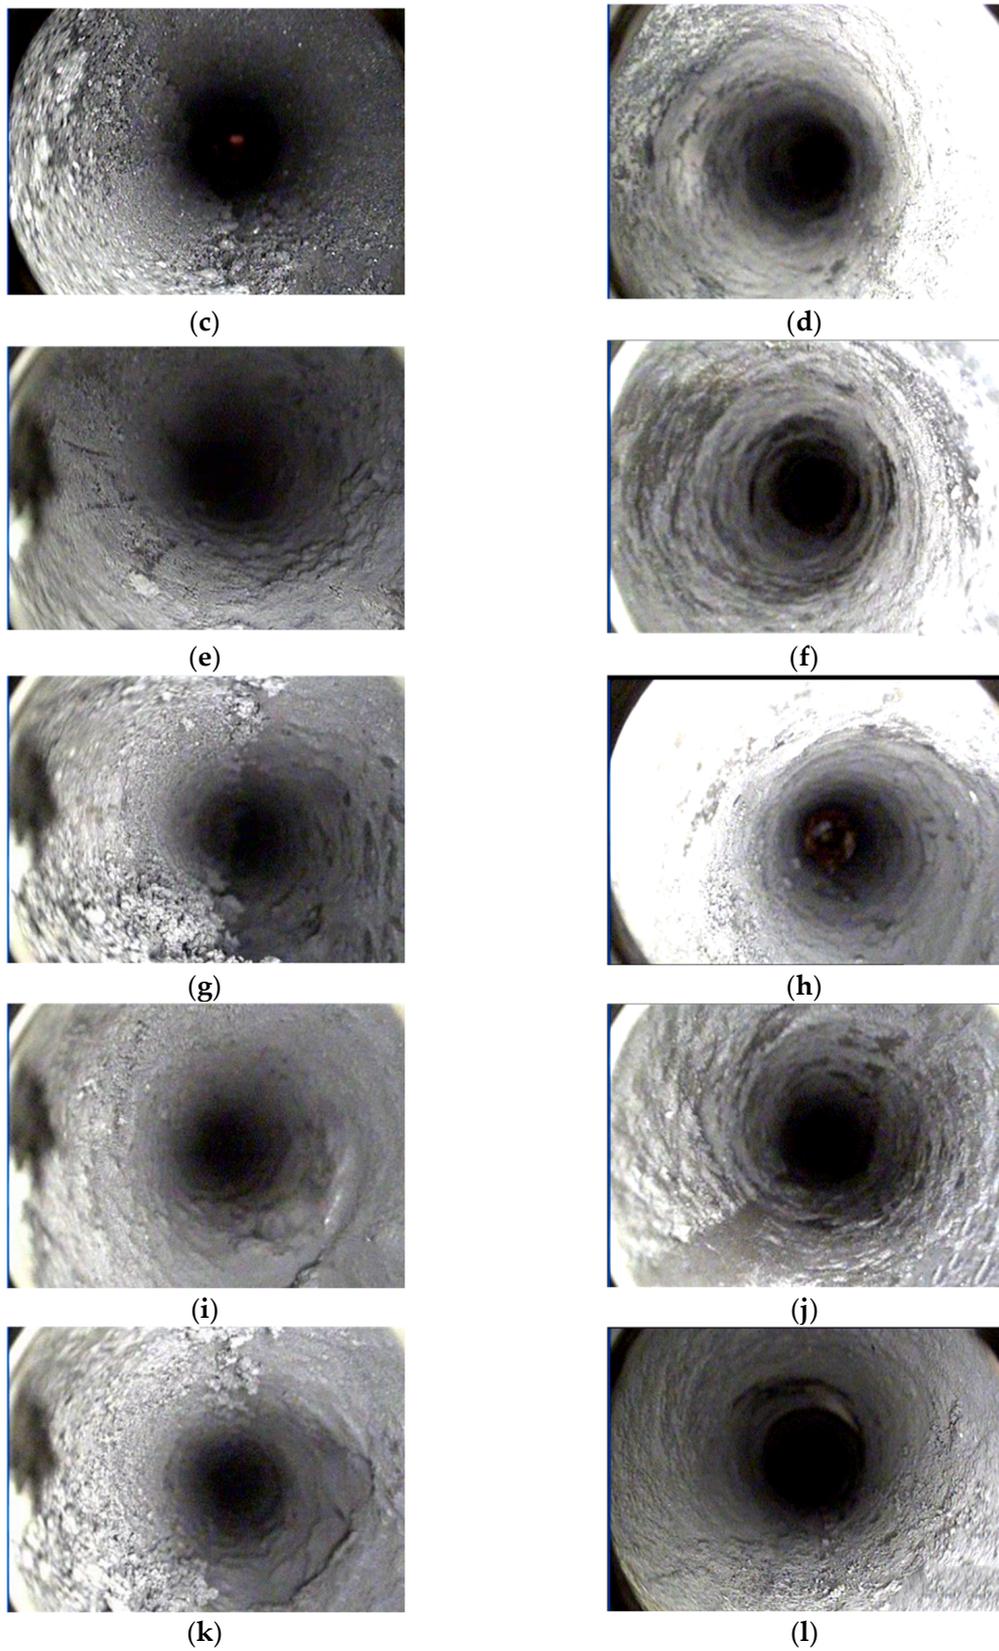
Figure 19. Comparison of borehole observation results before and after crack filling. (a) roof 1.0 m; (b) roof 1.0 m (filling); (c) roof 5.0 m; (d) roof 5.0 m (filling); (e) left rib 1.0 m; (f) left rib 1.0 m (filling); (g) left rib 5.0 m; (h) left rib 5.0 m (filling); (i) right rib 1.0 m; (j) right rib 1.0 m (filling); (k) right rib 5.0 m; (l) right rib 5.0 m (filling).

Figure 19 displays that the surrounding rock conditions were rather poor before crack filling. There were many radial and circumferential cracks in the shallow rock mass. Despite the small number of visible cracks in the deep rock mass, the rock mass was relatively loose. After the deep- and shallow-borehole crack-filling reinforcement, within the range of 3.0–6.0 m deep, the cracks of the roadway surrounding rock were no longer well developed, and the deep surrounding rock maintained good integrity. Within the filling range of 0–3.0 m anchor bolts, the cracks on the left and right ribs were basically sporadically developed. Although there were a few radial cracks, most of the cracks were filled with slurry. According to the results of borehole observation, cracks were basically symmetrically distributed on the left and right ribs; cracks were mainly developed in the shallow area, and the roof stability was well controlled, which played a positive role in maintaining the overall stability of the roadway surrounding rock.
