# Influence of Accumulated Geotechnical Deterioration on Semi-Detailed Scale Landslide Phenomena: Cortinas Sector, Toledo, Colombia

**Abstract:** In the initial investigations of hazard assessment for the Cortinas sector at a 1:25,000 scale, researchers validated the hypothesis that the terrain must be under specific magnitudes of conditioning factors for an instability event to occur, which does not depend only on certain critical thresholds of rainfall and earthquakes. This process was termed accumulated geotechnical deterioration (AGD). A larger-scale analysis of geotechnical criteria was conducted based on data obtained from direct exploration and geophysics, examining conditions prior to slope failure, immediately after failure, and several years later. The results showed that, indeed, the terrain experienced an increase in deterioration that, under the influence of a critical rainfall event, led to failure; however, the stability of the terrain later recovered to the point that failure did not occur under similar rainfall events. In accordance with this, a novel method of analysis is established herein at a 1:5000 scale, which uses AGD to predict instability events by calcul

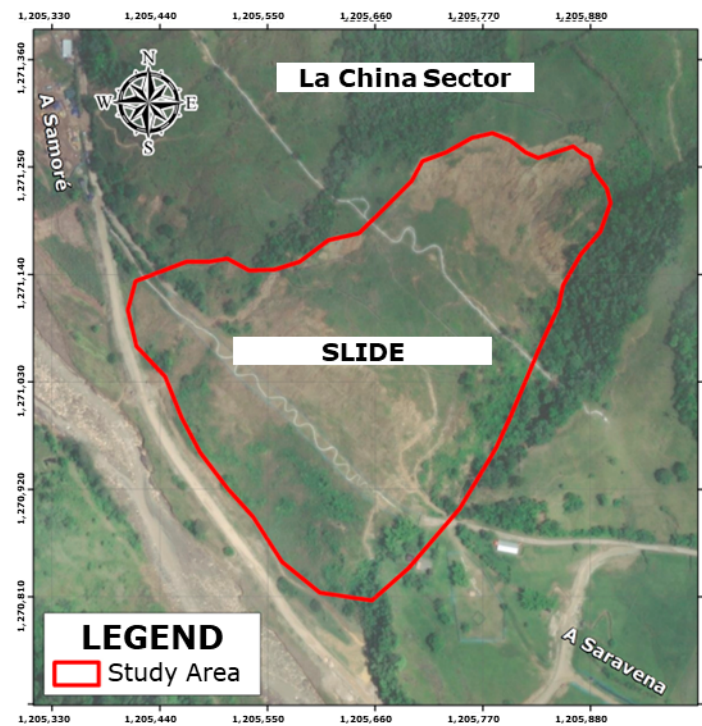
Figure 2. Slip sector, 2021.

In 2021, a landslide occurred (Figures 2 and 3) that generated a fault in the oil and gas lines that cross the sector, where an escarpment was generated in the upper part, and the material was deposited in the lower part of the slope.

The study area (Troya–Cortinas) lacks documentation of geotechnical behavior or initial studies related to the construction of its existing infrastructure, which includes roads, houses, an oil pipeline (1985), and a gas pipeline (2011) (Figure 2). Historically, it has suffered landslides, including a massive one in 1990 and others in 2013 and 2017. In 2015, extreme rainfall caused more than 50 instability sites, affecting infrastructure and agricultural activity, although the Cortinas slope did not show significant instability that year.

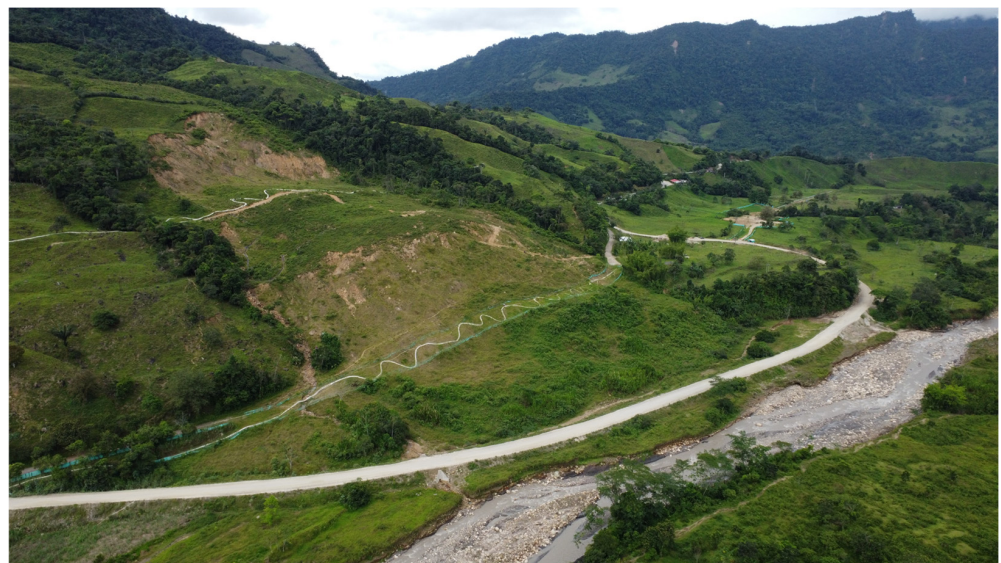
Figure 3. Aerial view of the landslide in 2021.
