# Leveraging Life Cycle Cost Analysis (LCCA) for Optimized Decision Making in Adobe Construction Materials

**Citation:** Albuja-Sánchez, J.; Damián-Chalán, A. Leveraging Life Cycle Cost Analysis (LCCA) for Optimized Decision Making in Adobe Construction Materials. *Appl. Sci.* **2024**, *14*, 1760. <https://doi.org/10.3390/app14051760>

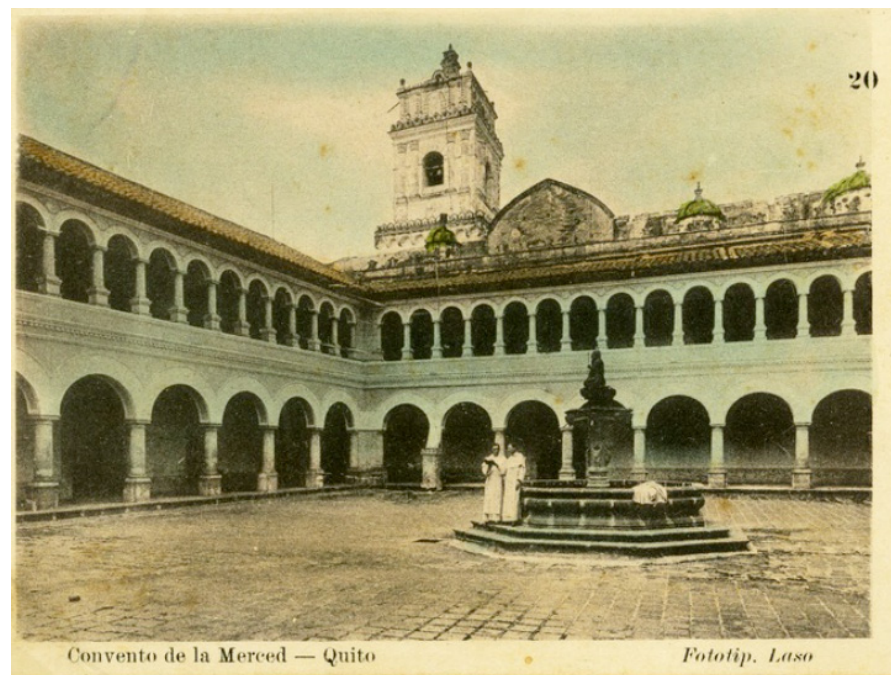
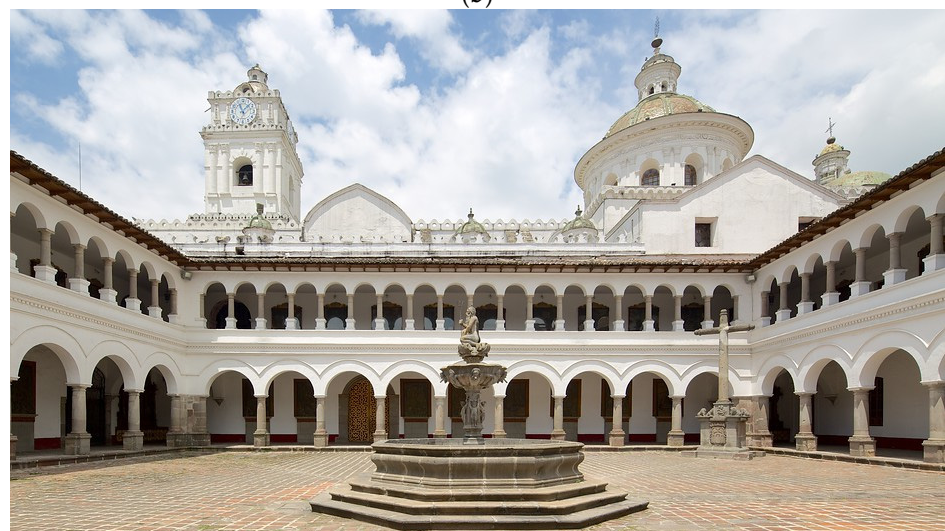
**Figure 3.** Convent of La Merced Quito over the years. (a) The proposed Inca structure, hypothesized to be the foundation upon which a Catholic convent was subsequently erected [19]; (b) Convent of La Merced—Quito, 1910–1920 (Photography by Instituto Nacional de Patrimonio Cultural); and (c) Convent of La Merced—Quito [20].

Furthermore, the Inca structures underwent not only adaptation and redesign but also transformation. An example of this is described by Peñaherrera [16], who asserted that the Catholic temple of La Merced in Quito was the result of modifying a pre-Columbian temple. The hypothesis posits that the main facade and the base that supports the tower were once the walls of the Inca temple were situated on this site, as shown in Figure 3.

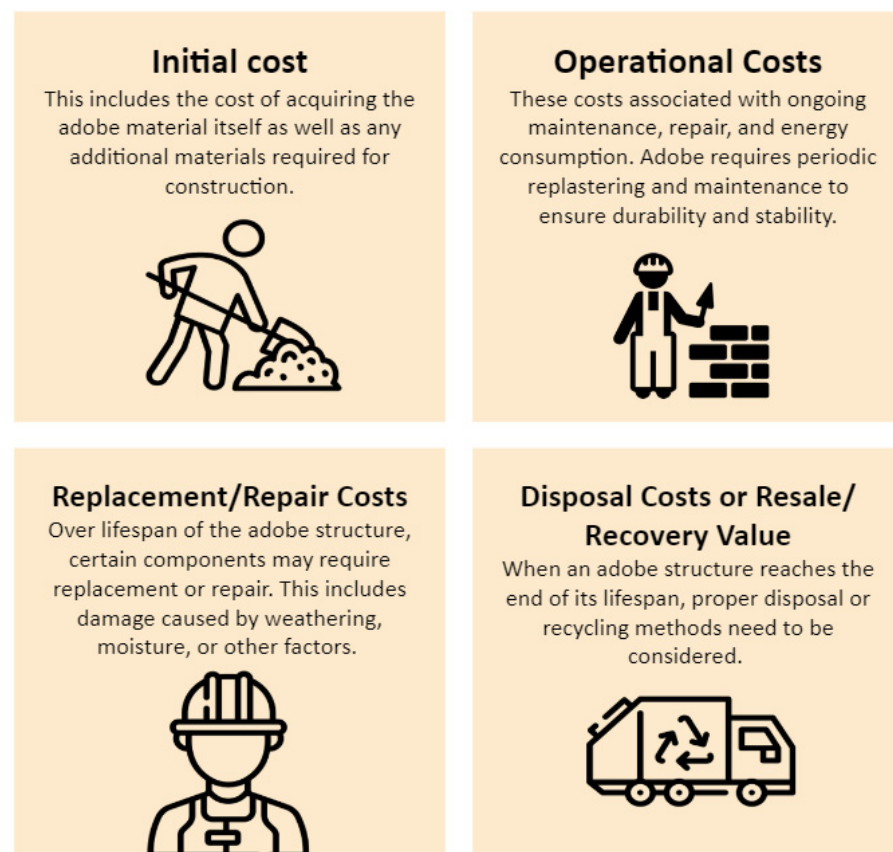
**Figure 6.** LCCA steps for analyzing (graphs by authors).

Several factors must be considered when conducting an LCCA for adobe construction, which will be analyzed in the following steps shown in Figure 6.
