Evaluation of the Performance of Gabion Walls as a High-Energy Rockfall Protection System Using 3D Numerical Analysis: A Case Study

Abstract: Cases of rockfalls that occurred on a slope in the Selendi District of Manisa Province are evaluated in this article. Field studies are evaluated and different measures are examined to reduce rockfall risk. Drone flights are used to evaluate previous studies and obtain 1/1000 scale digital topographic maps. These maps are used to create a 3D (three-dimensional) solid model of the project site, and on-site surveys are conducted to identify source rock locations and free blocks that pose a risk. Those 3D analyses are used to determine the paths, jump heights, and energies of the blocks in motion. The data from the 3D maps are used to determine the most appropriate remediation methods. The structural behavior of the recommended gabion wall, which is designed at a certain height and width as a result of rockfalls, has been examined. Structural behavior is determined by simulation based on the finite element model. Within the scope of this study, the ANSYS Workbench program is used. The “Explicit Dynamics” analysis type in ANSYS Workbench was cho

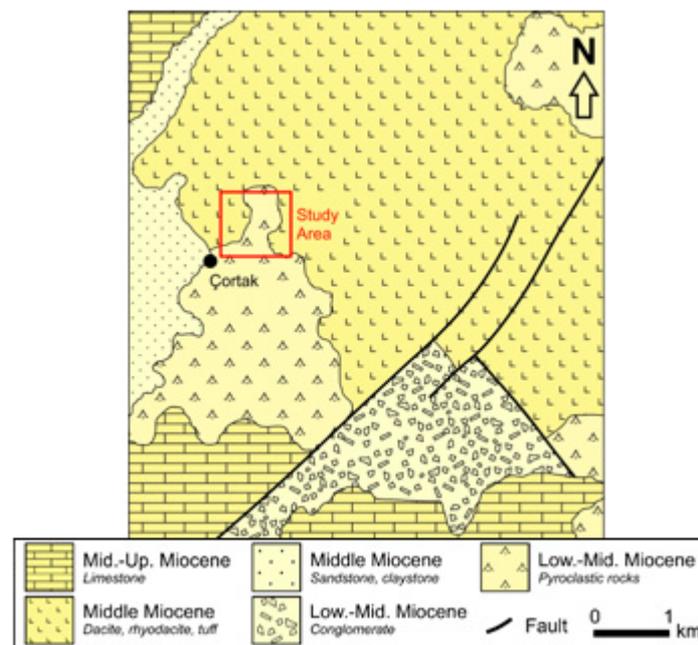
Figure 2. Geological map of the study site.

Selendi basin is located between Demirci basin in the west and Uşak-Güre basin in the east. There are Simav and Gediz grabens in the north and south of the basin, respectively [24]. Dikendere Volcanites, which consists of rhyolite, rhyodacite, and tuff, outcrop in the study area (Figure 2).

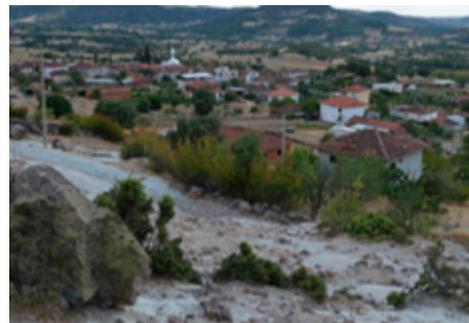
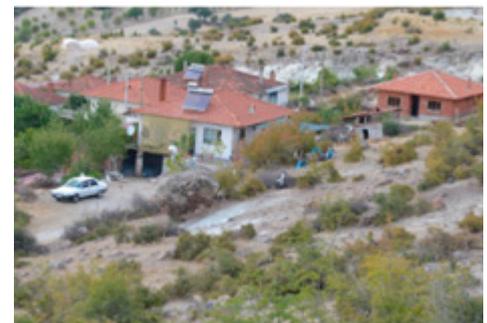
Figure 3. Large blocks reaching several meters in size (5–10 tons) breaking off from the source rock and reaching areas very close to the village.

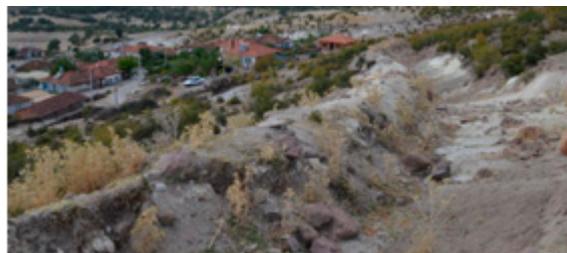
Figure 4. Trenches dug to reduce the risk of rockfall; their width reaches 2 m and depths up to 1 m.

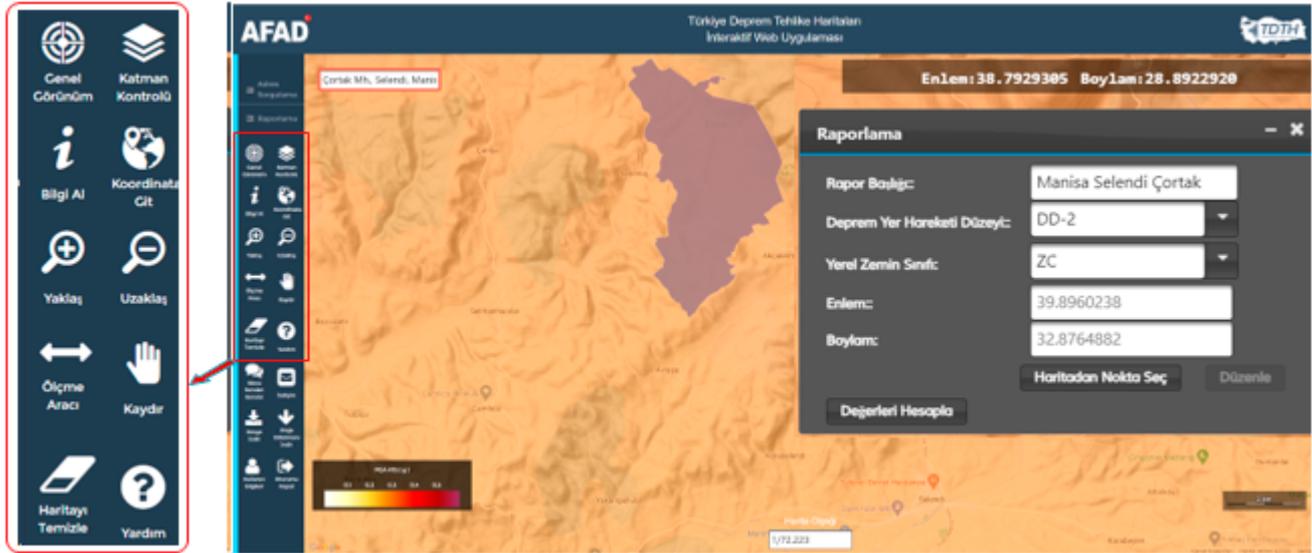
Figure 5. The maximum ground acceleration value according to the location of the study site in the AFAD Turkey Earthquake Hazard Map and the earthquake ground motion level with a probability of exceeding 10% in 50 years (recurrence period 475 years).

Seismicity of a region defines the geographical distribution, occurrence times, magnitudes, mechanisms, and damage of earthquakes that occurred in that region. Seismicity studies are mostly carried out to evaluate the seismic risk of a region. In order to compare a potential earthquake effect and the blast effect to be applied in the scope of this study, the necessary data was obtained from the Turkey Earthquake Hazard Map, taking into account the Turkey Building Earthquake Regulation 2018 [36] (Figure 5).

In this case, considering the 2018 TBER; “earthquake ground motion level” is taken as earthquake level (EL-2), exceedance in 50 years is 10% (recurrence period is 475 years), and “local soil class” is ZC (weak rocks with weathered cracks). The following values are obtained.

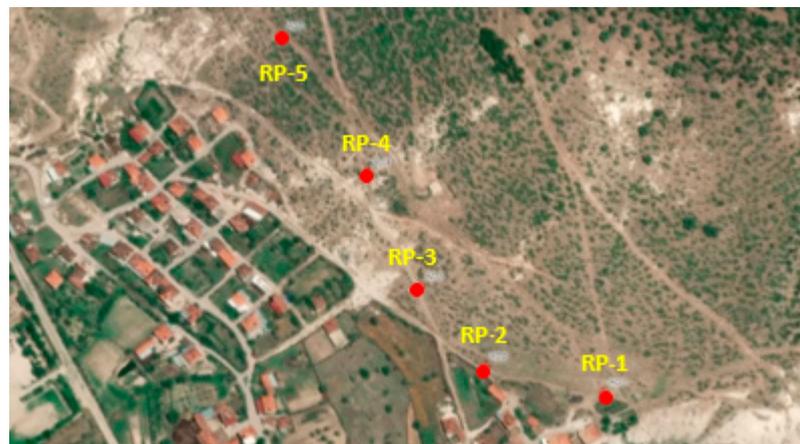
Figure 6. Location of the research pits opened within the scope of this study.

Research pits and their locations vary depending on the type, size, importance of the structure to be built, and the characteristics of the soil. A research pit was dug to a depth of 1.5 m and in five different locations. It was designed to reveal the soil profile, to determine the soil model to be used in the 3D rockfall analysis, and to determine the gabion wall foundation soil properties (Figures 6 and 7). After the lithological identification made in all research pits, talus of 50–70 cm was cut first and then tuffs with acidic character were cut. For this reason, it is recommended that approximately 50 cm of cover layer should be excavated and stripped before the gabion wall is built. Also, it is recommended that a foundation excavation be made so that the gabion base is at least 50 cm inside the tubes.

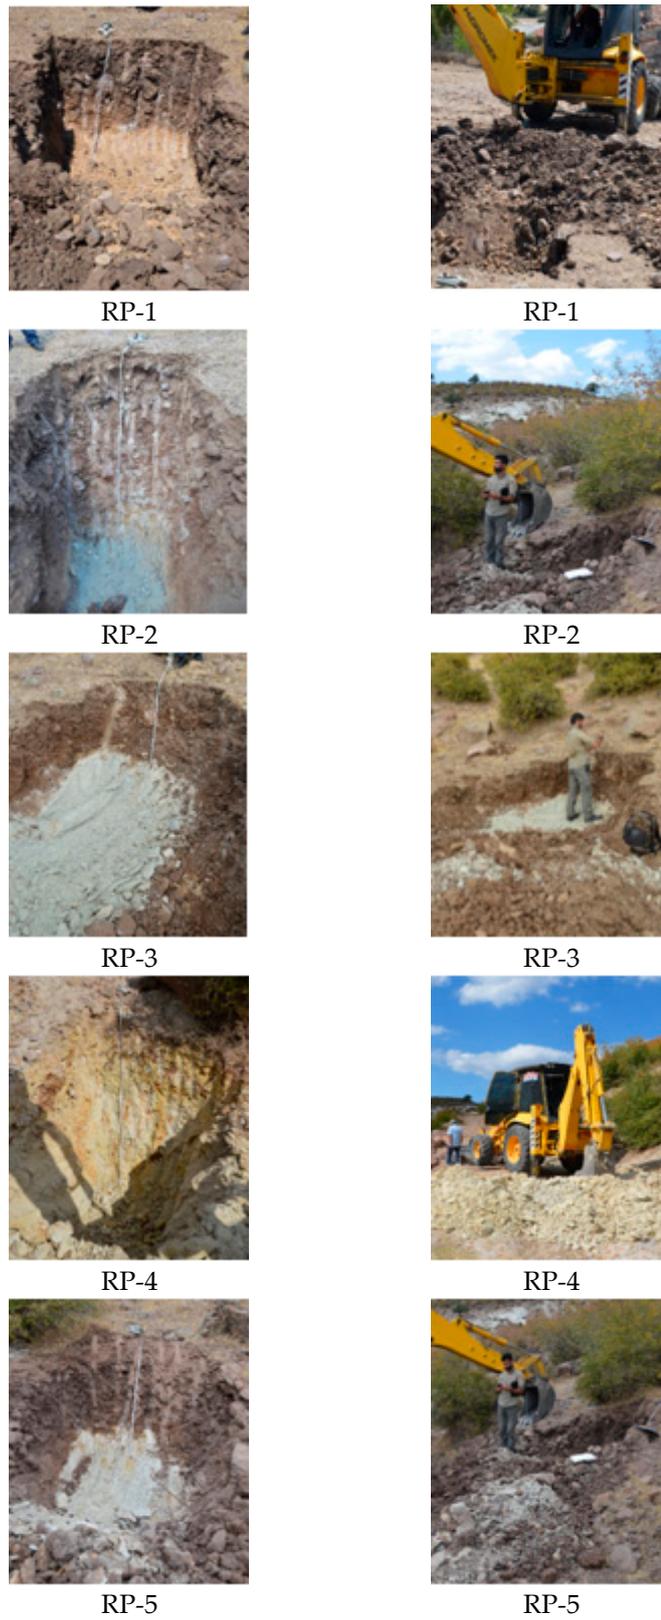
(a) General view of the research pits (b) Excavation of research pits

Figure 7. Appearance of the research pits.

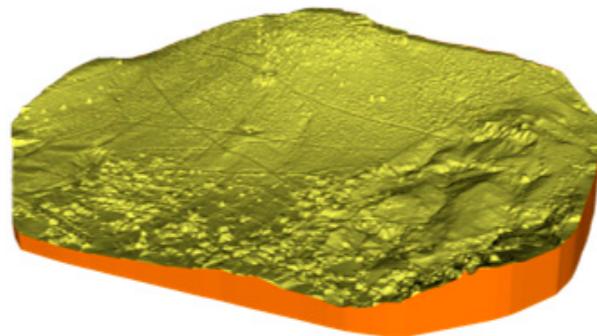
Figure 8. 3D solid model of the study site created using RocPro3D software (version 6.2).

Çortak Village was established on the foot of a moderately natural dip slope. Dacitic rock masses presenting a nearly vertical topography on the upper floors of the slope have acquired a highly fractured structure depending on discontinuities and the degree of weathering. Blocks broken off from these source masses due to erosion and freeze-thaw processes move down the slope and cause rockfall problems. As a result of field observations and measurements, it has been seen that the dimensions of these blocks can reach 2.0 m in places. Within the scope of this study, it was thought that the most effective solution in order to minimize the risk of rockfall is a gabion wall. For this reason, 3D rockfall analyses were carried out in order to prevent the risk of rockfalls in the examined areas. Also, jump heights and energy amounts were calculated. Based on the results obtained, gabion wall positions and dimensions were determined. The 3D numeric surface model of the study area was produced as a result of digitizing the maps produced by drone flights in the study area (Figure 8).

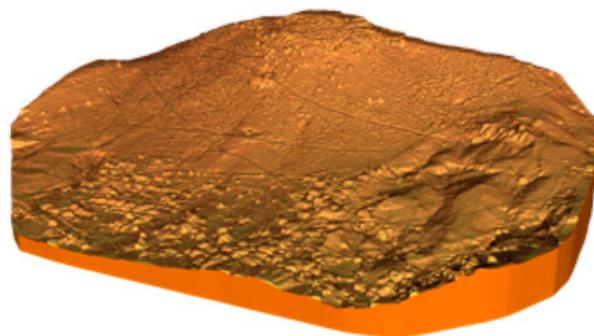
Figure 9. Triangulated irregular network (TIN) mesh created in RocPro3D software (version 6.2).

A DJI Matrice 300 drone was used in photogrammetric studies. While using the DJI Matrice 300, measurements were made with centimeter precision with the D RTK 2 module as a ground station. By performing a two-way and three-turn terrain oblique flight with the Zennume L1 Lidar Camera, the tree cover was removed, and the surface model was created. Since the slope of the land is high, the resolution was prevented from decreasing at the lower elevations of the land by terrain flying (following the land surface) from an altitude of 100 m. The DJI Matrice 300 Drone was connected to a geofixed point using the DRTK2 Mobile station to use the RTK feature at the centimeter level. The data was processed as UTM WGS84 six degrees and a high resolution orthophoto was created. The triangulated irregular network (TIN) obtained from the digitized map and underlying the 3D rockfall analyses is given in Figure 9 and the digital elevation model (DEM) is given in Figure 10.

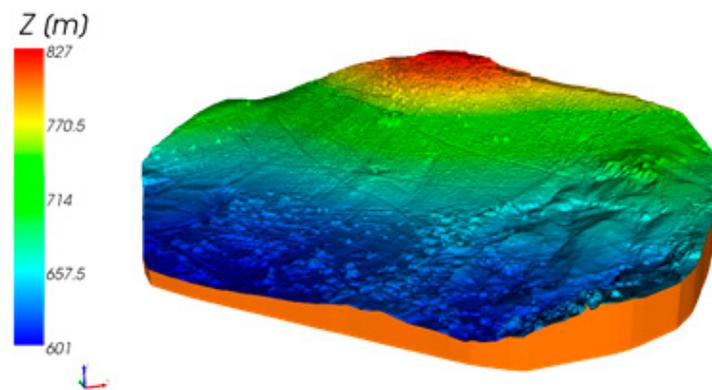
Figure 10. Digital elevation model created in RocPro3D software (version 6.2).

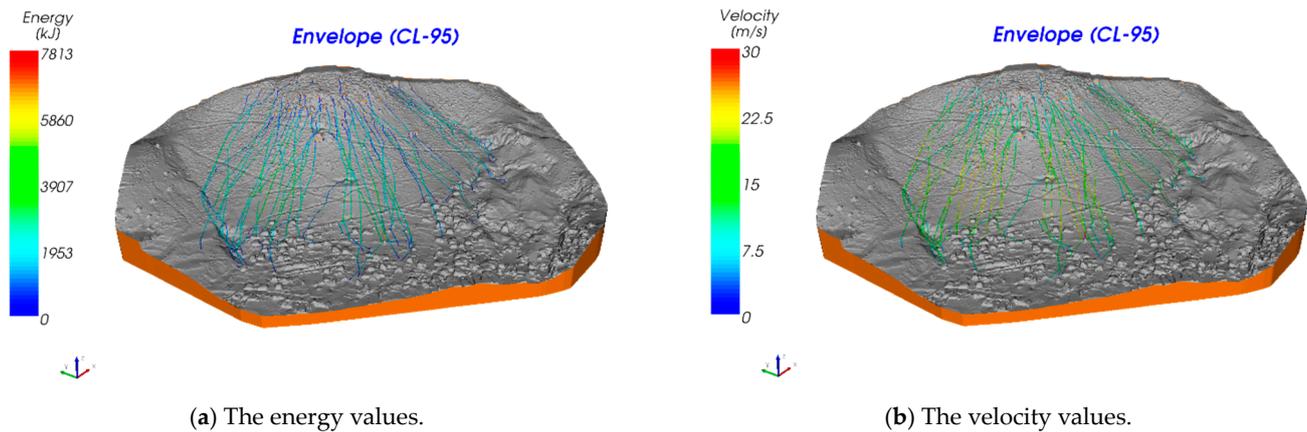
Figure 11. The energy and velocity values determined for the falling/rolling of a 10-ton rock block over the source rock masses.

Blocks with a mass of 10 tons were dropped along a line from the highest point of the source rock, taking into account the worst-case scenario in the three-dimensional rockfall analyses. Fifty blocks were modeled in each region. In RocPro3D software, different geological units can be defined on the three-dimensional numeric surface model to model the rockfall and different return coefficients (R_n and R_t), and friction coefficients can be assigned for these units. In the study area, a single geological unit has been distinguished based on field observations in the region where the rockfalls occurred. The normal coefficient of restitution (R_n) was accepted as 0.75, the coefficient of tangential restitution (R_t) as 0.75, and the coefficient of friction (k) as 0.4. Cover thickness (less than 50 cm) and dacites outcropping in many areas, as well as the literature data, were taken into account. Rolling lines, jump heights, velocities, and energy values obtained from three-dimensional rockfall

analyses are given in Figures 11 and 12. When the analyses were examined, it was seen that the jump heights for a 10-ton block exceeded 2 m on the steep cliffs at the top, 1 m on average along the slope, and only turned into a rolling shape at the lowest elevations (the areas where the gabion design is planned). However, jump heights of 3 m were recorded in some parts of the lower elevations. At these points, the energy amounts vary between 4000–8000 kJ for a 10-ton block, and the average speed reaches 30 m/s. All risks that may arise from free blocks on the slope are blocked by the farthest gabion design from the source rock. However, in this case, the most effective solution is a gabion wall, as the distance will increase. The gabion wall should be applied along a line with as low of a slope as possible. It can be very difficult to secure the stability of the gabion wall in areas with high slopes.

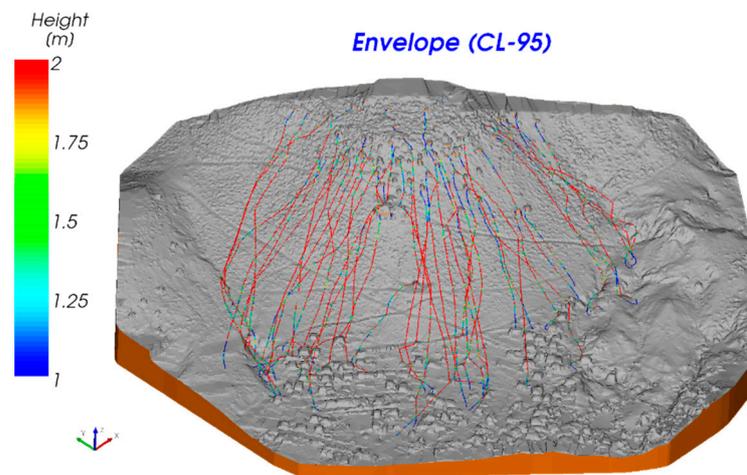
Figure 12. The jump height values determined for the falling/rolling of a 10-ton rock block over the source rock masses.

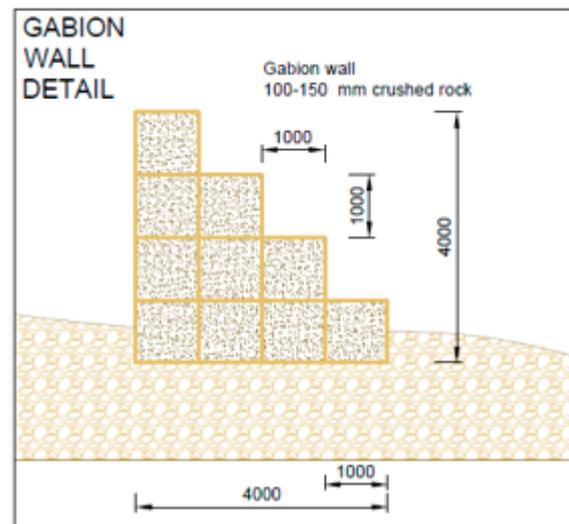
Figure 13. Suggested gabion wall detail.

Gabion wall details are given in Figures 13 and 14. In Figure 15, the results of the 3D analyses made after the gabion wall design are given. When all analyses are examined, it is seen that the design is safe. The start/end coordinates of the proposed gabion walls are given in Table 2.

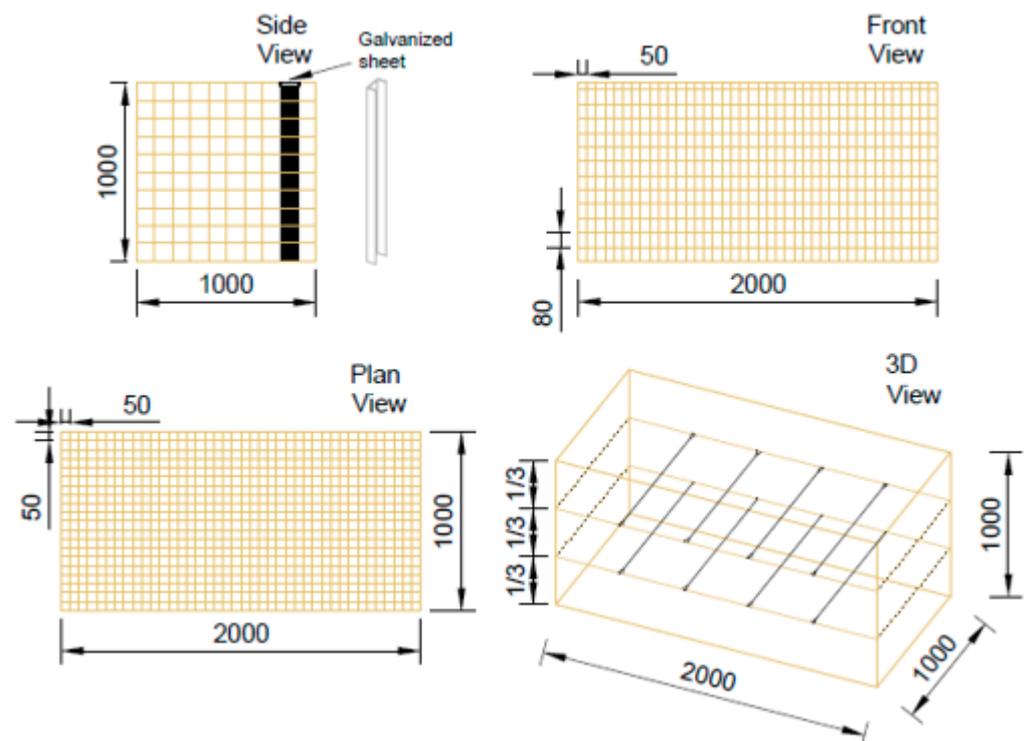
Figure 14. System dimensions of the gabion wall, view details from different directions, and pore sizes (in mm).

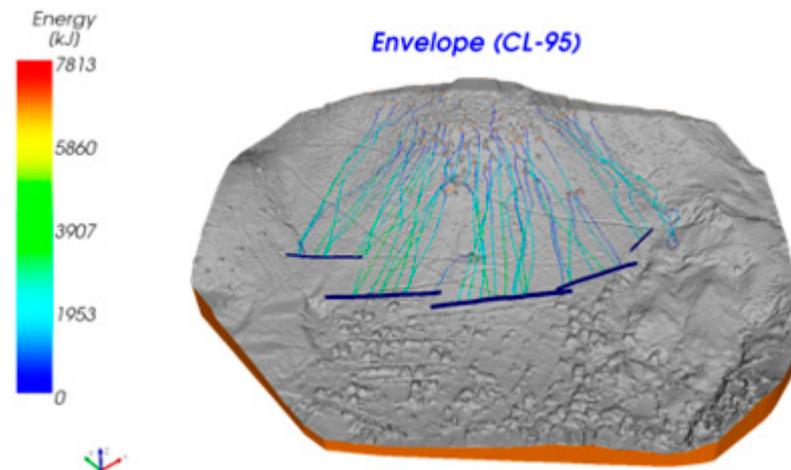
Figure 15. Three-dimensional rockfall analyses in case of designing a gabion wall.

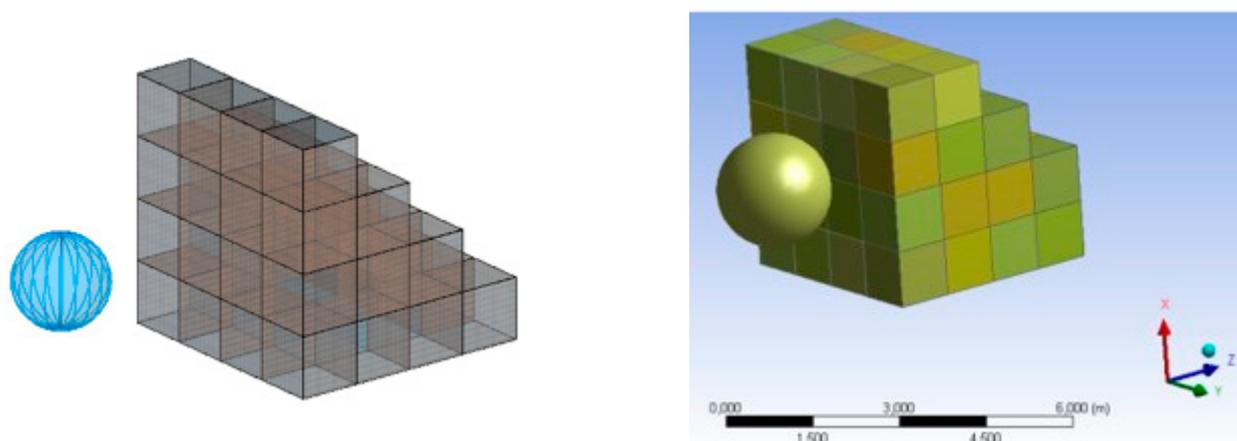
Figure 16. Screen interface of the modeling phase of Explicit Dynamics analysis.

wall and rock sphere geometry prepared on AutoCAD were imported into the program using the drawing file with the extension “.igs” (Figure 16). In the third step (“Model” step), assignment of material properties, meshing, loading conditions, support conditions, etc., parameters are set and analysis settings are made. In this step, the Explicit Dynamics-Mechanical tab is opened. Necessary assignments and adjustments are made on this screen (Figure 17a). Material assignments are performed by selecting the modeled geometries. The “Stiffness behavior” property of the rock has been determined as rigid (Figure 17b). The contact of the objects is defined in the “Body Interactions” section. Therefore, the “Contact” section in the “Connections” menu in the “outline” window should be deleted (Figure 18a). Since it would be sufficient to perform the meshing at default values, parameters were not changed. However, if a more frequent meshing is wanted, the wanted value can be entered in the “Element Size” section (Figure 18b). The impact of the rock against the gabion wall at an angle of 10 degrees and a speed of 30 m/s is modeled (Figure 19a). Explicit analyses are simulating events that occur in very short times, so the simulated times in the analysis are taken as very small in order to reduce the workload. For this reason, the modeled time in the analysis was determined as 0.02 s. This time may be extended within the scope of future studies (Figure 19b). Calculation of the wanted result value can be performed in the solution section of the Outline menu. For this study, the total displacement, equivalent stress, and velocity of the stone were calculated (Figure 20a). The change for the falling rock in a period of 0.02 s is seen on the graph. There is no need to extend the analysis simulation time as the speed drops to 10% of the initial level (Figure 20b). As a result of the analysis, the maximum displacement value was obtained as 13,655 cm (Figure 21). The stresses on the wall are given in Figure 22. Crash zone damage is given in Figure 23. Upon examining Figure 23, it is clearly seen that the damage remained in a limited area of the gabion wall, its structural integrity was not compromised, and the wall did not undergo a collective collapse, thus fulfilling its function. It can be seen from Figures 22 and 23 that the impact of the rock is absorbed by the entirety of the wall. As stated, analysis is stopped when the rock’s velocity drops to 10% of its initial speed. This results in approximately 99% of the rock’s energy being transferred to the gabion wall. Except for minor damage on the contact face, the wall remained intact. The highest stress levels were observed on four blocks that were hit by the rock and the highest equivalent stress was below 30 MPA. As expected, the purpose of such structural measures is for the gabion wall to perform its function by incurring damage and to protect the settlements located behind the wall. Therefore, the designed gabion wall has demonstrated the expected behavior by sustaining limited damage.

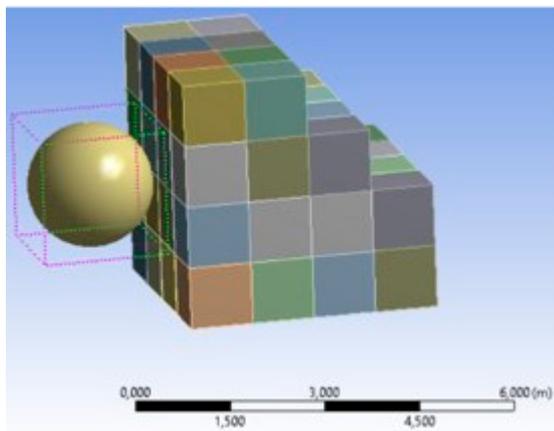
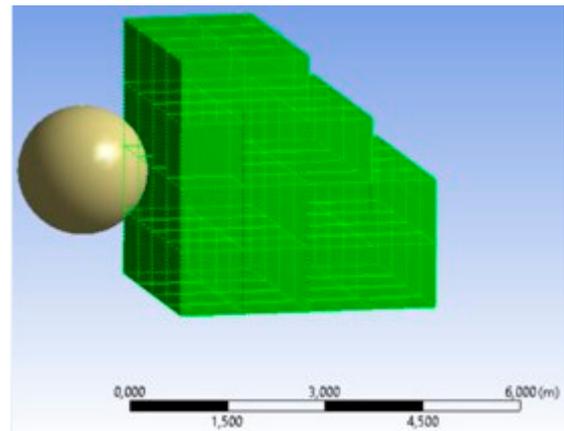
(a) Explicit Dynamics-Mechanical tab

(b) Assigning material properties

Figure 17. Screen interface of Explicit Dynamics-Mechanical tab and assigning material properties.

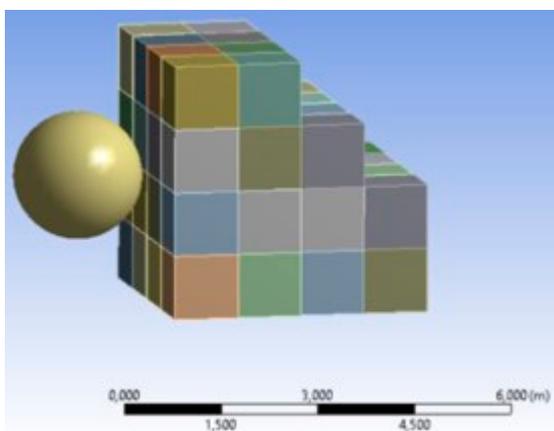
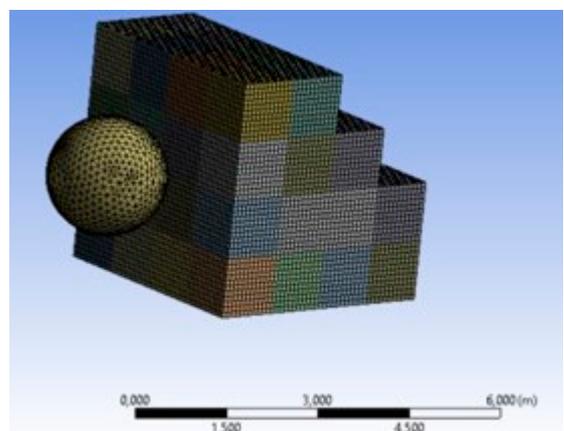
(a) Explicit Dynamics-Connections/Contact tab

(b) Explicit Dynamics-Meshing tab

Figure 18. Screen interface of Explicit Dynamics-Connections/Contact tab and the Explicit Dynamics-Meshing tab.

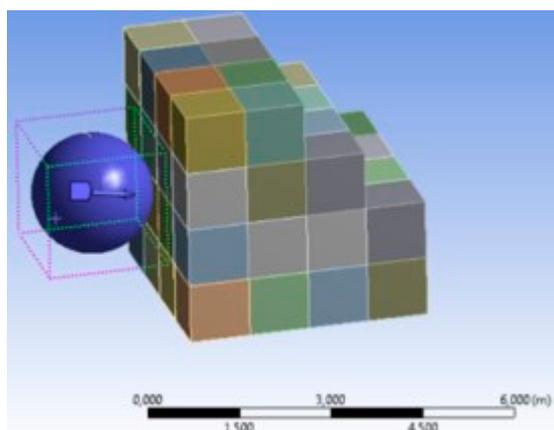
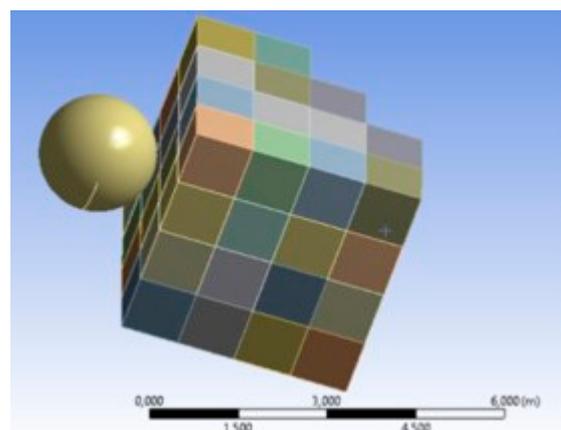
(a) Modeling the fall angle and velocity of the rock

(b) Determining the analysis time

Figure 19. Screen interface for modeling the fall angle and velocity of the rock and determining the analysis time.

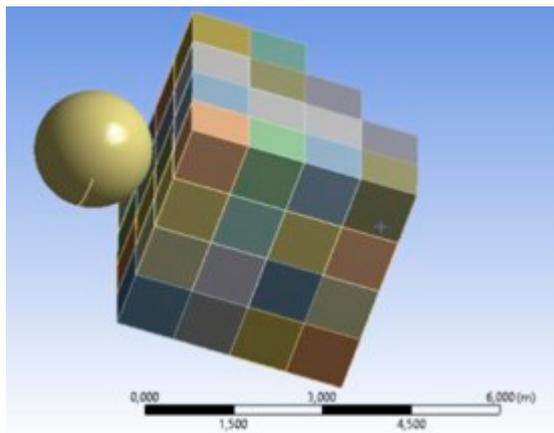
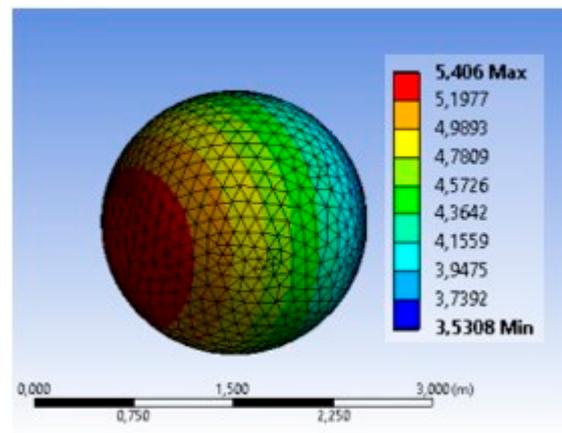
(a) The data to be obtained after the analyses

(b) The change for the falling rock in 0.02 s

Figure 20. Screen interface of the data to be obtained after the analyses and display interface of the change for the falling rock in 0.02 s.

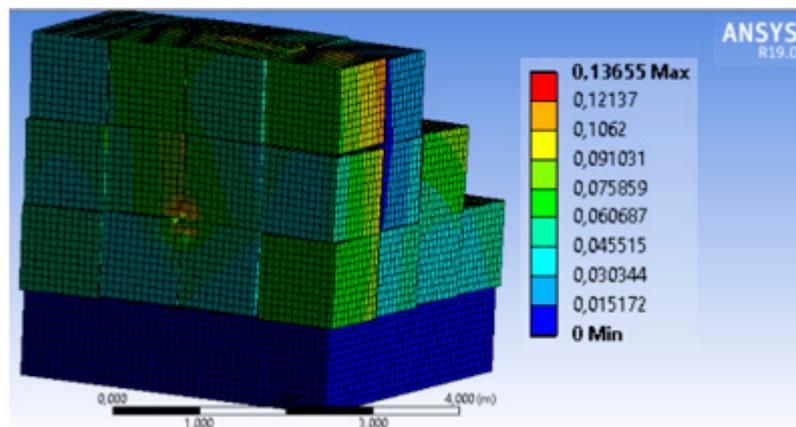
Figure 21. Screen interface of the maximum displacement obtained as a result of the analyses.

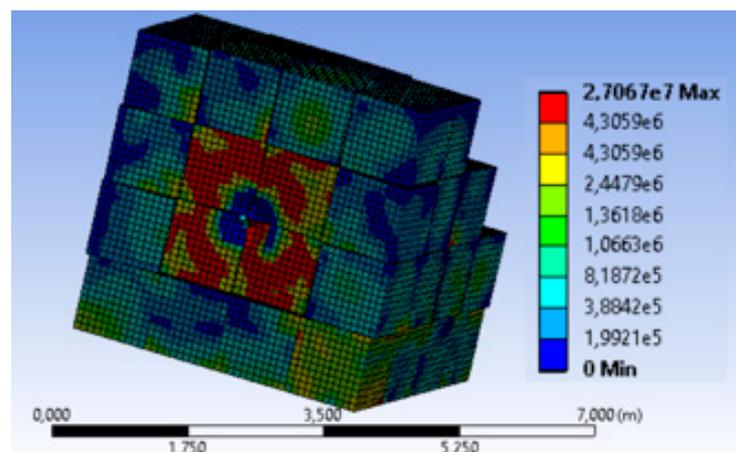
Figure 22. As a result of the analyses, the screen interface of the stresses.

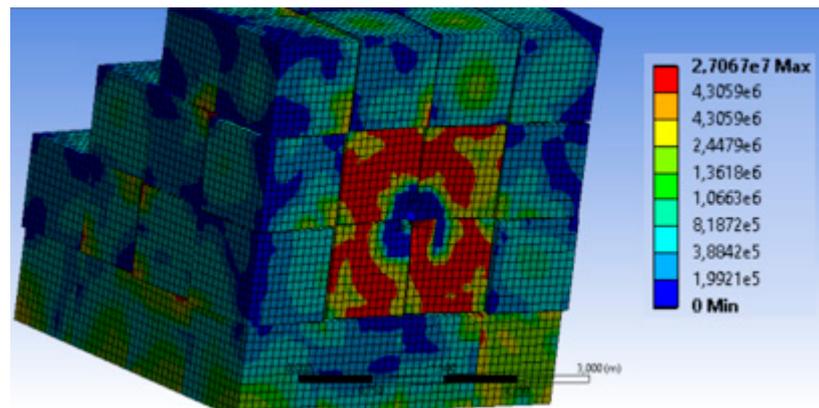
Figure 23. Screen interface of the crash damages obtained as a result of the analyses.
