# Towards the Resilience of Attica Region's Provincial Road 3 in Greece, Due to Slope Failure by Applying Civil Engineering Techniques and a Semi-Quantitative Assessment Approach

Nikolaos Tavoularis

Department of Technical Support of Attica's Region Municipal Islands, Directorate of Technical Works Piraeus and Islands, Regional Authority of Attica, Aigaleo 5 & Kastoros, Piraeus, 185 45 Attica, Greece; ntavoularis@metal.ntua.gr

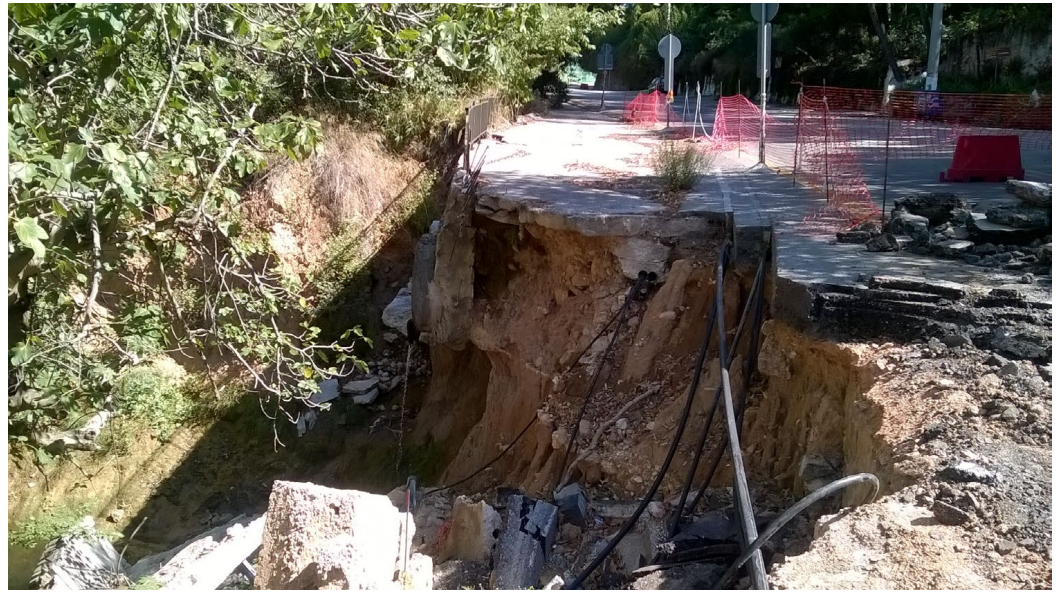
**Figure 2.** View from one characteristic slope failure (fall) of the examined road (Author's archive).

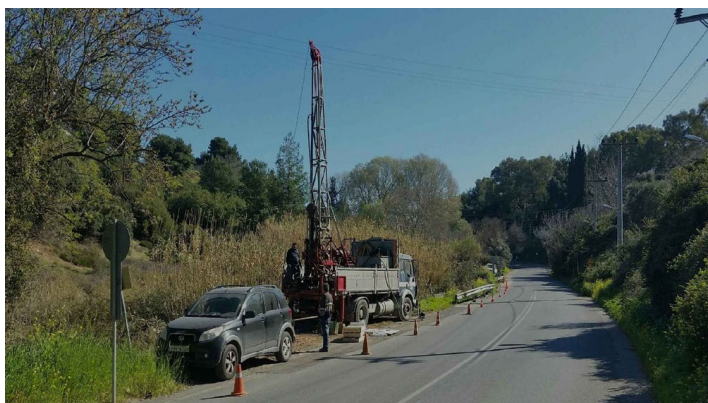
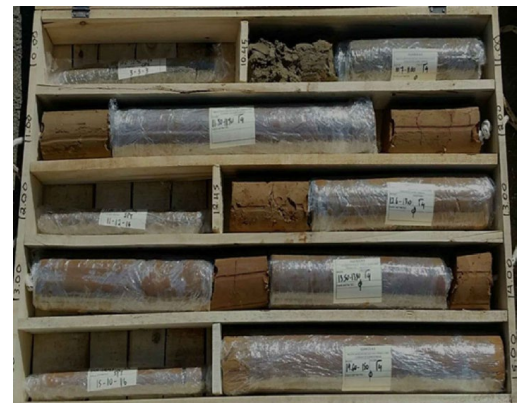
**Figure 4.** (a) Borehole drilling, (b) part of the borehole findings (sand to clayey geomaterial) is depicted [11].

To investigate the nature of the formations along the failures of the problematic section of Dekeleias Road, four sample boreholes with a total depth of 65 m were drilled, and field and laboratory tests were carried out. The field work took place in March 2018 (Figure 4a,b).

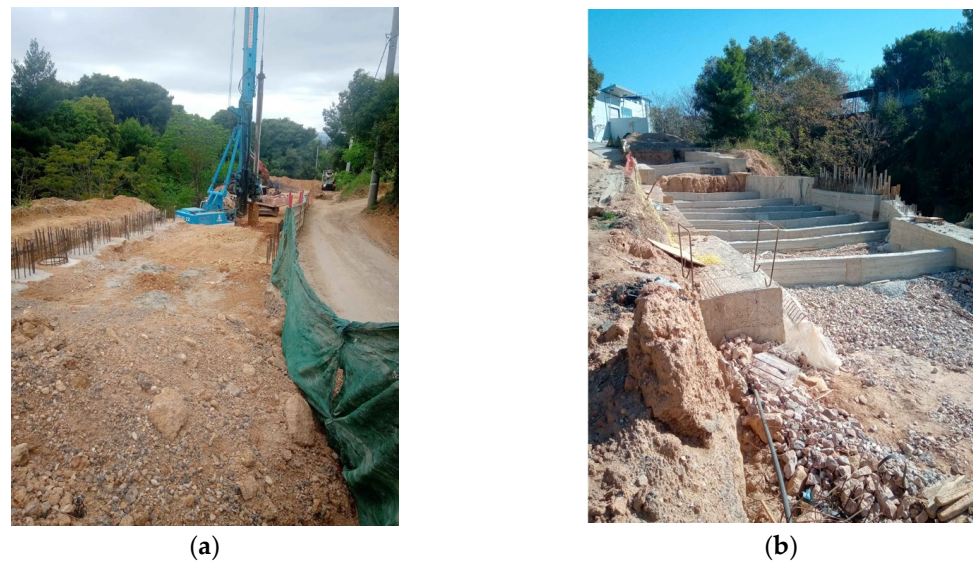
**Figure 5.** Views from Area A construction: (a) cutter bar machine, (b) pile walls made of intersecting piles (Author's archive).

In Area A, the main contributing factor to the failure mechanism is estimated to be, based on the failure morphology, the flow of the stream as the stream bed approaches the roadway slope (Figure 1). Area A was divided into three subareas (A1, A2, A3). Subarea A1 starts after the turn from the Athens Lamia Highway (Lainopoulos location) and extends 8.50 m to the west. To address the erosion mechanisms in subarea A1, it was decided to construct a pile wall with interlocking piles 1.00 m, with the reinforced piles having an axial spacing of 1.7 m. Subarea A2 starts from the end of area A1 and extends 32.90 m to the west. In this area, significant undermining has occurred on the existing road, with the crown of the existing steep slopes bound within the road zone. To address the erosion mechanisms, anchor walls 3.0 m and 5.5 m high were constructed, found on interlocking piles of 1.00 m diameter at 1.7 m intervals. In this section, the retaining elements (piles, retaining walls) needed to be anchored. Subarea A3 starts from the end of area A2 and extends 5.10 m towards the west. To address the erosive mechanisms in area A3, it was decided to construct a pile wall with intersecting 1.00 m piles, with the reinforced piles having an axial spacing of 1.7 m (Figure 5a,b).

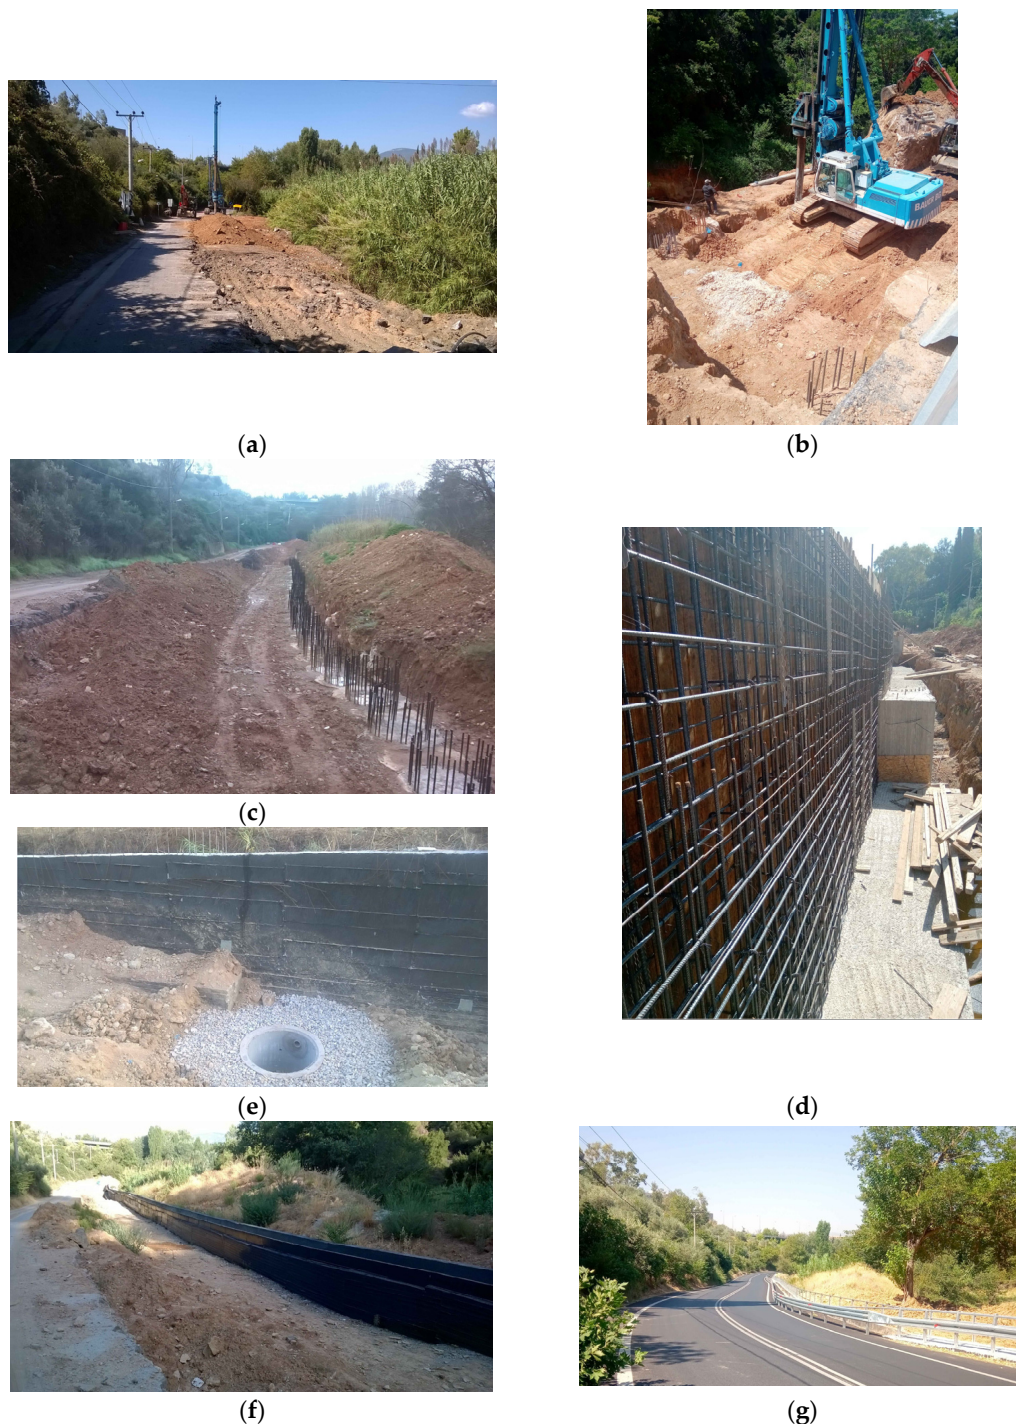
**Figure 6.** (a–g) Different successive steps of pile wall construction of Areas B to D (Author’s archive). In Figure (e), a view from the drainage system (for lowering the potential pore water pressures and accomplishing adaptation to possible disruption from heavy rainfall episodes) is depicted. Figure (g) is associated with the accomplishment—end of the technical works in September 2023 in the examined segment of the road (Author’s archive).

The geotechnical study was completed in January 2019, whereas the stabilization work started in September 2020 and was completed in September 2023. In Figure 6a–g, characteristic views from the construction phase of areas B to D are depicted.
