# Investigating the Influence of Site Soil and Water Chemistry on Durability of Precast Concrete Culverts

School of Civil & Mechanical Engineering, Curtin University, Kent Street, Bentley, WA 6102, Australia; s.ahmed@curtin.edu.au

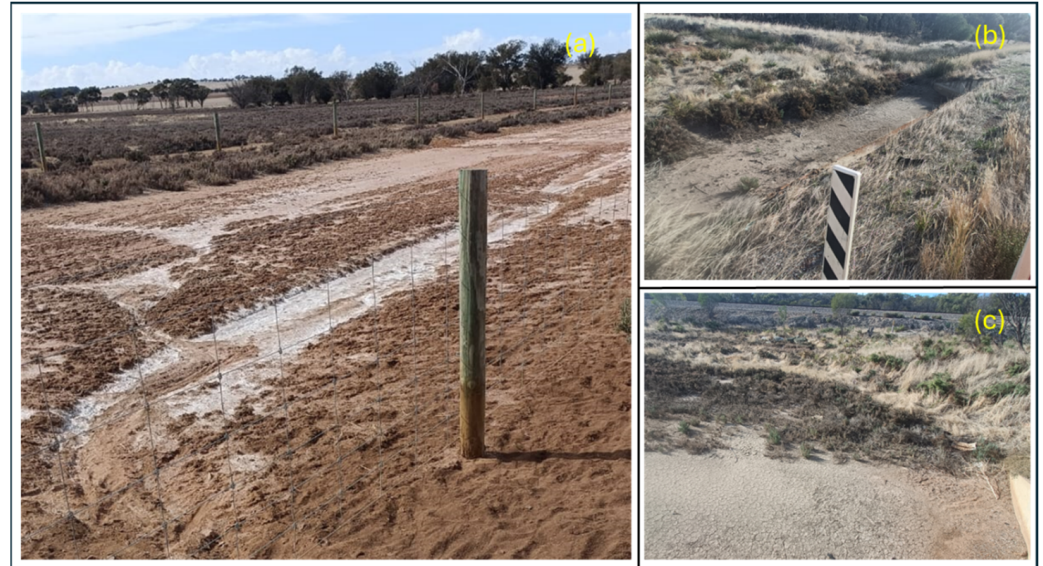
**Figure 5.** (a) Salt leaching out in culvert vicinity, (b,c) salt tolerant plant (beaded glasswort) in the vicinity of culvert site.

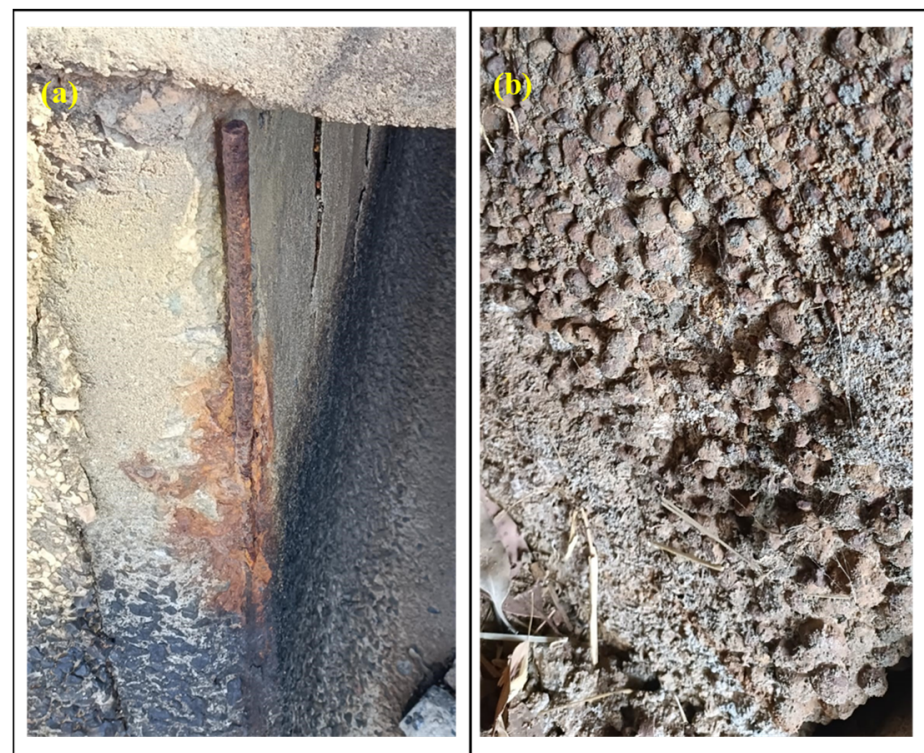
From the inspection, it was observed that 3 precast culverts (7, 8 and 10) needed more clear cover (Figure 6). The minimum clear cover required as per AS 1597.1 [9] and AS 1597.2 [10] for 50 MPa concrete at exposure class B1 is 25 mm, which increases to 50 mm for exposure class C. The lack of clear cover indicates the risk of early corrosion initiation time in concrete. Rasheeduzzafar et al. [29] reported that a 50 mm clear cover is twelve and six times more protective than 12.5 mm and 19 mm clear cover, respectively, in concrete with a water–cement ratio of 0.45. In contrast, at the water–cement ratio of 0.65, a 50 mm clear cover is considered six and three times more protective than a 12.5 mm and 19 mm clear cover, respectively [12]. Similarly, circular-shaped aggregates were observed inside the

culvert unit in Culvert 1 (Figure 6). Angular aggregates improve the interlocking property of concrete and produce more compressive strength. The rough texture and irregular shapes of angular aggregates result in better bond strength. Due to the increase in bond strength, there is usually less erosion. Therefore, as shown in Figure 6, round-shaped aggregates may also be one reason for surface erosion.

**Figure 6.** (a) Low clear cover and (b) round-shaped aggregates observed in some cases.

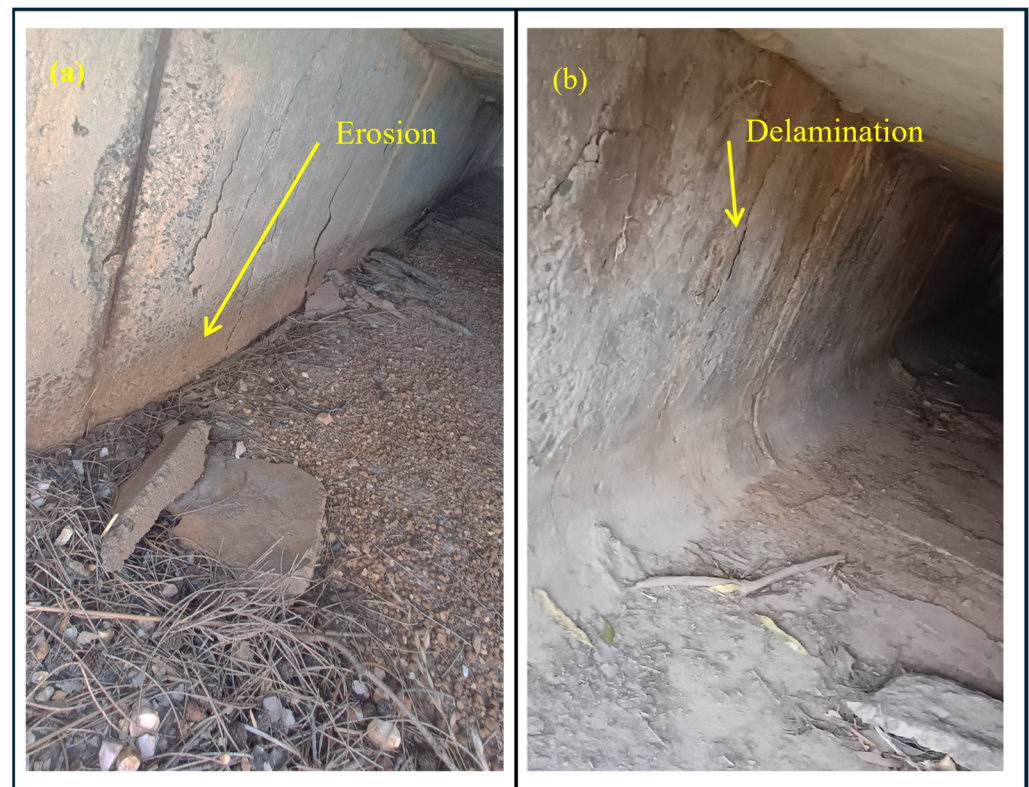
The deterioration issues seen on site included cracking, delamination, spalling, and exposed reinforcement in the culvert barrel (Figures 7 and 8). Corrosion of reinforcement was also observed in the deteriorated culverts. There were minor issues of erosion, a process

**Figure 8.** (a,b) Delamination observed in culvert unit.

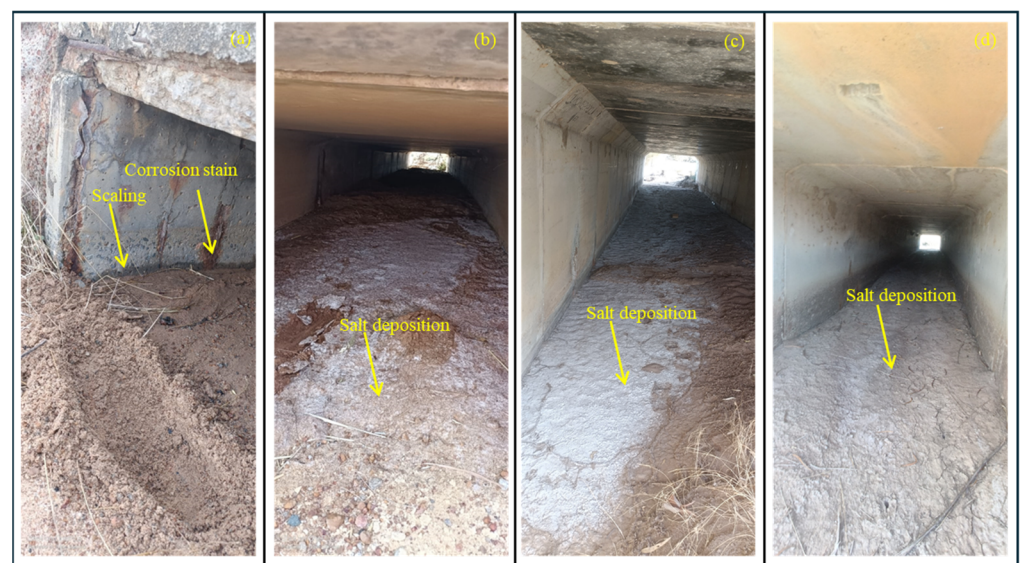
The chloride concentration results of the soil samples are given in Table 3. The chloride concentration in the water sample of culvert site 2 is 83,700 ppm, which is more than four times the seawater chloride content. For literature comparison, the chloride concentration of seawater is generally taken as 19,000–19,500 ppm [53,54]. Figure 9 shows evaporated salt deposited in silted soil inside the culverts. It is an indication of moisture evaporation, leaving crystalline salt deposits. High EC, sulphate, and chloride content in culverts are likely due to the presence of high salt in the soil, as shown in Figure 9. Pasupathy et al. [1] reported chloride concentrations of 150,080 ppm and 468,390 ppm in lake water in WA, where a precast culvert was placed. The chloride concentrations in other soil samples were also high. The sulphate and chloride concentrations of water were much higher than that of soil in culvert site 2. All the culverts would be facing numerous wet and dry cycles that might accelerate the deterioration process. Due to water logging, relief culverts will typically remain in contact with saline water for a long time.

**Figure 9.** (a) Scaling and corrosion stain in culvert 2, (b–d) evaporated salt deposits on silted soil inside the culverts 3, 13, and 14.

The combination of visual observations and the chemistry of surrounding soil and water indicates that high salinity significantly contributes to the deterioration of culverts in the Wheatbelt region. Delamination and spalling of the concrete are likely to be caused by corrosion of the reinforcement, external sulphate attack, or both. Sulphate ions react with hydration products inside the concrete matrix to form expansive ettringite, leading to tensile cracks in the concrete. Similarly, the rust formed after steel corrosion will have a higher volume than the reinforcement, which induces tensile cracks in the concrete. These cracks aid the entry of aggressive ions to accelerate the deterioration. High EC further escalates this ionic process, increasing the rate of deterioration, ultimately resulting in delamination and eventually spalling of the concrete. The corrosion here may likely be chloride-induced, as salt-tolerant plants and high soil and water chloride concentrations were seen in visual inspection. The primary ways to prevent these mechanisms are to reduce the permeability of concrete matrix, increase the concrete cover, or both. However, during steam curing of the precast concrete, unevenly distributed and coarse hydration products may form, leading to higher permeability and reduced resistance to ion ingress [55]. The adverse effects in concrete properties due to steam curing are termed ‘heat damage’. Therefore, to increase the durability of precast culverts in WA, the heat damage effect in culverts may be reduced, making the culvert less porous so the sulphate and chloride ions’ penetration to

the concrete matrix is reduced. It can be achieved by optimizing the steam curing regime, providing subsequent curing, using multiple transmission media to reduce heat damage, and/or using mineral additives.
