D-Band THz A-Scanner for Grout Void Inspection of External Bridge Tendons

Dae-Su Yee *, Ji Sang Yahng * and Seung Hyun Cho

Non-Destructive Metrology Group, Korea Research Institute of Standards and Science (KRISS), Daejeon 34113, Republic of Korea; seungcho@kriss.re.kr

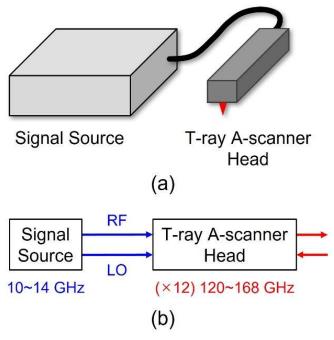
Figure 1 illustrates the schematic configuration of our D-band THz A-scanner. As shown in Figure 1a, the THz A-scanner consists of a signal source and a THz A-scanner head, which are interconnected via microwave cables. The THz A-scanner head acts as a handheld probe for target inspection. As depicted in Figure 1b, the signal source generates FMCW signals in the 10–14 GHz frequency range, which are transmitted to the THz A-scanner head through the connecting cables. The THz A-scanner head emits and receives FMCW THz radiation in the 120–168 GHz range, which is 12 times the input frequency.

Figure 1. Schematic configuration of our D-band THz A-scanner. (a) The system comprises a signal source and a THz A-scanner head, interconnected via microwave cables. (b) The signal source generates FMCW signals in the 10–14 GHz range, while the THz A-scanner head transmits and receives FMCW THz radiation in the 120–168 GHz range.

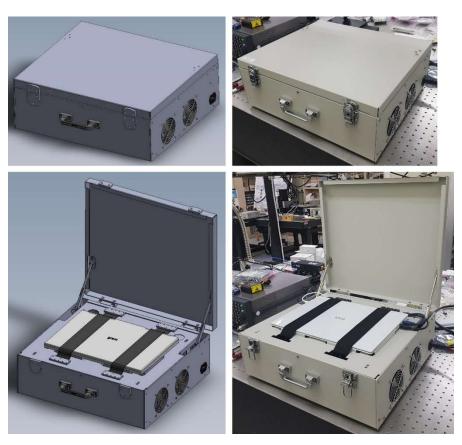
The IF signals output from the D-band frequency mixer within the TRx are acquired by a digitizer with a bandwidth of 100 MHz, a sampling rate of 500 MS/s, and a resolution of 12 bits. Frequency modulation of the DDS signal is driven by the FPGA board, which also generates a trigger signal to synchronize the digitizer with each modulation cycle. The digitizer repeatedly captures frequency-domain data, which is transmitted to a laptop computer for further processing. To enhance the signal-to-noise ratio (SNR), the laptop averages multiple traces of the frequency-domain data. The corresponding THz A-scan data is then derived by applying a fast Fourier transform (FFT) to the averaged data. Figure 3 shows the three-dimensional (3D) design schematics of the signal source, which is implemented in the form of a portable suitcase. Photographs of the fabricated signal source are also presented. The suitcase contains the digitizer, the laptop computer, and all associated electronic components.

Figure 3. Three-dimensional design schematics and photographs of the fabricated signal source.

Figure 6 presents the design schematics of the THz A-scanner head. Figure 6a,b show lateral views of the design, while Figure 6c,d depict its 3D views. As illustrated in Figure 6b, the THz A-scanner head comprises a TRx, a waveguide, a lens horn antenna, and an off-axis parabolic mirror. THz radiation emitted from the TRx propagates through the waveguide and is nearly collimated by the lens horn antenna. The off-axis parabolic mirror then focuses the THz beam downward, which then exits and enters through a hole in the base plate, as depicted in Figure 6c,d. The height of the THz A-scanner head can be adjusted using four supporting posts, allowing the focal point of the THz beam to align with the underside of the base plate. Figure 7 shows a photograph of the fabricated D-band THz A-scanner, which consists of the signal source presented in Figure 3 and the THz A-scanner head manufactured following the design schematics presented in Figure 6.

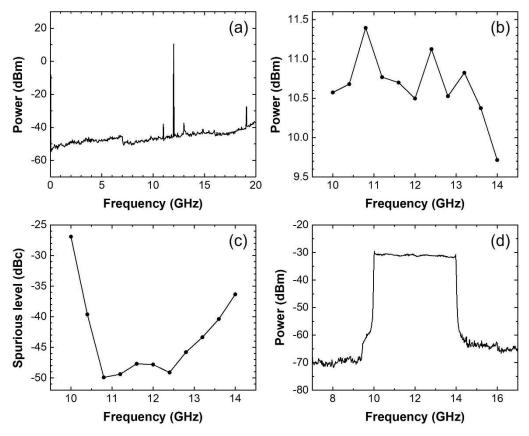
Figure 4 presents the measurement results of signals in the 10–14 GHz frequency range generated by the signal source and supplied to the TRx. Figure 4a shows the power spectrum of a continuous-wave (CW) signal at a fixed frequency of 12.0 GHz. The signal exhibits a power level of 10.5 dBm at 12.0 GHz, while a spurious component at 13.0 GHz is observed at -37.3 dBm, resulting in a spurious level of -47.8 dBc. Figure 4b,c show the measured signal power and spurious level, respectively, as functions of frequency for frequency-fixed CW signals in the 10–14 GHz range. Within this frequency range, the signal power satisfies the TRx input requirement of 10 ± 3 dBm, and the spurious level remains below -26 dBc. Figure 4d displays the power spectrum of a 10–14 GHz FMCW signal with a sweep repetition rate of approximately 244 kHz, indicating that the signal power gradually decreases with increasing frequency, which is consistent with the trend observed in Figure 4b.

Figure 4. Measurement results of signals in the 10–14 GHz frequency range generated by the signal source and supplied to the TRx. (a) Power spectrum of a CW signal at a fixed frequency of 12.0 GHz. (b) Signal power and (c) spurious level as functions of frequency for frequency-fixed CW signals in the 10–14 GHz range. (d) Power spectrum of a 10–14 GHz FMCW signal.

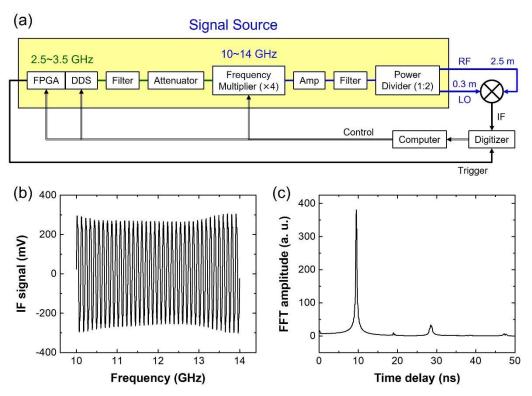
To verify the quality of the 10–14 GHz FMCW signal generated by the signal source, the RF and LO signals output from the signal source were input to a frequency mixer via microwave cables of 2.5 m and 0.3 m in length, respectively. The resulting IF signal output from the mixer was measured, as illustrated in Figure 5a. Figure 5b presents the frequency-domain data obtained by digitizing the IF signal and converting time into frequency based on the known frequency sweep rate. Figure 5c shows the corresponding time-domain data, obtained by applying an FFT to the frequency-domain data. In Figure 5c, the distinct peak at 9.5 ns indicates that the transmission time difference between the two microwave cables is 9.5 ns. Both the frequency- and time-domain data exhibit very low noise levels, confirming the high quality of the generated FMCW signal.

Figure 5. (a) Experimental setup for evaluating the 10–14 GHz FMCW signal generated by the signal source. The RF and LO signals output from the signal source are input to a frequency mixer via microwave cables of 2.5 m and 0.3 m in length, respectively. (b) Frequency-domain data obtained by digitizing the IF signal from the frequency mixer and converting time into frequency based on the known frequency sweep rate. (c) Corresponding time-domain data obtained by applying an FFT to the frequency-domain data.

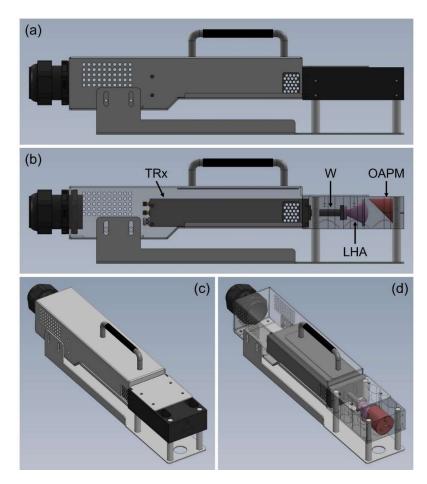
Figure 6. Design schematics of the THz A-scanner head. (a,b) Lateral views and (c,d) 3D views of the designed THz A-scanner head. In (b), W = waveguide, LHA = lens horn antenna, and OAPM = off-axis parabolic mirror.

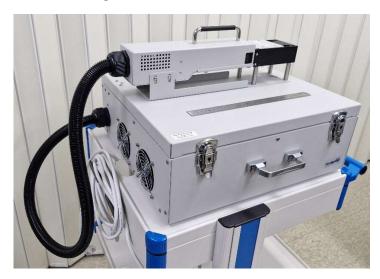
Figure 7. Photograph of the fabricated D-band THz A-scanner, with a 30 cm ruler included for scale reference.

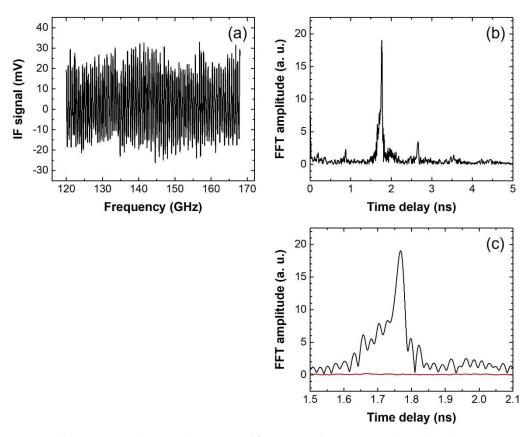
To evaluate the performance of the D-band THz A-scanner, a THz A-scan measurement was conducted on a metal target placed in contact with the underside of the base plate of the THz A-scanner head. Figure 8a presents the frequency-domain data measured in the 120–168 GHz range. Compared to the result shown in Figure 5b, the magnitude of the IF signal exhibits greater fluctuations across the frequency range. Figure 8b shows the corresponding THz A-scan data, which was derived from the frequency-domain data using FFT. Unlike the time-domain data in Figure 5c, the THz A-scan data in Figure 8b displays ripples throughout the entire time delay range. The peak at 1.77 ns corresponds to the reflection from the metal surface, and the peak at 0.88 ns is likely attributed to the interface between the waveguide and the lens horn antenna, while the peak at 2.66 ns is presumably the result of multiple reflections between this interface and the metal surface. However, since the peaks at 0.88 ns and 2.66 ns fall outside the time delay window of interest, they are considered negligible. Figure 8c provides a magnified view of the main

peak at 1.77 ns. The full width at half maximum (FWHM) of the peak is approximately 37 ps, corresponding to a THz A-scan resolution of approximately 5.6 mm, which was calculated using the relation $R = c \cdot FWHM/2$, where c is the speed of light. In addition, noise data is presented in Figure 8c, which was measured without a target. From the THz A-scan data and the noise data, the SNR was estimated to be about 240.

Figure 8. (a) Frequency-domain data acquired from a metal target using the D-band THz A-scanner. (b) Corresponding THz A-scan data derived from the frequency-domain data using FFT. (c) Enlarged view (black line) of the peak at 1.77 ns in (b) and noise data (red line) measured without a target.

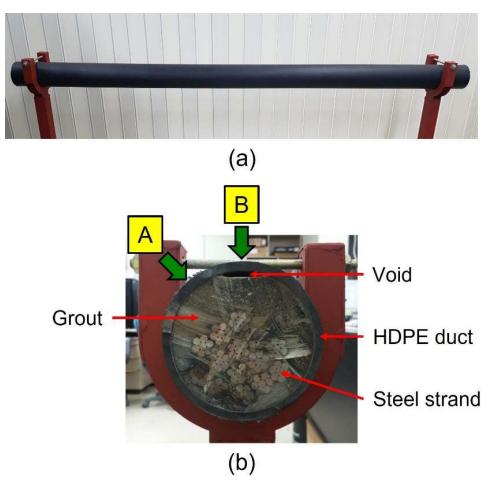
Figure 9a,b show the lateral and cross-sectional views, respectively, of a constructed bridge tendon specimen. The specimen was prepared by embedding fifteen steel strands, each with a nominal diameter of 15.2 mm, into an HDPE duct with an outer diameter of 110 mm. The duct was subsequently filled with cementitious grout, thereby replicating the structural configuration of an external tendon in post-tensioned bridges. During the grout curing process, voids—which can serve as reservoirs for moisture—were formed in the upper interior region of the HDPE duct. If cracks develop in the grout, moisture may penetrate through the cracks and reach the steel strands, thereby initiating corrosion. Accordingly, a nondestructive inspection technique capable of detecting the presence of such voids is essential. We investigated the applicability of the D-band THz A-scanner for detecting voids beneath the duct in external bridge tendons.

Figure 9. (a) Lateral view and (b) cross-sectional view of the external bridge tendon specimen. In (b), A and B indicate the void-free and void-containing regions of the specimen, respectively.

Figure 11 presents the THz A-scan data of the bridge tendon specimen measured using the D-band THz A-scanner. The THz A-scanner head was placed horizontally on the surface of the tendon specimen to acquire the THz A-scan data. Figure 11a shows the THz A-scan data acquired from the void-free region (A) indicated in Figure 9b. In the data, two distinct reflection signals are observed: P1, corresponding to the surface of the HDPE duct, and P2, corresponding to the duct/grout interface. Using the measured refractive index of HDPE and the time delay difference between P1 and P2, the thickness of the HDPE duct was estimated to be 5.7 mm, which was in excellent agreement with

Figure 11b shows the THz A-scan data acquired from the void-containing region (B) indicated in Figure 9b. In this data, three reflection signals are observed: P1 from the surface of the HDPE duct, P2 from the duct/void interface, and P3 from the void/grout interface. Given the THz A-scan resolution of 5.6 mm, the partial overlap of P2 and P3 suggests that the void thickness is less than 5.6 mm. The void thickness was estimated to be approximately 2.5 mm using the time delay difference ($\Delta \tau$) between P2 and P3, according to the equation $d = c \cdot \Delta \tau / 2$, where c is the speed of light. Due to the limited resolution and overlap between P2 and P3, their individual amplitudes could not be accurately determined. If P2 and P3 were fully resolved and their amplitudes were accurately determined, both the attenuation coefficient of the HDPE duct and the refractive index of the grout could be estimated. Specifically, the attenuation coefficient of the HDPE duct could be derived from the amplitude ratio of P2 to P1, along with the refractive index and thickness of the HDPE duct. Also, the refractive index of the grout could be estimated from the amplitude ratio of P3 to P2 and the refractive index of the HDPE duct.

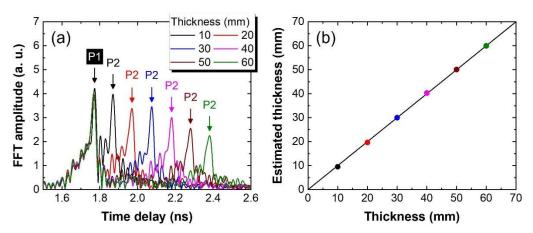
Before conducting measurements on the external tendon specimen using the D-band THz A-scanner, we measured the refractive index of HDPE. For this purpose, THz A-scan measurements were performed for HDPE blocks with thicknesses of 10, 20, 30, 40, 50, and 60 mm. Figure 10a presents the THz A-scan data measured on the HDPE blocks. The thickness of each HDPE block was estimated from the time delay difference ($\Delta \tau$) between the front (P1) and back (P2) surface reflections in the A-scan data, based on the relation $d = c \cdot \Delta \tau / (2n)$, where c is the speed of light and n is the refractive index of HDPE. The optimal refractive index value was determined by minimizing the sum of squared differences between the estimated thickness values and the reference measurements obtained using a vernier caliper, resulting in a refractive index of 1.534. Figure 10b shows the estimated thicknesses of the HDPE blocks using this refractive index.

Figure 10. (a) The THz A-scan data were measured on HDPE blocks with different thicknesses. (b) Thickness values of the HDPE blocks estimated from the THz A-scan data.

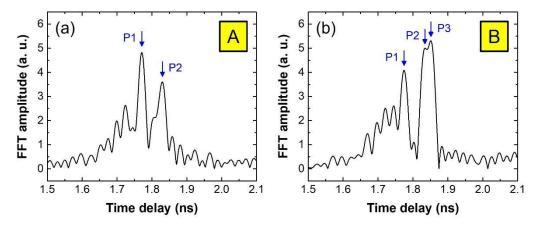
the reference value measured using a vernier caliper. The amplitude ratio of P2 to P1 was approximately 75%.

Figure 11. THz A-scan data acquired from (a) the void-free region and (b) the void-containing region of the external tendon specimen using the D-band THz A-scanner.

As shown in Figure 11b, when P2 and P3 are not resolved in the THz A-scan data acquired from the void-containing region, the combined amplitude of P2 and P3 relative to P1 exceeds 100%. This is clearly distinguishable from the amplitude ratio of P2 to P1 in the void-free region, which is approximately 75%. When the void thickness is significantly smaller than the resolution and approaches zero, the measured THz A-scan data would become indistinguishable from that of the void-free region, making such voids difficult to detect. If the void thickness exceeds the A-scan resolution and P2 and P3 are fully resolved, the presence of P3 alone would be sufficient to identify the void-containing region [12]. These observations indicate that voids with a thickness of approximately 2.5 mm or greater can be detected using THz A-scan data obtained from the bridge tendon specimen. The likelihood of steel strand corrosion would increase with larger void thickness. Hence, the developed D-band THz A-scanner can be regarded as an effective tool for detecting voids beneath the HDPE duct in external bridge tendons.
