# Hammering Test for Tile Wall Using Deep Learning

**Abstract:** Economic activities heavily rely on social infrastructure, such as bridges, tunnels, public structures, and buildings. In Japan, regular inspections are mandated by law to ensure these assets remain functional. This kind of requirement is rare worldwide. Similar regulations exist only in major cities in the United States and Canada. These inspections often focus on detecting issues that are not visible to the naked eye, such as cavities within concrete walls. The most widely used method for such inspections is the hammering test, in which inspectors analyze the sound variations produced when a hammer strikes a surface. By interpreting these auditory changes, they can assess the structural integrity and identify hidden defects within a structure. While effective, the accuracy of this method strongly depends on the inspector's sensory perception, which varies with individual experience and skill. Furthermore, because the test is conducted manually, it is time-consuming, especially for large-scale structures. The most critical problem is the shortage of skilled inspectors due to retirement. It is difficult to meet the d

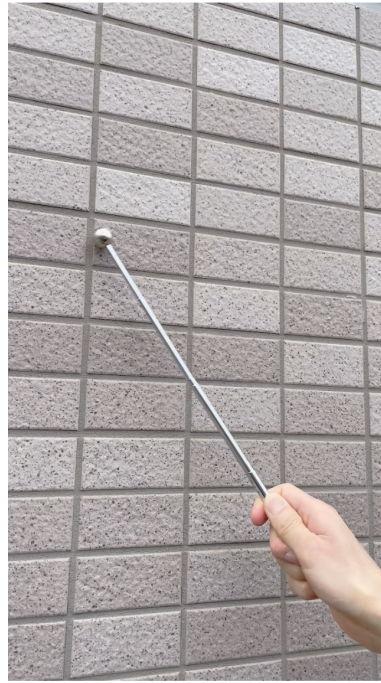
**Figure 5.** Hammering test on a tile wall (rubbing the surface).

For tile wall inspections, a hammering rod is typically preferred. This tool generates a friction sound by rubbing a small metal ball attached to the end of an inspection rod against the tile surface, as illustrated in Figure 5. This method provides a gentler approach, minimizing the risk of damaging the tiles while still allowing for effective inspection.

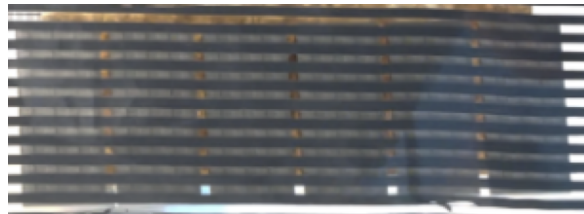
**Figure 8.** An example of 60% adhesion.

conditions, we used four different specimens with adhesion rates of 100%, 80%, 60%, and 0%. Figures 7–10 show the respective adhesion conditions for 0%, 60%, 80%, and 100%.

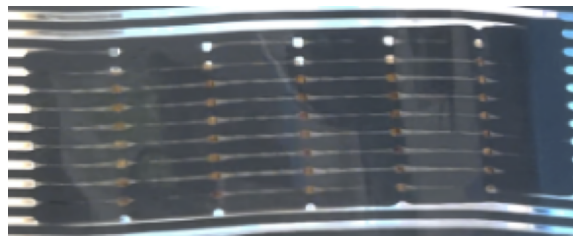
**Figure 9.** An example of 80% adhesion.

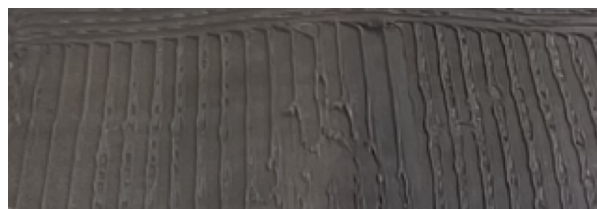
**Figure 10.** An example of 100% adhesion.
