Article

Optical Cutting Interruption Sensor for Fiber Lasers

Keywords: laser cutting; cut break detector; optical sensor

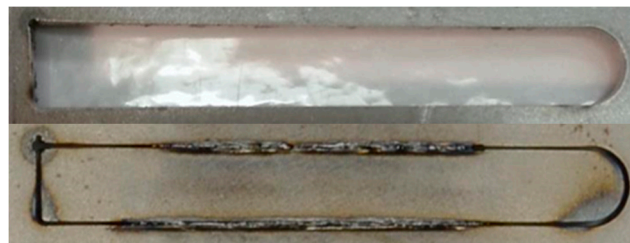
To demonstrate the function of the sensor, the results of two exemplarily chosen cuts in 1 mm thick mild steel are discussed. For both cuts, a nominal velocity of 100 mm/s, a gas pressure of 8 bar (nitrogen), and a nozzle to workpiece distance of 1 mm are chosen. In the first cut, the laser power is set to 1.4 kW, which results in a complete cut and, to highlight the different signal signature, for the second sample, 1.0 kW is used resulting in a cutting interruption on both long straight lines of the sample as shown in Figure 3.

Figure 3. Picture of the complete cut (**top**) and incomplete cut (**bottom**) with the cut interruption on both straight lines.

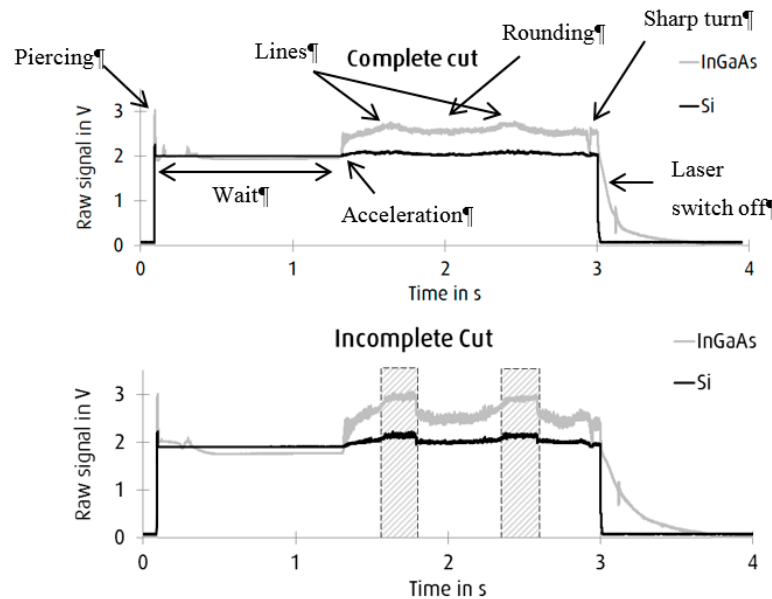
The voltage signals of both cuts for the Si and InGaAs diode are shown in Figure 4 for a specifically chosen scenario, including the piercing, a waiting period, an acceleration phase of the drives, the movement along the geometry depicted in Figure 1, and, finally, the laser switch off. Please note, the sensor signals look similar for a series of cuts when using constant laser parameters and no differences are observed between cutting stainless steel and mild steel.

During the time frame shown in Figure 4, the laser is switched on after 0.1 s. The immediately-detected sharp signal rise of both photodiodes marks the piercing. For the next 1.1 s, the laser remains switched on, yet the linear drives remain at the piercing position. During this phase, both photodiodes show an almost constant signal of about 2 V. After 1.2 s, the drives start to accelerate, which is indicated by a rise and jitter of both diode signals. The rounding in the cut geometry can be seen at about 2 s, being

expressed by a lower voltage from the InGaAs diode. The sharp 90-degree turn of the laser system at the end of the cut contour is associated with a negative peak in the sensor signal of the InGaAs diode shortly before second 3. The laser is switched off after 3 s, which leads to a sharp negative step of the Si diode signal and a slow decrease of the InGaAs signal. The latter is caused by the cooling process of the workpiece, with the main contributing intensities of the thermal radiation shifting towards a longer wavelength (the maximum shift according to Wien's law). It is worthwhile to stress that the signal behavior shown in Figure 4 (top), in general, reveals the described trend, independent of the employed process parameters for a complete cut.

Figure 4. Voltage signal delivered by the Si and InGaAs diodes of a complete (**top**) and incomplete (**bottom**) cut. The time of the cutting interruption is marked by dashed lines.

The temporal evolution of the signals of both photodiodes for an incomplete cut (Figure 4, bottom) shows, at first glance, a rather similar behavior as the complete cut. However, a detailed comparison yields remarkable differences for both photodiodes, particularly at the beginning and the end of the cutting interruption (highlighted by two grey shaded rectangular in Figure 4, bottom). These differences are observed consistently whenever a cutting interruption is enforced by changing process parameters, such as a decrease in laser power or an increase of velocity.

To obtain a characteristic signature in the photodiode signal that unambiguously identifies a cutting interruption, as a first step, we apply a digital two-element high pass filter ($y_k = x_k - x_{k-1}$) to the measured signals, as shown in Figure 4. The resulting filtered signals are depicted in Figure 5 for a complete cut (top) and an incomplete cut (bottom). Distinctive points in the filtered signal are found at, firstly, 0.1 s (pronounced peak) indicating the piercing; secondly, at 1.2 s the onset of the laser cut is indicated by a pronounced signal with strong fluctuations; and thirdly, the end of the laser cut is noticeable by a high negative peak at second 3.0.

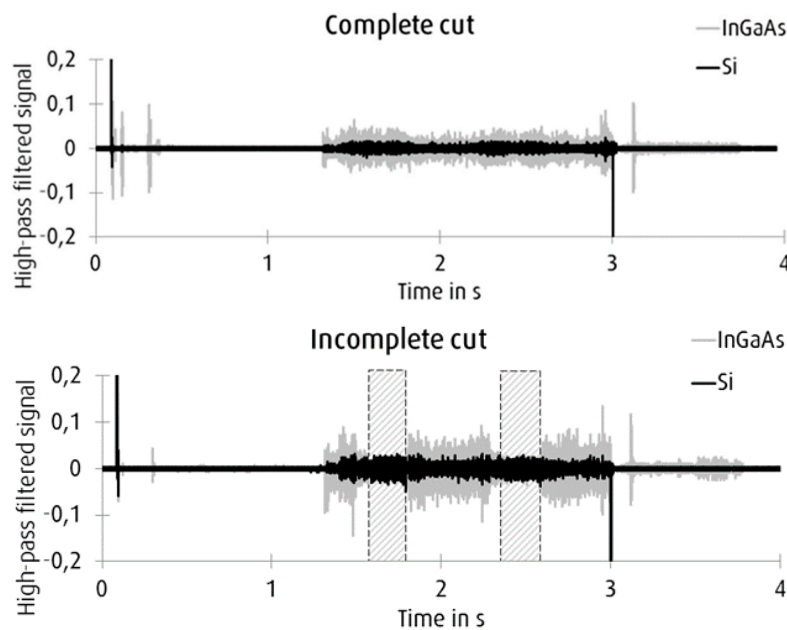
The comparison of the signals with and without cutting interruption reveals distinctive differences in the fluctuation range. During cutting (second 1.2 to second 3.0), the fluctuation range of the InGaAs diode is always higher as compared to the fluctuation range of the Si diode. When a cutting interruption occurs, as shown in Figure 5 (bottom), the fluctuation range of the InGaAs diode falls below the fluctuation range of the Si diode. At the end of the cutting interruption, controversially, the fluctuation range of the InGaAs signal exceeds that of the Si signal, *i.e.*, the degree of the filtered signal fluctuation can be utilized to discriminate a complete cut from a cutting interruption. We, therefore, calculate a measure of the degree for the fluctuation by determining the standard error from 50 sequent data points of the high pass filtered signal (Figure 5).

Figure 5. High pass filtered signal of a complete (**top**) and incomplete cut (**bottom**). The time domain in which the cutting interruption occurs is marked by the two grey shaded rectangular with dashed lines.

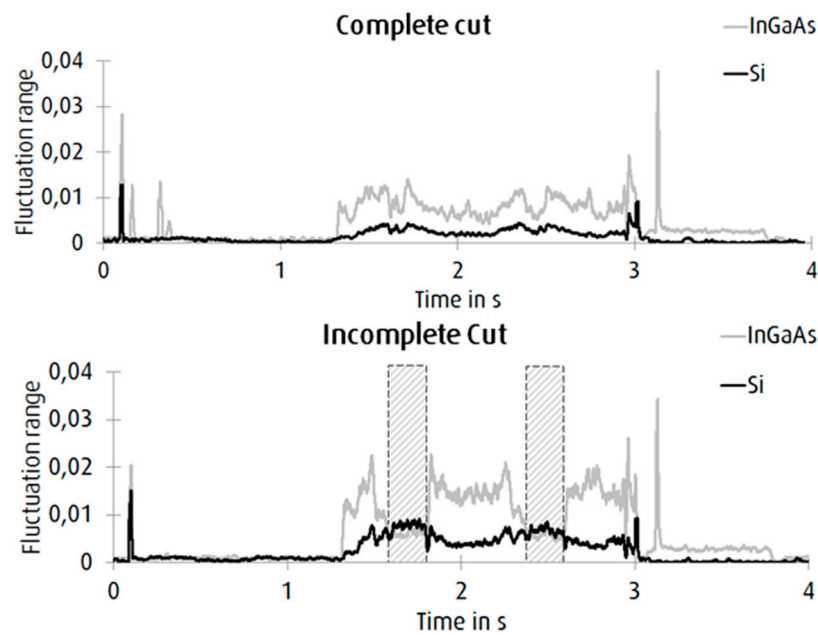
The results of this calculation are summarized in Figure 6 for the complete cut (top) and the incomplete cut (bottom). In this representation of the processed data, the signal of the complete cut is identified by the derived data from the InGaAs diode being continuously higher than that of the Si photodiode. Contrary to that, during the cutting interruption (marked by dashed lines in the lower part of Figure 6), the derived data from the InGaAs diode falls below that of the Si diode. To gain a digital value indicating whether a cutting interruption occurs or not, *i.e.*, discriminating the two regimes, the signal of both diodes must be compared. The calculation of this discriminating value is described in Equation (1), where C_t describes the binary value for a cutting interruption and f_r the fluctuation range of the particular diode signal. The if constraint returns a “1” whether the greater than condition in the square bracket is true and a “0” in case of a false condition. This digital value expresses a “1” for cutting interruption and a “0” for complete cutting. Further, c_f describes a correction factor for the fine tuning to achieve a high detection rate and low beta error rate. In a series of 20 cuts, a correction factor of 0.85 results is determined to detect all cutting interruptions without any false reports. With a

significantly higher correction factor, not all cutting interruptions were detected and a much lower correction factor errors are also indicated in faultless cuts.

Figure 6. Fluctuation range of the high pass filtered signal for a complete cut (**top**) and incomplete cut (**bottom**). The time domain with cutting interruption is marked by dashed lines.

When Equation (1) is applied to the signals shown in Figure 6, a digital signal is calculated, which is only 1 in case of a cutting interruption (*cf.* Figure 7). For the complete cut the signal is always 0 except from the end of the cut, *i.e.*, the sensor system even identifies the end of a cut, interpreted as a cutting interruption. In the lower part of Figure 7 the digital signal reveals a 1 for the piercing at 0.1 s, both cutting interruptions along the straight lines of the test geometry and the end of the cut at second 3.0.

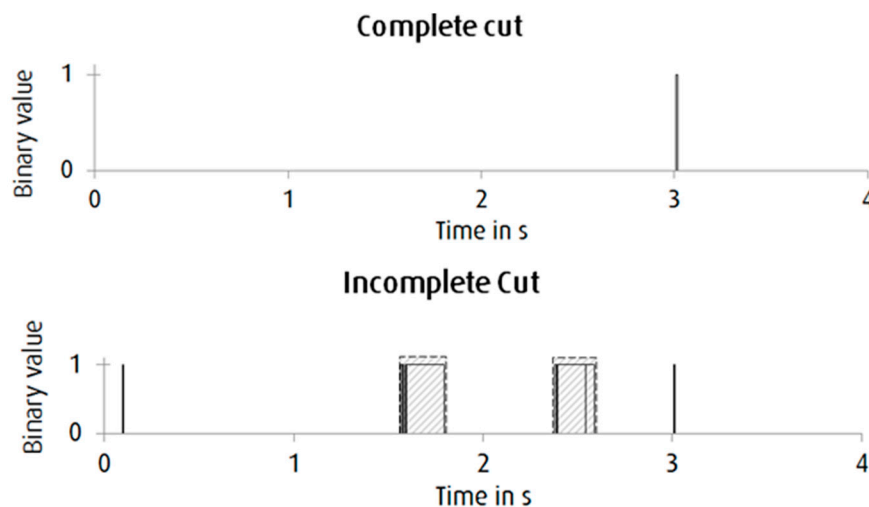
Figure 7. Calculated binary value indicating a cutting tear for (**top**) a complete cut and (**bottom**) an incomplete cut. The time domain with cutting interruption is marked by dashed lines.
