Article

Multispectral Applications of Infrared Thermography in the Diagnosis and Protection of Built Cultural Heritage

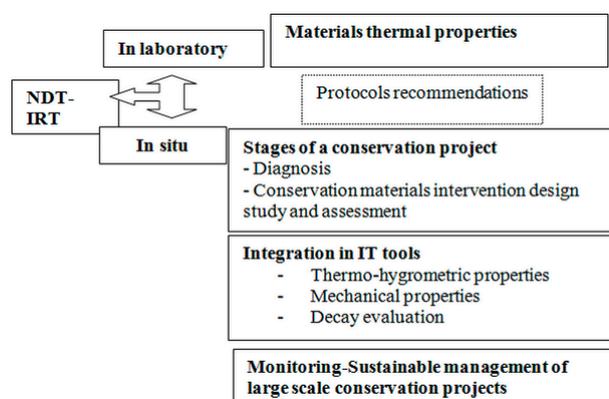
Figure 1. General graph for infrared thermography (IRT) application by National Technical University of Athens.

A general diagram for the application of IRT in built heritage is shown below (Figure 1).

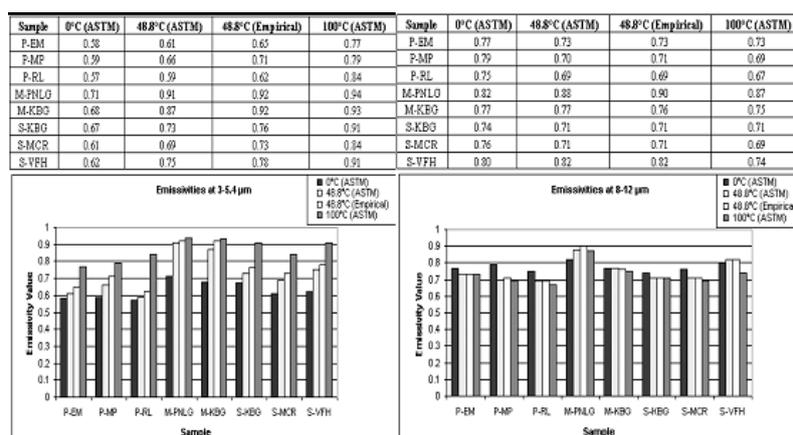
Figure 2 shows the emissivities of the investigated materials using both approaches. The standardized approach has more advanced analysis as it can obtain emissivity values at various temperatures when compared to the empirical developed approach. Furthermore, the results presented in the MWIR (i.e., 3–5.4 microns) show greater variability than in the LWIR (i.e., 8–12 microns). This leads us to conclude that the empirical approach is more suited for use in IRT surveys employing LWIR rather than in MWIR investigations.

Figure 2. Emissivity values for the 3–5.4 and 8–12 μm wavelengths.

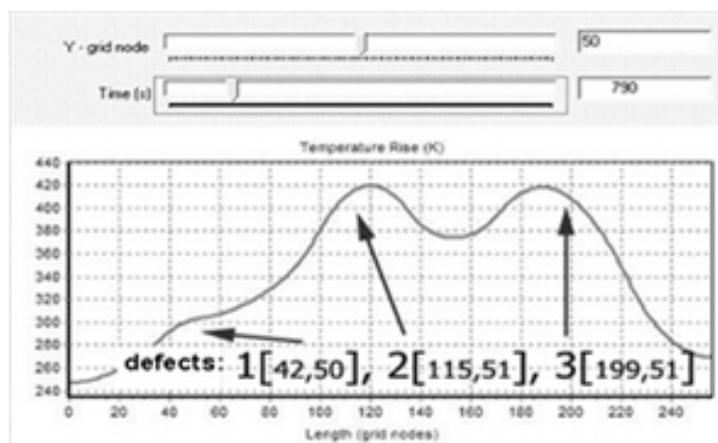
Figure 4. 3 Defects spatial profile.

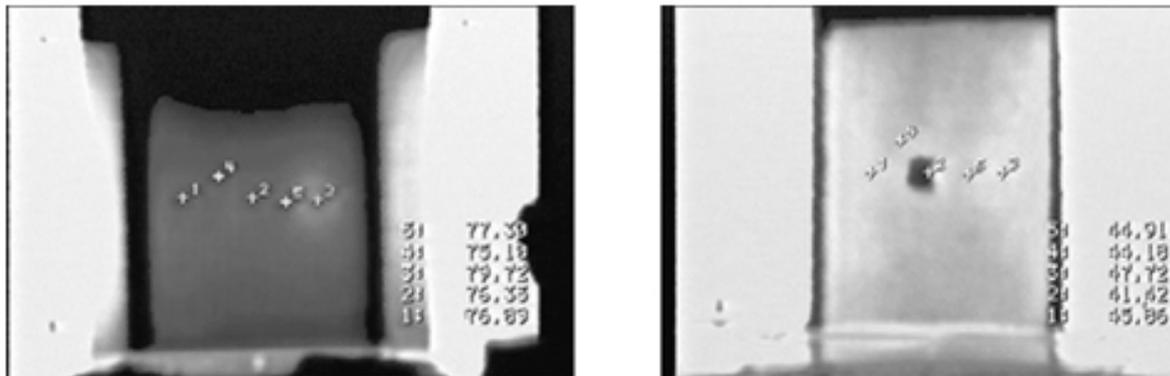
Figure 5. Thermograms of two different investigated samples.

We also applied mathematical-thermal modelling that enabled the modelling of the investigated subsurface defects, using the Thermocalc 3-D software. We also undertook quantification analysis (i.e., temperature-time plots, as well as thermal contrast curves) from the experimental work, as well as from the modelling, showing the thermal performance of building materials containing such defects (Figures 3–5). In Figure 5 shows the two different materials and their investigated defects.

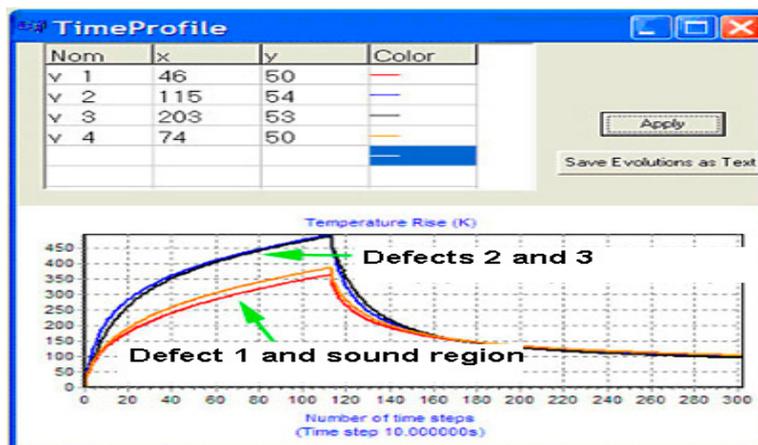
Figure 6. Temperature—Time plot from the modelling runs.

Temperature—time plots (Figure 6), as well as the contrast of the thermal images of the subsurface defects in relation to time were measured (plots of contrast vs. time). Information concerning the defects was obtained from the processed thermograms. The temperature-time plots from the acquired thermograms were also plotted (Figure 7). Such quantitative data could provide information concerning the detected defects. Furthermore, thermal diffusion of air (m^2/s) is lower than that of any of the investigated building materials (i.e., porous stone, marble). This means that regularly defected areas would be presented with higher temperature values [19].

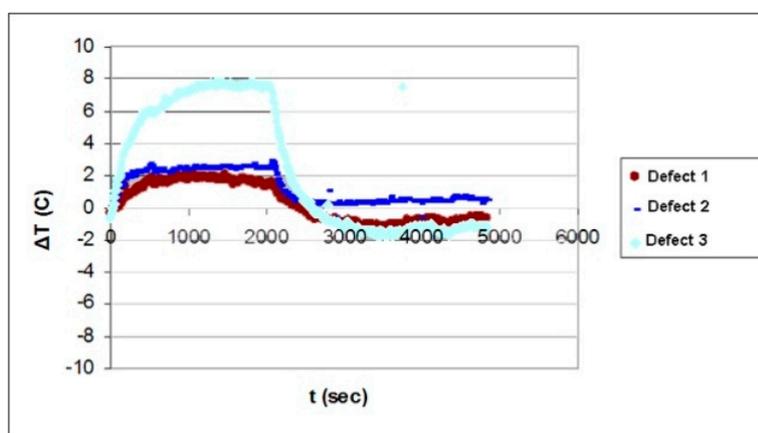
Figure 7. Temperature—Time plot from the experimental work.

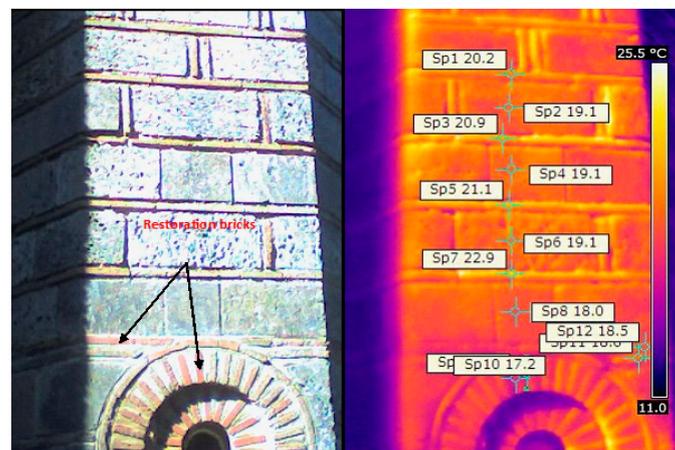
In this case, the main interesting finding was that, with the aid of NDTs, especially with the application of IRT, it was possible to identify the different construction phases based on the different temperatures of the different materials used, like mortars and ceramic bricks (Figure 8). For example, restoration bricks were identified, which presented different temperatures to the authentic ones. Restoration bricks presented lower temperatures ($\sim 17^\circ\text{C}$) in comparison to the historic ones ($\sim 21^\circ\text{C}$). The date the thermogram was taken was 17.02.2014, with air temperature $T = 12^\circ\text{C}$, $\text{RH} = 52\%$.

Figure 8. Kaisariani Monastery, area of investigation and thermal image.

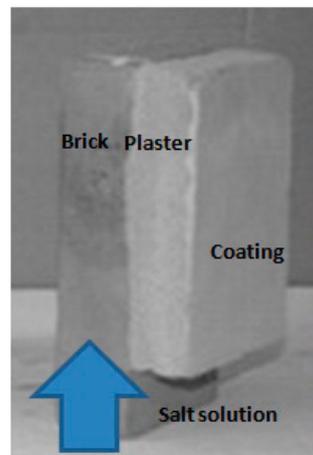
Figure 9. Brick-plaster-coating system.

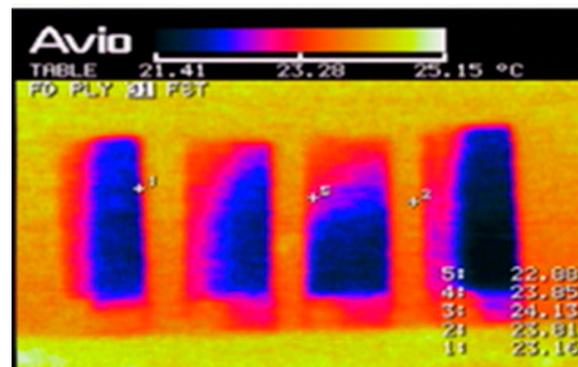
(the one on the left of the thermal image (point 1) and the other at the right side (point 2)). The air temperature was $\sim 20^\circ\text{C}$ and relative humidity $\sim 50\%$.

Figure 10. IRT investigation of a salt solution capillary rise test in brick-plaster-coating systems.

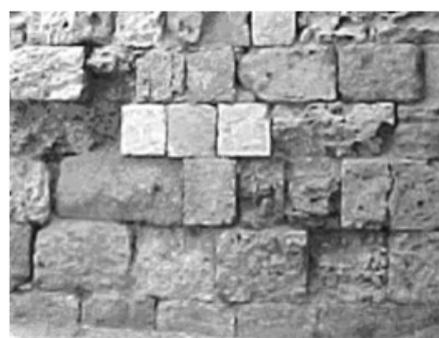
Moreover, in the following images we show the use of this technique on the masonry of the medieval complex of the island of Rhodes. This masonry is located at the moat and rising damp is one of the main causes of decay. A west-orientated masonry (Figures 11 and 12) comprised of consistently sized untreated stones was investigated. The back face of the masonry is constantly fed by salt solution due to the presence of the sea. The salt action is verified by the presence of efflorescence, while the extended recession of the surface is proved by the accumulation of disintegrated stone granules on the basis of the masonry.

Figure 11. Photograph the investigated masonry in the Medieval Fortifications of Rhodes.

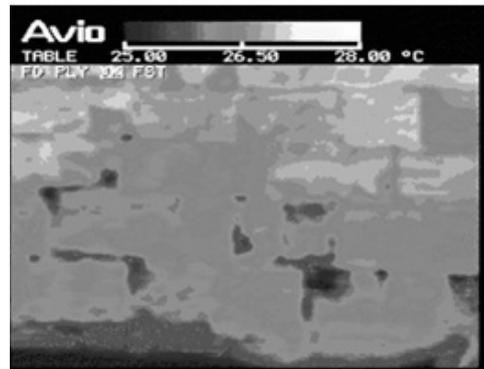
Figure 12. Thermograph of investigated masonry.

The obtained thermal image presents temperature variations on the surface of the investigated masonry, indicating the presence of humidity loads within the porous stones. The ambient conditions during the investigation were air temperature ~ 22 °C and air relative humidity of 60%. The presence of moisture (lower temperatures on the infrared image) that arises as a result of the capillary movement of water has caused deterioration of the porous stone masonry. This is mainly because, during water movement inside the pores, there is also a movement of salts (from the presence of sea). Since such porous stones have high porosity values and large amounts of large pores that trigger capillary action, water movement inside their porous systems occurs [22,24].

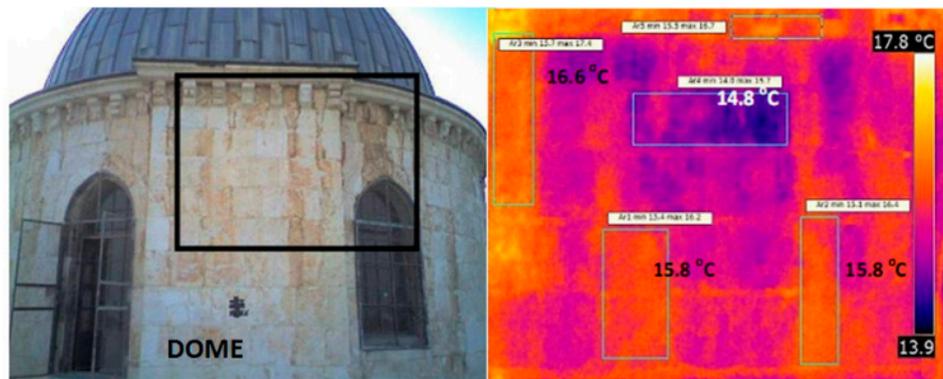
Figure 13 presents a characteristic area of investigation at the Dome of the Greek Catholic, as well as the corresponding thermal image. In the thermal image, temperature differences are investigated depending on the surface type of decay (stone mass loss, crusts, etc.). In general, the restoration mortars present higher temperatures [25]. The thermogram was taken on 27 January 2011, at 17:00, with air temperature ~ 13 °C and air relative humidity $\sim 60\%$.

Figure 13. Dome of Katholiko in Holy Selphuchre Temple, area of investigation and corresponded thermogram.

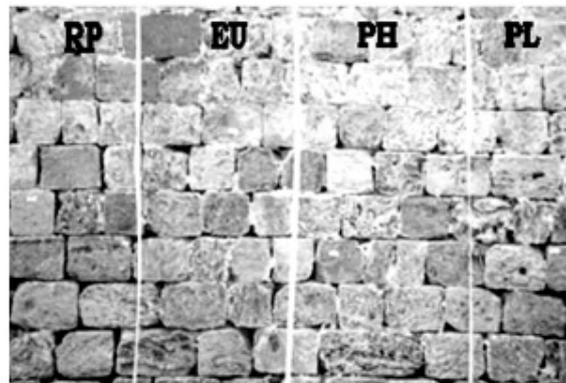
Figure 14. Consolidated masonry under investigation.

Thermal images were acquired 3, 15, 28 and 33 months after the consolidation treatment. Below a representative result from a thermographic survey from the investigated masonry (Figure 14) 3 months after the consolidation treatment (Figure 15) is presented.

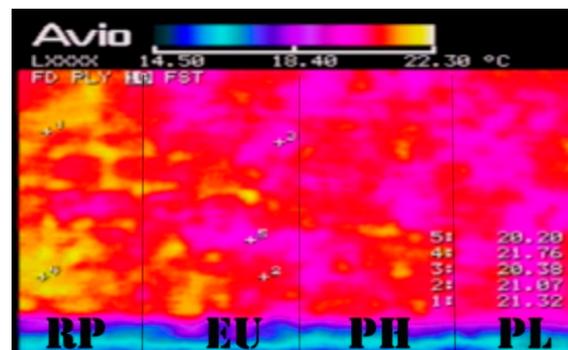
Figure 15. Thermogram of investigated-consolidated masonry.

Different temperatures at the same height of the stonework were noticed, due to the use of the various consolidants (air temperature 13 °C, relative humidity ~65%). Although the images were acquired at different times/seasons, it can be said that treatments with RP and EU present relatively higher temperatures when compared to the treatments with PH and PL. This is probably due to the fact that the first two treatments amend the respiration of the stones.

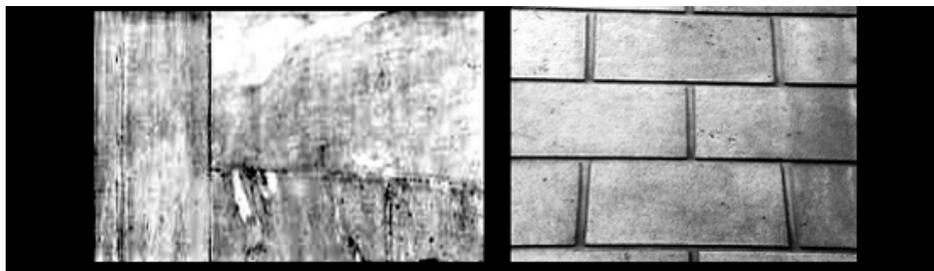
Figure 16. White Pentelic marble surface (left) and Kapandriti's stone surface (right) at the historic Bank of Greece building in Athens.

In this case, IRT (AVIO TVS-2000 Mk II LW, 8–12 μm), was used with the intention of investigating the efficiency of specific cleaning treatments on certain architectural surfaces of different materials and decay patterns at the historic Bank of Greece building in Athens. The cleaning methods applied on the architectural surfaces were either distilled water with controlled pressure or sepiolite poultices. In Figure 16, we present: a white Pentelic marble surface (left), a metamorphic limestone consisting almost exclusively of calcite grains and quarried from mountain Penteli in Athens and the investigated porous stone surface (Kapandriti's stone), consisting mainly of calcite minerals and quarried from the Kapandriti area in Attica (right).

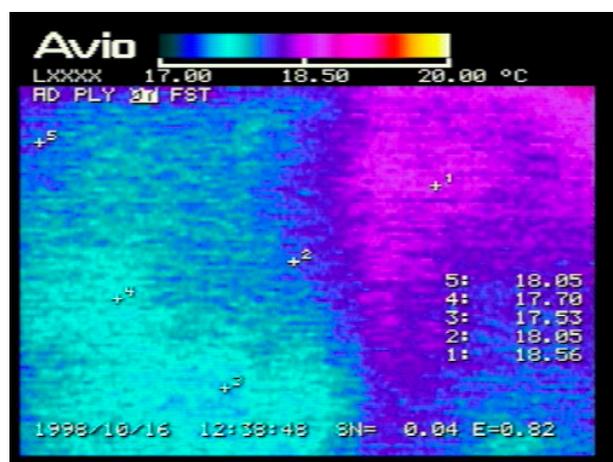
Figure 17. Thermal image of White Pentelic marble surface.

From the acquired thermograms (Figures 17 and 18), different temperatures can be observed on the surfaces according to the applied cleaning method. The air temperature was about 16 °C and air relative humidity was 55%. Sepiolite residues were traced on the cleaned architectural surfaces by poultices (left side of thermograms), leading to a withholding of moisture and therefore lower temperatures on the thermograms compared to the cleaned areas on the right (i.e., distilled water with controlled pressure). A thorough water rinse should take place whenever sepiolite poultices are applied for cleaning, while the use of Japanese paper between the poultice and the material to be cleaned is also recommended. Furthermore, the sepiolite poultices should be covered with polyethylene film so as to prevent swift water vaporization when at high temperature and low humidity conditions that leads to the hardening of the sepiolite on the stone.

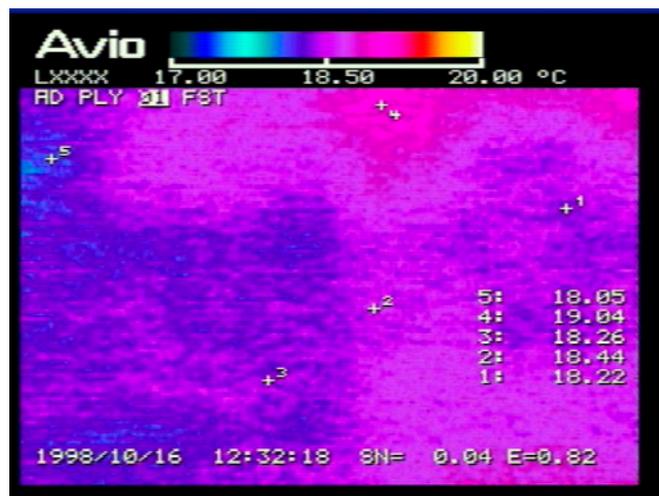
Figure 18. Thermal image of Kapandriti's stone surface.

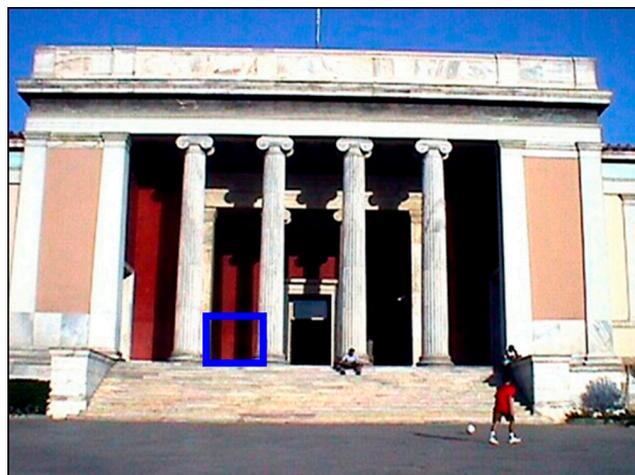
Figure 19. Façade of the National Archaeological Museum of Athens: The blue box indicates the plastered area of propylaem, investigated by IRT.

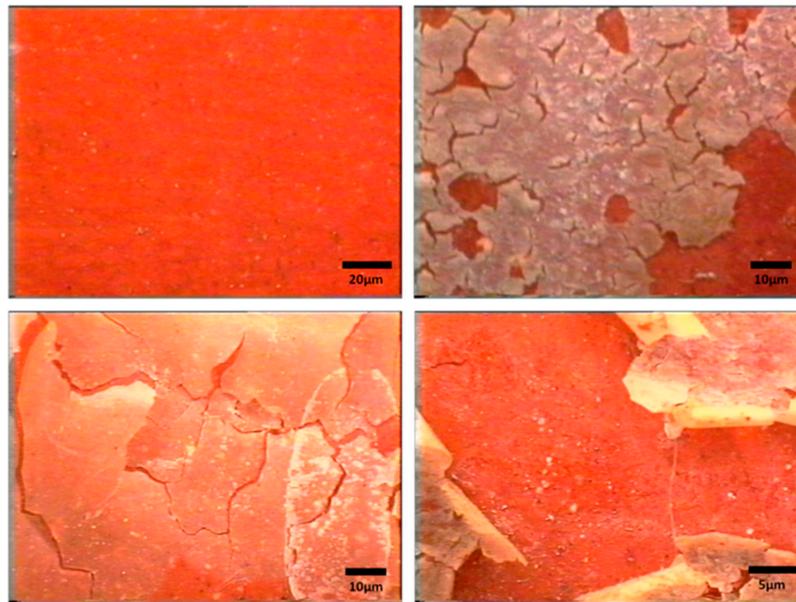
The plaster under investigation was of marmorino type (lime binder with fine grained calcite aggregates), and its purple colouring was attributed to the natural earth pigment of Fe_2O_3 [30]. However, major discolorations were observed all over the purple plastered architectural surfaces of the NAM propylaem and galleries because of the poor preservation state of a coating applied during previous protection interventions. Digital microscopy was applied on the plastered surfaces under investigation, demonstrating that, at some areas of the plastered surfaces, the protective coating was firmly attached to the substrate (Figure 20, top row, left), while at other areas, the coating was friable, loosely attached to the substrate, and presented a whitish hue (Figure 20, top row, right). Furthermore, in many cases, the protective coating was fractured and detached from the substrate, presenting a yellow hue (Figure 20, low row, right and left).

Figure 20. Digital microscopy images displaying the different preservation states of the protective coating applied on the plastered surfaces.

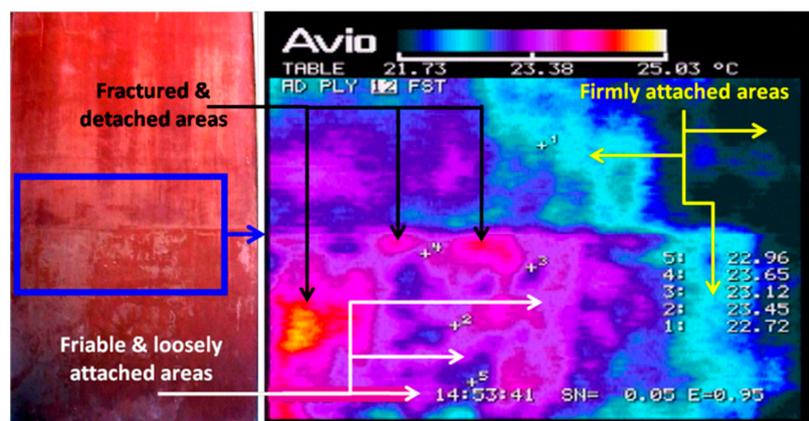
IRT investigation (AVIO TVS-2000 Mk II LW, 8–12 µm) took place when no direct sunlight was affecting the plastered architectural surfaces (Figure 21, environmental conditions: T = 22.5 °C, RH = 53%). It was shown that the areas of fractured, detached, friable and loose coating presented higher temperatures (from 24.2 °C to 25 °C) compared with areas of firmly attached coating (temperature readings from 21.73 °C to 22.53 °C). In particular, the areas where the protective coating is fractured and detached from the plaster are depicted by yellow and red colours, while the areas of friable and loosely attached coating are rendered by purple colours. The areas displayed by blue and black colours correspond to the coating firmly attached to the plaster.

Figure 21. Plastered area under investigation and corresponding IRT image.

This non-uniform temperature distribution is attributed to moisture withholding because of the protective coating application (a material of organic composition) that constrained the substrate transpiration, which affected its vapour permeability. Therefore, in addition to the inspected discolorations, the applied protective coating presented physicochemical incompatibility to the substrate. During the planning phase of the conservation interventions on the NAM’s architectural surfaces, the decision was made to remove this coating.

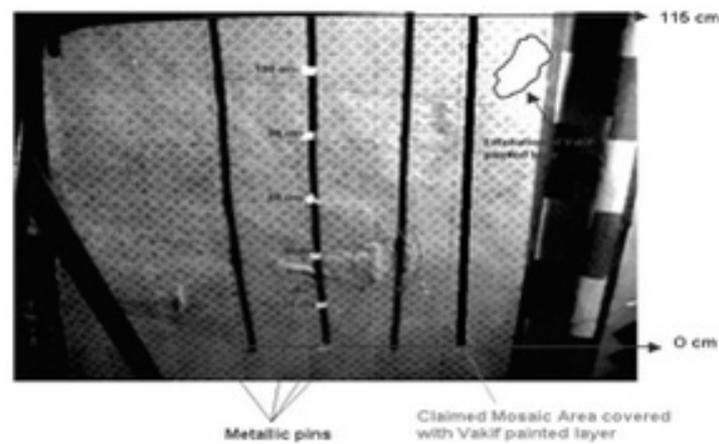
Figure 22. Photograph of investigated surface in the Hagia Sophia dome.

In the first case, IRT (AVIO TVS-2000 Mk II LW, 8–12 μm) was used along with other non-destructive techniques in an attempt to investigate the plastered surfaces of dome mosaics. Interventions in the past have triggered aesthetic problems leading in some cases to severe damage of the mosaics. Such an example is the intervention that occurred in the early 1900s, under the General Directorate of Pious Foundations, mostly known as the “Vakif intervention”. The plaster of this intervention was covered with an opaque yellow pigment in a glue medium. A pattern of stencil ornaments was applied on this yellow ground [33]. In this work, a plastered mosaic surface (characteristic Vakif intervention surface) in the Hagia Sophia dome was investigated. The surface was situated between the 19th and the 20th rib at the northwest part of the dome, 16 m from the centre of the dome. Figure 22 shows the examined surface whilst a thermal image obtained from the investigation of this surface is shown in Figure 23, in order to reveal the mosaic tesserae beneath the plastered surfaces. Due to the different thermal diffusion that each layer renders, IRT was able to detect the different sub-surfaces on the plastered mosaics by presenting the temperature variations on the surfaces. This was accomplished after employing the active thermographic approach, using an external optical heat source in order to uniformly heat the inspected panels.

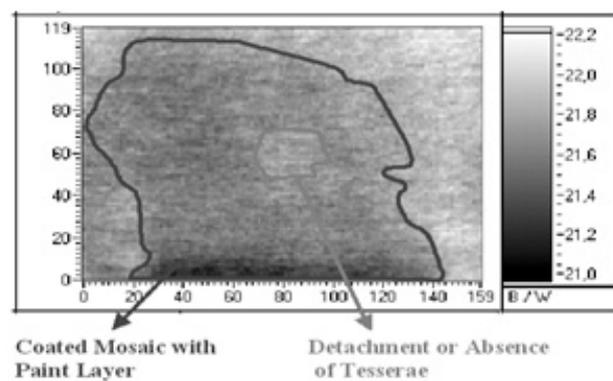
Figure 23. Thermal image of the investigated plastered mosaic surface.

The surface was heated with optical lamps (1000 watts power output from a distance of 50 cm), and the presented thermal image was obtained during the cooling down process. The image illustrates

the existence of the coated mosaic, as well as the detached area within it. Darker grey areas, i.e., lower temperature values, represent the mosaic. The detached areas, behaving similar to a sub-surface defect, hold remarkably higher temperature values due to the different thermal diffusion rate (thermal contrast). The higher temperature of the detached area was between 0.8 and 1 °C.

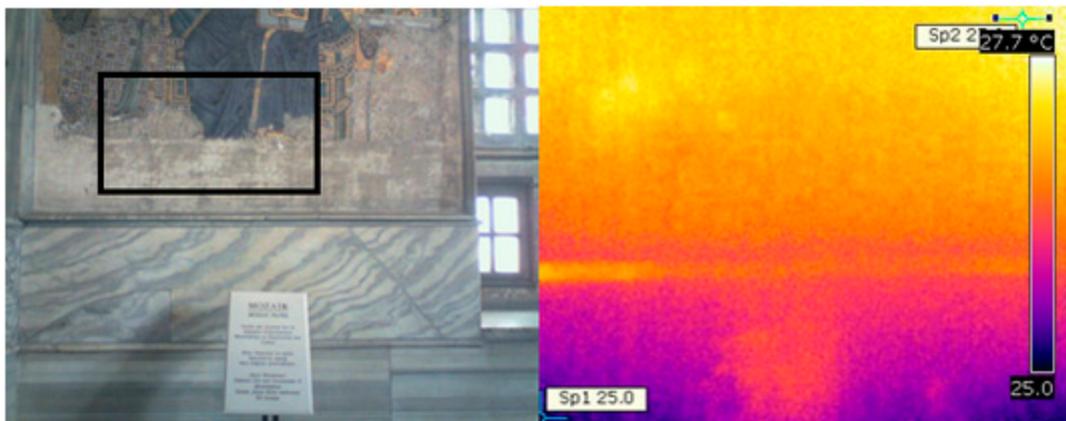
In Figure 24, we present our investigation of an area of the mosaic of Constantine IX Monomachos and Augusta Zoe. This mosaic was rediscovered by the Byzantine Institute in 1934. The lower part of the mosaic is missing. In this case, IRT was applied in order to diagnose the preservation state of the mosaic. This mosaic is located on the interior of an east external masonry, and a past cement intervention is present at its lower part. With the aid of IRT, we investigated areas with different temperatures at the bedding cement mortar, but also at the existing tesserae. These temperature differences can be attributed to the action of the main deterioration factors, such as the presence of salts and moisture. The air temperature was 23 °C and the relative humidity was 70%. In the following microscopical image (×30) (Figure 25), it can be observed the areas with grey tesserae presented extended surface spalling and salt efflorescences.

Figure 24. Thermal image of the mosaic surface in the investigated galleries.

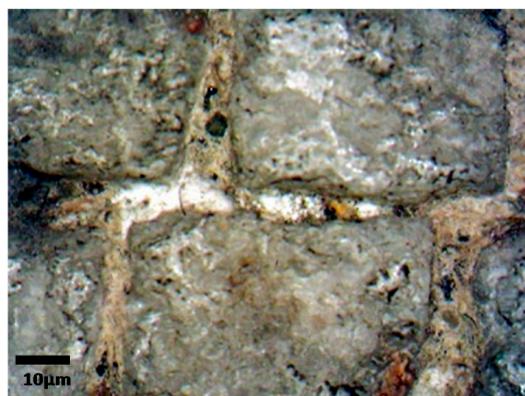
Figure 25. Microscopic image of the mosaic surface in the investigated galleries.

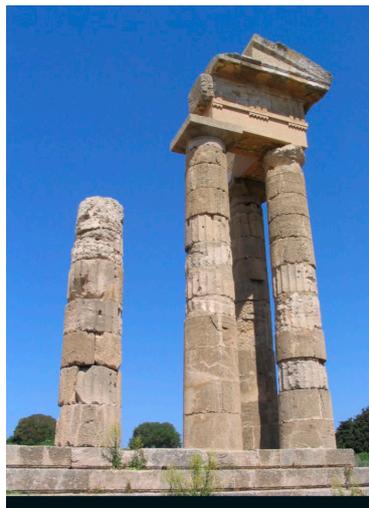
Figure 26. The Temple of Pythian Apollo in Rhodes before the scaffolding (2001).

The Temple of Pythian Apollo of Rhodes is located in the southern area of the Acropolis of the island and dates from the 3rd century BC. It is a peripteral Doric order temple, with dimensions of 20.05 m in width and 37.37 m in length, which consists of 6 columns on the small side and 11 on the long side [34]. The temple is orientated from east to west and is entrenched in an artificially shaped rock at its centre [35]. During the first Italian excavations (1912–1936), pieces from the ruins of the temple were revealed. The complete anastylosis of four columns and part of the entablature on the eastern corner of the temple began in 1938 (Figure 26), although the experts, headed by the archaeologist Paolini [35], were not sure about the original architectural morphology of the temple. The authentic stone material that was found (a fossiliferous biocalcarene stone) was limited. Thus, the restoration works were performed using either an artificial stone made of concrete, or biocalcarene restoration stones. Concrete and cement products were also used in order to fill the drums (Figure 27). The stone core of the shafts was removed, and reinforced concrete was injected into it. Moreover, cement mortars, metal joints and lattices have been used for the mechanical support and stabilization of the stones. In recent years, scaffolding was put in place by the Greek archaeological service (Figure 28).

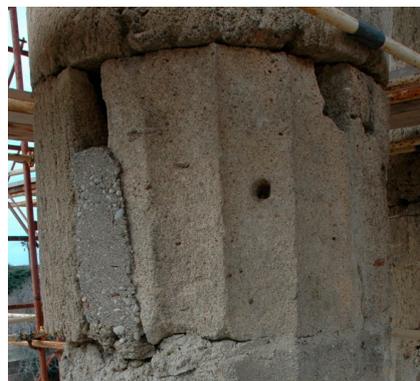
Figure 27. Concrete and cement products were used to fill the drums.

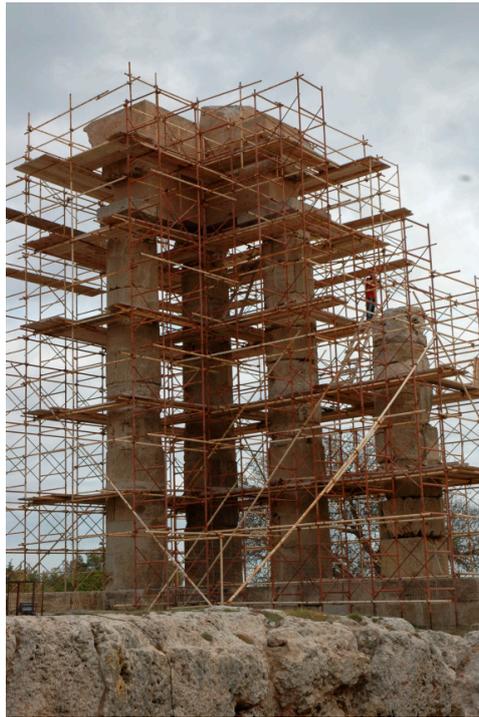
Figure 28. The Temple of Pythian Apollo of Rhodes Today (2017).

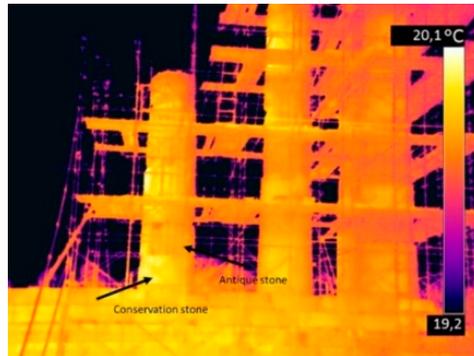
More specifically, thermal incompatibility of the materials was noted in all the thermographs because the rehabilitation materials presented higher temperatures than the antique ones (Figure 29). The cracks, the cellulosic material and the loss of materials (Figure 30) are noted in the thermographic images as having lower temperatures. The edges of the shafts are noted in the thermographic images as having higher temperatures (Figure 31). This anisotropic thermal distribution (Figure 32) may cause a non-uniform mechanical stress distribution.

Figure 29. Thermal incompatibility between the antique and restoration materials.

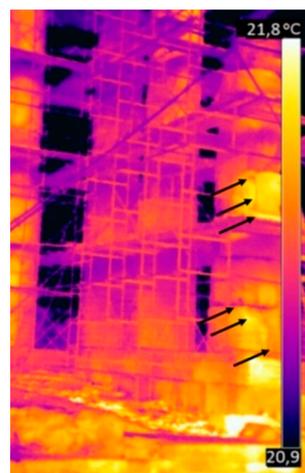
Figure 30. Cracks, cellulosic material and loss of materials are noted in the thermographic images as having lower temperatures.

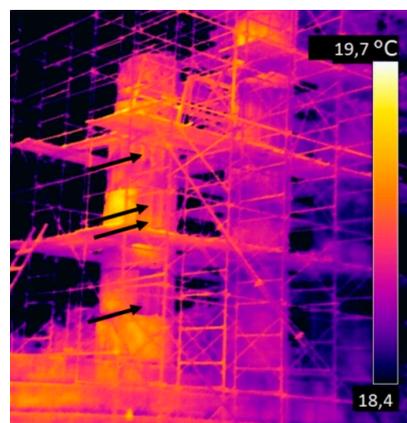
Figure 31. The edges of the shafts are noted in the thermographic images as having higher temperature.

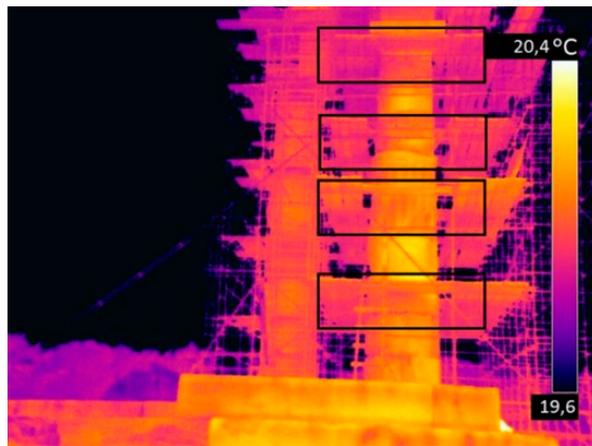
Figure 32. Anisotropic thermal distribution.

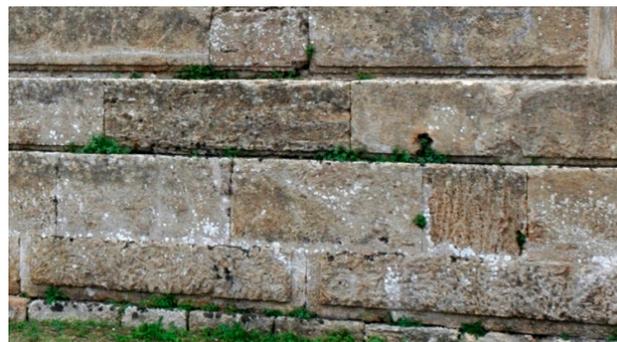
Moreover, the evaluation of the moisture content of the materials was performed. More specifically, the moisture content of the materials was reduced vertically in the column, from bottom to top, due to the possible presence of rising damp. At specific points on the steps of the temple, with rising salt damp phenomena (Figure 33), the development of mosses was macroscopically observed. In the corresponding thermogram (Figure 34,) these areas were inspected with lower temperatures.

Figure 33. Areas with higher moisture content.

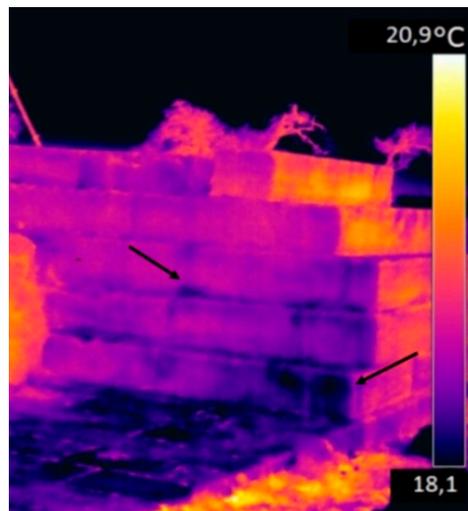
Figure 34. Detection of areas where mosses were macroscopically observed.

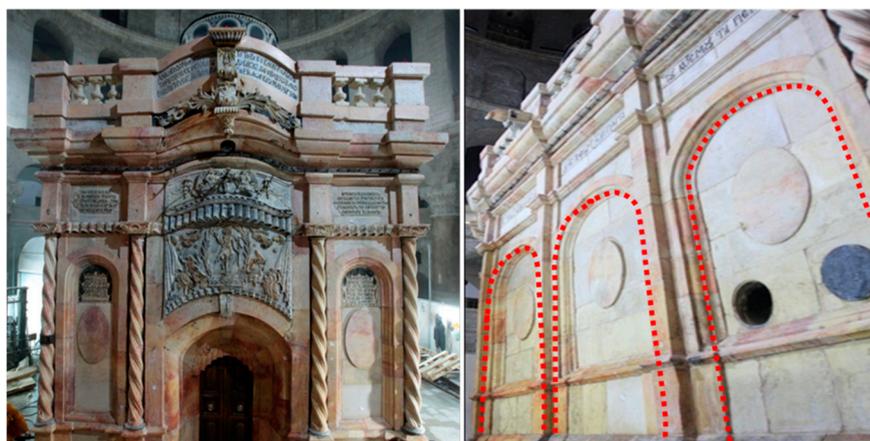
Figure 35. East façade (entrance) of the Holy Aedicule (**left**); façade areas where the stones were removed and then reassembled (**right**).

IRT was used for monitoring the works' progress throughout the rehabilitation phases of the Holy Aedicule of the Holy Sepulchre in Jerusalem (Figure 35) in the recently completed rehabilitation project, undertaken by the NTUA Interdisciplinary Team for the Protection of Monuments [39]. IRT application, undertaken in real time during the construction works, enabled (a) the evaluation of the preservation state of several historical building elements that could not be examined at the diagnosis phase, as well as (b) the assessment of the application of several conservation intervention materials [40].

At the beginning of the rehabilitation project, certain areas of the external façade stones (named stone panels and depicted in Figure 35) were disassembled. IRT was employed to study and assess the preservation state of the filling mortar that was found underneath the removed panel stone slabs. The filling mortar layer was found to be highly disintegrated and to have partially collapsed in many panels. IRT investigation of the N2 panel (second panel of the north façade, numbered from the east) indicated intense rising damp from the underground through the capillary rise (Figure 36 under the following environmental conditions: $T = 26\text{ }^{\circ}\text{C}$, $\text{RH} = 60.4\%$, June 2016). Two distinctive temperature zones were detected corresponding to the lower and the upper masonry parts, with the lower masonry part

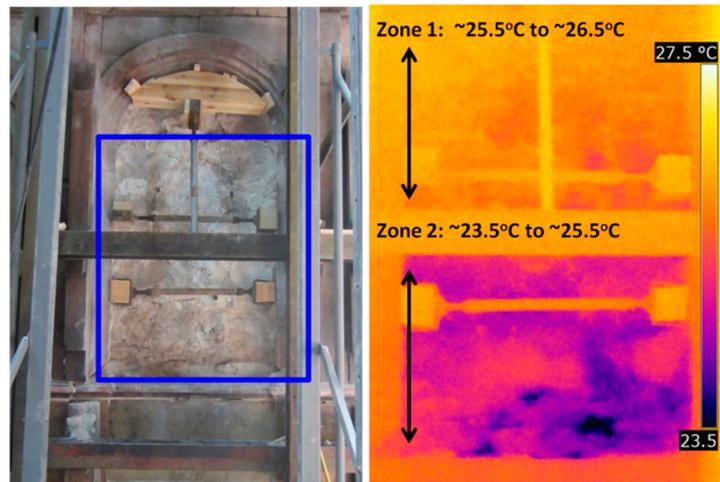
presenting lower temperatures. In particular, the lower masonry part (zone 2) presented temperatures of approximately 23.5 °C to 25.5 °C, whereas the upper masonry part (zone 1) displayed temperatures of approximately 25.5 °C to 26.5 °C. The temperature distribution was not found to be homogenous, which indicates anisotropy regarding the moisture transfer phenomena and thus explains the poor preservation state of the filling mortar layer.

Figure 36. N2 panel with the filling mortar layer and corresponding IRT image.

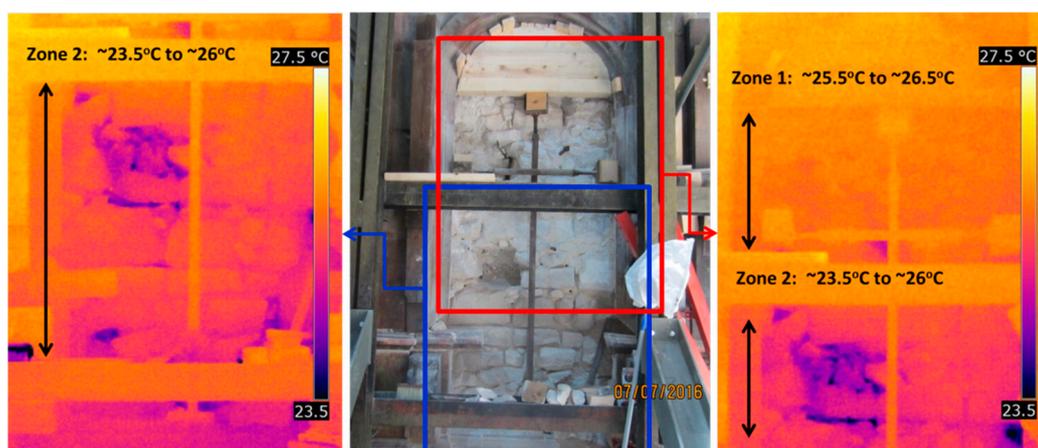
A rubble-type of masonry was revealed, when the disintegrated filling mortar layer was removed. Two distinct temperature zones were still evident in the panel under investigation after the filling mortar removal, as IRT results demonstrated (Figure 37, environmental conditions: $T = 26\text{ °C}$, $RH = 53\%$, July 2016). The lower masonry part (zone 2) presented lower temperatures compared to the upper masonry part (zone 1). The N2 panel masonry withheld moisture at its lower part and thus inhomogeneous temperature distribution among the historic building materials was displayed.

Figure 37. N2 panel masonry after filling mortar removal and respective IRT measurements.

During the following phase of the rehabilitation works, the joints were cleaned and the masonry was repointed in depth. While applying a compatible and performing restoration mortar (a commercial lime-metakaolin based material), grout injection tubes were installed [41]. IRT showed that, after repointing, the temperature distribution width of the area under investigation was approximately 1 °C. Before the application of the restoration mortar, the same N2 panel area presented a temperature distribution width of approximately 2.5 °C (Figures 37 and 38 respectively). Therefore, the temperature

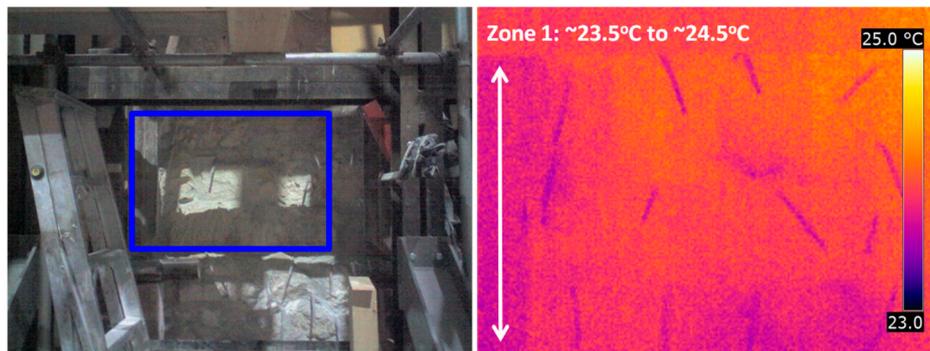
distribution width became tighter compared to the one that this masonry part displayed before the repointing, indicating compatibility among restoration mortar, building stones and historic mortar.

Figure 38. Panel N2 after repointing with installed grout injection tubes and corresponding IRT image.

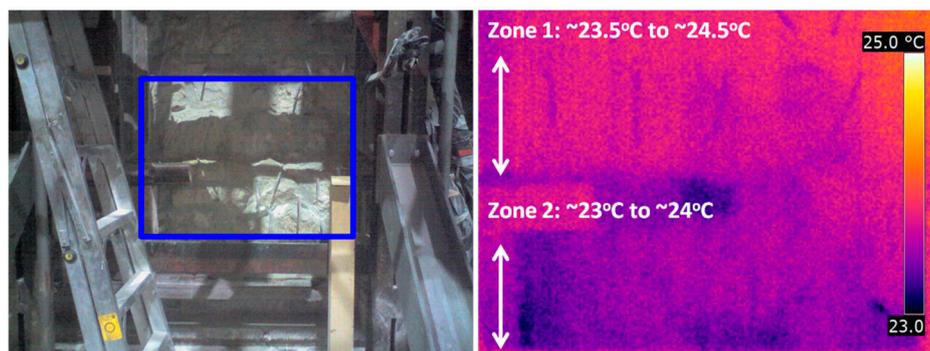
However, the lower masonry part of the N2 panel (zone 2) continued to present lower temperatures (slightly lower though) compared to the masonry part above, showing that capillary rise from the ground continues to affect the restored masonry (Figure 39).

Figure 39. Another area of panel N2 after repointing with installed grout injection tubes and corresponding IRT image.

Summarizing the above results, it is evident that one of the main causes of the deterioration of the masonry is the intense rising damp from underground. Furthermore, IRT demonstrated that rising damp is found in the lower parts of the historical masonry, before and after repointing, indicating that moisture is a major environmental load with a continuous negative impact on the structure. Thus, the IRT investigation of the rising damp was instrumental in the decision-making process during the rehabilitation project, as it led to a survey of the Holy Aedicule's underground area to identify moisture sources and propose appropriate measures. Finally, IRT confirmed the compatibility of the applied restoration mortar with the historical building elements.
