Acoustic Emission Monitoring of Industrial Facilities under Static and Cyclic Loading

Featured Application: Structure health monitoring for refinery equipment, bridges, rotating machines, cranes and draglines.

Abstract: Acoustic emission (AE) testing is traditionally carried out on non-operating objects. Such requirement is associated both with the Kaiser effect, leading to the necessity for exceeding the test load above the working one and with a high level of noise during object operation. However, AE testing could be performed under operating conditions, if the AE data acquisition period is increased and a specialized method is developed, which should take account of the effect of various noise, features of the object loading under operating conditions, the effect of damaging factors and possible destruction mechanisms. This paper investigates the possibility to carry out structural health monitoring (SHM) of hydrotreaters, highway bridges, high-temperature pipelines, gas adsorbers, roller bearings of rotary kilns and draglines on the basis of AE method. Architecture of SHM-system and specific data analysis procedures are proposed.

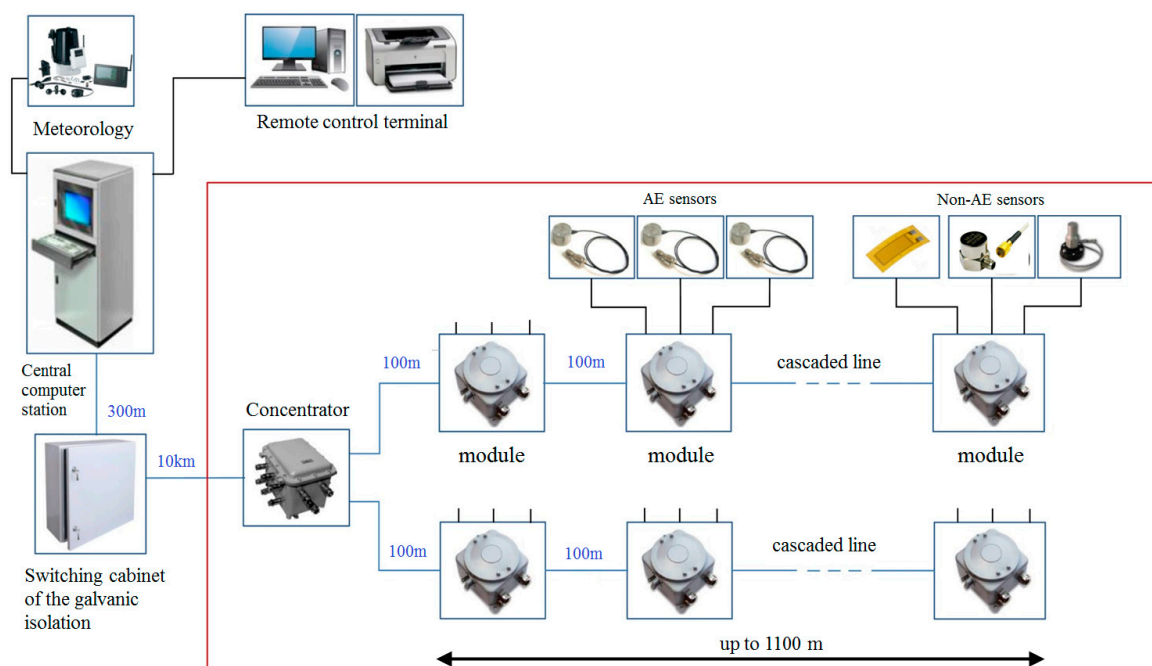
Figure 1. Example of structural health monitoring (SHM)-system structural scheme.

SHM-system is a system designed to assess the diagnostics of hazardous matters in real time without stopping, dismantling and shut down. SHM-system provides information about the status of the monitoring facility in the required quantity and quality for testing. The structure of SHM-system includes the following functional elements: equipment for primary data collection, multifunctional data acquisition and transmission modules, concentrators, galvanic isolation switching cabinet and central computer station (Figure 1).

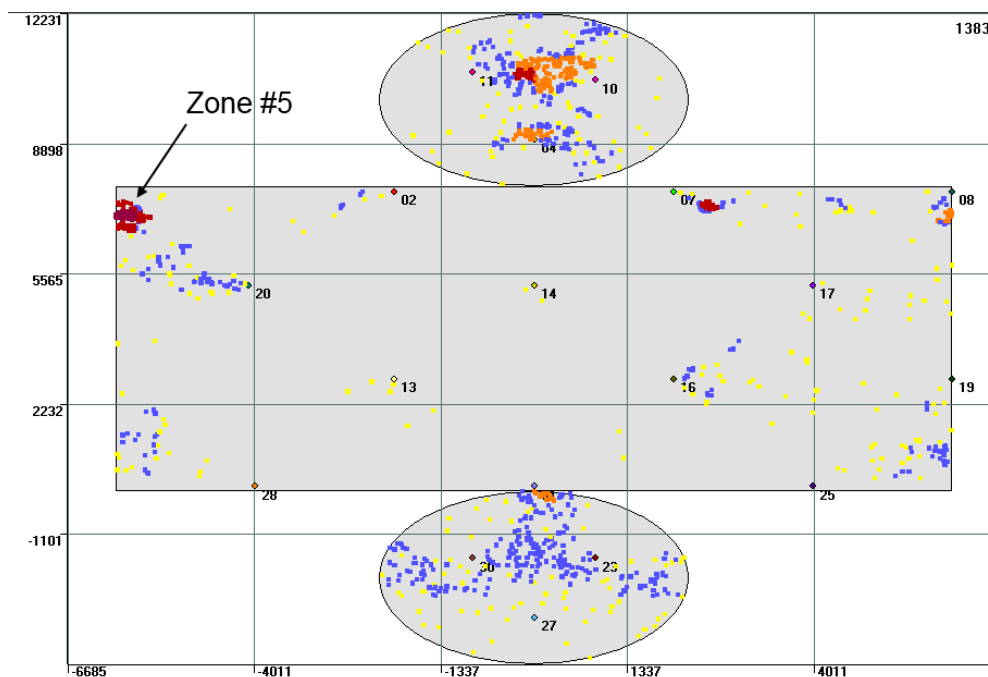
Figure 2. Location map. Color of points mean quantity of location events. Blue points: 1–2 events, yellow: 3–10 events, orange points: 11–25 events, red points: 26–100 events, brown points: more than 100 events.

By May 2007, the state of the hydrotreater had deteriorated. It was found to have 9 active zones, corresponding to AE sources with varying degrees of danger (Figure 2). The activity of some zones increased significantly, which indicated a progressive flaw growth and the possibility of the hydrotreater destruction. The source found in zone #5 and characterized by 370 events, was considered to be critically active.

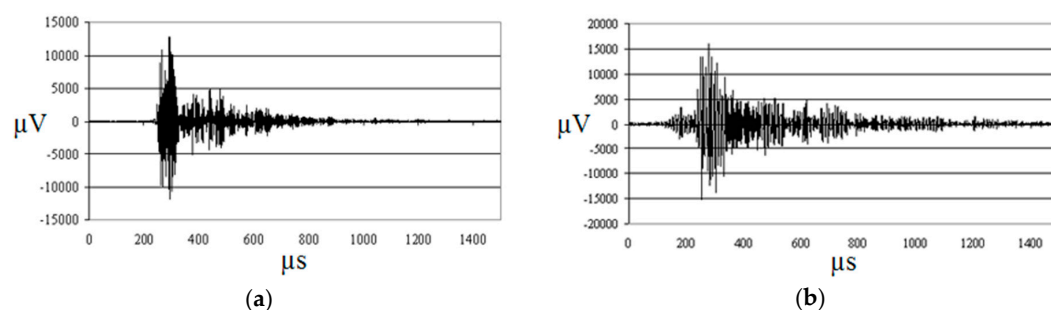
Figure 3. Waveforms corresponding to clusters centers of mass, for acoustic emission (AE) signals from channels: (a) channel #8; (b) channel #17.

The most representative clusters were formed for signals registered by channels № 8 and № 17 (Figure 3, Table 1). These signals had an amplitude of more than 70 dB_{AE} with a high probability they were generated by AE source located in zone #5.

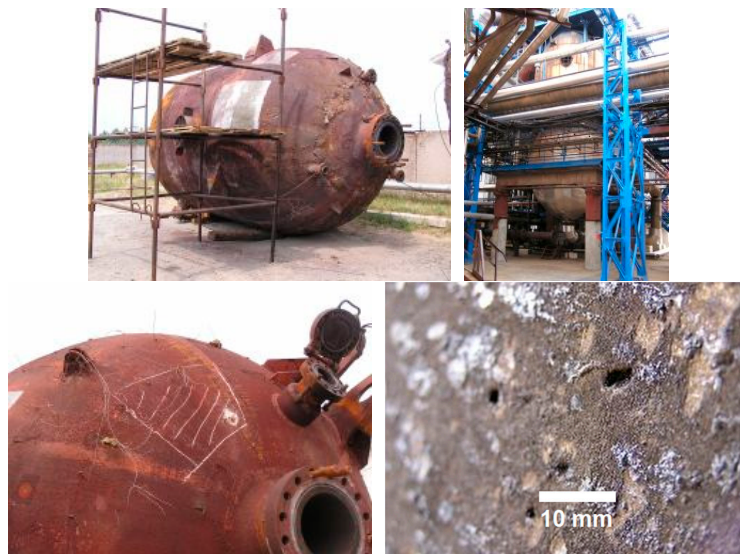
Figure 4. Breach of the cladding layer.

Thus, the results of the cluster analysis confirmed a previously determined degree of danger of AE source located in zone #5. A final decision to stop the hydrotreater was made. The dismantled hydrotreater was investigated by NDT in order to establish the reasons of its transition to the critical state. Internal examination revealed numerous disintegrations of the cladding layer (up to its complete absence in some areas) (Figure 4). Dimensions of damages were up to 5 mm. Ultrasonic testing revealed numerous discontinuities in welds and the base metal shell. The lengths of discontinuities were 100 mm along and 15 mm in depth. In one of the most active zones, discontinuities were detected both in welds and in the heat-affected zone. Certain discontinuities occurred at different depths, from 26 to 80 mm. These damages demonstrated significant degradation with loss of mechanical properties of the metal, which leads to brittle fracture of the structure [11].

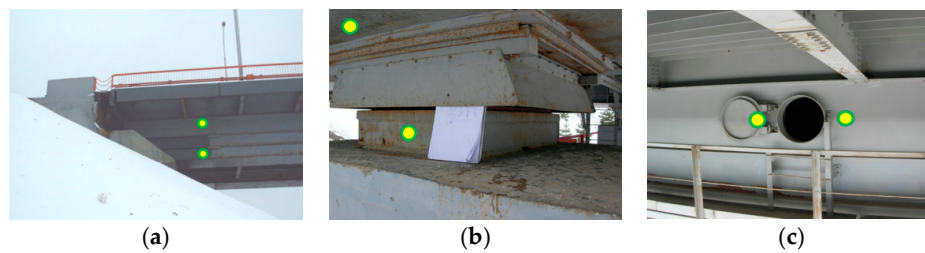
Figure 5. Experiment scheme: (a) Zone I; (b) Zone II; (c) Zone III. AE sensors are marked as yellow-green circles.

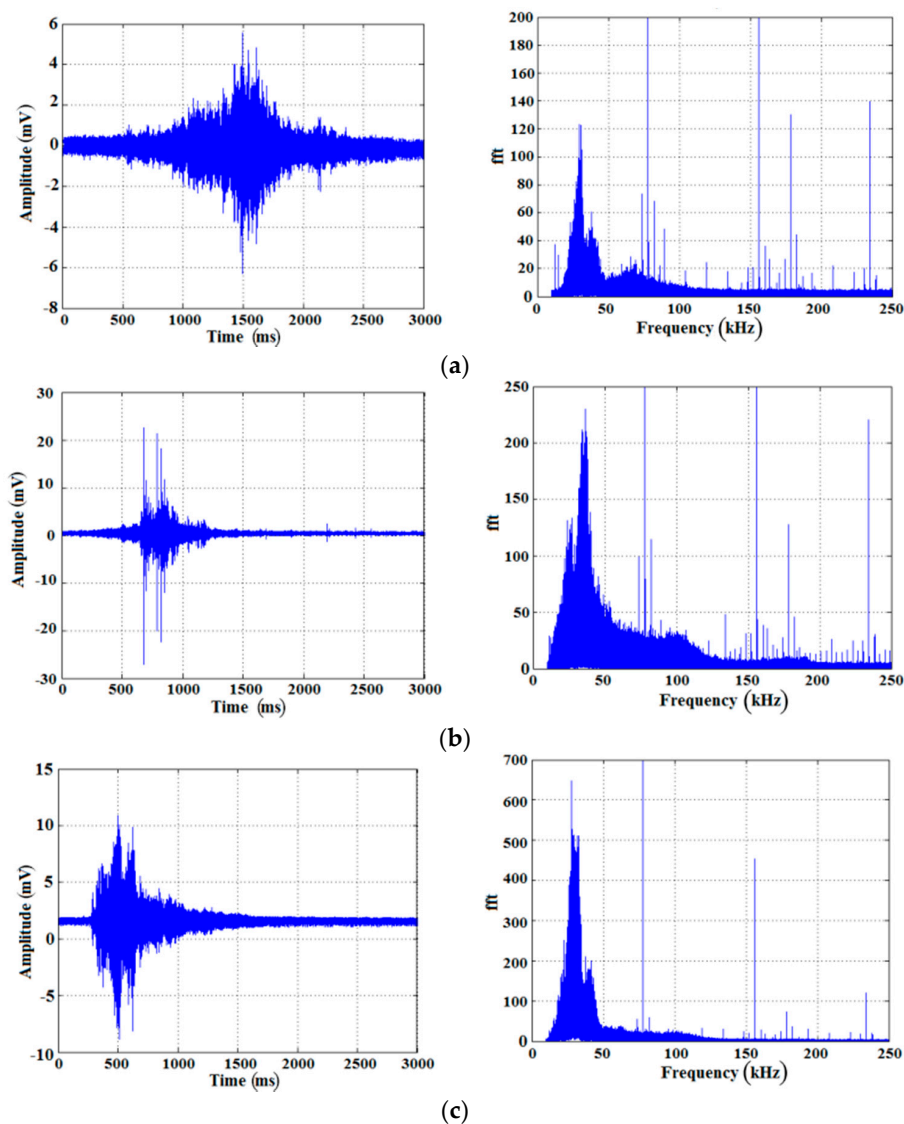
Figure 6. Acoustic emission (AE) signals from passing vehicles: (a) Zone I; (b) Zone II; (c) Zone III.

Vibration of the bridge from passing vehicles was the most common type of noise (Figure 6). Some characteristic features of these signals are a long duration (1–3 s) and relatively high amplitudes of about 56–90 dB_{AE}. The primary reason for the appearance of these signals is the fact that the passage of the cars leads to vibration and friction of poorly fixed structural elements.

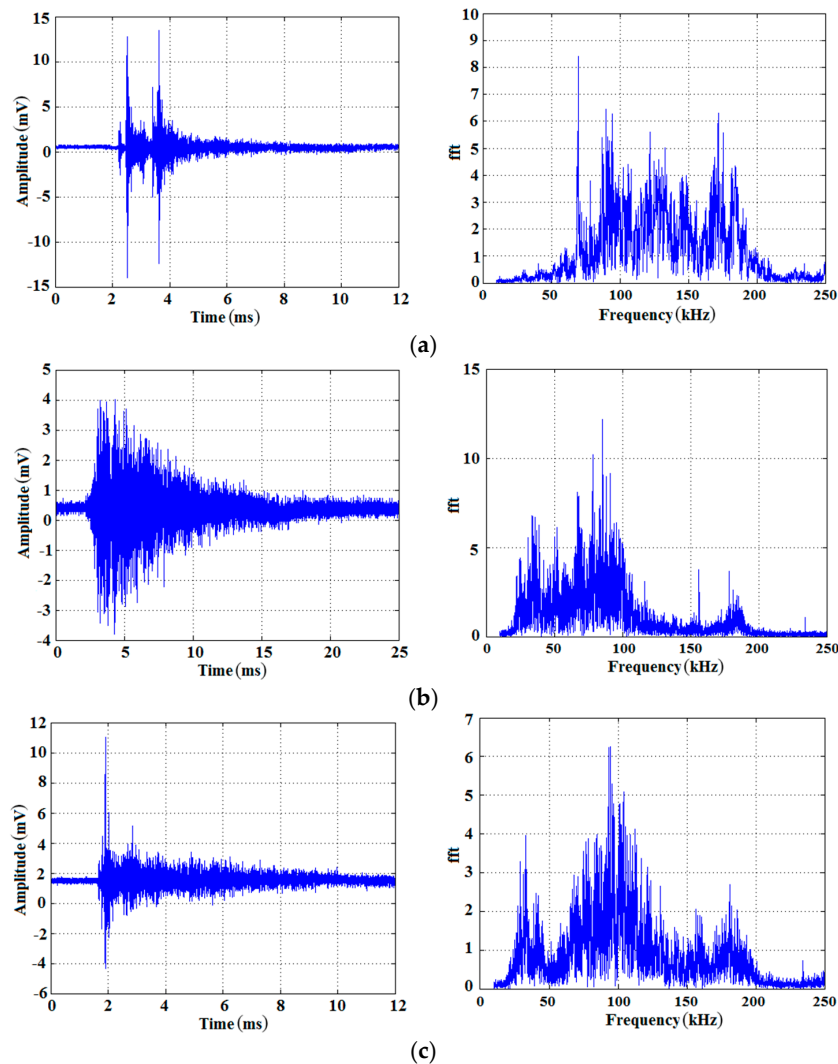
Figure 7. AE signals caused by impacts of structural elements: (a) Zone I; (b) Zone II; (c) Zone III.

Signals caused by impacts of structural elements have amplitudes similar to signals from passing vehicles, of the order of 56–90 dB_{AE} but they have 1–2 times shorter duration, not exceeding 50,000 μ s (Figure 7). The energy of the signals, as a rule, lies in the frequency range up to 200 kHz. The primary cause of these signals is the vibration of weakly fixed structural components of the bridge, as a result of which their collision occurs. An example may be the impact of a ladder or hatch on the bridge girder or the impact of wheel sets on the expansion joint [14].

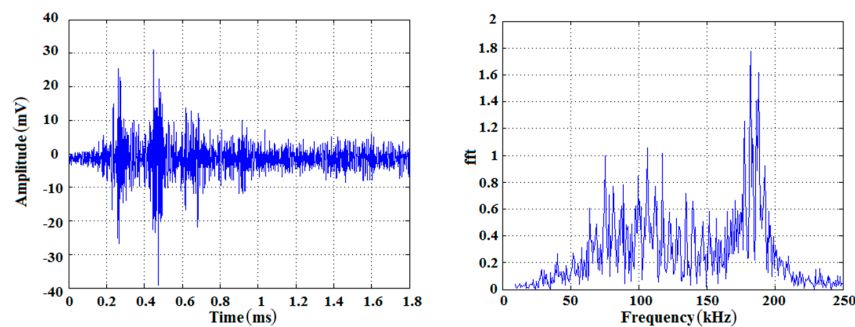
Figure 8. Signals from Hsu-Nielsen source at 1 m distance from AE sensor.

Simulation of AE signals by the Hsu-Nielsen source was carried out at various points of the lateral beam of the bridge structure inside one of the bridge sections. The distance from the sensor to the Hsu-Nielsen source was from 0.15 to 15 m. Totally about 100 pulses were excited (Figure 8).

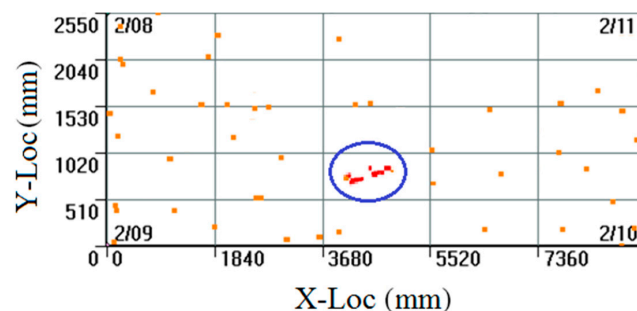
Figure 9. Planar location. Hsu-Nielsen source signals are marked by red, noise is marked by orange. Color of points indicates total number of events in this coordinates. Yellow points: 3–10 events, orange points: 11–25 events, red points: 26–100 events. Blue circle – location cluster of signals from Hsu-Nielsen source.

For detection of signals from the Hsu-Nielsen source, a planar location was constructed (Figure 9). It is revealed that the signals from Hsu-Nielsen source are with certainty located in their actual places and form compact clusters, in contrast to noise. This confirms the possibility of identifying signals from defects based on location data.

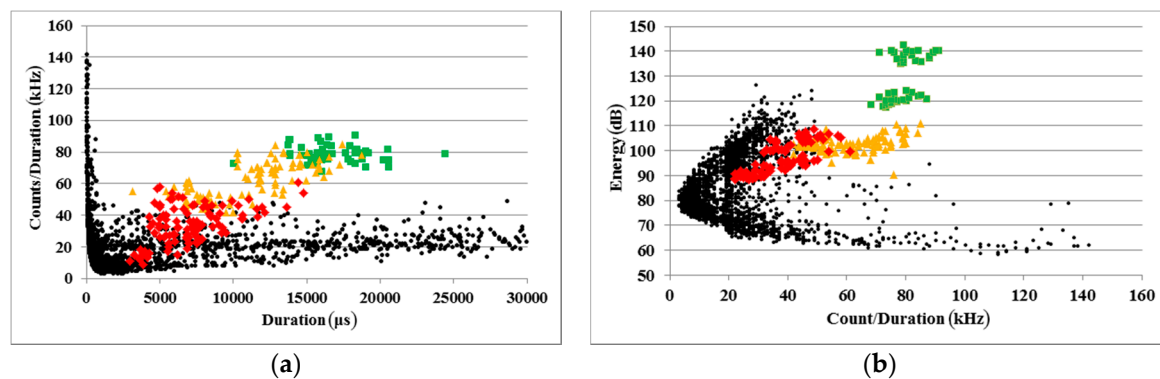
Figure 10. (a) Scatter plot diagram of AE signal energy and duration; (b) scatter plot diagram of amplitude and parameter “counts/duration.” Impulses corresponding to noise are marked black, while impulses from the Hsu-Nielsen source emitted at distances of 0–2 m, 2–7 m and 7–15 m from AE sensors are marked green, yellow and red, respectively.

The difference of parameters is best shown in the two-dimensional plots of characteristics, for example, on the scatter plot diagram “Counts/Duration versus Duration” (Figure 10a) and the scatter plot diagram “Energy versus Counts/Duration” (Figure 10b). As can be seen from the chart, the AE impulses emitted at the distance of 7 m from the sensor have the parameter distribution other than the noise distribution. When the distance increases over 7 m, the differences disappear, the AE impulse parameters become close to those of noise [13].

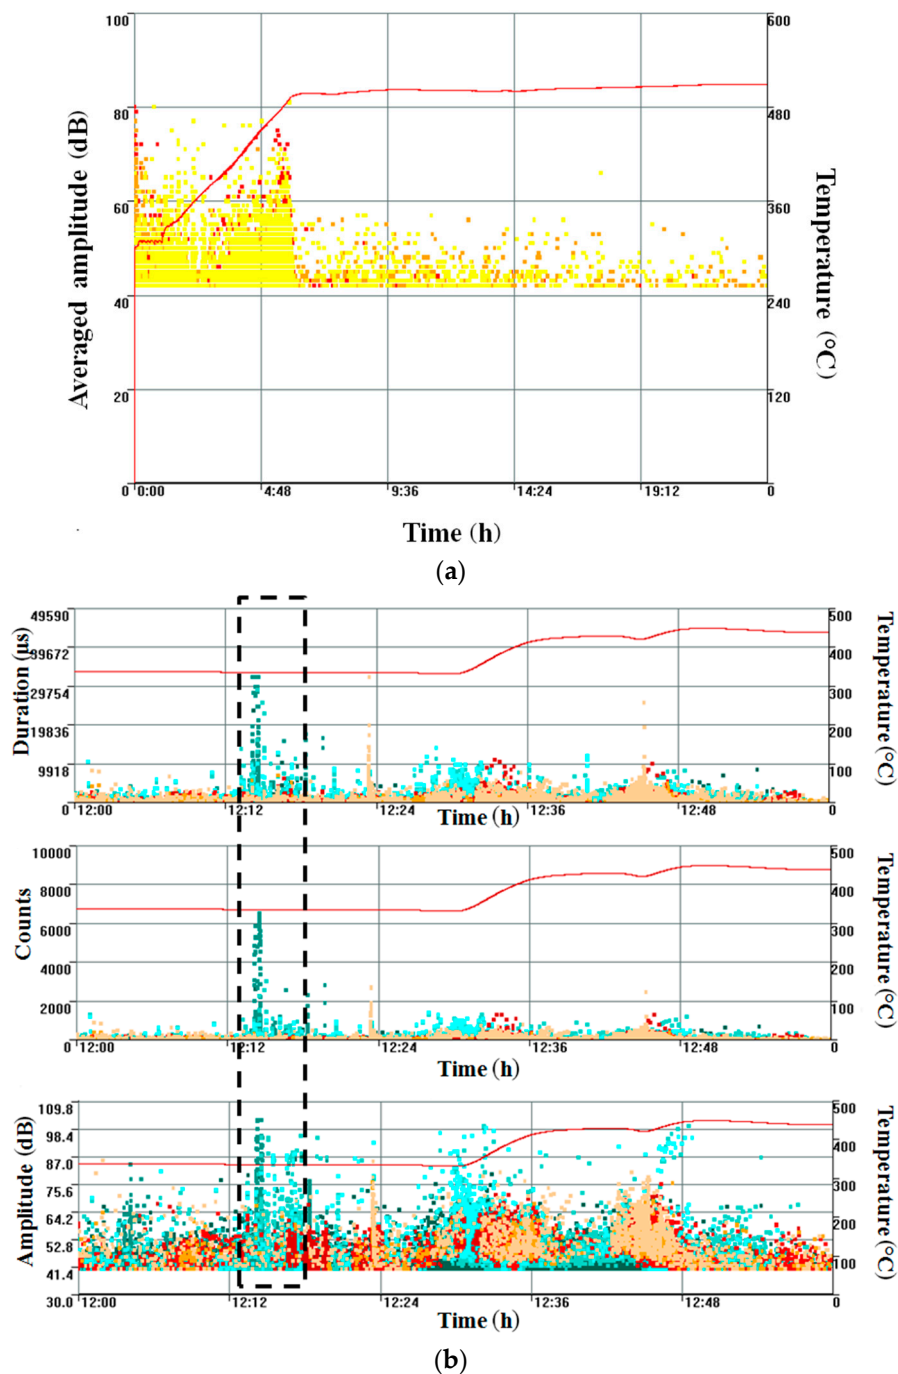
Figure 11. Amplitudes of noise depend on the pipeline temperature (a); the melt leakage (b). Colors of points indicates different channels.

In the course of the work, the melt leakage was observed as a result of the destruction of the flange joint gasket. In this case, the AE system recorded an increase in the duration of the AE signals a few hours before the leak invisible under the layer of thermal insulation began to be observed visually (Figure 11b).

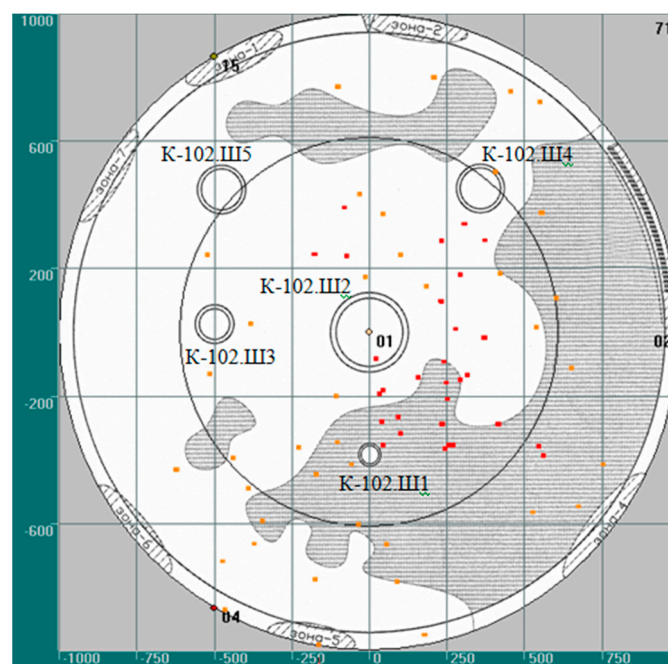
Figure 12. Previously found defects of gas absorber head plate: lamination in the vessel head (gray areas) and locations of the registered AE source (orange). Color of points indicates total number of events in this coordinates. Yellow points: 3–10 events, orange points: 11–25 events, red points: 26–100 events.

Prior to installation of the monitoring system during the overhaul in the spring of 2012, its AE testing was carried out (Figures 12 and 13). AE sources of class I and II were registered, the locations of which were correlated with the place of previously detected defects on the vessel head of the adsorber (Figure 12). This allowed us to assume the possibility of further expansion of the lamination zone during the life extension period of the adsorber.

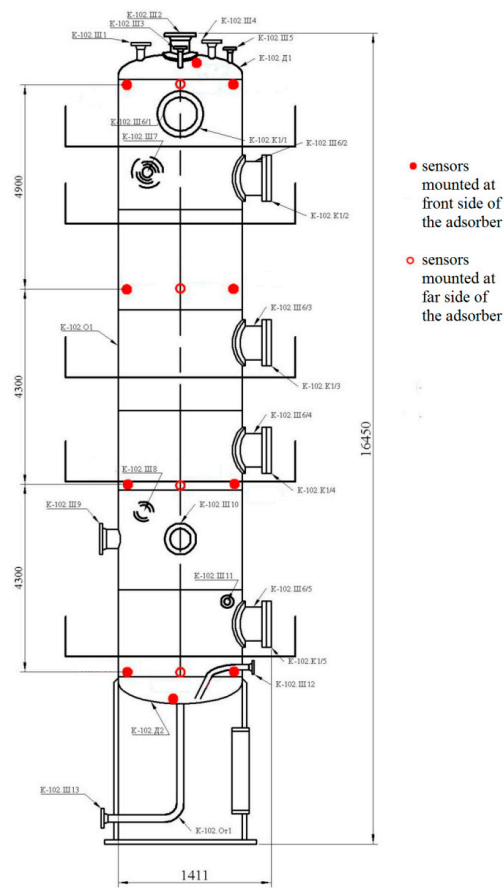
Figure 13. Gas adsorber schematic drawing with places of AE sensors mounting.

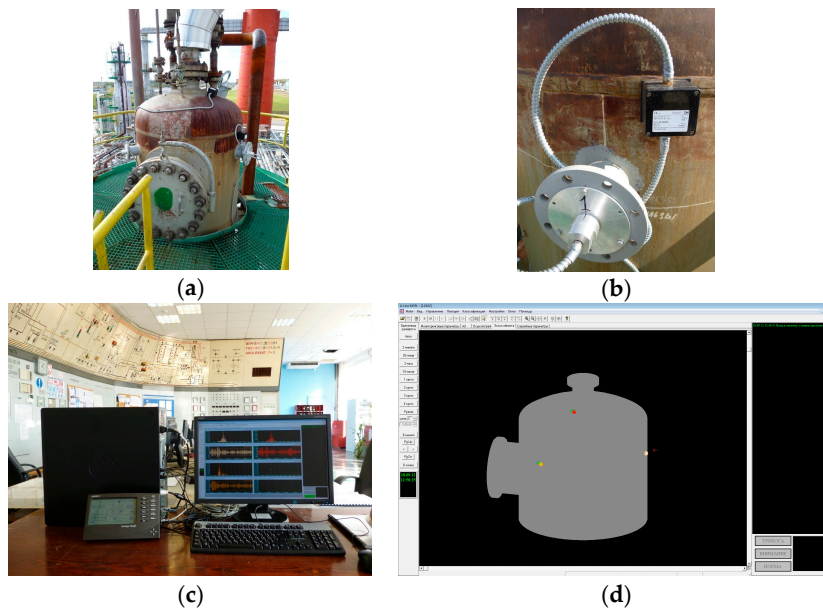
Figure 14. SHM-system for gas adsorber: (a) overall view of the head part; (b) AE sensor mounting place; (c) workplace of operator; (d) dialogue box of the software A-Line Mon. Color of points indicates total number of events in this coordinates. Green points: 1–2 events, yellow points: 3–10 events, orange points: 11–25 events, red points: 26–100

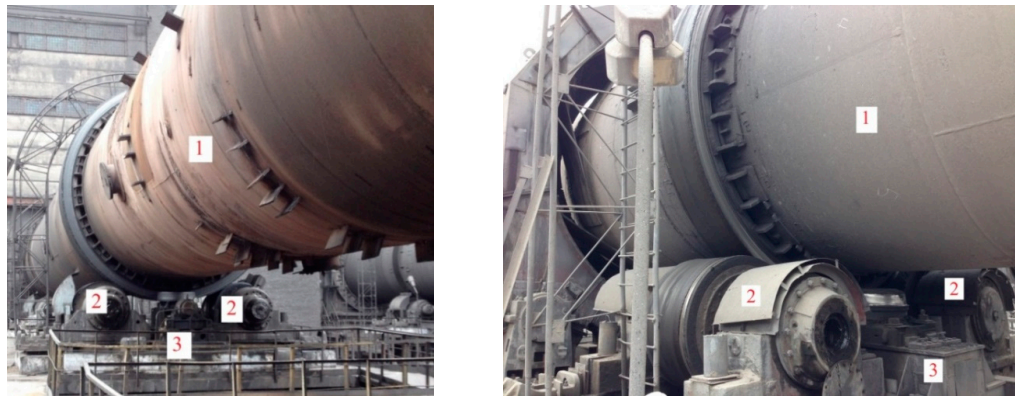
Figure 15. Rotary kiln on paired roller bearings. 1: kiln; 2: roller bearings; 3: support foundation.

The possibility of conducting AE testing of roller bearings of rotary kilns without their decommissioning was investigated (Figure 15). Using AE monitoring for rotating equipment is an alternative solution to vibrodiagnostics [19,20]. In the case of slowly rotating elements, the use of the AE method is more effective for the diagnosis of rolling bearings, rotating shafts, rollers and others [21,22]. Experimental work was carried out at an alumina plant in the sintering and calcination shops and also in the repair shop.

The kiln is a cylinder with a diameter of up to 5 m and a length of up to 185 m, installed with a slope. The kiln is supported by 7–8 pairs of roller bearings. Each pair of roller bearings consists of 2 support blocks, mounted on a common foundation. Each block consists of a shaft pressed onto it by a supporting roller and 3 bearing assemblies mounted in 2 bearing housings (Figure 16). The rotation period of the kiln is 50 s; the rotation period of the support roller is 12.5 s. The lifetime of the monitored supports was from 1 to 13 years.

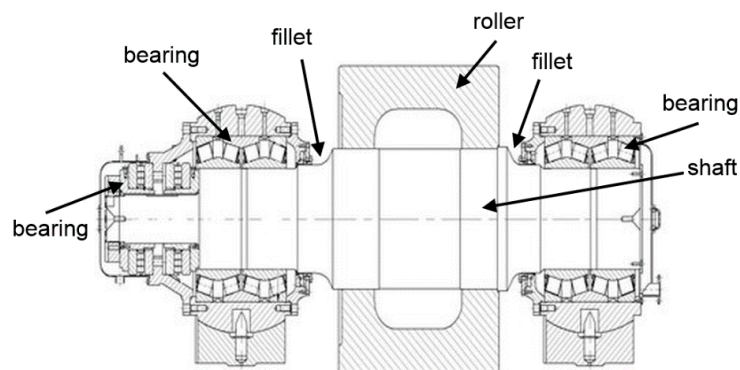
Figure 16. Roller support.

The roller is a part of the support block and is in direct contact with the kiln. Thus, the main defects on it are scoring and metal chipping from rolling contact under load.

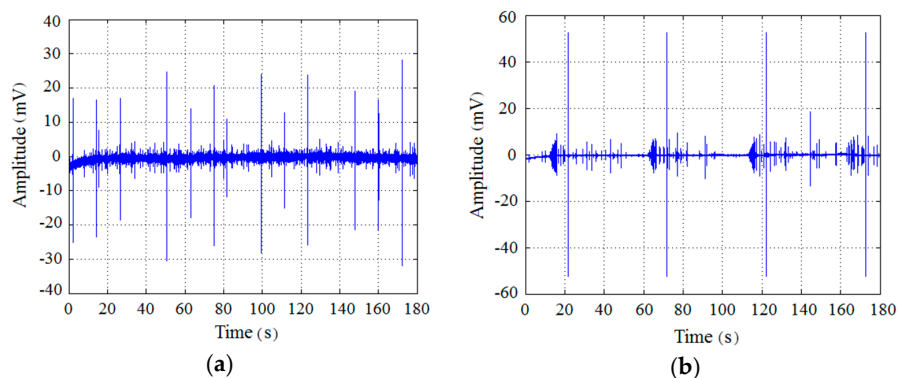
Figure 17. AE signals with periods (a) 12.5 s and (b) 50 s associated with scoring and roughness on the roller surface or a kiln bandage.

In the case of roller bearings of a rotary kiln in the operating mode, the noise level in the audible range is quite high. However, in the range above 30 kHz, due to the point dry contact between the shroud of the kiln and the roller, the acoustic noise, as a rule, was no more than 32 dB_{AE} at the most unfavorable point of the structure: at the feed point of the batch. The only significant external source of acoustic noise is scoring and roughness on the surface of the roller or kiln bandage. When it touches the place of scuffing, an AE signal with amplitude of up to 100 dB_{AE} arises. However, such noise signals can easily be excluded from further analysis, since their registration occurs with a certain period equal to the period of rotation of the roller support, or the kiln (Figure 17).

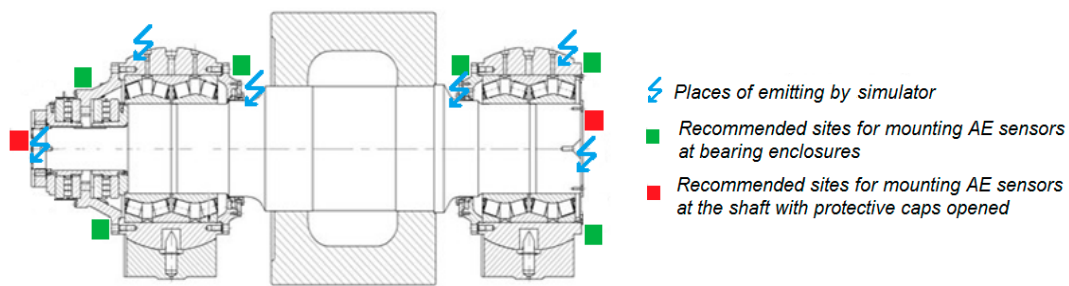
Figure 18. Scheme of the roller bearing with the protective caps removed. The points of emitting by simulator and the recommended positions for the sensors mounting.

In the repair shop, measurements were made to determine attenuation and propagation velocity of the acoustic signal on the decommissioned support block with the end caps removed. To simulate the sources of AE, an electronic simulator was used. The emission was produced on the shaft in the region of the fillet and at the ends of the shaft, as well as on the inner and outer rings of the bearings (Figure 18).

The obtained results revealed that the AE testing should be performed as follows (Figure 18). For full AE testing of all 3 bearings, use the zone location with the accuracy of the element of a specific bearing. For this task, it is required to place the AE sensors at all available access points, namely 3 sensors on each of the 2 bearing housings (Figure 19a). Since the length of the shaft is small (4050 mm), it is enough to provide access to the shaft by removing the covers and to install one sensor at each of 2 ends (Figure 19b) for its full AE testing including linear location. Slow rotation of the sensor at the shaft ends does not cause significant technical difficulties with the duration of the AE testing of about 1 h.

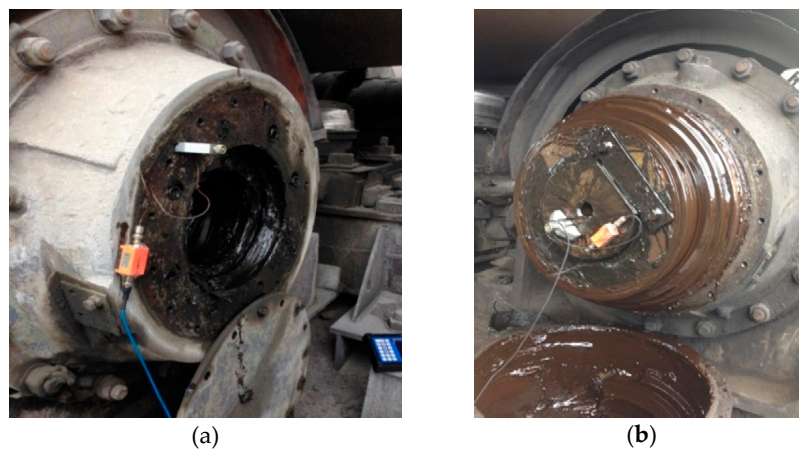
Figure 19. Sensors mounted at bearing housing (a) and at the end of the roller bearing (b) with the protective caps removed.

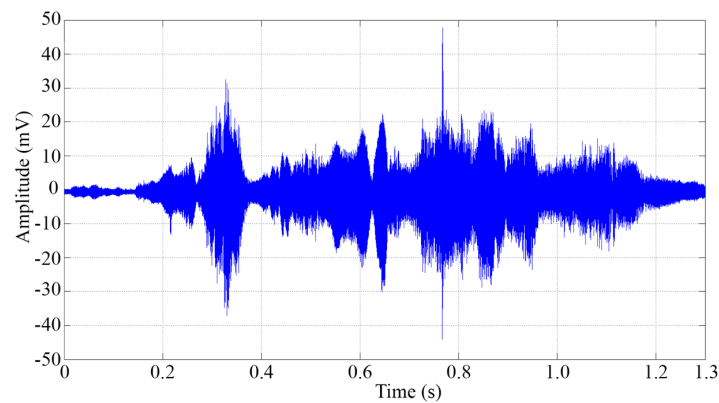
Figure 20. AE signal recorded on the bearing housing. Drying of lubricant.

In one of the bearings, the lubricant dried, which led to intense friction and a rattling in the audible range. AE sensors also recorded signals with an amplitude of about 100 dB_{AE} and a duration of more than 100,000 μ s (Figure 20).

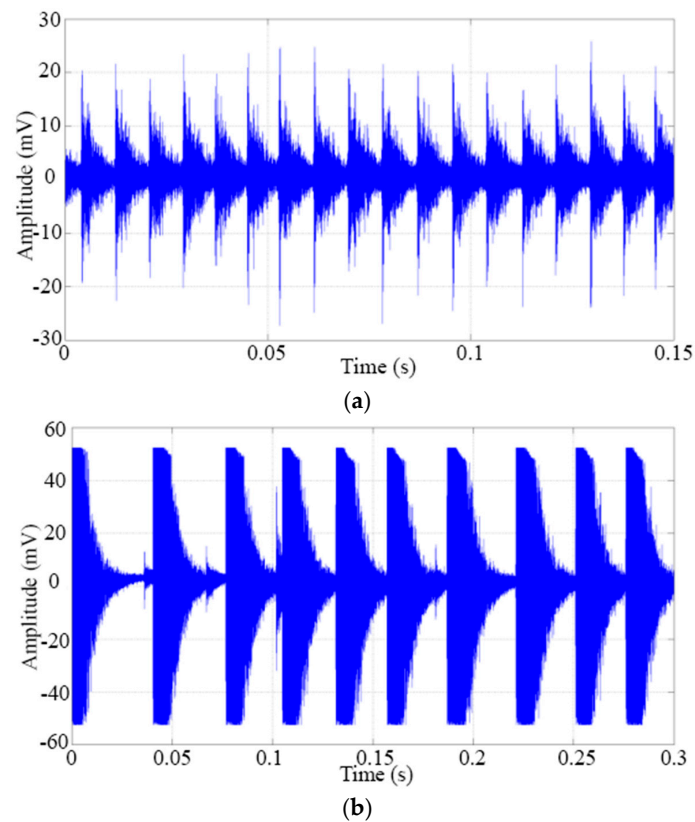
Figure 21. Periodic AE signals registered on the bearing housing. (a) Moderately active source of AE; (b) external ring crack.

A moderately active source of AE was detected on the bearing of one of the supports (Figure 21a), which, due to a low characteristic amplitude level, did not undergo the confirmation procedure. A more powerful periodic source of AE (about 100 dB_{AE}), found on another support (Figure 21b), was a crack in the outer ring of the bearing.

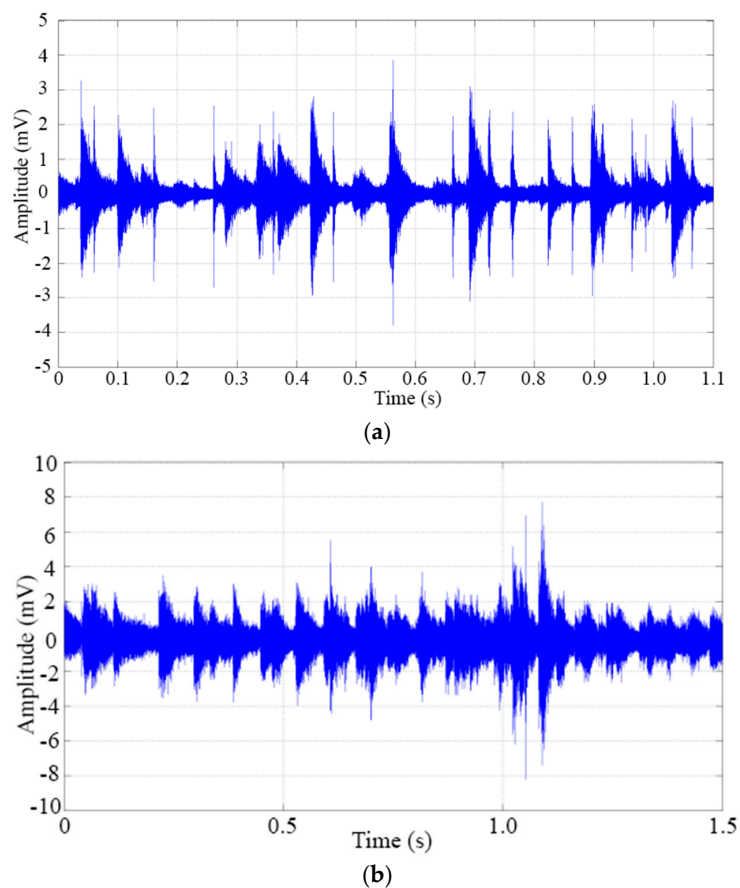
Figure 22. AE signals obtained during the diagnostics of shafts of roller bearings being in operation for (a) 2 and (b) 9 years. The corresponding RMS amplitudes are 0.9 mV and 2.2 mV.

The AE signal, characteristic for the friction process, is a continuous random process characterized by a distribution of pulse amplitudes close to normal, which is not typical for cracks. It is found that higher RMS amplitudes of the acoustic signal are observed in roller bearings with a long service life, which allows us to conclude that the RMS amplitude of the AE signal characterizes the integral degree of wear of the shaft surface [24]. Figure 22 shows the signals obtained in the diagnosis of roller shafts that were in service for 2 and 9 years. The corresponding RMS amplitudes are 0.9 mV and 2.2 mV.

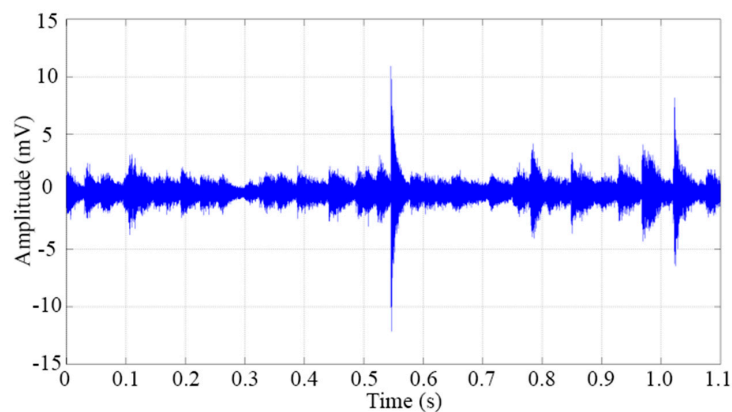
Figure 23. AE signals received during the diagnosis of shafts. The beginning of the destruction of the shaft surface during frictional contact.

The appearance of individual pulses of large amplitude (up to 81 dB_{AE}) against the background of a continuous signal may indicate the beginning of the destruction of the surface of the shaft in the support block during frictional contact (Figure 23).

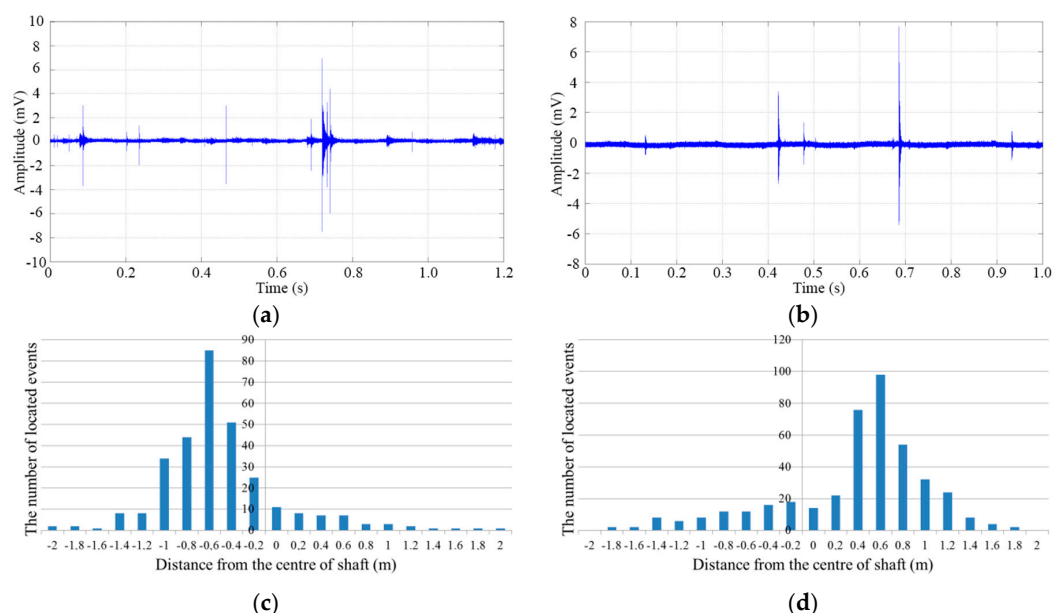
Figure 24. Waveforms of AE signals recorded on shafts of 2 roller bearings (a,b) and linear location results (c,d).

Acoustic emission that is caused by the formation and growth of cracks has a fundamentally discrete and aperiodic nature. When the crack grows, as a rule, high-amplitude signals are generated, with a certain characteristic distribution of the parameters of the AE data stream. AE testing of the support blocks on 2 shafts being in operation for 11 and 13 years revealed AE sources with amplitudes up to 78 dB_{AE} and activity of about 10–20 s^{−1} (Figure 24), which, judging from the waveforms and the distribution of the AE parameters, correspond to active fatigue cracks. Analysis of the linear location showed that the sources of AE are located in the region of the fillets, that is in places with the greatest concentration of stresses. The identified sources of AE turned out to belong to the I and II hazard classes and for this reason did not undergo the confirmation procedure.

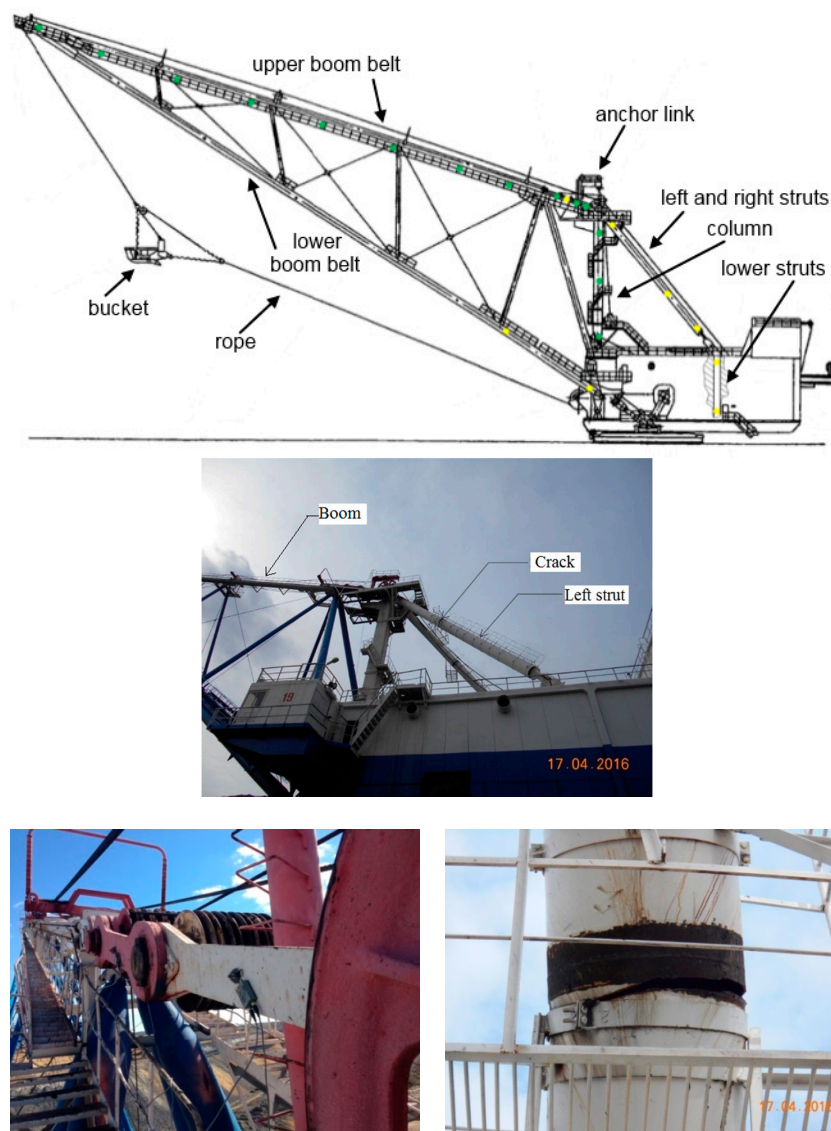
Figure 25. Tested dragline excavator.

Research work was carried out on booms and struts of dragline with bucket capacity—20 m³ and boom length—90 m, which previously had damage at the left strut near the weld (Figure 25). The work was carried out without dragline excavator decommissioning. A 30-channel A-Line DDM AE system and GT200 AE sensors with a working frequency range of 130–200 kHz were used. A-Line DDM system provides the principle of digital data transmission. The system consists of several sequentially connected measuring lines. The amplification of AE signals, filtering, AD conversion and threshold impulse detection and calculation of AE parameters are carried out in the AE module, which is located next to the AE sensor directly in the tested structure. AE sensors were installed on the main structural elements of the dragline: 3 on the left and right struts, 8 on the upper boom belt and 4 on the lower boom belt, 4 on the lower struts and 3 on the column. The distances between the AE sensors were from 5 to 15 m. In addition, 5 AE sensors were mounted on the anchor links where the zone location was carried out, since they consist of structural elements between which there is no acoustic contact. AE monitoring of a rope was not carried out, as the damage to the rope does not lead to prolonged downtime. In addition, the rope is a movable part, that greatly complicates its AE testing. Data was collected directly during the work of the dragline.

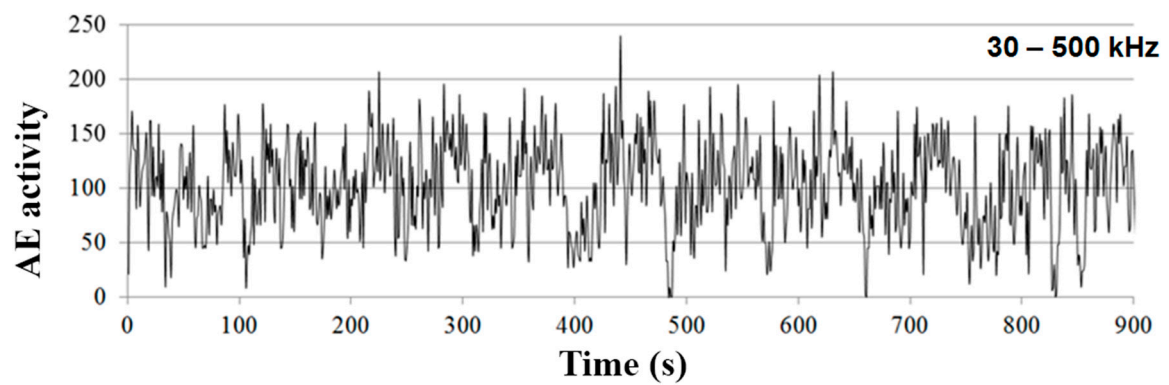
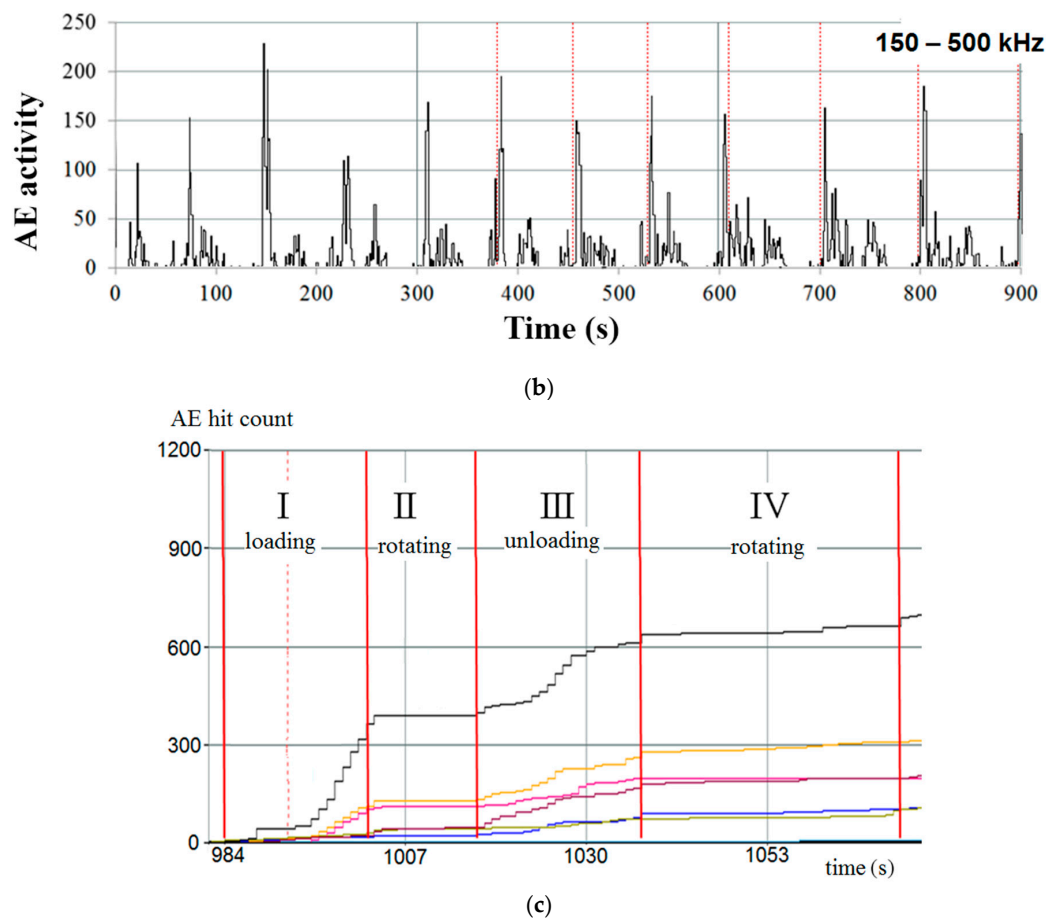
Figure 26. AE activity when using 30–500 kHz (a) and 150–500 kHz (b) frequency filters. Correlation of AE hit count with the cycle of operation of the dragline excavator when using 150–500 kHz frequency range (c).

At the first stage, the frequency range and threshold were selected and the acoustic properties of the monitored object were determined. Two frequency ranges were tested: 30–500 and 150–500 kHz. When using a wide frequency range (30–500 kHz), an extremely high AE activity was observed, which did not have a visible dependence on the operating mode of the dragline excavator, that is, on the value of the load. Such noise is associated with the continuous operation of the equipment (working winch, loose structural elements, engine operation, vibration, etc.).

Therefore, a filter of 150–500 kHz was used. Complete noise detuning by the threshold method was still impossible, since the noise reached 100 dB_{AE}. As a compromise, a threshold value of 50 dB_{AE} was chosen. With such settings, the nature of AE activity became synchronized with the cycle of operation of the dragline excavator (Figure 26). The greatest activity was observed with excavation of the ground and with unloading the bucket, that is at the loading of the structure, when cracks could grow and at structure unloading, when the crack edges can rub each other.

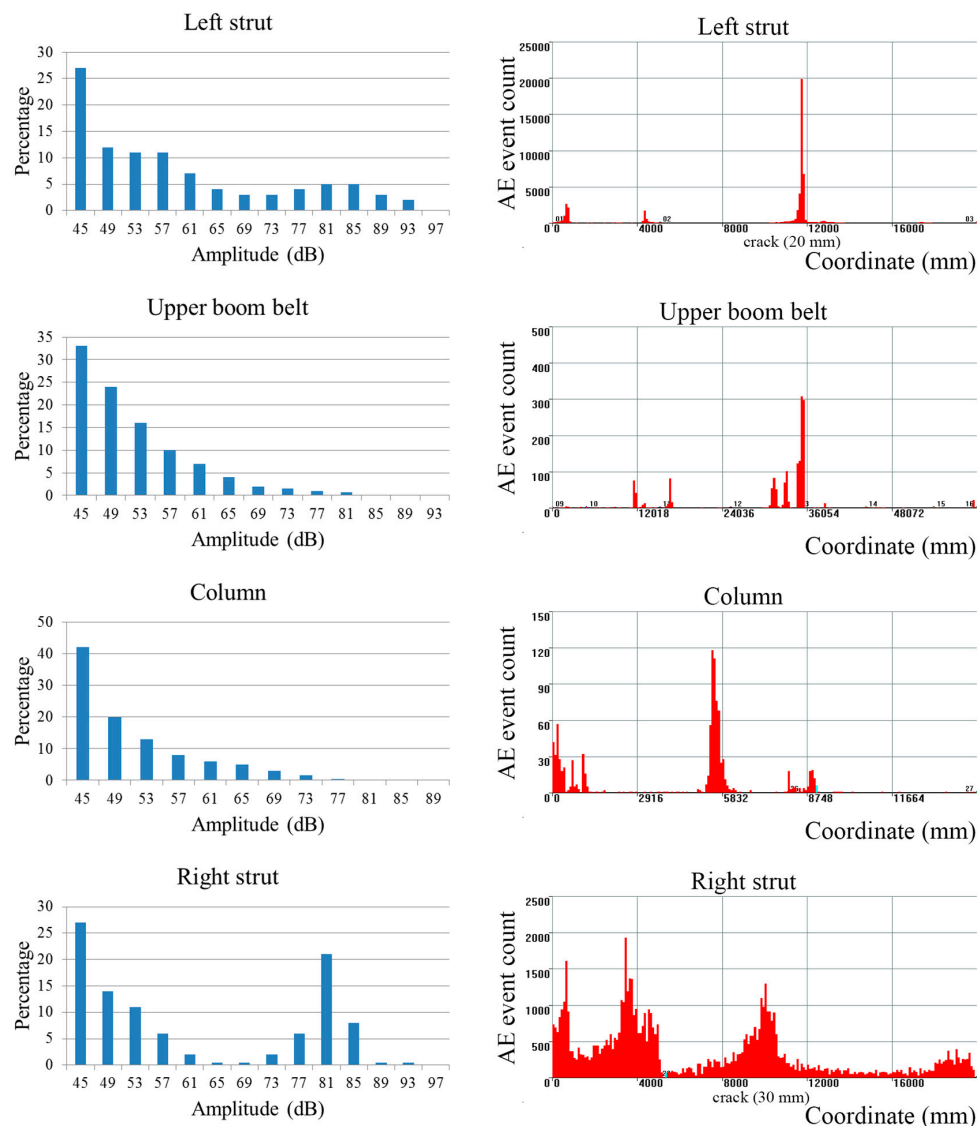
Figure 27. Results of acoustic emission location.

The results of linear location analysis were as follows (Figure 27). On the lower boom belt, there were no sources of AE. Several sources were found on the column and the upper boom belt, which turned out to be noise, since they were localized near the winch attachment points, or were inactive. On the left and right struts, a linear location revealed 3 sources of AE on each, near which there were no potential sources of noise. Signals appeared at the stages of loading and unloading. The amplitude distributions presented above also make it possible to classify these sources as defects.

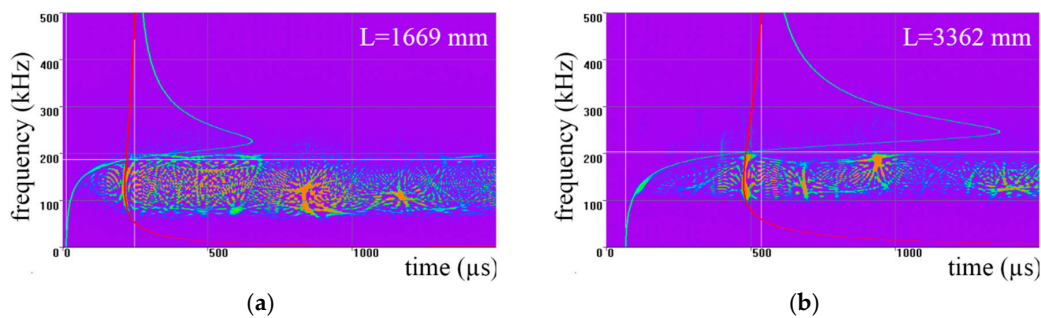
Figure 28. Dispersion curves for channel 29 (a); and for channel 30 (b).

In addition, the spectrograms of the signals on the struts were analyzed, which made it possible to determine the arrival times of different frequency components (Figure 28). It was confirmed that the signals were emitted by impulsive sources and propagated along the walls of the object as Lamb waves. With the help of the spectrogram analysis, the distances between the AE sources and AE sensors were obtained, which coincided with the results of the usual linear location based on the analysis of the arrival times difference [27,28].
