Article

Experimental Investigation on the Performance of Historical Squat Masonry Walls Strengthened by UHPC and Reinforced Polymer Mortar Layers

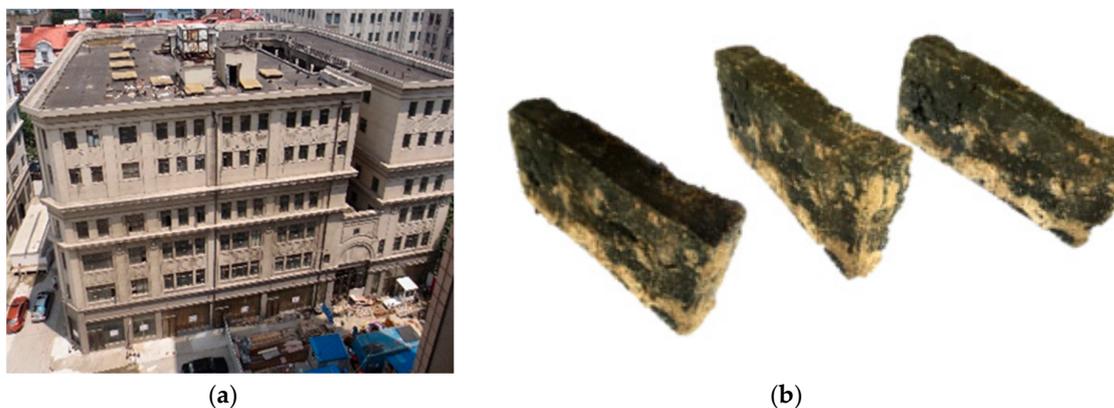
Figure 1. The historical building and bricks: (a) The historical building under rehabilitation; (b) the bricks sampled from the historical building.

The above-mentioned characteristics of historical brick masonry walls influence the effect of the strengthening methods significantly. To simulate the historical brick masonry walls under strengthening authentically, the bricks used in this research were collected from a real historical building under rehabilitation, as shown in Figure 1a. The six-story building was constructed in 1929 and it has a mixed structure that consisted of concrete frames, masonry walls, and concrete floors. The height of story 1 to story 6 are 4.877 m, 3.353 m, 3.353 m, 3.353 m, 3.000 m, and 3.000 m, respectively. The plan of each story is close to a rectangular whose dimension is 17.2 m × 32.7 m. The bricks used in this research were collected from the masonry walls in story 5. The historical bricks had damages and their shape was irregular, as shown in Figure 1b. They helped to reproduce the rough brick-mortar interface within the historical walls. The authors measured the strength of the historical bricks by conducting compressive tests of 10 random samples. It found that the average compressive strength was 6.2 N/mm² and the standard deviation was 0.5 N/mm².

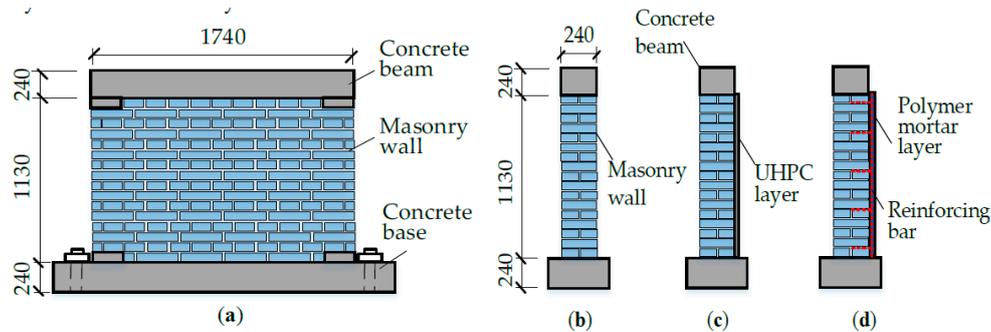
Figure 2. Profile of the historical wall specimens: (a) Front view; (b) right view of W1; (c) right view of W2 and W1S; (d) right view of W3.

The profile of the walls is shown in Figure 2. Thickness of the walls was 240 mm and thickness of the mortar joints was 10 mm, like those measured in the historical building. Thickness of the UHPC layers on W2 and W1S was 40 mm, like that of the general strengthening layers used in practices (in China). The UHPC layers are thinner than other strengthening layers that work with inner reinforcement. Therefore, it is possible to apply extra strengthening measures on top of the UHPC layers without changing the profile of the historical walls. The authors controlled the thickness of the UHPC layers using a wooden mold, as shown in Figure 3a. They injected the UHPC batch from a

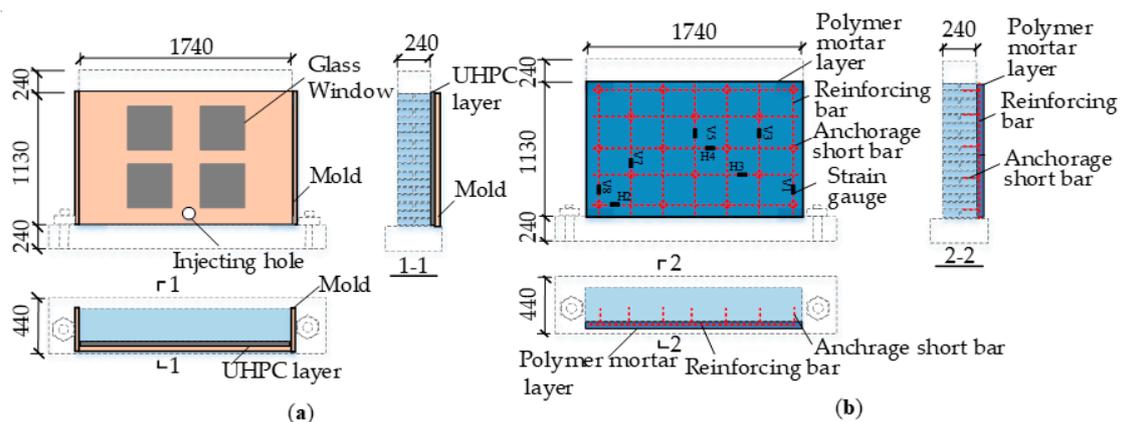
Figure 3. Construction of the strengthening layers: (a) The UHPC layer; (b) The reinforced polymer mortar layer.

hole on the bottom of the mold, until the space between the mold and the wall surfaces was filled. During the procedure, the UHPC batch also immersed and filled the existing damages in the walls. Such a strengthening procedure had slight intervention on the damaged masonry walls, as required by most rehabilitation practices. Moreover, it potentially helped to improve the integrity of the masonry substrates, the elastic modulus of the target walls, and the bondage between the UHPC layers and the masonry substrates.

Comparatively, strengthening with the reinforced polymer mortar layer was more complicated. First, the surface of the masonry substrate was cleared, and then anchoring short reinforcing bars were planted into the masonry, as shown in Figure 3b. As the following step, the reinforced grid was hung on the anchoring short bars and then was fastened by binding. The polymer mortar was then spread onto the cleared surface of the masonry substrate by two times. After the first time, the polymer mortar layer was just thick enough to cover the reinforced grid; after the second time, the polymer mortar layer reached its design thickness of 50 mm. Planting of anchoring short bars and spreading of polymer mortar had obvious intervention on the target wall. These measurements can be inapplicable if the masonry substrate had been damaged severely, as the case of W1S. In addition, the polymer mortar layer had a minimum thickness to coat the reinforced grid effectively. Such a minimum thickness is not always applicable for rehabilitation of historical buildings.

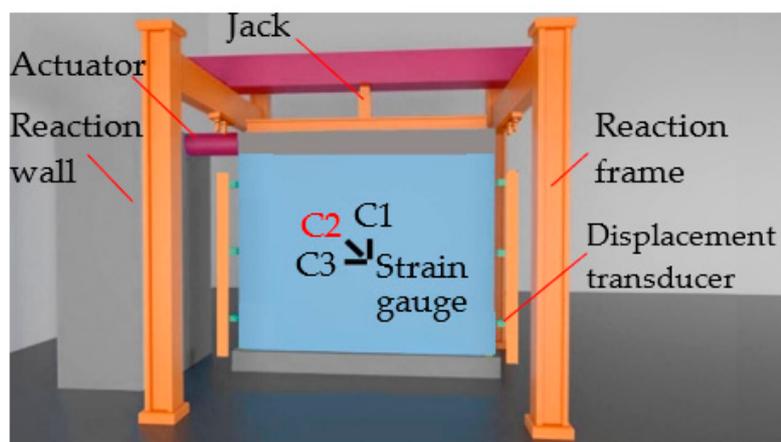
Figure 4. Test setup.

The test setup and transducer layout are shown in Figure 4. The displacement transducers were used to measure deformation of the walls, and their records were used to evaluate the walls' failure modes. The strain gauges C1, C2, and C3 on the strengthening layers, along with those on the reinforcing bars and shown in Figure 3b, were used to evaluate the strain distribution within the walls and to evaluate the deformation of the strengthening layers.

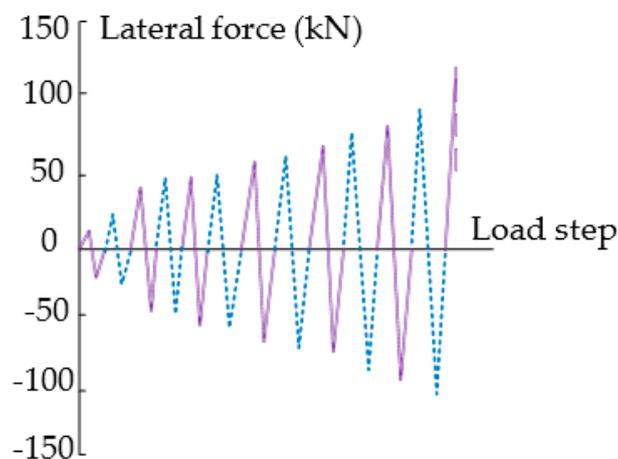
Figure 5. Lateral load cycles.

The loading mechanism was same for all the walls. Vertical compression was firstly applied by a jack and then remained unchanged, resulting in a constant compressive ratio of 0.3 on the wall being tested. The compressive ratio is typical of the bottom walls of regular two-story masonry buildings (in China). After vertical loading, cyclical lateral forces were applied along the top concrete beam by a servo-hydraulic actuator. The lateral loading stopped if the force of the actuator dropped by 15% or more, as illustrated in Figure 5.

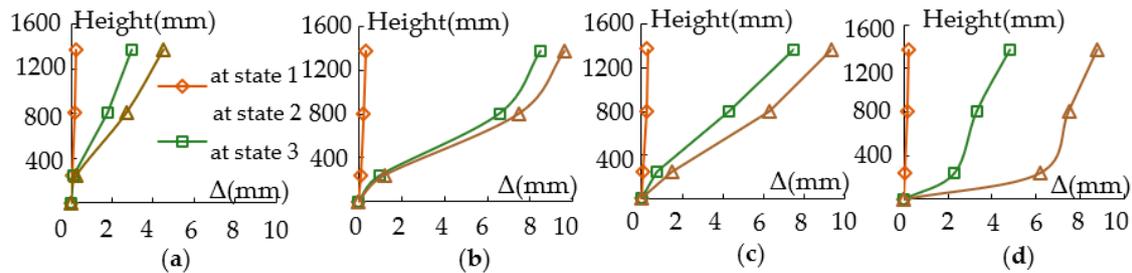
Figure 6. Lateral displacement of the walls: (a) W1; (b) W1S; (c) W2; (d) W3.

There were three typical states of the walls during they deformed under the lateral loading. At state 1, major cracks in the walls became visible; at state 2, lateral forces on the walls reached their peak values; and at state 3, the forces of the actuator dropped by 15% or more after reaching peak values and the walls failed. The lateral displacement of the walls along their height at the three typical states is shown in Figure 6, in which Δ represents the displacement.

The displacement of the lower part of the W1 remained small until the wall failed, while the displacement of the lower parts of all the strengthened walls increased obviously with the load.

The W1 and W1S deformed similarly at state 1, indicating the UHPC layer had recovered the stiffness of the failed W1. However, the displacement of W1S at state 2 and state 3 is much larger than that of W1, indicating the UHPC layer had postponed the cracking and changed the failure mode. Because of the favorable cooperation between the UHPC layer and the masonry substrate, the ultimate deformation of W1S—which was recovered from the severely damaged W1—increased by 113% than that of W1. Similar result was observed for W2, whose ultimate deformation increased by 109% than that of W1. The difference between the increase of the ultimate deformation of W1S and W2 was less than 4%, indicating the improvement of ultimate deformation was similar for the two walls. The similarity can be explained by the walls' failure mode. Both W1S and W2 failed in a bed-joint slide mode that was premature and the strengthening layers had not taken full effect. Therefore, the ultimate deformation of W1S and W2 relied much on the resistance of the masonry in their bottom, as explained in Section 4.3. The resistance of the bottom masonry is similar for W1S and W2, because the W1 had previously failed in a typical shear-compressive mode and its bottom masonry was still in good condition after the failure. The results indicate the UHPC layers significantly improved the deformation ability of the masonry walls.

While, the ultimate deformation of W3 increased by 96% than that of W1. The increase is less than that of W1S and W2 because the UHPC layers deformed with the masonry substrates better than the reinforced polymer layer did, as explained in Section 4.2 and Figure 14. Besides, the W3 had a large displacement at the bottom when it failed, indicating a severe bed-joint slide.

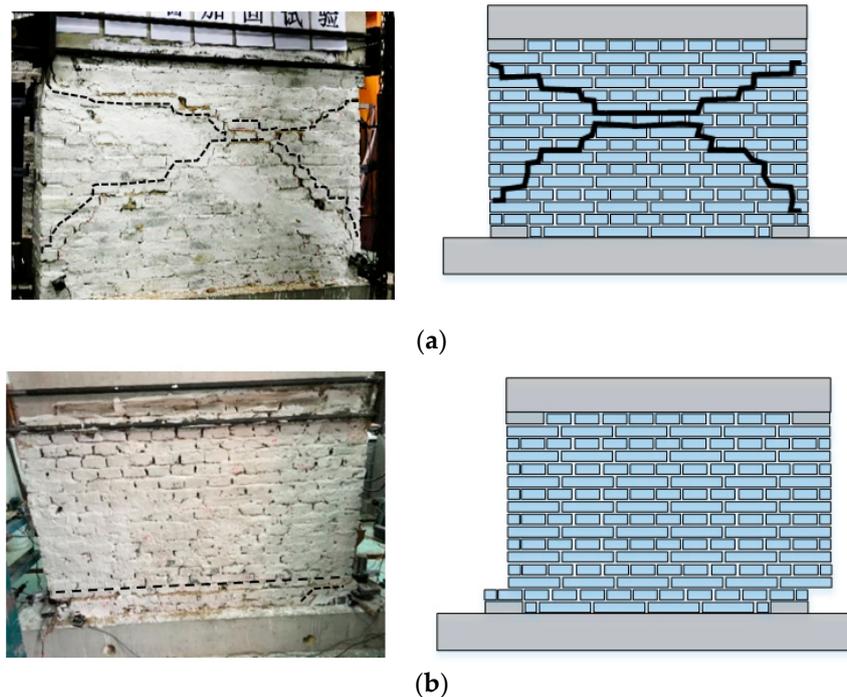
Figure 7. Failure modes of the walls: (a) Shear-compressive failure of the unstrengthened W1; (b) bed-joint slide of the strengthened walls.

There were two failure modes of the walls, as shown in Figure 7. The unstrengthened W1 failed in a typical shear-compressive mode, like most load-bearing walls with weak mortar joints. Cracks originated when the lateral force was only 18 kN, and crossing cracks formed when the lateral force was only 35 kN. In the subsequent load cycles, lateral deformation of the wall increased significantly. It failed suddenly when the lateral force was 41.4 kN, and then the force of the actuator dropped.

For the strengthened walls W1S, W2, and W3, horizontal cracks formed and developed at their bottom along with the increase of the lateral forces, and the walls failed through bed-joint slide finally. The horizontal cracks of the W1S, W2, and W3 formed at their bottom when the lateral forces were 32.4 kN, 40.8 kN, and 31.0 kN respectively, which were much higher than that of the cracking load of W1. No severe cracks formed in other parts of the walls after the horizontal cracking, until the walls failed through bed-joint slide suddenly. Such a failure mode of strengthened historical masonry walls hardly happens for strengthened regular masonry walls, for which debonding of the externally bonded layers or strips is the typical failure mode.

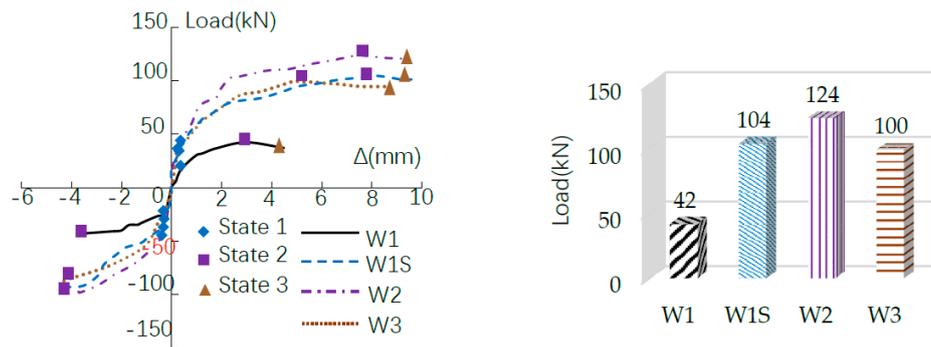
Figure 8. In-plane shear resistance of the walls: (a) Skeleton curves; (b) resistance.

The skeleton curves the walls are illustrated in Figure 8. The in-plane shear resistance of W1 was low because the historical bricks and mortar were weak. Moreover, irregular shapes of the historical bricks resulted in complicated interactions between the bricks and the surrounding mortar. Failure was more prompt to happen under the combined effect of shear stress, compressive stress, and extra stress introduced by the strain difference between the bricks and the mortar. The wall cracked and crushed severely and lost integrity when it failed. Although it was crushed and split into several parts, the UHPC layer effectively rehabilitated it. The in-plane shear resistance of W1S, which was constructed by strengthening the crushed W1, was 147% higher than that of W1.

The W2 was strengthened by the UHPC layer before loading, and it had the highest in-plane shear resistance within all the walls. Its resistance was 193% higher than that of W1. It shows that the applied UHPC layer also improved the resistance of the masonry wall that has visible but not severe damages.

The W3 was strengthened by the reinforced polymer mortar layer before loading. Its in-plane shear resistance increased less than that of W2 and W1S.

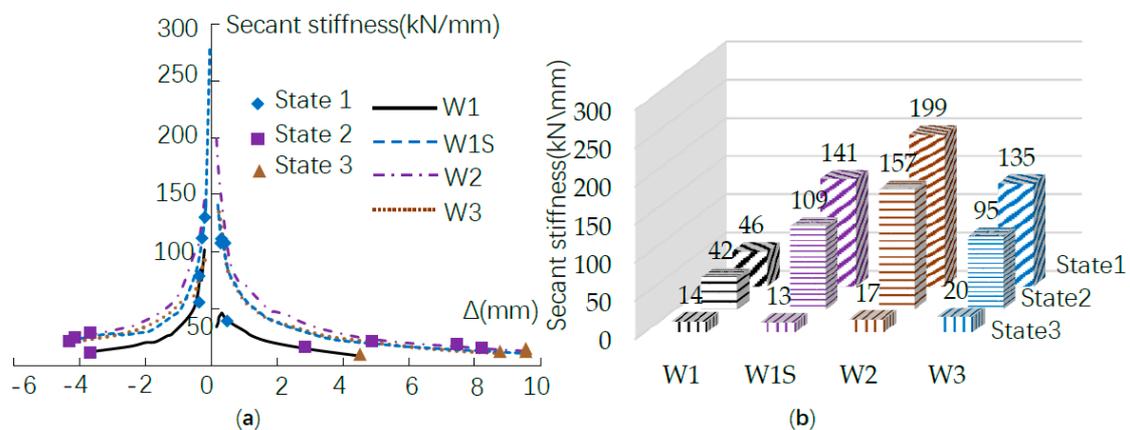
Figure 9. Stiffness degradation: (a) Stiffness degradation during the loading procedures; (b) stiffness at typical states.

The secant stiffness of the walls decreased at different pace along with the increase of lateral forces, as shown in Figure 9. The secant stiffness dropped dramatically before state 1, indicating the existing damages in the bricks, the mortar, and the brick-mortar interface were very sensitive and could develop significantly under very small lateral forces. After dropping to a low level at state 1, the secant stiffness degraded gradually.

The strengthened walls retained their stiffness in a rather long deformation procedure before they failed, indicating the UHPC layers and the reinforced polymer mortar layer took obvious effect after state 1 and the walls' integrity was rehabilitated.

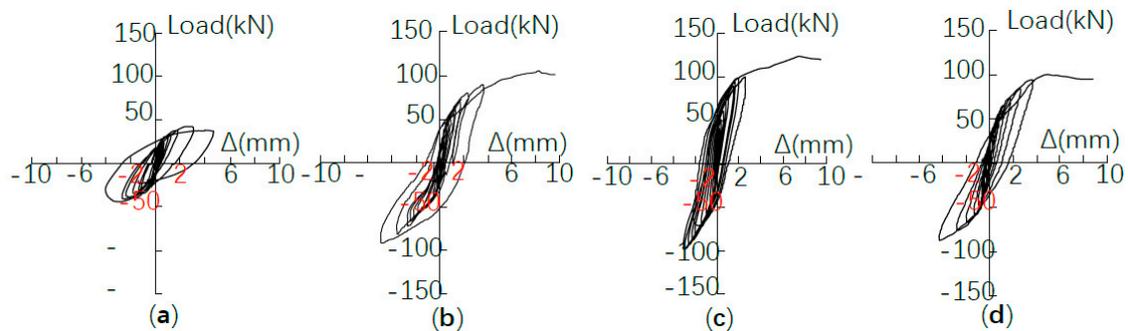
Figure 10. Hysteretic loops of the walls: (a) W1; (b) W1S; (c) W2; (d) W3.

The ultimate deformation of the strengthened W1S, W2, and W3 was 113%, 109%, and 96% higher than that of the unstrengthened W1, and the area of the hysteretic loops of the strengthened W1S, W2, and W3 was 68%, 120%, and 50% higher than that of the unstrengthened W1, as shown in Figure 10.

The results indicate that the strengthened walls dissipated more energy before failure. The UHPC layers improved the energy dissipation ability of the masonry walls, whether the wall was in good condition as the W2 or had been severely damaged as the failed W1.

Although the hysteretic loops of the strengthened walls surrounded more area, they were not plump. Therefore, the increase of energy dissipation mainly resulted from the increase of resistance, and the strengthened walls' energy dissipation ability was not as favorable as their in-plane shear resistance. This can be illustrated by Figure 11, in which the energy dissipation coefficient equals the area of the shaded part ABCD divided by the sum of the area of the triangle OBE and triangle ODF. The enhancement of energy dissipation had been reversed by the premature bed-joint slide failure, in which the strengthening layers had not taken effect sufficiently.

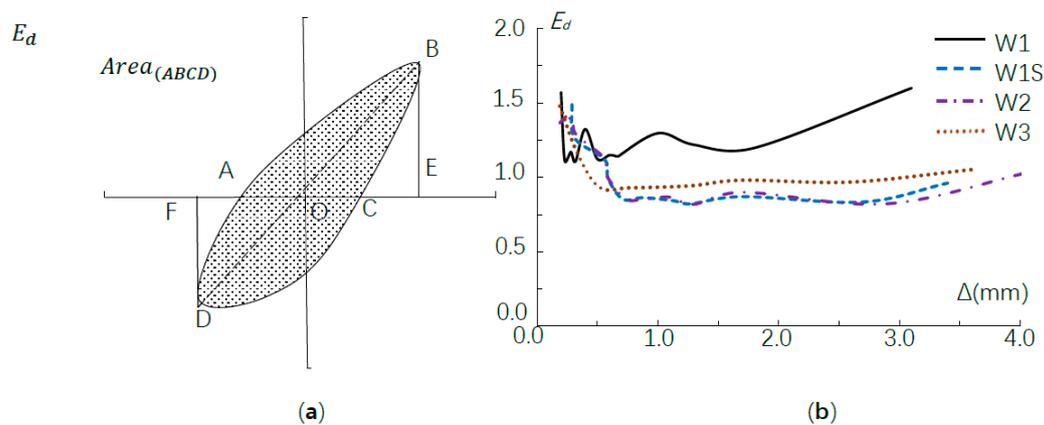
Figure 11. Energy dissipation coefficients (E_d) of the walls: (a) Calculation of the energy dissipation coefficient; (b) energy dissipation coefficients of the walls.

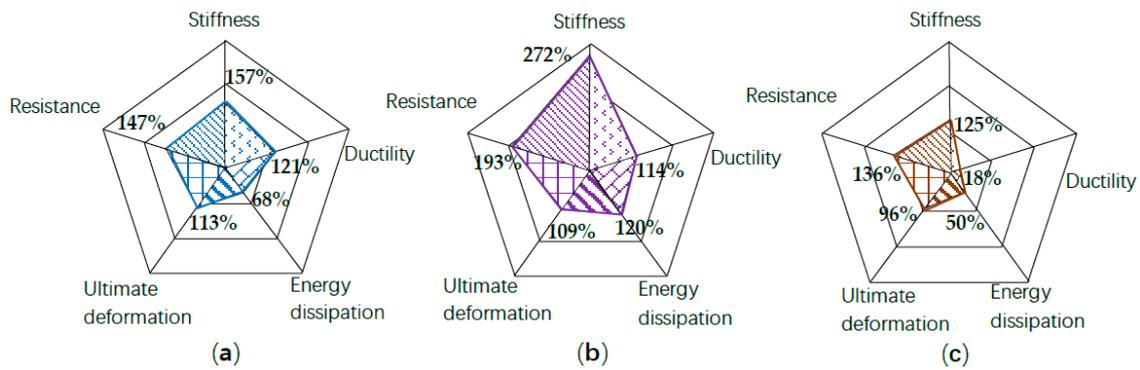
Figure 12. Percentage of performance rehabilitation and improvement of the strengthened walls comparing to the unstrengthened W1: (a) W1S; (b) W2; (c) W3.

The strengthening layers simultaneously improved the resistance, ultimate deformation, ductility, and energy dissipation ability of the masonry walls, as shown in Figure 12. They also improved the stiffness of the walls, indicating an obvious effect of integrity rehabilitation. However, from a seismic point of view an increment of stiffness is generally associated to an increment of the spectral acceleration, that is an increment on the force acting on the structure in seismic conditions. Therefore, an increment in the stiffness of the panel cannot be considered good for the structure and the benefit in terms of increment of resistance could partially or totally vanish because of the higher stiffness.

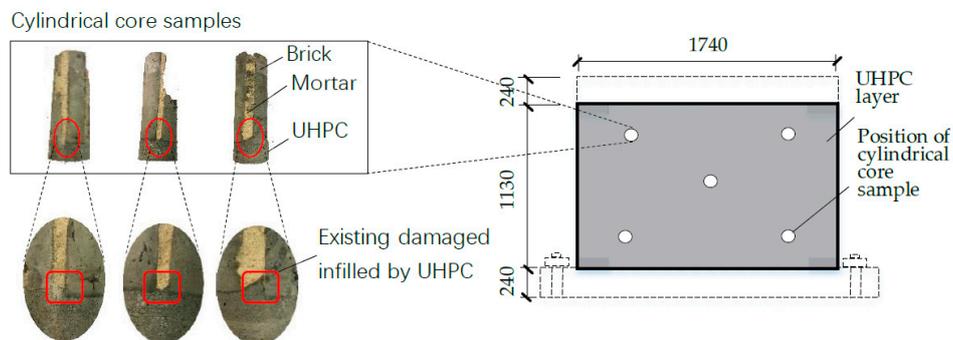
Figure 13. Interaction mechanism between the UHPC layer and the masonry substrate.

To investigate the interaction between the UHPC layers and the masonry substrate, cylinder core samples were drilled out of the failed W1S and W2, as shown in Figure 13. It shows the UHPC had flowed into and filled the existing damages in the masonry substrate, and it had rehabilitated the masonry substrate before strengthening the walls. The mechanism not only prevented the development of the damages that had existed in the target walls before strengthening, but also improved the bondage between the UHPC layers and the masonry substrate. Moreover, it would relieve the unfavorable stress provoked by the thermal strain difference between the UHPC layers and the masonry substrate.

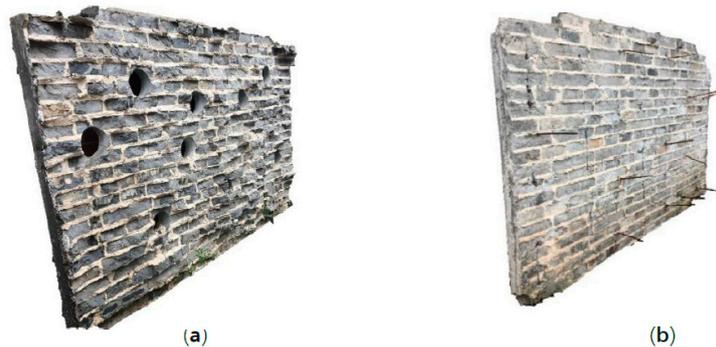
Figure 14. The interface between the strengthening layers and the masonry substrate: (a) The coarse interface between the UHPC layer and the masonry substrate; (b) The smooth interface between the reinforced polymer mortar layer and the masonry substrate.

The mechanism that results in the favorable strengthening effect has minor relation to the walls' aspect ratio. Therefore, similar strengthening effect could be expected when the UHPC layers are applied on slender masonry walls. It should be noticed that the UHPC layers could change the ratio of the bending stiffness to the shearing stiffness of the slender walls, and then change the walls' ductility or failure mode. The reinforced polymer mortar layer did not have the above-mentioned mechanism. The interface between the layer and the masonry substrate was much smoother than that between the UHPC layer and the masonry substrate, as shown in Figure 14. The reinforced polymer mortar layer ensured the bondage with the masonry substrate by cohesion and dowel action from the anchorage short bars illustrated in Figure 3b. As a result, it was less effective than the UHPC layers.

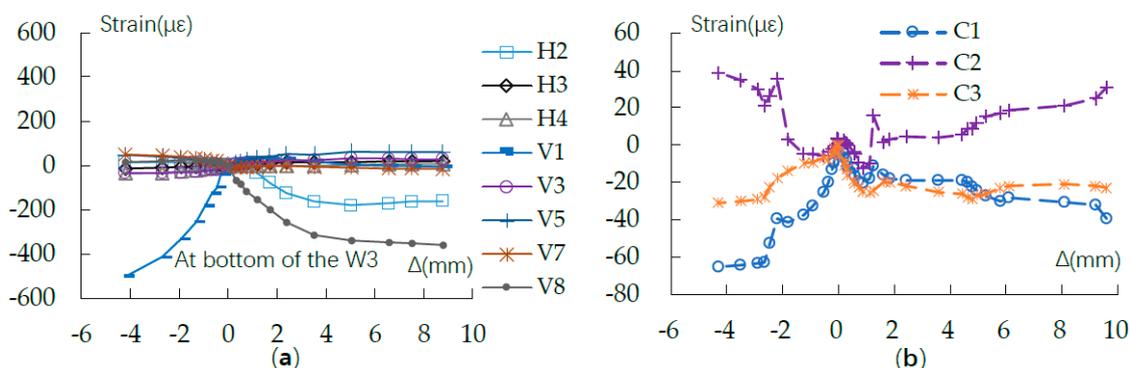
Figure 15. Strain of the strengthening layers: (a) Strain of the reinforcing bars of W3, the gauge position is illustrated in Figure 3b; (b) Strain of the UHPC of W2, the gauge position is illustrated in Figure 4.

During the procedure of the bed-joint slide, the strain of the reinforcing bars at the bottom of the W3 was larger than that of the reinforcing bars in other parts, as shown in Figure 15a. Figure 15 also shows the strain of all the reinforcing bars and the UHPC was far less than their ultimate strain during the procedure. Therefore, the strengthening layers had not taken full effect and the failure by bed-joint slide was premature.
