Blistering Mechanism Analysis of Hydraulic Asphalt Concrete Facing

Abstract: Two years after the Zhanghewan Pumped-Storage Power Station was put into operation, more than 500 blisters appeared in the asphalt concrete facing of the upper reservoir, and nearly half of them ruptured at the surface. The blistering mechanism of the asphalt concrete facing was studied in this paper. Through on-site inspection and coring inspection, it was found that the blistering was caused by the vapor pressure formed by the water enclosed in the middle of the impervious layer during high temperatures. Numerical analysis showed that the temperature 5 cm below the surface could reach 50–60 °C. Through numerical analysis and model tests, the internal water at this temperature may form a vapor pressure of 20 kPa. Finally, the blister size of the asphalt concrete facing at this temperature and pressure was studied with a model test. The possible sources of moisture inside the impervious layer were also analyzed through a core test, which found that moisture was most likely to be introduced by water spraying during rolling.

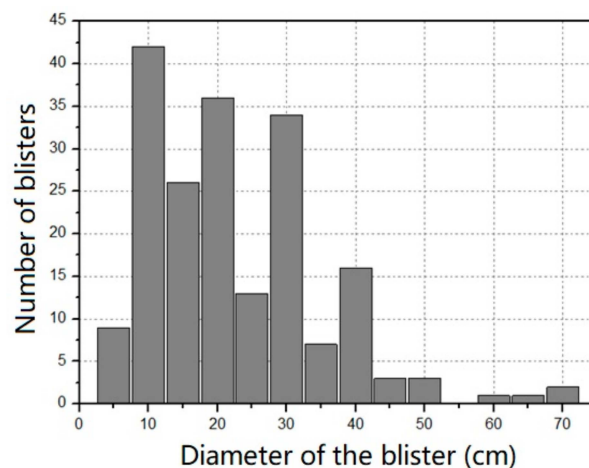
Figure 3. Blister size distribution.

horizontal crack, and a blister on the sealing layer. The blisters were distributed between EL. 795 m and EL. 811 m, which was more or less consistent with the zone of the water level fluctuations; for example, the number of blisters from EL. 808 m to EL. 809 m was 41 (shown in Figure 2), indicating that blistering was related to exposure. In terms of size, blisters with diameters between 10 cm and 30 cm accounted for 78%, and those with a diameter of 10 cm were the most common with about 42 (shown in Figure 3). Blister size was substantially evenly distributed along the elevations. In terms of appearance, half of the blisters were cracked at the surface and half were not (shown in Figure 4).

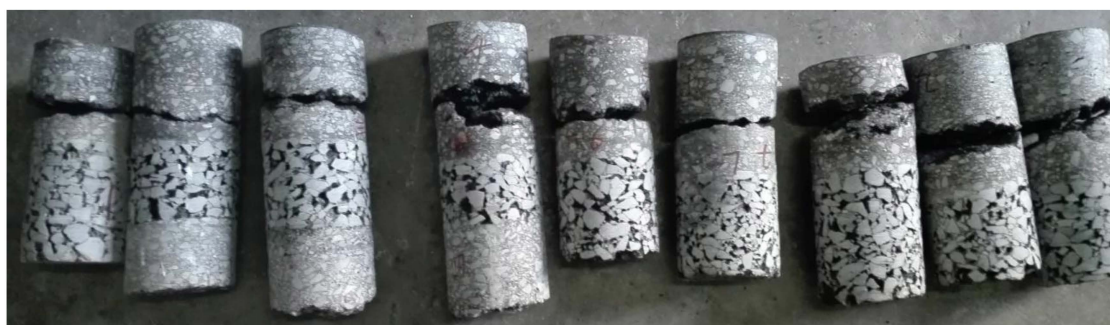
In order to further inspect the blister, 9 $\Phi 10$ cm core samples were drilled in three typical areas, and the void content of the upper impervious layer of the core samples were tested. The void content and the permeability coefficient of the drainage layer were also tested and are listed in Table 2. It was found that all the core samples showed separation in the upper impervious layer, as shown in Figure 6. Geological radar test results also indicated that the blister defect was located in the upper impervious layer [14]. It can be seen from the test results that the void content and permeability coefficient of the drainage layer were moderate, the drainage layer was smooth, and no leakage water was seen in the drainage gallery, indicating that the moisture in the blister was less likely to have come from the drainage layer. At the same time, the void content of the impervious layer was less than 3%. As we know, when the void content of asphalt concrete is below 3%, the permeability coefficient will be less than 10^{-8} cm/s [15] and it is almost impermeable, which indicates that reservoir water is not likely to diffuse into the asphalt concrete. Therefore, the moisture in the blister was not likely to have come from reservoir water.

Figure 6. Core samples (the coarse part is the drainage layer).

In addition, there were no problems of “sick” aggregate or impure aggregates in the asphalt concrete in the core samples. Therefore, according to these actual conditions, the moisture in the blister was more likely to have entered the impervious layer during the construction period. How the moisture in the impervious layer triggered the blisters currently seen requires further research.

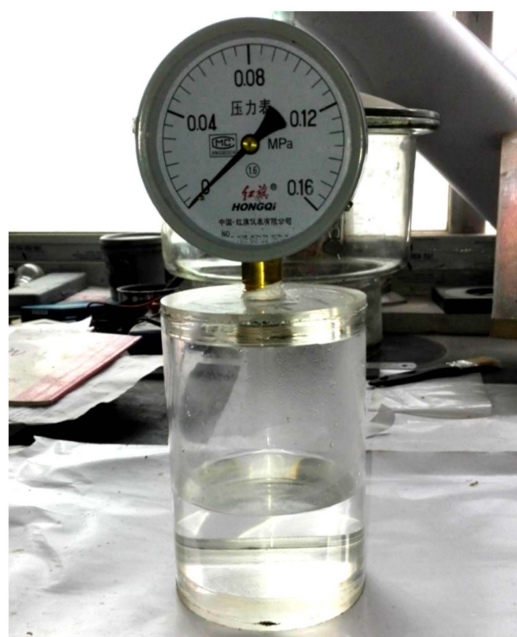
In order to verify Equation (4), a test was carried out in laboratory. The test device was a 500 mL closed glass bottle with 50 mL of water inside. A pressure gauge was used to test the pressure inside the bottle, as seen in Figure 7. The initial temperature was selected as $T_0 = 25^\circ\text{C}$, and the calculation results and test results are shown in Table 3. It can be seen that the measured pressure values are all less than the calculated pressure values, as shown in Figure 8, which may be related to the fact that air is not an ideal gas. In addition, if the numerical temperature is selected as $T_0 = 40^\circ\text{C}$, the pressure gauge value of $T = 70^\circ\text{C}$ can be calculated by Equation (4) to be 32.8 kPa, which indicates that the lower the initial temperature, the higher the pressure value at the same temperature.

Figure 7. Test device for steam pressure.
