Article

Ground-Borne Vibration Due to Construction Works with Respect to Brownfield Areas

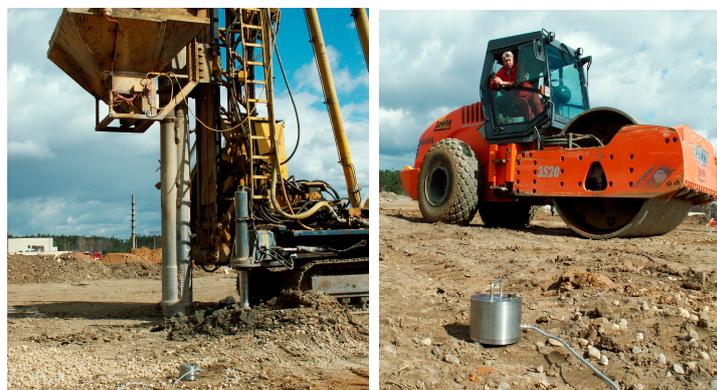
In total, data from three measurements were processed. Namely, the seismic response of the rock environment from the vibrating gravel piles, from the sheet piles, and from the vibrating roller was monitored (Figure 3). Common geotechnical technologies were monitored, which were also used, for example, in the construction of Nova Karolina. In all three cases, this uses harmonic oscillation—cyclic variation in amplitude that repeats many times, which is more damaging than intermittent vibrations. All measurements were made as profile measurements perpendicular to the vibration source.

Figure 3. Example photos of measurements—vibrated gravel piles (left) and vibrating roller (right).
