Article

Structural Health Monitoring and Interface Damage Detection for Infill Reinforced Concrete Walls in Seismic Retrofit of Reinforced Concrete Frames Using Piezoceramic-Based Transducers Under the Cyclic Loading

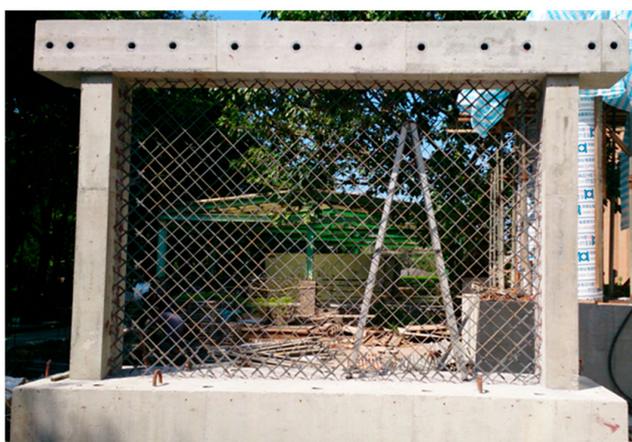
Figure 1. RC frame and the reinforcement arrangement of the post-installed wall of RCW1.

In this work, two non-ductile RC frame specimens that are retrofitted by installing a shear wall (RCW1 and RCW2) are tested under cyclic loading. A non-ductile RC frame was constructed first and then rebar connections were post-installed and wall rebar cage were installed, as depicted in Figure 1. Concrete was finally cast to form an RC shear wall, as presented in Figure 2. Figure 3 shows the dimensions and wall panel reinforcements of RCW1 and RCW 2; the thickness of the wall panel is 15 cm. To improve ductility, the reinforcements in the wall panels of both RCW1 and RCW2 are set to 45 degrees from horizontal. The reinforcements in the wall panels are arranged identically in both specimens. These two specimens include the boundary columns with a cross-sectional area of $30 \times 50 \text{ cm}^2$. Each column is designed with main bars of 4-D22 and 8-D19 and a transverse reinforcement of D10@20cm at both ends. The web reinforcement of the shear wall is connected to the existing RC frame using adhesive rebars. The embedded length of the adhesive reinforcement is 12 cm and the lap length of the reinforcements is 30 cm. Figure 4 displays the arrangement of reinforcements of the boundary columns and beams. Table 1 presents the yielding strength and ultimate strength of the reinforcement in the specimens. Table 2 presents the mean concrete strengths in the wall panel, boundary column and foundation.

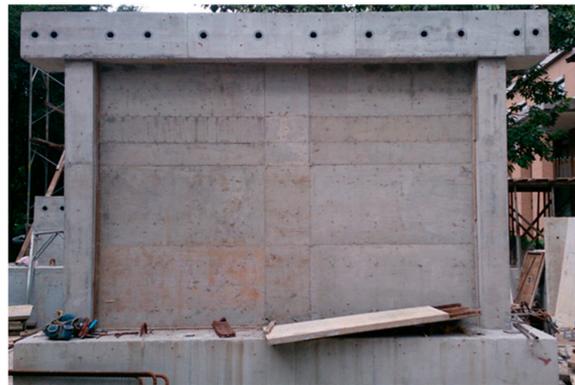
Figure 2. The front view of the specimen RCW1.

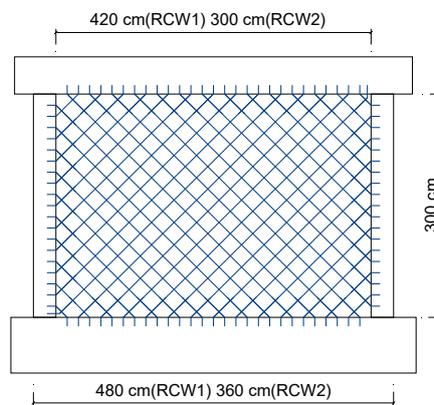
Figure 3. Dimensions of the specimens of RCW1 and RCW2. (unit: cm).

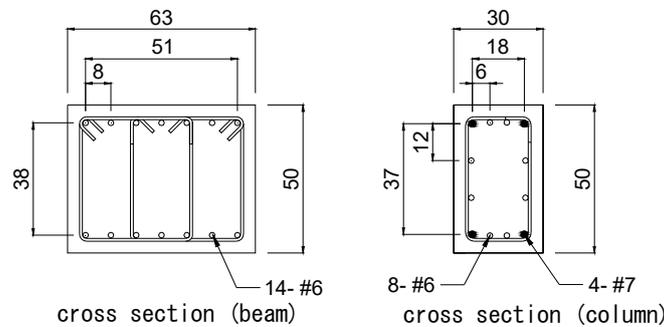
Figure 4. Dimensions and reinforcements of the column and beam. (unit: cm).

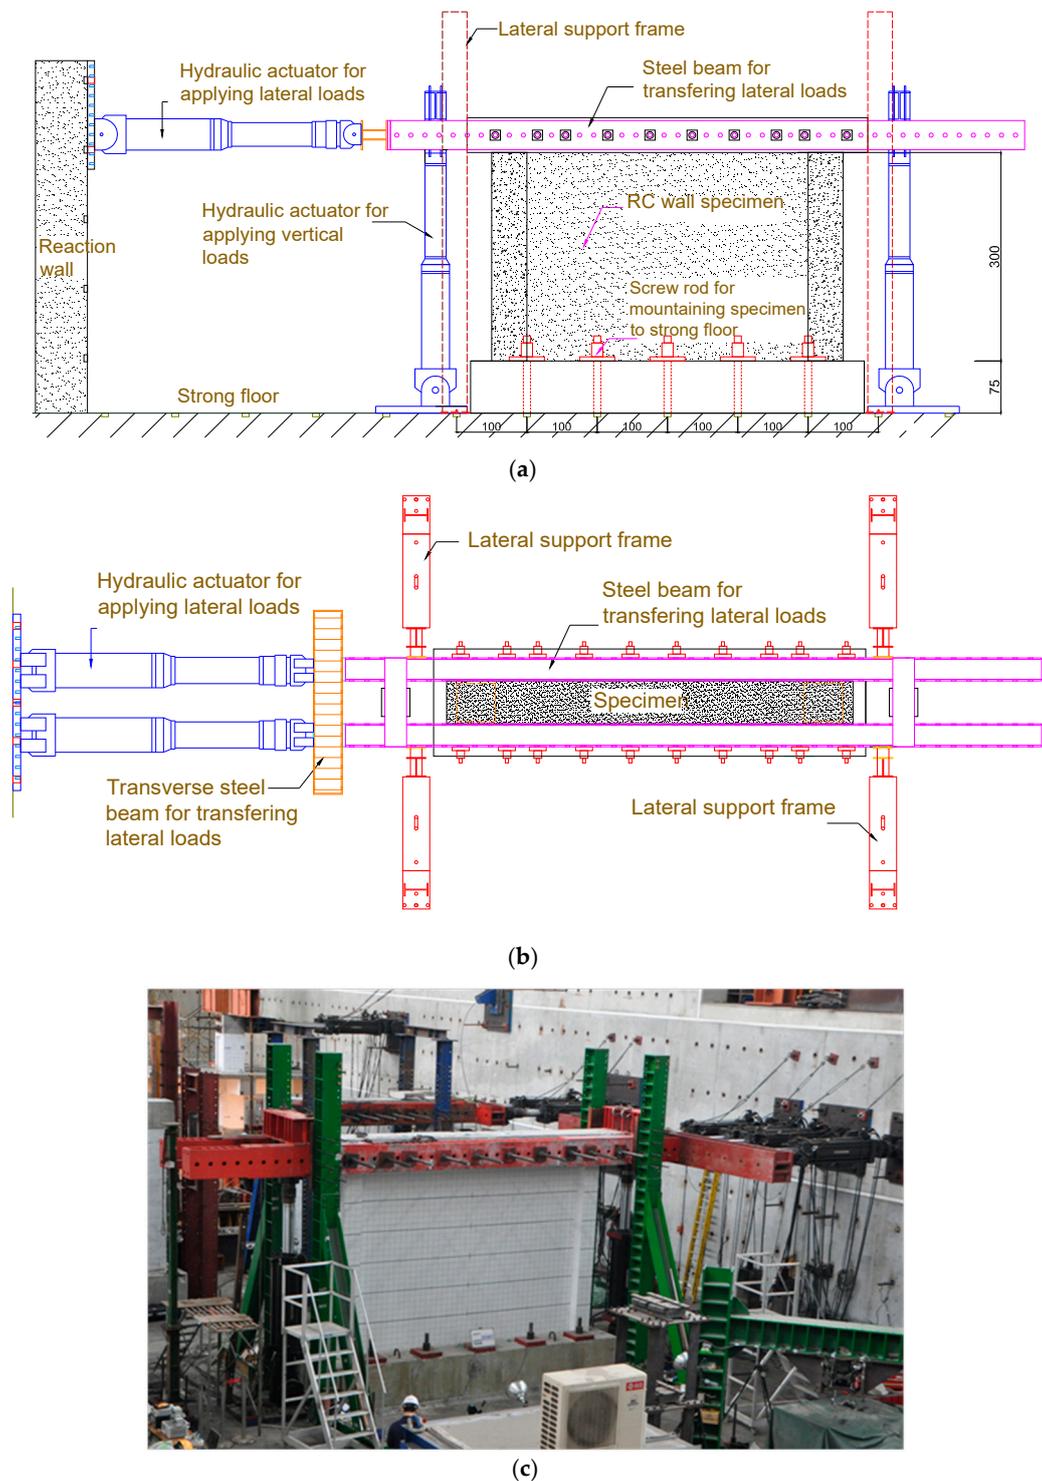
Figure 5. Experimental set-up of the cyclic loading test, (a) lateral view, (b) top view and (c) the photo.

The loading system in this work includes actuators, lateral support frames and a steel rigid beam of loading distribution as shown in Figure 5. The loading system includes horizontal and vertical actuators to apply horizontal and vertical loading to the tested specimen. Horizontal loading simulates seismic force. Vertical loading simulates a gravitational load. It was applied to 90 tf for vertical of each column using the two vertical hydraulic actuators equipped on the two sides of the wall specimen during the test. Based on the loading-distribution steel rigid beam and steel anchor bolts, horizontal and vertical loadings could be assumed to be uniformly distributed into the beam of the specimen.

The load cell on the beam end was used to measure the horizontal loads that were applied by the actuators. Linear variation displacement transducers (LVDT) were used to measure the top and bottom horizontal displacements of the wall panel and a dial gauge was used to monitor the deformation of the foundation. Figure 5 shows a configuration drawing and photograph of the setup for the reversed cyclic loading test. Steel bracing frames were installed on both sides of the tested specimen to prevent unexpected torsional motion of the wall specimen. A reversed cyclic loading test was carried out with a predetermined increment in drift ratio in each step until the specimen completely failed.

The loading system in this work includes the actuators and a rigid beam of loading distribution, as shown in Figure 5. The applied loading system in this work includes the horizontal and vertical actuators and could apply the horizontal and vertical loading on a specimen, separately. The horizontal loading could be used to simulate the seismic force. The vertical loading could be used to simulate the gravity load applied into specimens. It was applied 90 tf for vertical of each column using the two vertical hydraulic actuators equipped on the two sides of the wall specimen during the test. Base on the loading distribution steel beam and steel anchor bolts, the horizontal and vertical loading could be assumed uniformly distribute into the beam of specimens. The load cell equipped on the beam end was used to measure the horizontal loads applied by the actuators. The linear variation displacement transducers (LVDT) were used to measure the top and bottom horizontal displacements of the wall panel and the dial gauge was used to monitor the foundation deformation. The configuration drawing and photo of the test setup for the reversed cyclic loading test are shown in Figure 5. Steel bracing frames were installed on the two sides of the tested specimen to avoid the unexpected torsional motion of the wall specimen. Reversed cyclic loading test was performed with a predetermined increasing drift ratio for each step until the complete failure of the specimen.

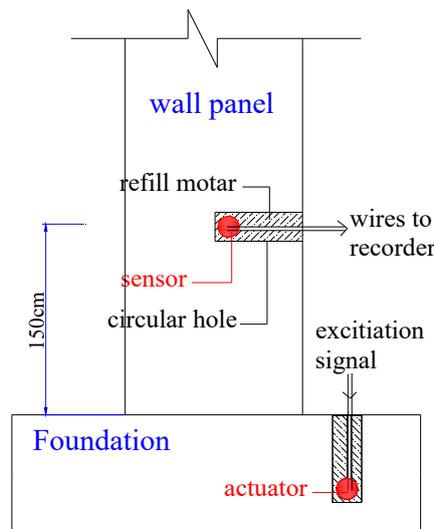
Figure 6. Configuration of the post-embedded transducers.

Piezoceramic-based sensors (PPTs) were post-embedded at predetermined locations after 28 days of concrete casting of the wall panel. The distributed PPTs, labeled with the capital letters "S" and "A" in Figures 6 and 7 were used as receivers (sensors) and actuators, respectively. The catalog values of the piezoelectric voltage constants (g_{33}) and the piezoelectric strain constant (d_{33}) in the polarization direction for the sensors are 250×10^{-4} Vm/N and 43×10^{-11} m/V, respectively; and those for the actuators are 140×10^{-4} Vm/N and 65×10^{-11} m/V, respectively. For the post-embedded transducers in the existing RC structures, the size of the SA adopted in the research [9,10] is too large for post-embedding them into the RC structures. Therefore, piezoceramic patches that were coated only with a waterproof layer were directly embedded into the structures as sensors and/or actuators for SHM. The transducers are installed by drilling small holes in the wall, top beam and foundation. The depth and diameter of each drilled hole are approximately 8 cm 1.2 cm, respectively. The transducers with a waterproof layer are then placed in the holes, which are refilled with non-shrinking cement mortar. Figure 6 displays the configuration of the installation of the post-embedded transducers. Figure 7 shows the locations of the PPTs in the foundation, wall and foundation. The wave paths for monitoring are also shown in figure. Each specimen has nine PPTs as depicted in Figure 7. Six (S1–S6) are embedded as sensors in the top beam and in the middle-height region of the wall panel. The others (A1–A3) are set in the foundation as actuators. Wave signals that are received from the sensors are used to assess the state and location of damage throughout the wall structure.

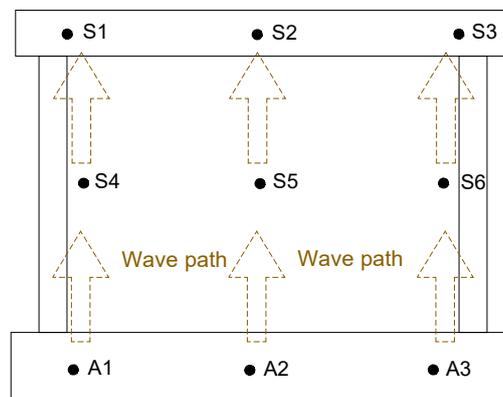
Figure 7. Locations of the actuators and sensors in the specimen and the wave path.

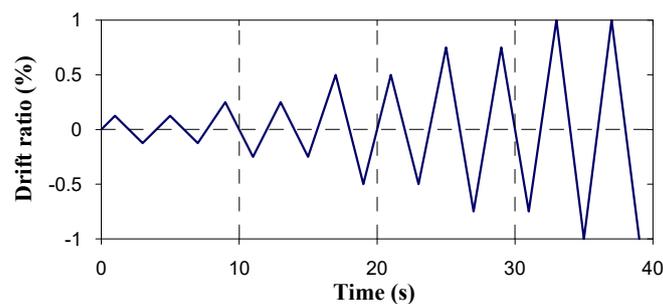
Figure 8. Loading history of the reversed cyclic loading test.

This work applied the cyclic horizontal loads on the top beam of the specimens using the displacement control, as shown in Figure 8. For the specimen of RCW1 at the drift ratio of 0.25%, the slight cracks developed horizontally at the bottom end of the boundary columns. Additionally, the cracks with an inclination angle close to 45 degrees distributed uniformly in the region of the wall panel. At the drift ratio of 0.5%, the crack development is similar to the drift of 0.25%. However, the foundation and bottom end of the boundary columns have slight spalling of concrete cover since their compressive strength of concrete is relatively lower than the wall panel. Figure 9 shows the cracking patterns at each drift level and the final failure status of the specimen at the drift ratio of 1.0% and the concrete at the bottom end of the boundary columns and foundation crushed in the second cycle. The experimental results showed which the foundation of the existing RC frame is much weaker than the retrofitted RC wall. Then, the failure could be found at the interface of the foundation of the existing RC frame and the retrofitted RC wall. The major cracks could be found on the positions of the foundation of the existing RC frame under the boundary columns. Due to the specimen was failed in bending behavior, the middle part of the interface of the foundation of the existing RC frame and the retrofitted RC wall was not found with too many cracks.

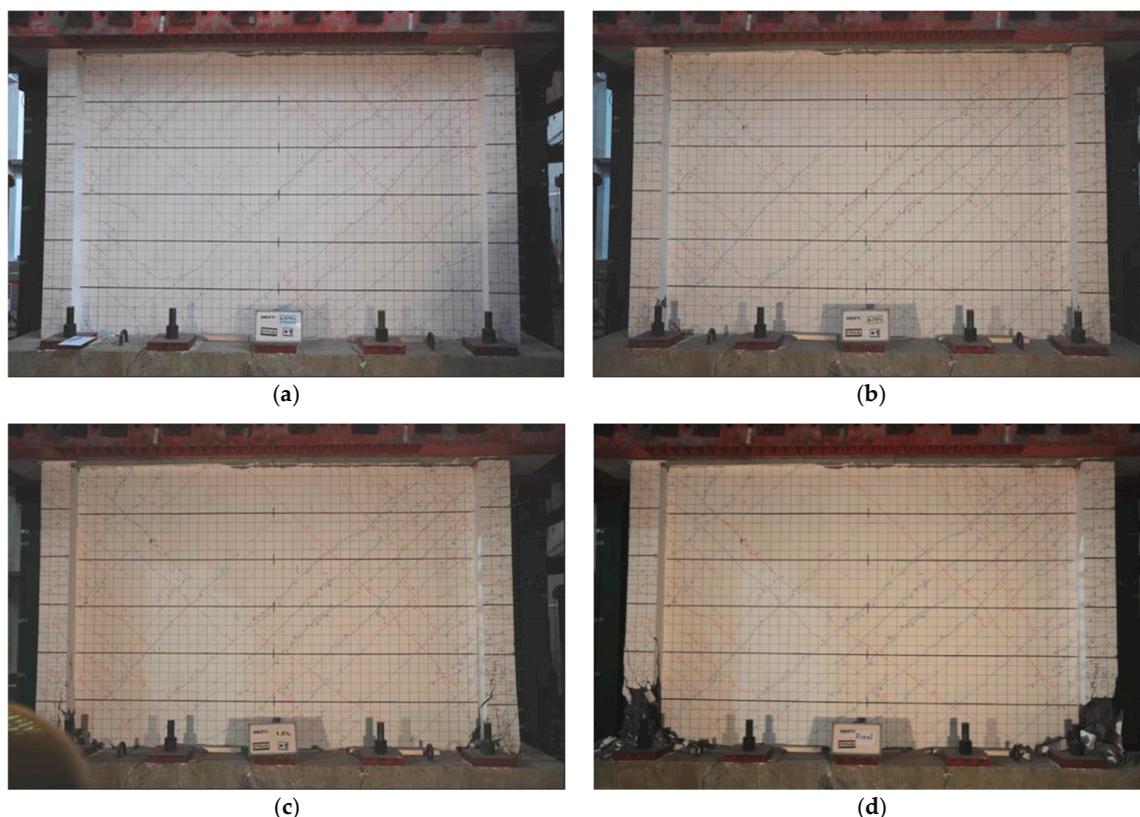
Figure 9. Failure mode of the specimen RCW1. Cracking patterns of the specimen RCW1 at (a) drift 0.25%, (b) drift 0.5%, (c) drift 0.75% and (d) final failure mode at drift 1.0%.

In specimen RCW1, the foundation and boundary column were damaged during the test because of the low compressive strength of concrete. In such a design, the existing RC frame is much weaker than the retrofitted member. Therefore, the failure occurs at an interface between the existing RC frame and the retrofitted RC wall. In specimen RCW2, the interface between the top beam and the wall panel was damaged first and then the concrete around the top corner of the wall panel was crushed. Finally, the concrete in the top region of the boundary columns was crushed and severely spalled. In this design, the strength of an interface between the existing RC frame and the retrofitted RC wall is insufficient. Therefore, failure also occurs at an interface between the existing RC frame and retrofitted RC wall.

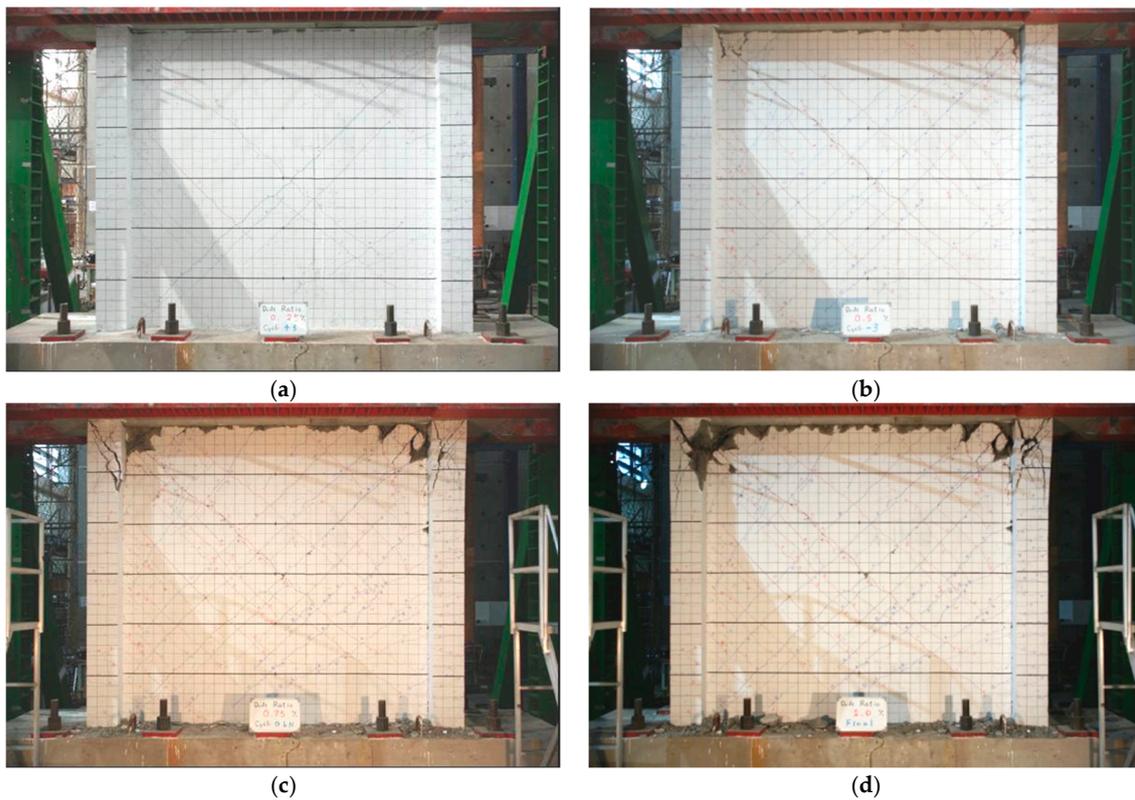
Figure 10. Cracking patterns of the specimen RCW2 at (a) drift 0.25%, (b) drift 0.5%, (c) drift 0.75% and (d) final failure mode at drift 1.0%.

For the specimen of RCW2 at the drift ratio of 0.25%, the crack development is similar with RCW1. When the drift ratio reached 0.5%, the extended cracks with the width of 1 mm at the interface between the RC wall panel and top beam are observed. Figure 10 shows the cracking patterns at each drift level and the final failure status of the specimen. The failure mode of RCW2 occurs at the drift ratio of 1.0% in which the concrete at the top end of the boundary columns and at the wall top corner crushed in the second cycle. This experimental results showed that the strength of the interface of existing RC frame and the retrofitted RC wall is not strong enough to transfer the shear force. Then, the failure could be found at the interface of the beam of the existing RC frame and the retrofitted RC wall. The failure of the interface of the beam and the wall was also resulting in the failure of boundary columns.

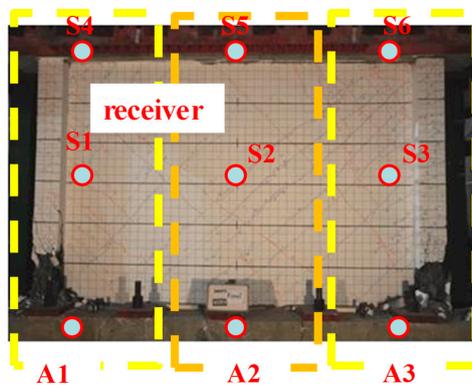
Figure 11. Regions and sensor locations for damage detection.

For each specimen, when a specified drift ratio is reached under cyclic loading, the PPTs are used to conduct SHM and to locate damage in the specimen. Figure 11 shows the concept of local damage detection; the wall panel is divided into three regions (path) and each region has a main actuator. The severities of damage in the difference regions are compared and serious damage is located. First, actuator A1, as depicted in Figures 7 and 11, is used to generate a stress wave with frequencies of 100 Hz, 1 kHz and 5 kHz. Sensors S1 and S4, which are embedded in the wall panels and beams at a middling height, receive the stress waves. The damage index in Equation (2) is calculated and the damage state in each of the propagation paths from A1 to S4, A2–S5 and A3–S6, is identified. Comparing the damage indices that are obtained upon excitation by A1, A2 and A3 reveals the severity of damage in each path and allows serious damage to be located. In SHM using a piezoelectric-based sensing system, the arrangement of actuators and sensors may strongly influence the obtained values of the damage index. Since the damage status of a structure member between an actuator and sensor differs, then damage index is affected by the locations of sensor and actuator. Therefore, the proposed method is better suited to diagnosing local damage to a structure as in this test than to diagnosing the overall damage to the entire structure. For example, in this investigation, actuator A2 was installed in the middle of the foundation and sensor S2 was installed in the center of the wall panel. The signal that was excited by A2 and received by S2 can be used to detect the local damage status of the lower center of the wall panel. Although the sensitivity limit and resolution of the sensing system may be influenced by the propagation distance of the excitation wave, the test results demonstrate that the proposed damage index reflects the severity of structural damage.

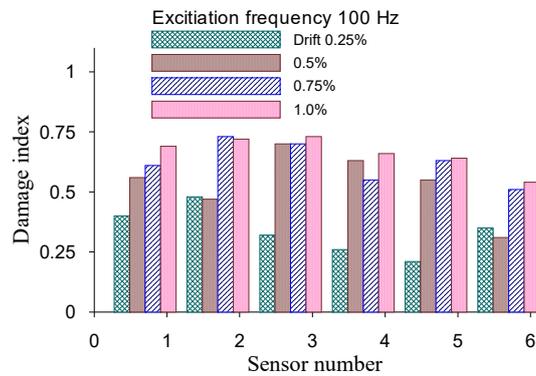
Figure 12. Damage index at each drift ratio for RCW 1 (excitation frequency 100 Hz).

Since the results obtained from the excitation frequency of 5000 Hz is similar to 1000 Hz, the work only demonstrates the results obtained from the excitation frequencies of 100 Hz and 1000 Hz. Figures 12 and 13 show the damage indices of the sensors of RCW1 at various drift ratios under the various excitation frequencies of 100 Hz and 1000 Hz. According to these figures, the damage indices and damage state of each sensor in various frequencies have an increasing trend with the drift ratio increasing. In Figure 13, the damage indices of the sensors of S1, S4, S3 and S6 at the drift ratio of 1.0% are relatively higher than those of the sensors of S2 and S5. It can be observed that the damage state in the two sides of the wall are more serious than the center area. Additionally, the results have a high correlation with the final failure pattern of the specimen including the concrete crush in the bottom region of the boundary columns. However, the damage indices obtained from the excitation frequency of 100 Hz, as shown in Figure 12, cannot identify the location with the serious damage. The experimental results have demonstrated the effectiveness of the proposed damage index that can be

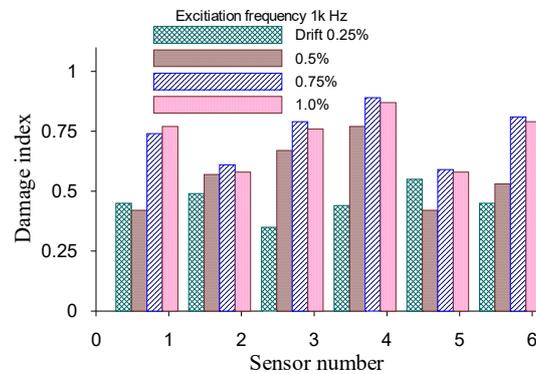
Figure 13. Damage index at each drift ratio for RCW 1 (excitation frequency 1 kHz).

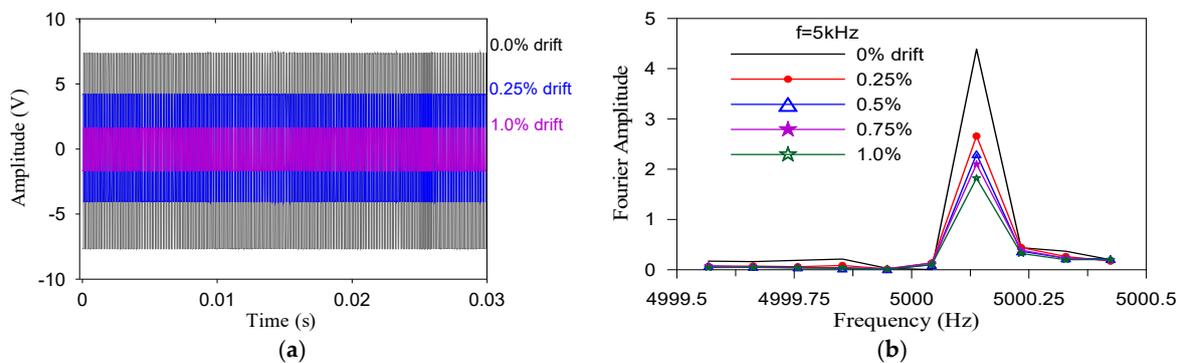
Figure 14. (a) Time history of received sensor voltage and (b) corresponding Fourier amplitude of sensor S4 for excitation frequency 5 kHz.

The loss of energy of a propagating stress wave that is caused by cracks or damage can be interestingly investigated in the frequency domain. For single-frequency excitation waves, the Fourier amplitude is concentrated around the designated excitation frequency in the frequency spectrum, so variation in the Fourier amplitude of received signals in the frequency spectrum can reveal the severity of damage in terms of the damage index that is defined in Equation (2). Figure 14 plots the time history of received sensor voltage and its corresponding Fourier amplitudes of sensor S4 under excitation by actuator A1 (frequency 5 kHz). The Fourier amplitudes around the frequency 5 kHz clearly decrease as the drift ratio of the specimen increases, indicating again that the transmission energy of the stress waves is attenuated by cracks and damage.

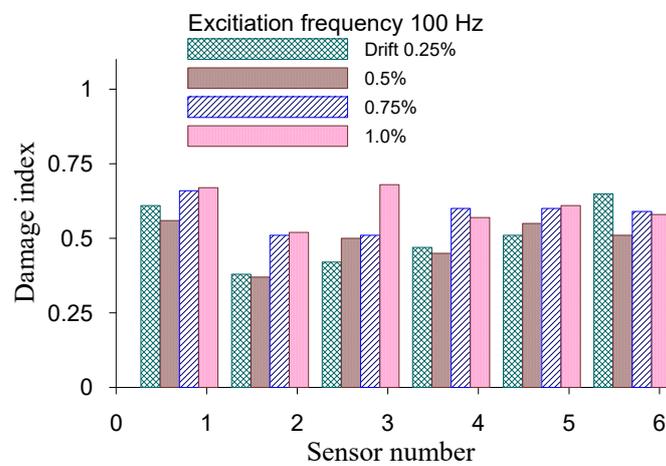
Figure 15. Damage index at each drift ratio for RCW2 (excitation frequency 100 Hz).

Figures 15 and 16 plot the testing results of specimen RCW2 at various drift ratios under excitation frequencies of 100 Hz and 1000 Hz, respectively. As the drift ratio increases, the damage indices of each PZT sensor increase, revealing a trend similar to that in Figures 12 and 13. According to Figure 16, the damage indices of sensors S4-S6 at the final drift ratio of 1.0% are higher than those of sensors S1-S3, mainly because the damage state in the upper region of the wall is more serious than that in the bottom region. The results are also strongly correlated with the final failure pattern of the specimen, including concrete spalling in the top region of the wall panel and crushing of the concrete in the boundary columns. Minor interface cracks between the existing top beam and the wall panel are observed at a drift ratio 0.25% during the test. The damage index of sensor S5 in Figure 16 is obviously higher than the indices of other sensors, especially sensor S2, at this drift ratio. This result is consistent with experimental observations and demonstrates that a PPS sensor can effectively detect interface cracks between structural members. Experimental results demonstrate that the piezoceramic-based method not only provides sensitive structural health monitoring but also is effective in the location of damage in concrete wall structures.

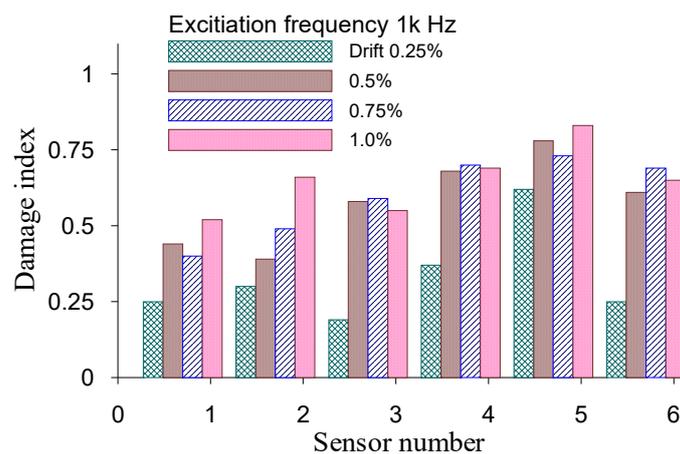
Figure 16. Damage index at each drift ratio for RCW2 (excitation frequency 1 kHz).
