Article

Safety Improvements on Wood Chippers Currently in Use: A Study on Feasibility in the Italian Context

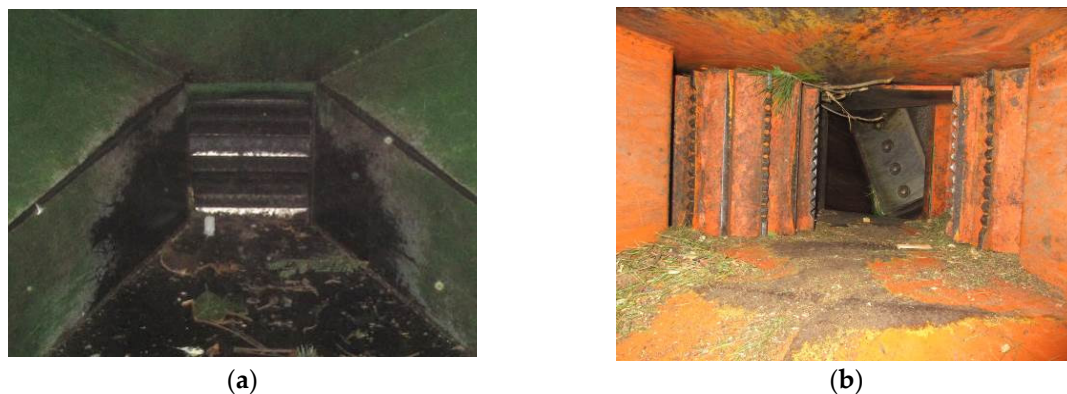
The recruited manually-fed wood chippers were all equipped with integrated infeed components (rollers) and disk-type chipping components with a variable number of knives (Figure 1). The mean age of the studied machinery was about 14.5 years. The oldest one was manufactured in 1989, and the most recent was manufactured in 2014.

Figure 1. Detail of infeed components (rollers) (a) and knife on the disk shaft (b) of the surveyed in-use wood chippers.

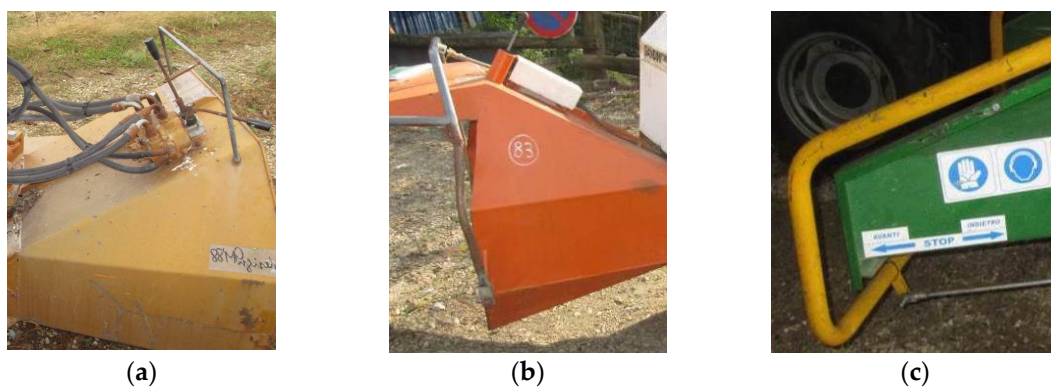
Although the control mechanism of all machines included the three compulsory functions (“Feed”, “Stop”, and “Reverse”) some position and functional requirements were disregarded. The infeed area was not always visible due to the design of the chute and the control bar. Indeed, in one instance (Figure 2) the upper part of the chute was prolonged by a plate and was encased by a bulging safety bar that did not allow a direct view of the infeed area. Moreover, the positions and functions of operator controls were not always clearly indicated, while these should have been affixed near the control device on both sides of the chute. Especially in older units, respective safety pictograms were deteriorating or missing altogether (Figure 2).

With regard to functional requirements, even in the most recent examined units, the “Reverse” function was not provided with the “hold to run” function.

Figure 2. Examples of non-compliant infeed controls for in-use wood chipper. Details shown in figure (a) and (b) highlight the lack of any indication of machine operator controls; while figure (c) shows that the pictograms are placed in the correct position, but the functional requirements are not. Each of the examples included the reverse function but there was no “hold to run control” as requested by the paragraph 4.2.4.3 of the 6th revision draft of EN 13525.

According to the last revision draft of the standard, the “reverse” function should always be hold-to-run, but for the moment, this condition is not available on current machines. In fact, as observed during the onsite inspection, in most cases the “reverse” function is activated by a maintained position and it is mechanically controlled. With regard to this issue, both users and manufacturers expressed some perplexities about the standard’s required implementation but also about its functionality. Generally speaking, respondents found difficulty in understanding the section of the revised draft that shows the combination of infeed controls allowed for lower protective devices. In particular, a couple of final users interviewed contested the worth of an optional reverse function beyond the chute edge, but this was probably because they were accustomed to other control configurations.

Finally, one of the two manufacturers consulted proposed a feasible solution involving working on the control of the existing hydraulic distribution system. If the hydraulic distributors are to adapt to the safety requirements imposed by the draft, they must be replaced in a sustained position by others, thereby providing the “hold to run” control.

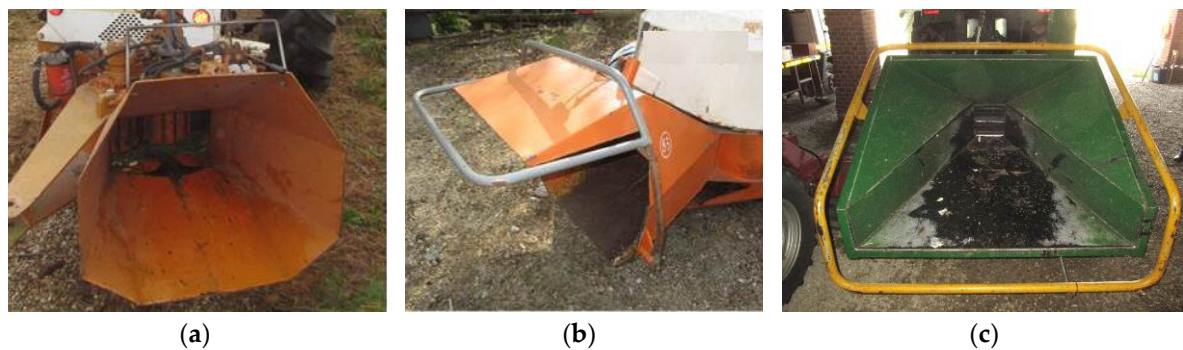
Half of the machines inspected completely lacked or presented incomplete lower horizontal and side vertical protective devices around the infeed chute edges (Figure 3). These protective devices

The safety devices in the oldest of the units were not red and yellow as recommended by the standard nor were they in bright colors contrasting with the background color of the infeed chute. In those cases, when lower and side protective devices were present, these did not always comply with the location regulations. In particular, regarding side protective devices, in some cases the distance from the outermost edge of the infeed chute was shorter than the standard 150 mm and did not cover at least the 75% of the maximum vertical opening of the infeed chute.

Figure 3. Some examples of protective devices that do not comply with standard requirements. (a) This machine presented no safety devices around the edges of infeed chute. (b) Side and upper protective devices were present, but there was no lower protective device (mandatory for the standard). (c) The infeed chute was equipped with side, lower and top protective devices, but in order to comply with the safety standard draft, the top protective bar should have a separate control or be replaced by an emergency stop.

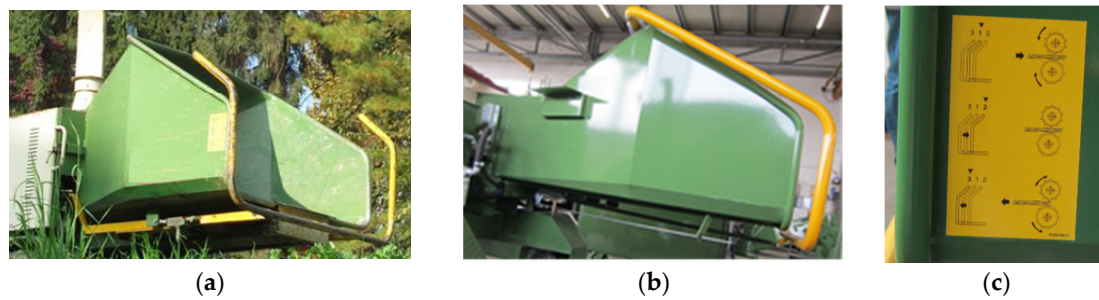
The standard revised draft obliges all machinery to be equipped with a Top protective device consisting of one or more different devices that have the exclusive function of halting the infeed components. Unlike lower and side protective devices, the top horizontal bar is for intentional activation from both sides outside of the chute and from the ground. Among the examined case studies, a third of the verified machines did not have any top protective device, while in other cases where a top bar was provided, it was not completely independent from the other controls, meaning that it defaulted on one of the main functional requirements (Figure 4). The combination of a top protective device with other controls prevents a further condition: the operator cannot restart the infeed process merely by returning the top stop protective device to any position. In those machines surveyed that were equipped with the top protective device, the top bar is connected to the functional requirements and follows the same control patterns of the lower and side protective devices, meaning that the infeed action cannot be activated by a separate control. Likewise, for the lower and the side protective bars, the color of the protective device was not always respected.

Figure 4. Examples of the different configurations of protective devices. On the left (a) the chute was found non-compliant due to the lack of a top protective device while in a more recent unit (b) the top protective bar is combined with side and lower protective devices and these respond to the same controls (c). This solution does not conform to the standard either as the top protective device should be independent and there are no emergency stops.

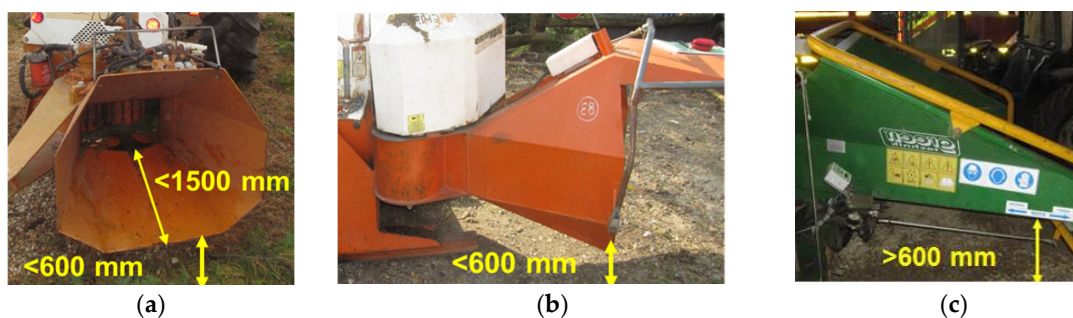
According to the standard, the height of the chute floor should be 600 mm from the ground and the chute itself should be 1500 mm deep, machines with a lower chute height and/or depth are hazardous as the operator can easily get their hands or feet stuck in the moving parts. In half of the infeed chutes inspected, the lower edge of the infeed chute was insufficiently distant from the ground, and in one instance the horizontal distance from the outer edge of the chute to the reference plane—corresponding to the feeding rollers—was not deep enough (Figure 5).

Figure 5. Case studies of infeed chute of in-use wood chippers. Following onsite measurements, in the first case (a) the lower edge of the infeed chute was lower than 600 mm from the ground and the chute was less than 1500 mm deep, in the second example (b) only the height of chute did not conform to standard requirements, while, in the last example (c) all positional measurements of infeed components were satisfactory.

The standard demands set dimensions for the infeed chute and precise distances from the ground. The manufacturers interviewed confirmed that they were aware of the standard conditions and dimension requirements regarding wood chippers, as referred to in the previous version of the standard. Most of the recently designed models of manually-fed wood chippers do fulfil such conditions, while the older ones require intervention for compliance of different level of complexity. Both users and manufactures pointed out potential issues related to the stability of the machine in the event of interventions, such as increased infeed chute height and extended chute depth.

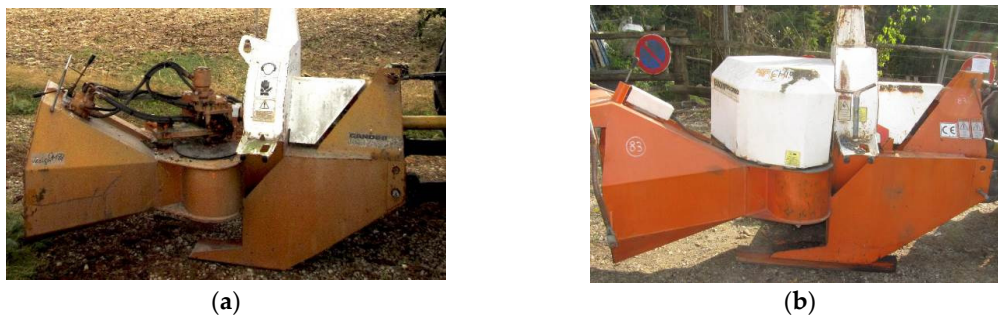
The designated feeding area is defined in the standard as “one or more safe areas around the machine indicated by the manufacturer when the operator is manually feeding the machine” and it is particularly important since as it is used as a reference point in defining the positional requirements of operator controls. This area should be determined by the manufacturer, but in the samples examined, the machines lacked clear indications as requested by the standard (Figure 6).

Figure 6. Specimens of the same model of wood chipper manufactured in different years on which lacked feeding area identification and safety pictorials were worn or incomplete. Moreover on (a) the hydraulic components are freely accessible while in (b) they are housed in a metal protection case.

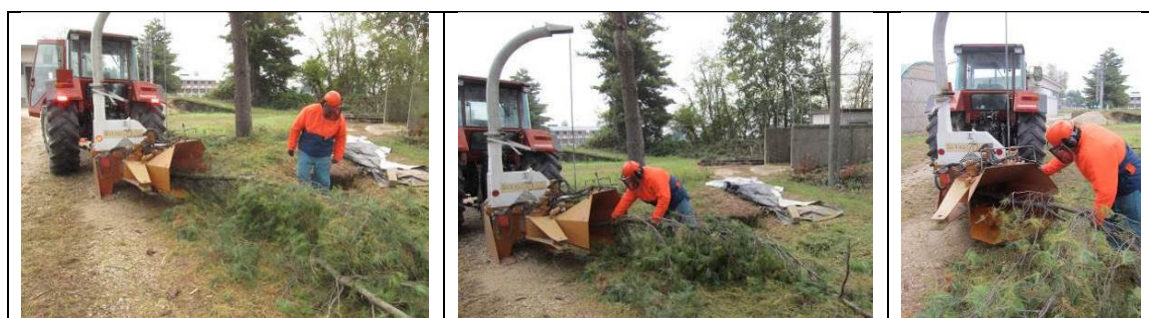
On the machines under inspection, the speed of wood tested below the limit of the maximum nominal speed of 1.0 m s^{-1} defined in the standard. The average speed of the tested logs was 0.2 m s^{-1} (Figure 7). The time wood takes to travel from the outermost edge of the chute to the rollers is particularly significant as it is closely tied with the time required by the standard for protective devices to stop infeed components. Increase in wood speed increases the speed of entanglement and reduces the reaction times for dealing with a dangerous situation.

Figure 7. Images of the procedures followed during the wood speed test, operated with a 28-years-old wood chipper.

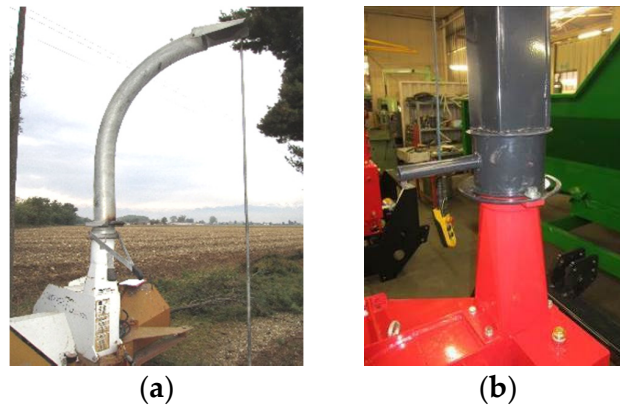
When chipping, discharge chute rotation should be limited to 20 degrees from a line drawn through the center of rotation and the outer edge of either side of the infeed chute. In some specimens of wood chippers inspected, it was possible to direct the discharge chute over the infeed chute, and in one case in particular, no obstacles were present to limit the rotation (Figure 8).

Figure 8. In some of the study cases (a) and (b), the discharge chute could be fully rotated, therefore well beyond the limit defined by the standard draft.

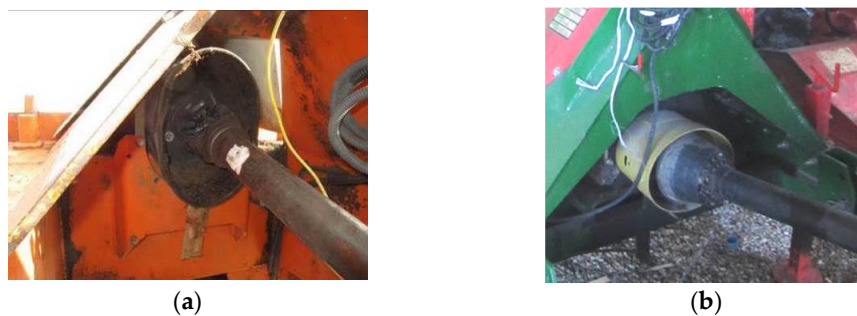
All the machines inspected were powered by a tractor PTO. In two cases, moving power transmission parts were not adequately shielded by fixed repair such as a PTO safety shield (Figure 9).

Figure 9. Example of observed unshielded power take-off (PTO) shafts (a) and partially shielded PTO (b) Hydraulic components (§ 4.4.2 6th revision draft of EN 13525).

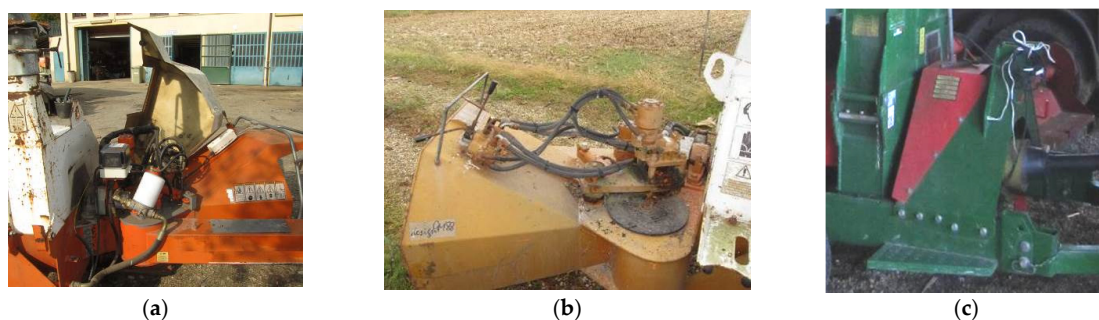
In all the units inspected, hydraulic components were protected by a hood, but in the case of the two oldest units, the protective hood was merely hinged rather than bolted with interlocks, meaning that it was not firmly fixed to the machine (Figure 10).

Figure 10. Observed case studies of wood chippers: pictures (a) and (b) show chippers equipped with an easily removable hood that, when open, leaves the hydraulic lines without protection, on the right (c) a case study with a fixed repair (bolted hood).

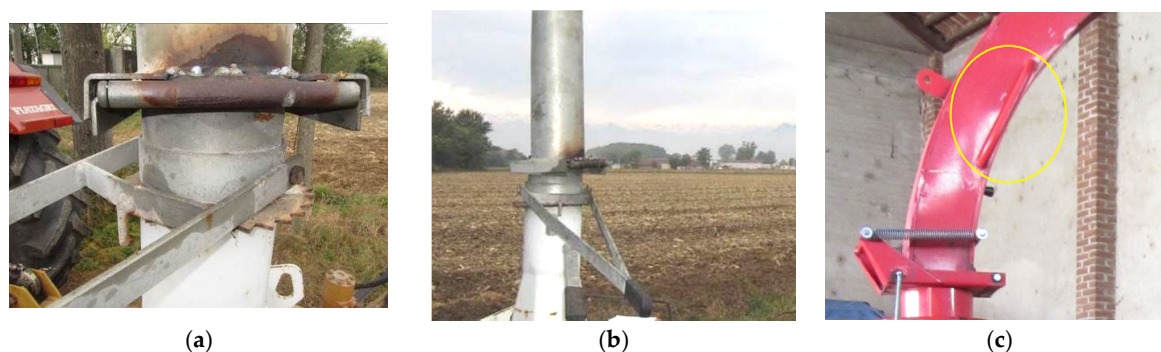
The infeed and discharge chutes/conveyors lacked handles near the articulation point to be easily folded for transport or maintenance (Figure 11). Even though this solution is not a hazard prevention device in any way, in terms of safety standard compliance, the implementation of required features has economic implications.

Figure 11. The discharge chute of the examined machine (a) and (b) was lacking in the two handles requested by the standard draft. These should be located at a distance of at least 300 mm from the nearest articulation point as shown in the picture on the right (c).
