Article

# Shoreline Changes from Erosion and Sea Level Rise with Coastal Management in Phuket, Thailand

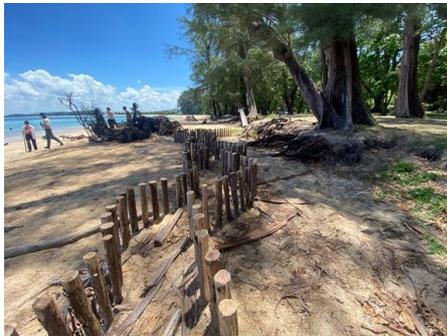
PKT1

Coastal Structure	Photo	Location
Wooden beach fence

From the field observation, there were 10 coastal structure types in the study area, which were wooden beach fences, gabions, revetment seawalls, vertical seawalls, step seawalls, and geotextiles. Their locations and example photos are shown in Table 3.

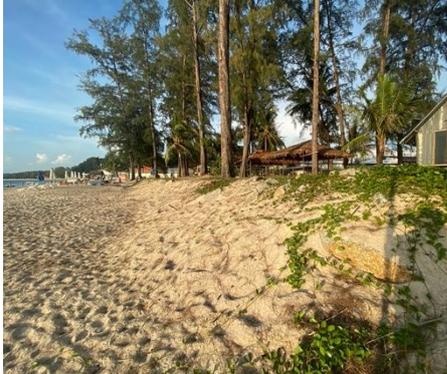
Coastal Structure	Photo	Location
Gabian

PKT7
Revetment seawall

- (2) Bang Tao beach (PKT7) has many coastal protection structures that are disorganized, which may cause coastal erosion. The stakeholders and organizations in this area must determine the efficiency and organize all structures together.

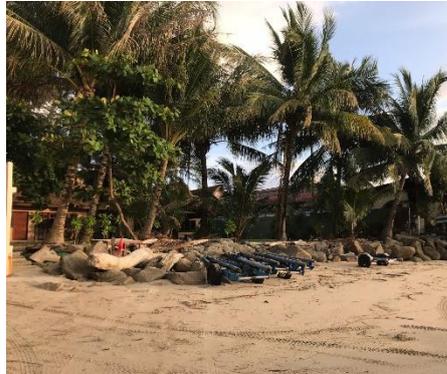
PKT7, PKT16, PKT33
Vertical seawall

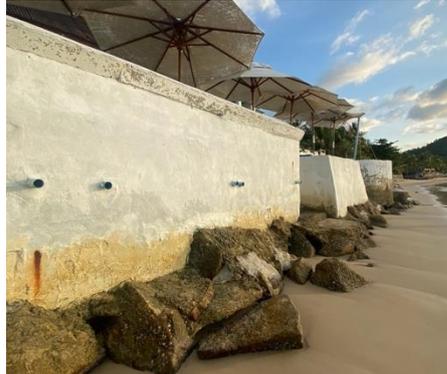
PKT7, PKT12, PKT13, PKT14, PKT20, PKT21, PKT22, PKT24, PKT26, PKT31, PKT33
Step seawall

- (6) Hua beach (PKT13) has a sea wall along the coast, which may cause erosion problems. This location has a public-access park near the beach, but it does not have good scenery because of the improper design of the seawall. Hence, seawall renovation and landscape design are essential for this location to be used for recreational purposes.

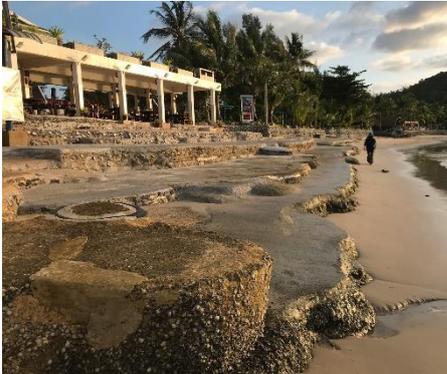
PKT7

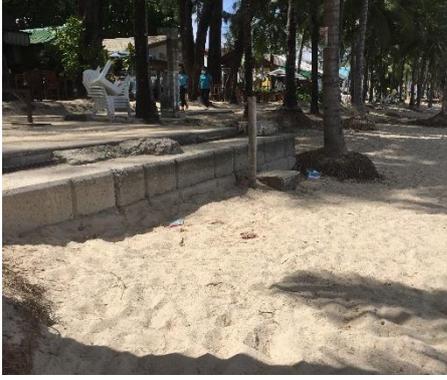
PKT15
Durahold retaining wall

PKT11, PKT16, PKT19, PKT25
Curve seawall

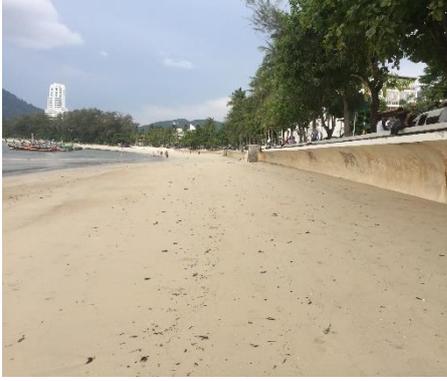
PKT17, PKT19
Pathway

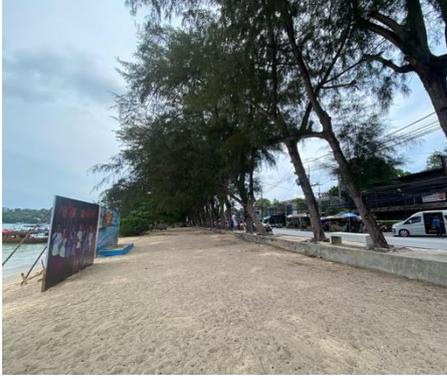
PKT33
