The Making of a Gravel Beach (Cavo, Elba Island, Italy)

Abstract: This paper presents the history and evolution of the different projects carried out from 1999 to 2008 at Cavo beach in the Elba Island, Italy. The village of Cavo almost completely lost its beach in the 1970s due to the reduction of sedimentary input, and the backing coastal road was defended by a revetment and two detached breakwaters. Such severe erosion processes continued in the following years and impeded any possibility of beach tourist development. In 1999, a project based on the removal of existing breakwaters and beach nourishment works based on the use of gravel as borrow sediment and the construction of two short groins to maintain nourished sediment, raised environmental concern and did not find the approval of the stakeholders. They were worried about the characteristics of the sediments, i.e., waste materials from iron mining rich in red silt and clay. Such sediment fractions made the sea red during the nourishment and deposited on the *Posidonia oceanica* meadow in front of the beach, with a potential environmental impact. Furthermore, they cemented the gravel fraction forming a beach rock. Between 20

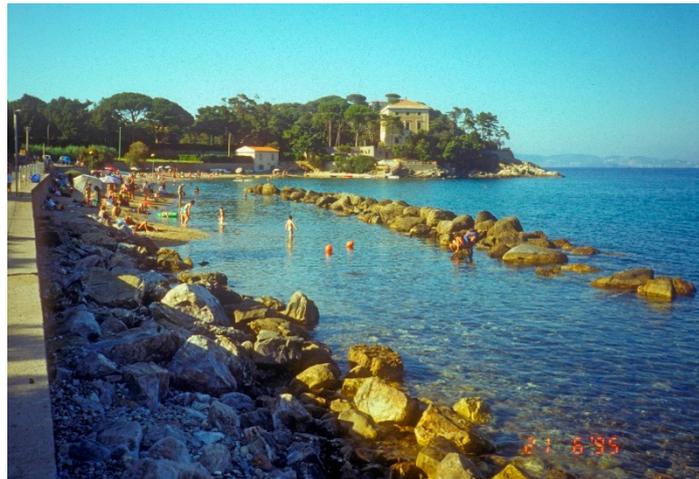
Figure 2. The central part of the beach at Cavo in June 1995.

At the end of the 1990s, the beach in front of the village of Cavo was constituted by only two narrow strips of sand, one close to the northern headland and one leaned on the marina downcoast dock. In addition, the coastal road was defended by two detached breakwaters and by a revetment (before 1954) making difficult and extremely dangerous the use the beach for bathing activity (Figure 2).

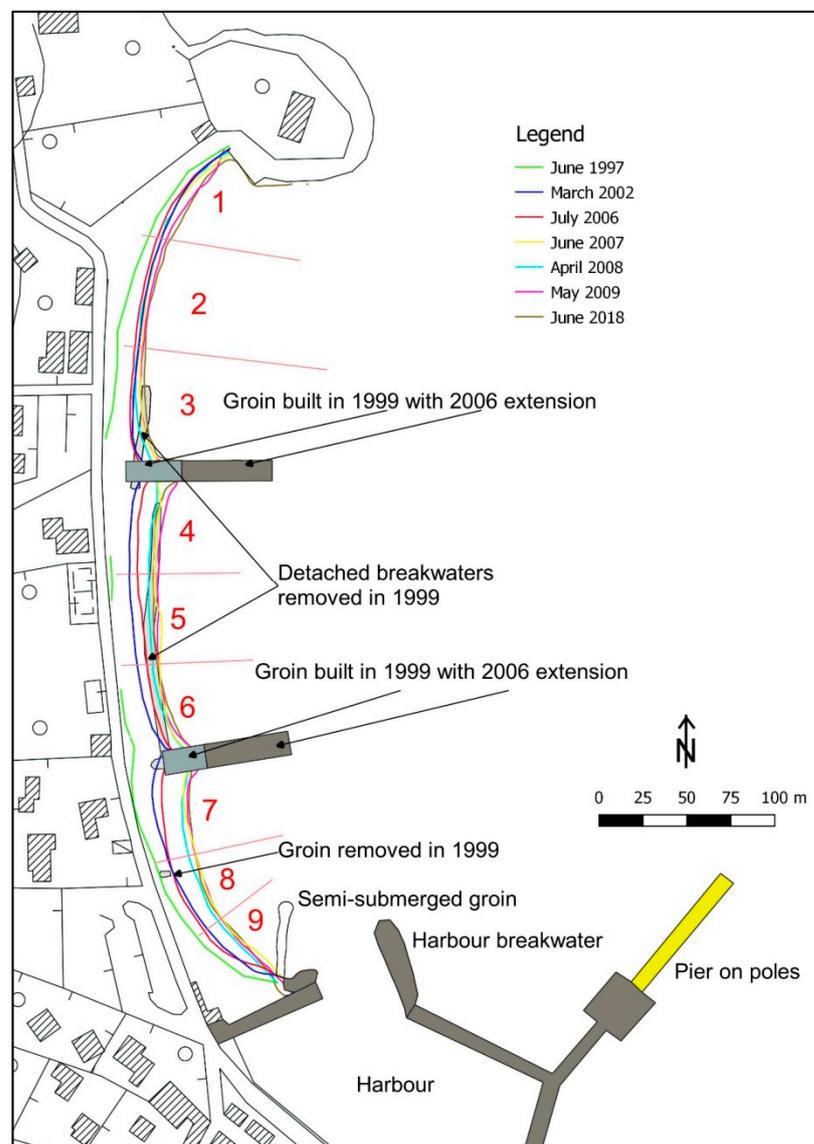
Figure 3. Shoreline (zero isobath) evolution at Cavo from 1997 (before the first nourishment) to 2018 (ten years after the end of the second nourishment). In red sectors number.

In 1999 a project was carried out to create a 10-meter-large beach in front of the street wall. The previous detached breakwaters and the revetment were removed, and two short groins constructed to divide in three parts the 497 m long coastal sector delimited by the headland to the north and the marina to the south (Figure 3).

The first nourishment induced a notable dry beach expansion, with the March 2002 beach 9.8 m wider on average respect to the June 1997 one (Figures 3 and 7; Table 2).

From March 2002 to July 2006 the beach was as a whole stable, with only some sediment shift from the side sectors to the central ones (no. 4 to no. 7; Figure 3; Table 1), favoured by the low groins height.

This beach nourishment was not homogeneous along the coast but concentrated where the beach was narrower. The different dry beach expansion is visible in Figures 3 and 7 and in Table 2: external sectors 1, 2 and 9 received a limited or null volume of sediments, whereas the central ones obtained more (Table 2). Such distribution of nourished sediments was essentially aimed to cover the previously deposited iron-rich material (1999 nourishment), more than to expand the beach.

From June 2007 to April 2008, i.e., in the first winter after the nourishment, all the sectors of the beach recorded moderate erosion (Figure 3): overall beach surface reduction was approximately 1189 m², with a mean beach retreat of 2.26 m.

When comparing the evolution of the different sectors (Figure 3), a very homogeneous behaviour is observed and characterised by synchronous accretion and erosion in the period 2006–2009, showing that no significant beach rotation occurred in each cell.

It is only in the nine following years (May 2009–June 2018) that the three cells show a slightly different behaviour. In the northern one (sectors 1–3), sector no. 1 accretes more than the others, which results in a slight clockwise rotation, although within a general beach progradation. On the contrary, the central cell (sectors 4–6) behaves in an opposite way, with the first sectors eroding and the latter accreting, with an anticlockwise rotation and limited beach erosion. In the southern cell (sectors 7–9) a widespread but limited beach accretion is measured, especially at the central segment (no. 8, Figure 3).

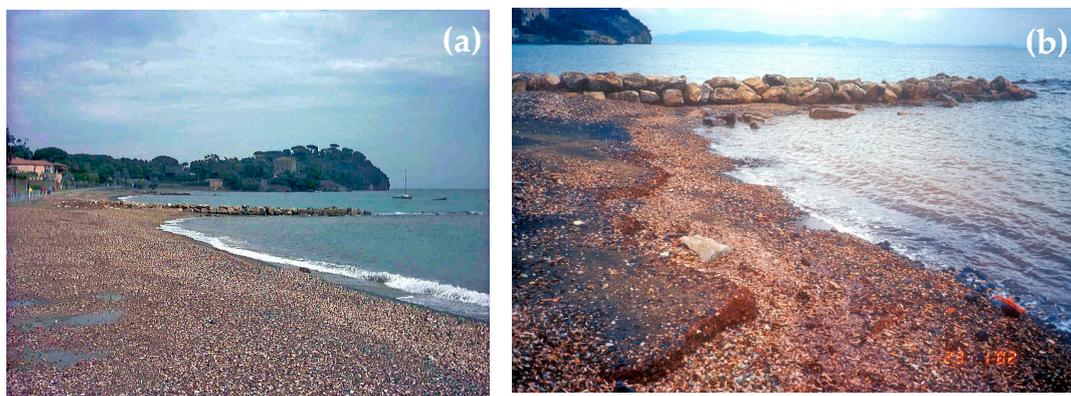
Figure 4. The beach at Cavo in January 2002, after the nourishment performed with iron rich materials with puddles showing the low permeability of the sediments (a); outcropping of the consolidated and impermeable fill material layer (b).

In the months after the nourishment, the borrow material compacted and became impermeable because something similar to a beach rock was formed (Figure 4) so that, during the following winter storms, run up water was not able to infiltrate into beach sediments and reached the coastal road [31]. Permeability measurements were performed by the University of Florence in three points of the beach (north, centre, south), giving a permeability coefficient (K_s) between 5.0×10^{-6} and 1.3×10^{-7} m/s (typical of silty to silty-clay sediments).

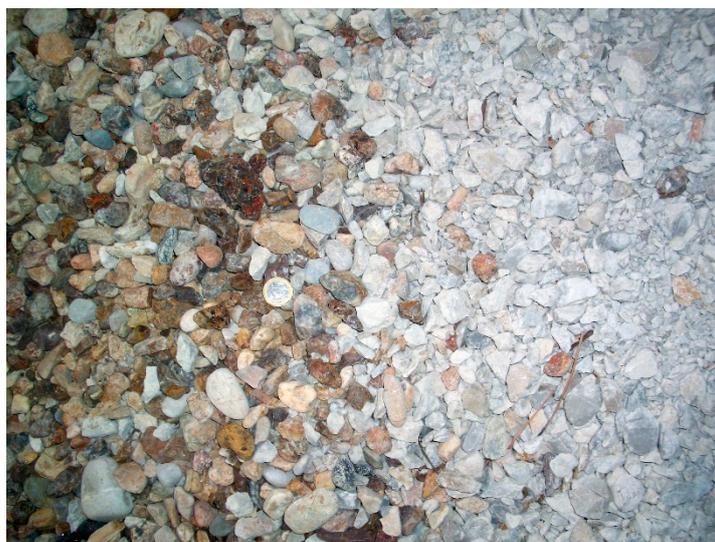
Figure 5. Fill materials used at Cavo: on the left side the iron rich mining waste, on the right side the new carbonate sandstone of the second nourishment. One euro coin for reference at the centre of the photo.

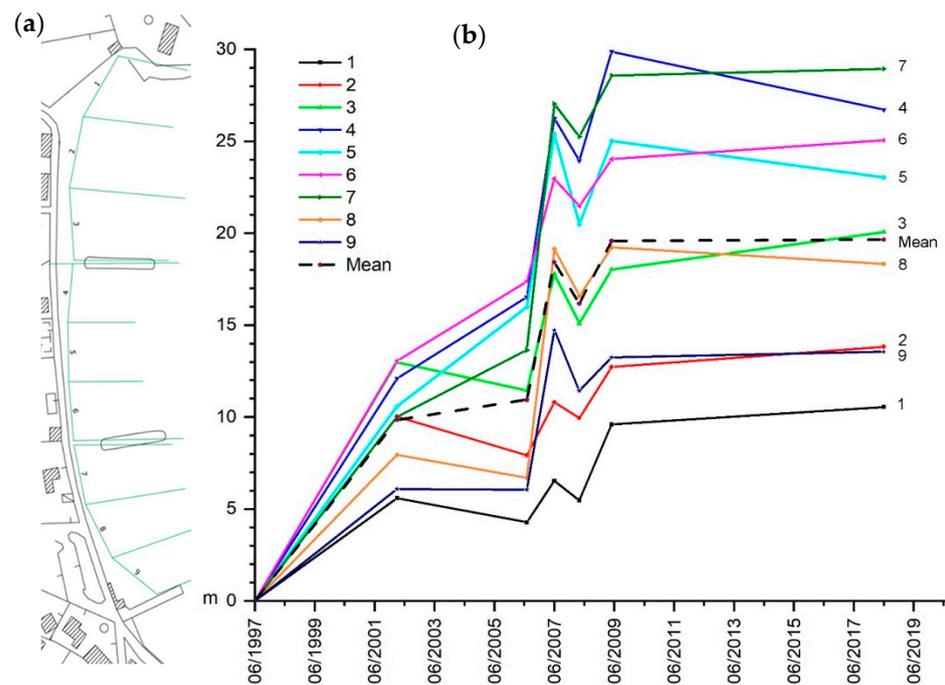
Figure 7. Location of sectors (a) and sectors and total mean beach width evolution (b) from 1997 to 2018. First nourishment 1999; second nourishment 2006–2008.

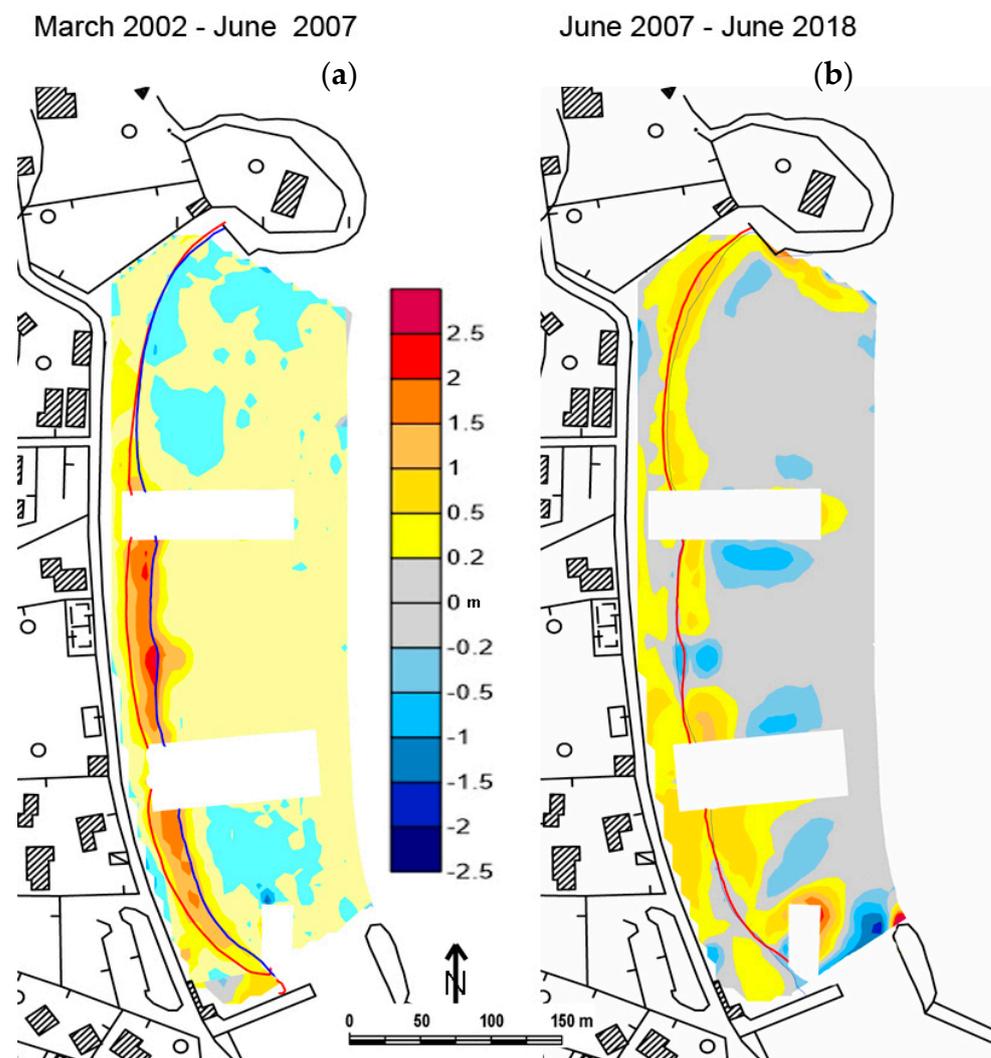
Figure 8. Beach vertical changes (m) at Cavo considering the 2002–2007 (a) and 2007–2018 (b) surveys.

Concerning beach morphology, the beach profile constructed during the nourishment works was flat and wide; in the following months, after the impacts of winter waves, storm berm crests were observed. This involved the migration of material from the swash zone to a more internal position, with a reduction of the beach surface, but without changes in gravel volume, as proved by elevation change maps (Figure 8).

To assess the morphological evolution of the beach, and the sediment budget of the emerged and the submerged parts, 3D topo-bathymetric models produced in each survey were compared limiting the offshore part to that in which full overlapping was possible, i.e., down to ca. 5 m water depth (Figure 8).

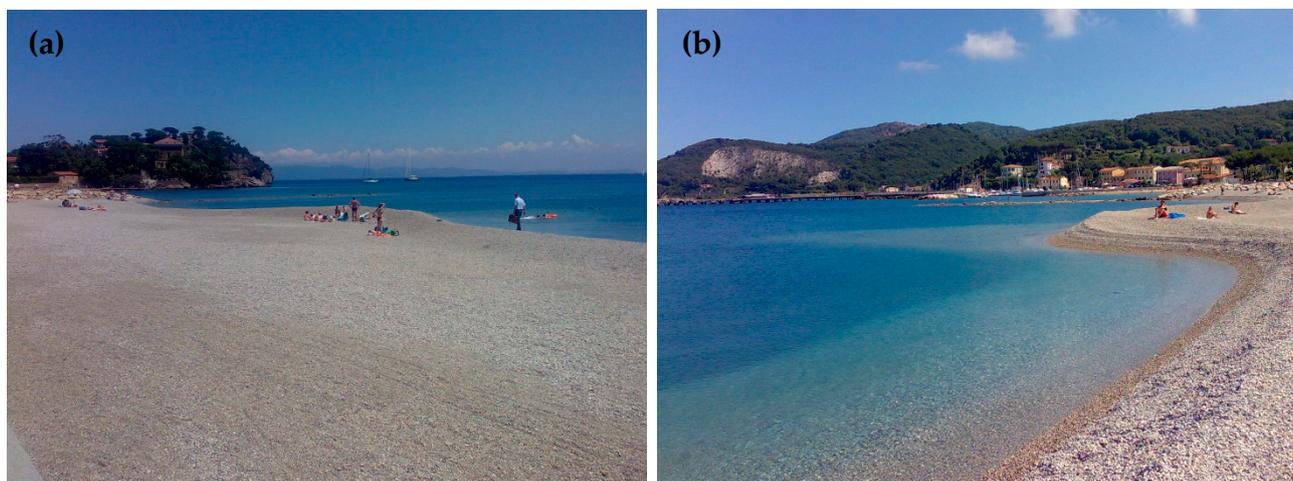
Figure 9. Northward (a) and southward (b) views of the remains of the filling groins on 18 June 2008.

From May 2002 to June 2007 the direct effect of the nourishment is visible with beach surface rising both on the dry beach and on the submerged profile, especially in the central cell, where most of the volume was deposited. At the centre of this cell a lobe is evident, where the main feeding groin was positioned (Figure 9).

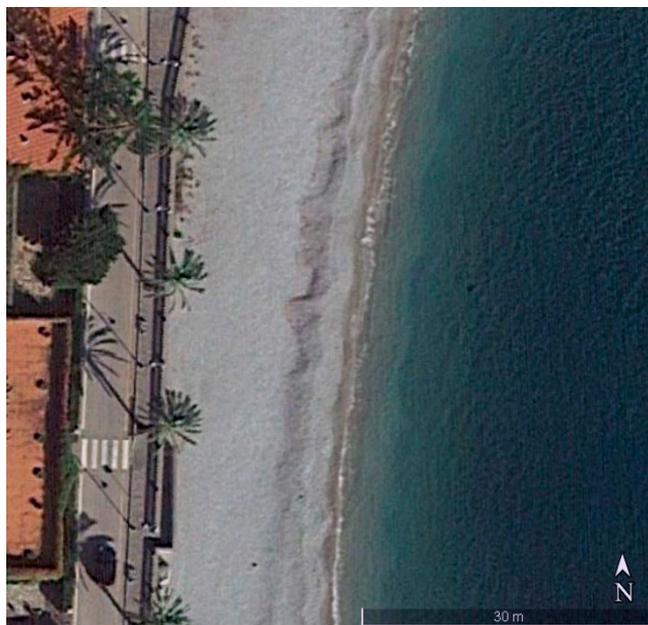
Figure 10. Storm berm crest on the Northern Cell, October 2018 (Google Earth).

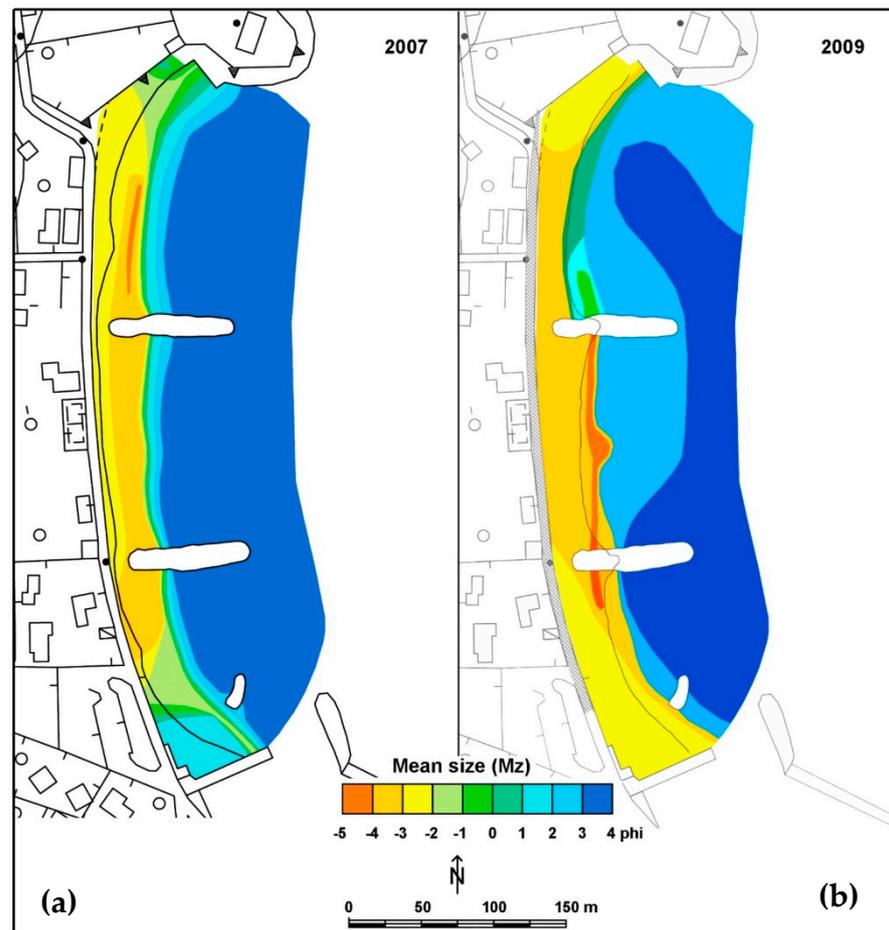
Figure 11. Sediment mean size (M_z) in June 2007 (a) and May 2009 (b).

A first sedimentological study was performed in June 2007 (Figure 11a), i.e., at the end of the second nourishment work, when sediments have not yet been sorted by wave action

A second sedimentological survey was performed in May 2009, before beach raking, to assess whether offshore gravel displacement occurred or not. Results (Figure 11b) show that all the gravel remained in the dry beach or in the nearshore close to the shoreline, with no sediments coarser than 2.0 phi (0.250 mm) offshore of the 2 m isobath, confirming the cross-shore sorting of sediments observed in other natural [34–37] and artificially nourished beaches [21,37]. The coarsest grains of the nourishment, between -5 and -4 phi (16 and 32 mm) were found in the central cell, all along the beach step and, between -1.5 m and -2.0 m, in the point where the filling groin was located. There, coarse and very well sorted lag deposits are present. In addition to this, evident is a lobe of 2–3 phi (0.250–0.125 mm) sediments in the central area, possibly due to a limited migration of the fine grains present in the fill material.

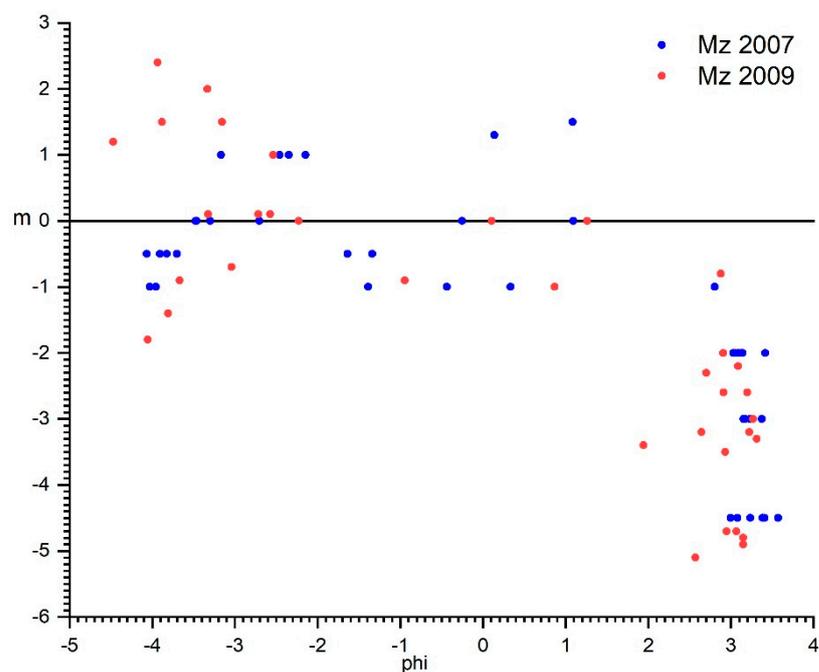
Figure 12. Mean size (ϕ) vs. Depth (m) for the sediments at Cavo in June 2007 and May 2009.

Both 2007 and 2009 grain size data show that below the 2 m isobath, where wave energy is lower, no gravel is present (Figure 12).

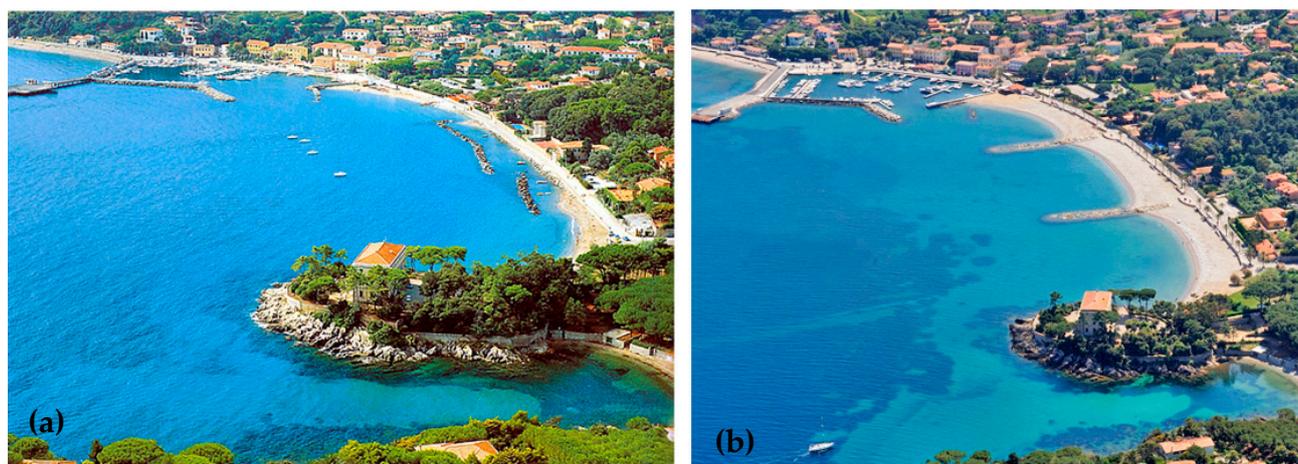
Figure 13. The beach at Cavo before (a) and after (b) the works (Courtesy Elbaworld).

The wide beach, the transparent coastal water, the new promenade (Figure 13), and beach services (Figure 14), were all made possible thanks to the choice to build a gravel beach, demonstrating that coarse sediment nourishment can be a viable solution to beach erosion, especially in areas where sand is not available, or its use should be accompanied with harder shore protection structure.
