Methods and Products for the Conservation of Vandalized Urban Art Murals

Abstract: The possibility of contemporary mural paintings to be “tagged” by vandals, with spray and/or markers, represents a serious problem for the conservation of urban art. The present study aims to define the applicability of a protective coating on murals’ surface to preserve them against vandalism. The research has been focused on anti-graffiti products currently used in the field of cultural heritage conservation. These products represent an optimum start point to preserve mural artwork from vandal actions. The commercially available anti-graffiti products have been compared with an innovative product, PRO-ART, specifically formulated by YOCOCU in collaboration with Pelicoat, for the conservation of murals. At the same time, it has tested the cleaning of contemporary murals by using different mixtures of solvents and surfactants. The experimentations have been carried out on external walls, followed by the conducting of in situ tests (application tests, empirical evaluations and colorimetric analysis), as well as laboratory investigations (contact angle and optical/electronic microscopy).

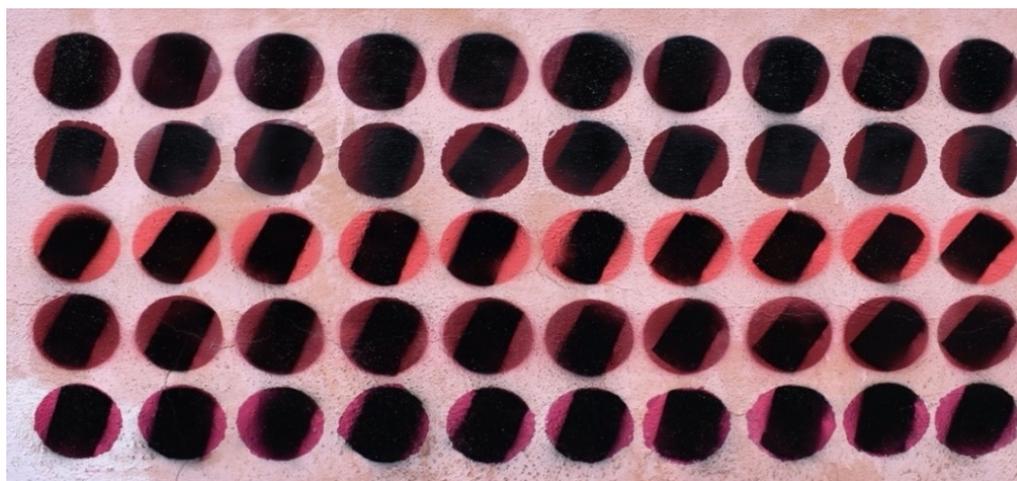
Figure 1. Vandalism carried out on selected specimens for cleaning tests.

A simulation of an act of vandalism was performed on specimens (coated and uncoated by anti-graffiti) by using a MTN94 black aerosol paint, the same as paint A (see Table 1), except for the color. In order to check the distribution of the coating on the surface and their possible penetration, TiO₂ and ZnO have been added (5% *w/w*) to the coatings as a contrast agent for electronic microscopy observations.

The efficacy of several mixtures of solvents and surfactants on samples (Figure 1) were tested. The following materials were used: water, ethanol, acetone, DBE-LVP (a mixture of dimethyl adipate/dimethyl glutarate, having a low vapor pressure), 2-methyltetrahydrofuran (2-MeTHF), which represents a greener alternative to common organic solvents [20], Tween 20 (a non-ionic surfactant) and sodium laureth sulfate (an anionic surfactant). The cleaning tests have been carried out by wiping the surfaces with a swab containing the mixture, and making visual inspections by evaluating empirical parameters such as the progressive coloring of the swab, how many strokes were needed to start removing the black layer, and how much solvent was needed (details are reported in Supplementary Materials).

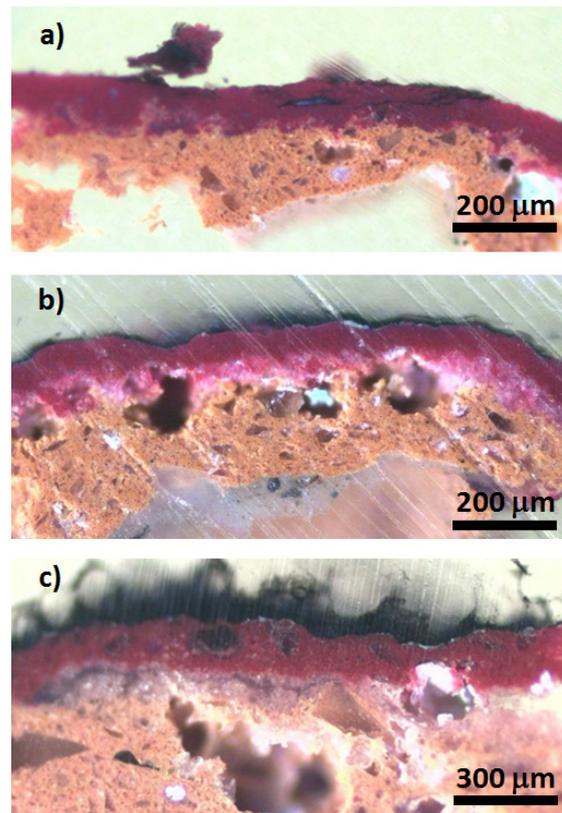
Figure 2a shows the stratigraphy of a MTN94 ink as paint, vandalized and without any protective coating. It is clear that the black layer penetrates into the red layer, and this occurs because the solvent of the black paint can dissolve the underlying paint. In Figure 2b the MTN94 paint coated with KEIM is shown; here penetration did not take place because of the protective layer. Figure 2c illustrates the following sequence: IVAS SP as paint, PRO-ART as coating, and the black layer on the top. In this case there is a visible penetration of the black layer into the red one; this is due to the porosity of the substrate, which leads to the penetration of the coating as well. SEM EDS analysis was carried out on samples treated with coatings containing TiO₂ and ZnO (materials which have a great contrast in BSE mode), in order to assess the location and distribution of the coatings within the sample. Results revealed a certain penetration of the coatings when the vandal layer is applied. In Figure 3a, a layer containing Ti is visible on the top, while in Figure 3b such a layer is less visible. This fact can be due to the solvent effect exerted by the thinner on the black paint. Generally, there was found a good homogeneity of the coating detected by Ti and Zn mapping (Figure 3c).

Figure 2. Microscopy images of: (a) MTN94 paint—vandal layer; (b) MTN94 paint—KEIM coating—vandal layer; (c) IVAS SP paint—RO-ART coating—vandal layer.

Microscopic observations suggest that anti-graffiti applications can avoid the penetration of the vandal layer into the substrate, although significant color variations were detected by colorimetric analyses. Higher values were revealed as LOOP paint was coated with anti-graffiti. PRO-ART coating seems to be the best product in terms of color changing.

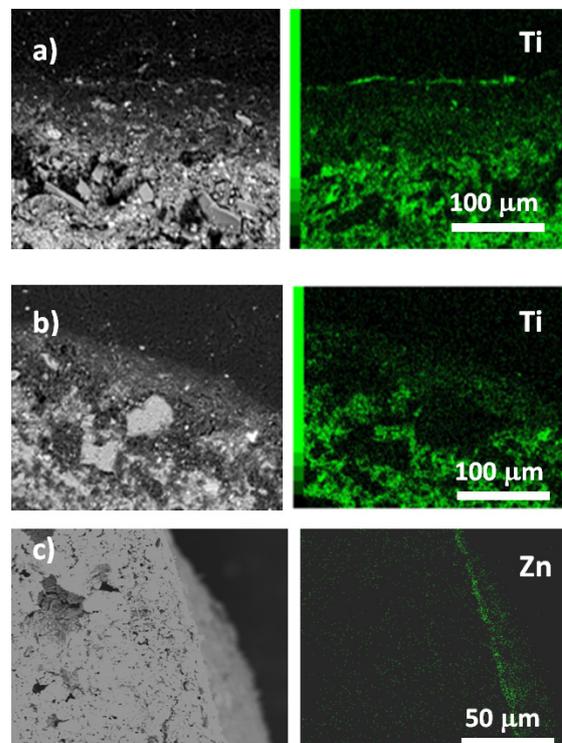
Figure 3. SEM-EDS images (SE/BSE on the left and EDS elemental map on the right) of: (a) MTN 94 coated with Pro-Art (TiO_2), it is visible a continuous layer of TiO_2 on the top (b) MTN 94 coated with Pro-Art (TiO_2) with vandal layer, there is not any visible layer of TiO_2 on the top (c) MTN 94 coated with PRO-ART, the Zn map suggests a homogeneous distribution of the coating on the surface.

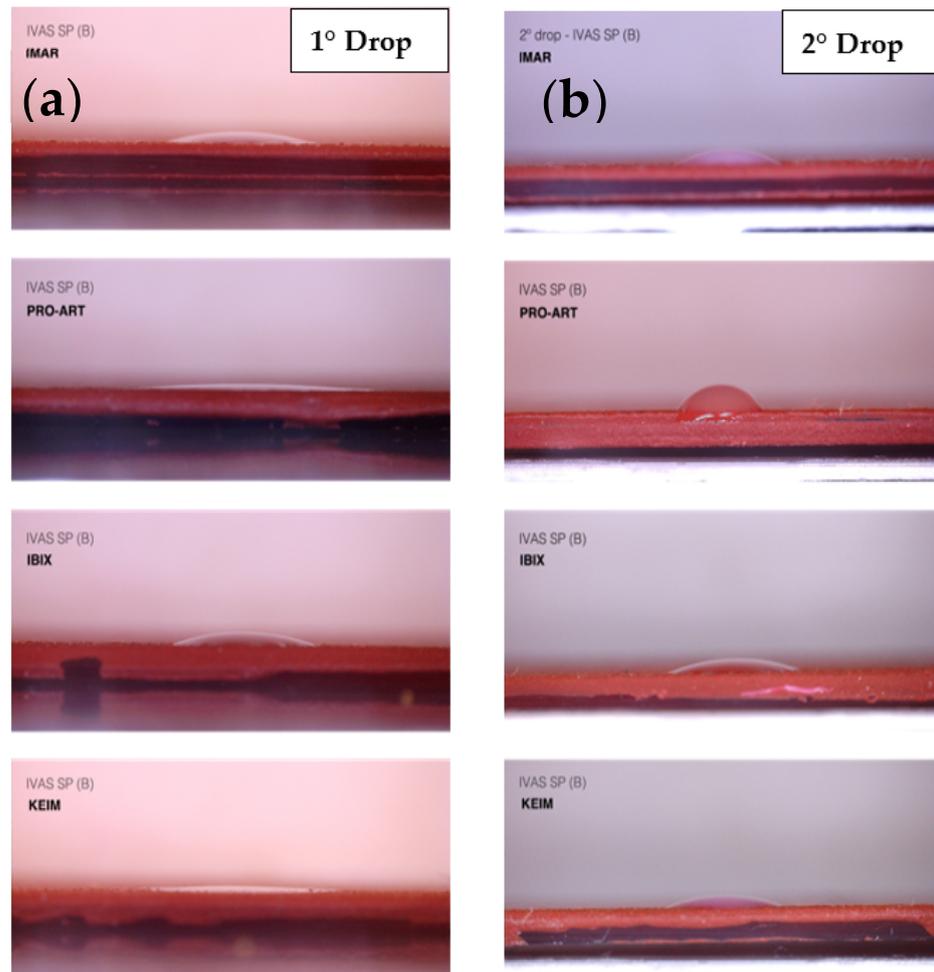
The behavior of Ivas SP toward the coating wettability was also verified by the contact angle. Figure 4 reports the images of wettability of the different anti-graffiti applied to the surfaces of the slides painted with Ivas SP paint that allows the comparison of all coatings. One drop of any coating was instantly absorbed by Ivas SP, but a second drop had a bigger contact angle, particularly the PRO-ART coating.

The lower wettability is due to the formation of a hydrophobic layer on the surface. This could represent a drawback, since if a hydrophobic surface is created a second layer of coating (which is water-based) is hardly applicable in the short-term.

Figure 4. Coatings wetting test on Ivas SP: (a) first coating drop and (b) second coating drop.

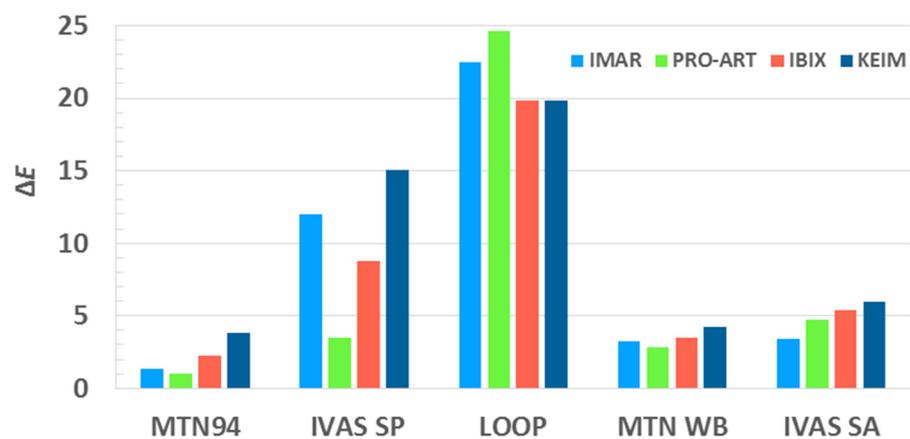
Colorimetric measures were performed after application of the coatings and again after four months. Figure 5 shows the differences between the two sets of measurements. Good performance was achieved by IMAR on MTN94 and on Ivas SA, but for the other paints, greater colorimetric differences were detected. The best performances were shown by PRO-ART on MTN94, Ivas SP and MTN WB, while poor performance was demonstrated on LOOP. IBIX does not show a good performance on any paint, while KEIM produces the greatest colorimetric difference.

Figure 5. Colorimetric differences between paints four months after the coatings were applied.

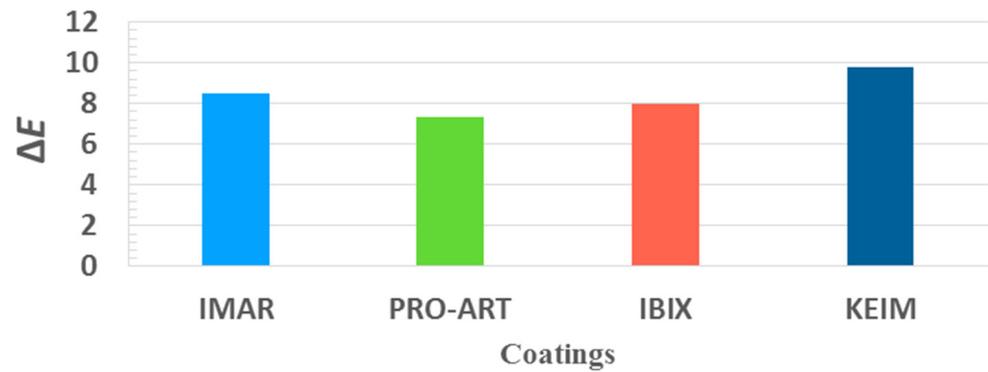
Figure 6 illustrates the chromatic difference values (as an average of three measurements) of all paints coated with each anti-graffiti substance after four months of aging. The results suggest that PRO-ART is the most suitable coating for all paints.

Figure 6. Colorimetric measures averaged for all paints four months after the application of coatings.

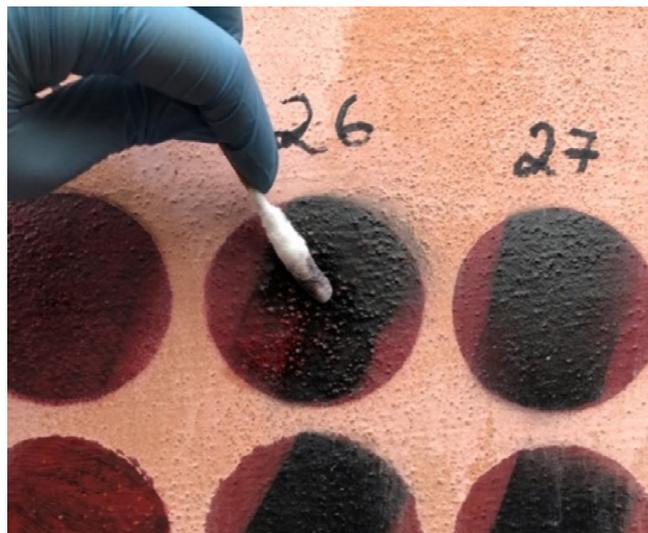
All chemical mixtures were tested on the vandalized paints (Figure 7). Results are reported in Tables S1–S4 and summarized in Table 5 and in Figure 8.

Figure 7. Cleaning test carried out by wiping the vandalized surface with a mixture of solvents.

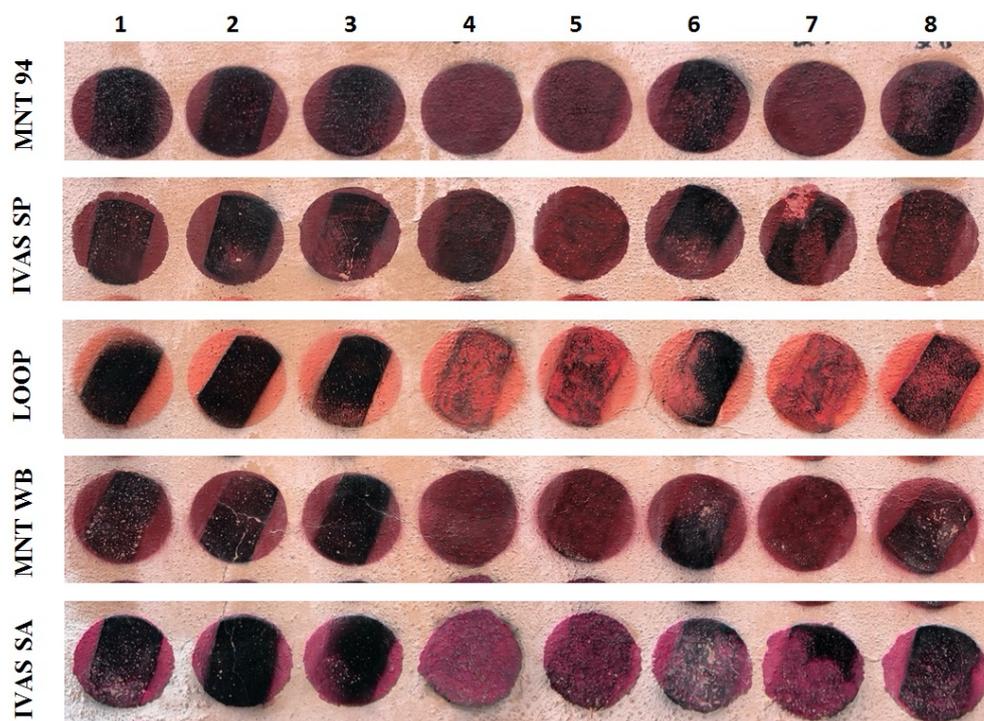
Figure 8. Cleaning tests performed on vandalized specimens.

For surfaces painted with Montana 94, mixtures 6 and 7 showed the better results. The solubilization of the vandal paint by the mixture 4 was easy and quick, and it did not remove the underlying pictorial layer. However, the rapid evaporation of acetone produced a whitish appearance. Mixture 6 showed a quick solubilization the vandalized chemical without showing any chromatic alteration; however, the embossing belonging to the substrate, was removed. Mixture 7 showed a poor control of the cleaning of thin layers of vandalism, so its use would be recommended only for thicker vandalism layers.

For surface painted with Ivas SP, solubility tests did not allow a choice of a solution suitable for a controlled removal of the black layer. Mixtures 4, 6 and 7 induced a rapid solubilization of the vandalism varnish, but the removal of the Ivas SP paint as well. Mixtures 1, 2 and 3 partially removed Ivas SP paint together with the vandalism layer.

Regarding surfaces painted with LOOP, for thin vandalism layers, solutions 1, 2, and 6 achieved a good performance, and for thick vandalism layers, mixture number 7 was the best one. Mixtures 1, 2 and 6 had shown a rather poor performance, although they did not affect the underlying color. Mixture 7 had the fastest action, but it should be used only for thick vandalism layers, since it would quickly dissolve the underlying layer.

The Montana water-based paint, when compared to MTN94, showed similar behavior toward mixture 4, and an easy and quick solubilization of the vandal paint occurred; unfortunately, it also induced the formation of a whitish surface, which resulted from the rapid evaporation of the acetone, together with the removal of some embossments. Solution 5 was slightly more aggressive than the previous one because it rapidly removed the embossments from the underlying surface, but it was verified that with the rolling cleaning technique it was possible to avoid this issue. Mixture 7 effectively removed the thick vandal layers, but partially dissolved the substrate as well.

For thin layers of vandalism on Ivas Idromatt, mixture 1 showed a controlled and homogeneous cleaning of the vandal's chemical on smooth surfaces. Mixture 4 showed quick results, while mixture 5 was slightly more aggressive, but by using the rolling cleaning technique, it was possible to avoid the alteration of the chromatic layer. With mixture 7, the rolling cleaning technique should also be used to avoid dissolution of the underlying layer.
