# Corrosion Fatigue Test and Performance Evaluation of High-Strength Steel Wires Based on the Suspender of a 11-Year-Old Concrete-Filled Steel Tube Arch Bridge

Yulin Deng and Luming Deng \*

Department of Road and Bridge Engineering, School of Transportation and Logistics Engineering, Wuhan University of Technology, Wuhan 430063, China

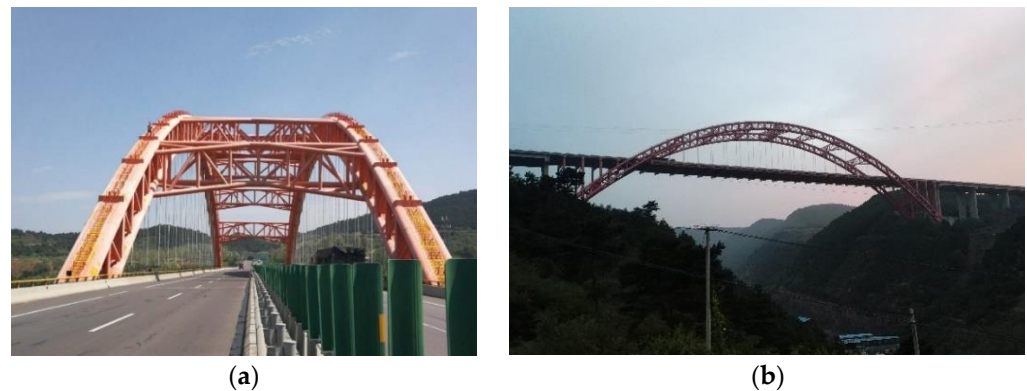
**Figure 1.** Beishengou concrete-filled steel tube arch bridge. (a) Arch bridge lane, (b) Overall state of arch bridge.

The long-span suspender arch bridge is a half-through concrete-filled steel tubular arch bridge that spans a deep ditch in a mountainous area, with a main span of 260 m. The carriageway beam is a  $7.5 + 3 \times 9 + 9.85 + 8.15 + 19 \times 9 + 8.15 + 9.85 + 3 \times 9 + 7.5$  m reinforced concrete  $\pi$ -shaped beam. The entire bridge first adopts simple support, followed by a continuous construction technology. The plan view of the main bridge structure is shown in Figures 1 and 2.

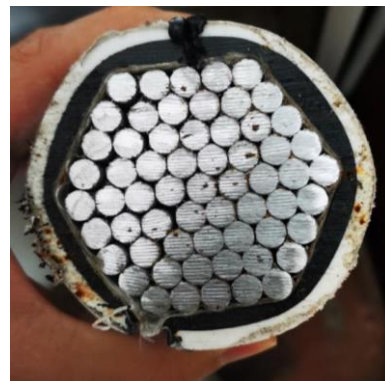
**Figure 5.** Cross section of boom.

The salt spray test wire came from Beishengou concrete-filled steel tube arch bridge. The bridge used OVMLZM-I type parallel steel wire cold cast anchor system. The suspender consisted of 61 parallel steel wires with a diameter of 7 mm and a tensile strength of 1670 MPa; its structure system mainly consists of dozens of parallel steel wire wrapped with polyurethane tape followed by HDPE protective layer, as shown in Figure 5. To ensure the reliability of the test, the steel wire used for the salt spray test was a non-corroded steel wire with a fully galvanised layer inside the suspender.

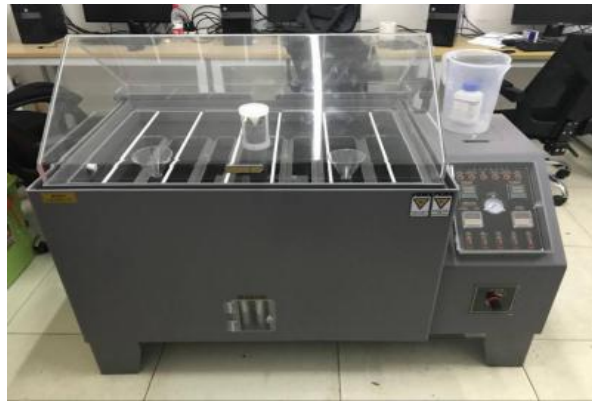
**Figure 6.** Salt fog corrosion chamber.

The corrosion test was performed using the salt-spray corrosion chamber (Ayi Instrument Technology Co. LTD, Shanghai, China) shown in Figure 6. The accelerated corrosion test was conducted using acetic acid salt spray (AASS) according to ISO 9227: 1990 [26]. The temperature of the corrosion environment for the acetic acid accelerated salt spray test was 35 °C; solid NaCl crystals with a purity of >99.5% were used, and the sodium chloride concentration was 50 g/L ± 5 g/L in the salt solution prepared with pure water. Then, an appropriate amount of glacial acetic acid was added to adjust the pH of the corrosion solution to 3.0. A salt spray test machine was used to atomise the corrosive solution. After a specified test period, the relevant corrosion data were observed and measured for the steel wire. The intervals for this test were 10, 20, 40, 60, and 90 days.

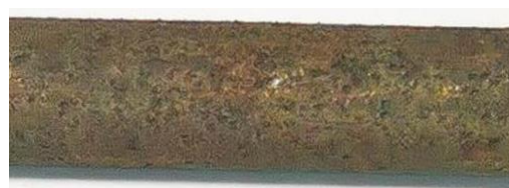
**Figure 9.** Macroscopic surface of corroded steel wire.

Figure 9 shows the macroscopic appearance of the surface of the corroded steel wire; the corroded state was relatively uniform. The steel wire was scanned with a LexT OLS5100 laser microscope produced by Olympus Corporation (Olympus Corporation, Tokyo, Japan) (accuracy  $0.12 \mu\text{m}$ ). The equipment used in this study is shown in Figure 10. Typical surface scan results for the steel wire are shown in Figure 11. The size of a single scan block is a square with  $260 \mu\text{m}$  side length. The surface conditions of the steel wire can be more intuitively visualised with 3D scanning and contour maps. Corrosion pits in areas of severe corrosion are interconnected, resulting in a loss of the cross-section area. The relationship between the specimen roughness and corrosion time is shown in Figure 12. As can be seen from Figure 12, the average roughness of the specimens gradually increases as the corrosion increases.

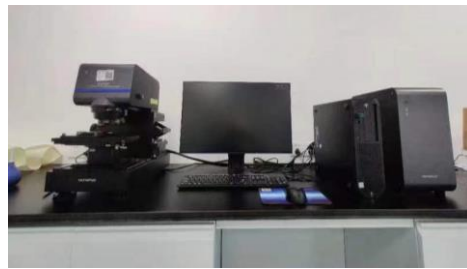
Figure 10. Laser microscope.

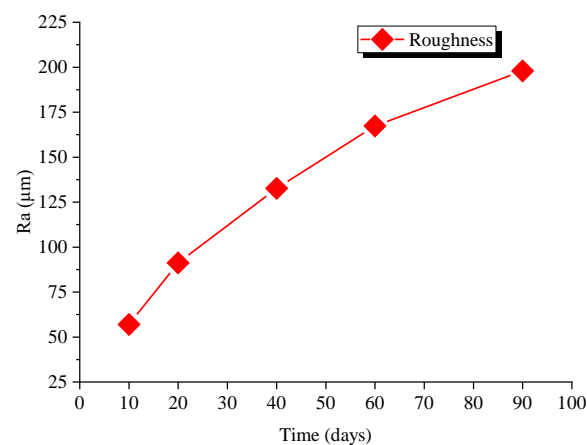
Figure 12. The relationship between roughness and time.

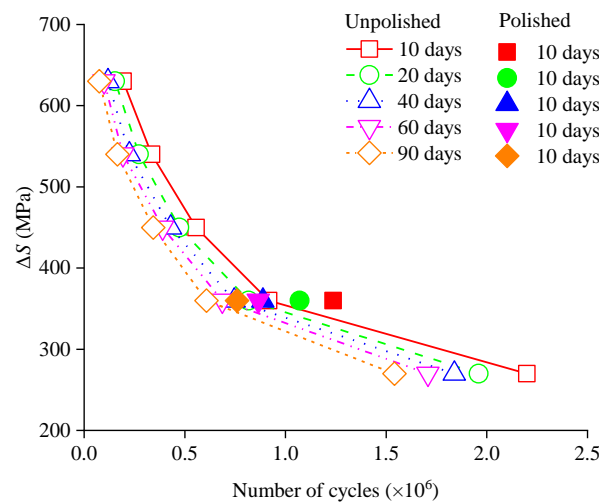
**Figure 15.** Relationship between fatigue life and quality loss of pre-corroded steel wire.

As shown in Figure 15, there is an obvious two-stage relationship between stress amplitude and fatigue life of steel wires with different degrees of corrosion. When  $\Delta S \leq 360$  MPa, the decrease of stress amplitude  $\Delta S$  leads to the obvious increase of steel wire fatigue life. When  $\Delta S > 360$  MPa, with the decrease of stress amplitude  $\Delta S$ , the increasing trend of fatigue life of steel wire is obviously smaller than that of the interval with  $\Delta S \leq 360$ . Under the same stress amplitude, when  $\Delta S \leq 360$  MPa, the decrease rate of steel wire fatigue life with increasing corrosion degree is more drastic than that of  $\Delta S > 360$  MPa. It can be seen that the lower the stress amplitude is, the more sensitive the steel wire life is to corrosion.
