# Corrosion Fatigue Test and Performance Evaluation of High-Strength Steel Wires Based on the Suspender of a 11-Year-Old Concrete-Filled Steel Tube Arch Bridge

Yulin Deng and Luming Deng \*

Department of Road and Bridge Engineering, School of Transportation and Logistics Engineering, Wuhan University of Technology, Wuhan 430063, China

**Citation:** Deng, Y.; Deng, L. Corrosion Fatigue Test and Performance Evaluation of High-Strength Steel Wires Based on the Suspender of a 11-Year-Old Concrete-Filled Steel Tube Arch Bridge. *Coatings* **2022**, *12*, 1475. <https://doi.org/10.3390/coatings12101475>

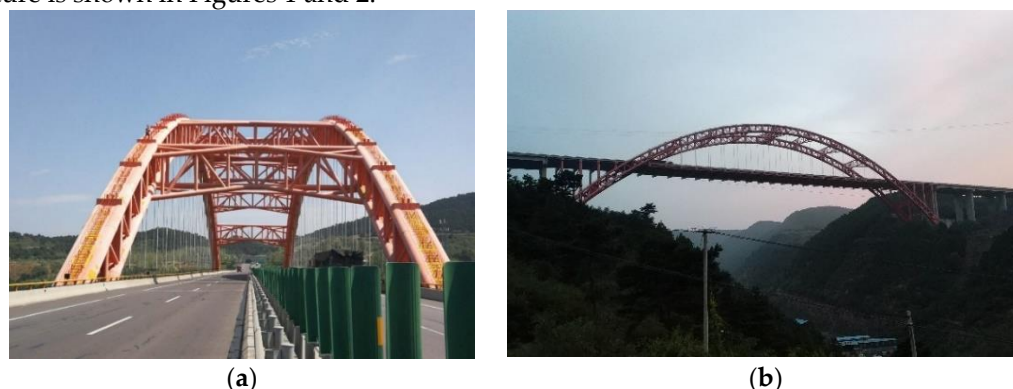
**Figure 1.** Beishengou concrete-filled steel tube arch bridge. (a) Arch bridge lane, (b) Overall state of arch bridge.

reinforced concrete  $\pi$ -shaped beam. The entire bridge first adopts simple support, followed by a continuous construction technology. The plan view of the main bridge structure is shown in Figures 1 and 2.

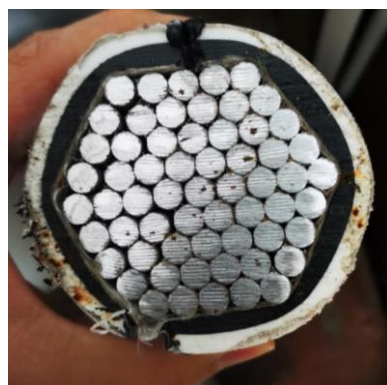
**Figure 5.** Cross section of boom.

The salt spray test wire came from Beishengou concrete-filled steel tube arch bridge. The bridge used OVMLZM-I type parallel steel wire cold cast anchor system. The suspender consisted of 61 parallel steel wires with a diameter of 7 mm and a tensile strength of 1670 MPa; its structure system mainly consists of dozens of parallel steel wire wrapped with polyurethane tape followed by HDPE protective layer, as shown in Figure 5. To ensure the reliability of the test, the steel wire used for the salt spray test was a non-corroded steel wire with a fully galvanised layer inside the suspender.

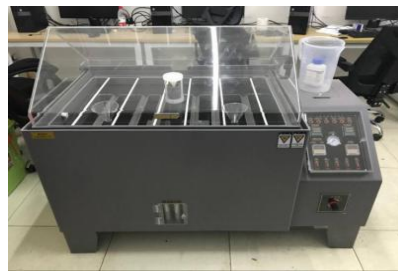
**Figure 6.** Salt fog corrosion chamber.

The corrosion test was performed using the salt-spray corrosion chamber (Ayi Instrument Technology Co. LTD, Shanghai, China) shown in Figure 6. The accelerated corrosion test was conducted using acetic acid salt spray (AASS) according to ISO 9227: 1990 [26]. The temperature of the corrosion environment for the acetic acid accelerated salt spray test was 35 °C; solid NaCl crystals with a purity of >99.5% were used, and the sodium chloride concentration was 50 g/L ± 5 g/L in the salt solution prepared with pure water. Then, an appropriate amount of glacial acetic acid was added to adjust the pH of the corrosion solution to 3.0. A salt spray test machine was used to atomise the corrosive solution. After a specified test period, the relevant corrosion data were observed and measured for the steel wire. The intervals for this test were 10, 20, 40, 60, and 90 days.

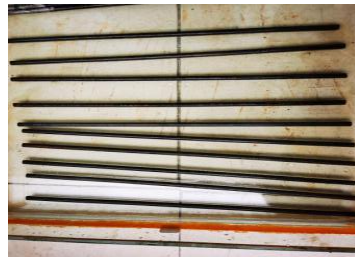
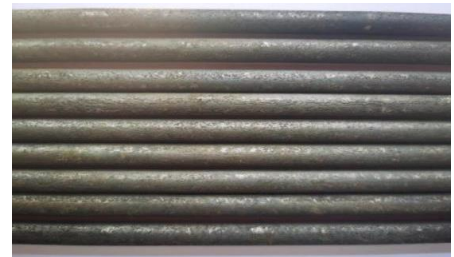
(a) Derusting with hydrochloric acid

(b) De-rusting with steel wire

**Figure 8.** De-rusting of steel wire. (a) Derusting with hydrochloric acid, (b) De-rusting with steel wire.

Then, in order to control the reaction speed, the steel wire was derusted with a cleaning solution mixed with dilute hydrochloric acid and hexamethylenetetramine [29]. The corroded samples were placed in a glass container, diluted with hydrochloric acid, soaked for 5–6 min, and then cleaned. The acid-washed high-strength steel wire was placed in a  $\text{Ca}(\text{OH})_2$  solution to neutralise the residual hydrochloric acid on the surface and then placed in clean water (not higher than 40 °C) to wash off the residual  $\text{Ca}(\text{OH})_2$  on the high-strength steel wire. Finally, the steel wire was dried, as shown in Figure 8. The quality loss rate was used to evaluate the degree of corrosion, and the loss of weight  $\eta$  for each steel wire was measured as follows:

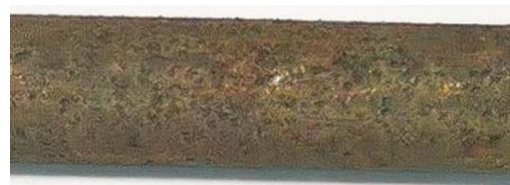
**Figure 9.** Macroscopic surface of corroded steel wire.

Figure 9 shows the macroscopic appearance of the surface of the corroded steel wire; the corroded state was relatively uniform. The steel wire was scanned with a LexT OLS5100 laser microscope produced by Olympus Corporation (Olympus Corporation, Tokyo, Japan) (accuracy  $0.12 \mu\text{m}$ ). The equipment used in this study is shown in Figure 10. Typical surface scan results for the steel wire are shown in Figure 11. The size of a single scan block is a square with  $260 \mu\text{m}$  side length. The surface conditions of the steel wire can be more intuitively visualised with 3D scanning and contour maps. Corrosion pits in areas of severe corrosion are interconnected, resulting in a loss of the cross-section area. The relationship between the specimen roughness and corrosion time is shown in Figure 12. As can be seen from Figure 12, the average roughness of the specimens gradually increases as the corrosion increases.

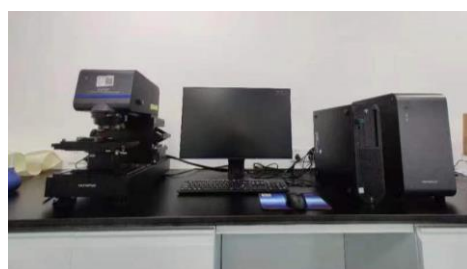
Figure 10. Laser microscope.
