Article

Moisture Sensitivity Evaluation of the Asphalt Mortar-Aggregate Filler Interface Using Pull-Out Testing and 3-D Structural Imaging

Citation: Xu, F.; Nie, X.; Gan, W.; E, H.; Xu, P.; Cao, H.; Gong, R.; Zhang, Y. Moisture Sensitivity Evaluation of the Asphalt Mortar-Aggregate Filler Interface Using Pull-Out Testing and 3-D Structural Imaging. *Coatings* **2023**, *13*, 868. <https://doi.org/10.3390/coatings13050868>

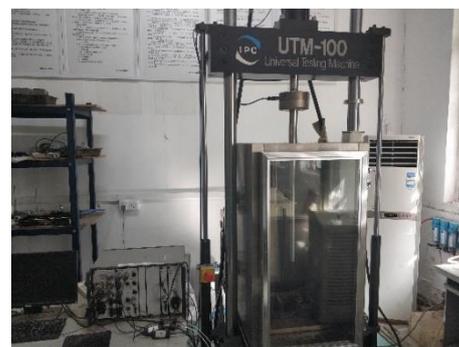
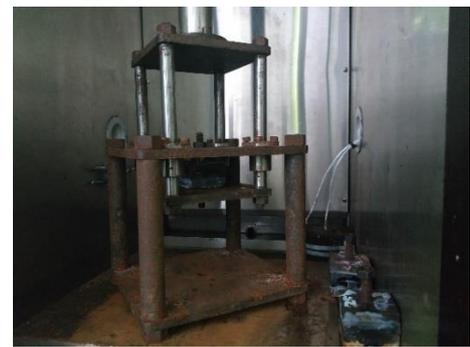
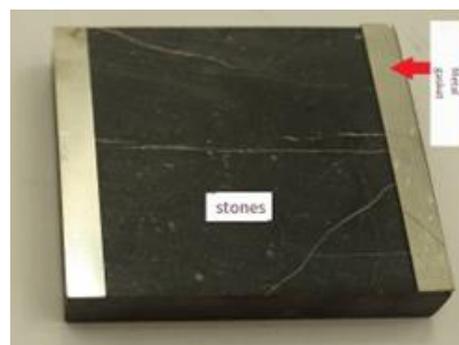
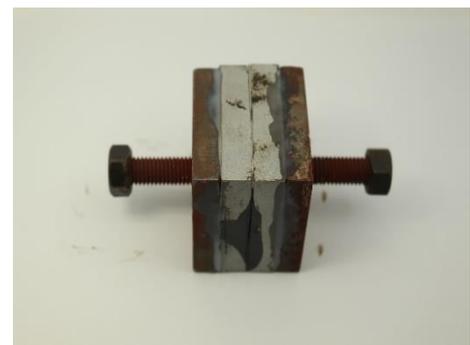
Figure 1. The pull-out loading configuration and test sample setup.

As shown in Figure 1, a UTM loading frame (namely UTM-100) (IPCG, Hong Kong China) with custom designed and in-house made testing jigs, was used for conducting the pull-out test on the asphalt mortar with different fillers under the coupling effects of water and temperature. A 50 mm × 5 mm × 0.4 mm metal jig was custom fabricated in-house by these authors and placed on both sides of 50 mm × 50 mm × 10 mm limestone cubes—see Figure 1c. The asphalt mortar was then poured onto the 110 °C preheated

cubes, covered with another cube, and then pressed to a thickness of 0.4 mm to form the test specimen assembly shown in Figure 1d. Thereafter, the pull-out test, at a monotonic tensile pull-out rate of 10 mm/min, was conducted on the asphalt mortar specimens with different filler materials. The maximum pull-out force was captured and accordingly recorded to quantitatively characterize the adhesive bonding between the asphalt mortar and the aggregate (namely limestone cubes). Details of the test procedure is provided in the subsequent text.

(a) UTM-100 testing machine

(b) Reaction support

(c) Stone (limestone) and metal spacers

(d) Test specimen assembly

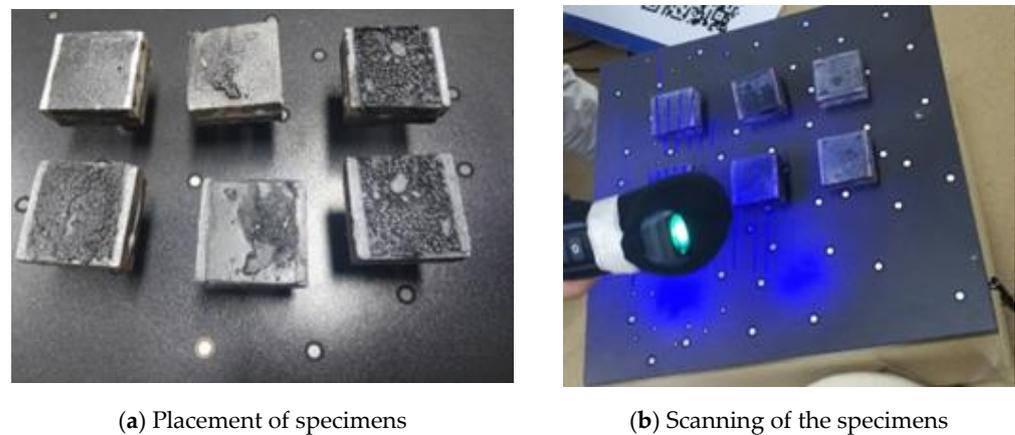
Figure 2. Structured light scanning of the asphalt mortar specimens.

Structured light 3-D scanning technology has been widely used in the fields of national defense, aerospace, industrial design, mold manufacturing, precision engraving, rehabilitation, and medical treatment, but it is rarely used in asphalt mortar applications [36]. In this study, structured light 3-D scanning was exploratorily used to study the spalling rate of the asphalt mortar with different fillers. The technical objective was to quantitatively evaluate the anti-spalling performance of the asphalt mortar. The methodology incorporated the following procedural steps:

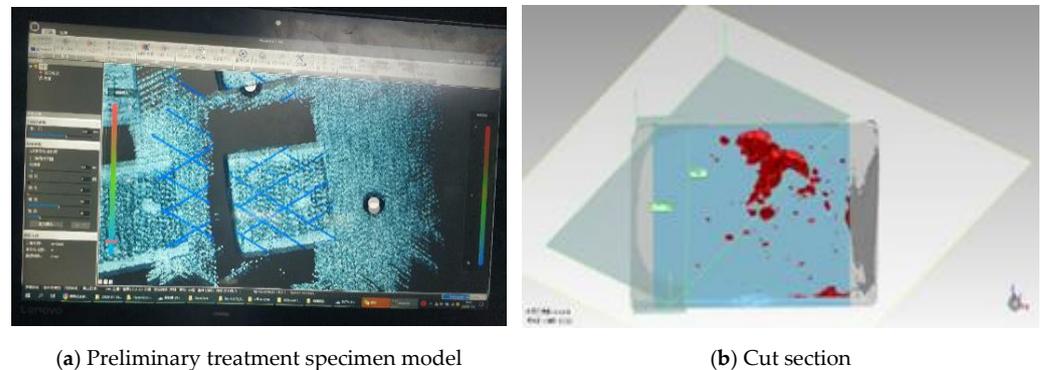
Step 3—selection and calculation of the exfoliation section. Multilayer horizontal exfoliation sections parallel to the interface with 0.2, 0.4, and 0.6 mm distances were established, and the area above each exfoliation section was obtained. The exfoliation rate of the asphalt mortar (slurry) on the exfoliation surface image of the specimens was calculated using Equation (2).

Figure 3. Geomagic Wrap software image processing.

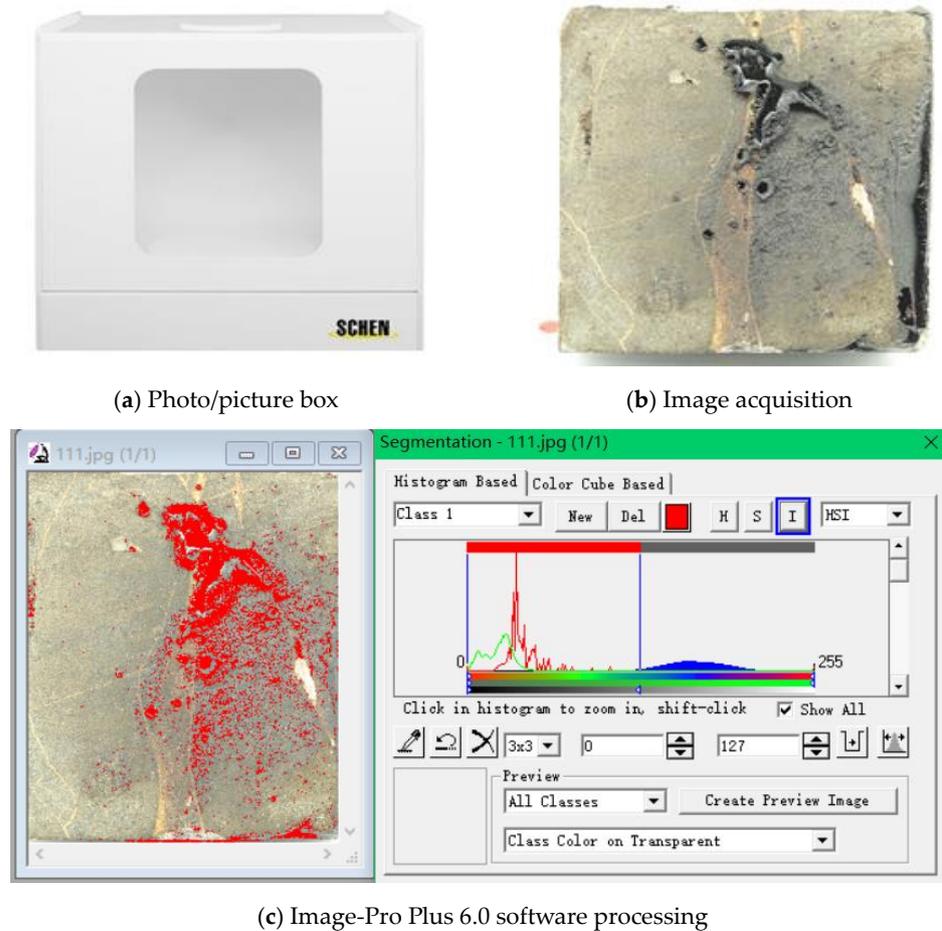
Step 1—image preprocessing. The color saturation of the shot image is generally low. So, the gray units of the system were converted into optical density units through Photoshop format transformation to reduce the systematic errors associated with the image. Thereafter, the color ratio of the image was adjusted using the Image-Pro Plus software [24]. The HIS color format was used for color separation selection, where H is the hue, S is the saturation, and I is the intensity. When selecting the AOI (Automated Optical Inspection), first keep H and S as the maximum range and then select the red component from I to reduce the systematic errors associated with the image. Refer to Figure 4 for an example of a processed image.

Figure 4. Image acquisition and processing with the Image-Pro Plus software.

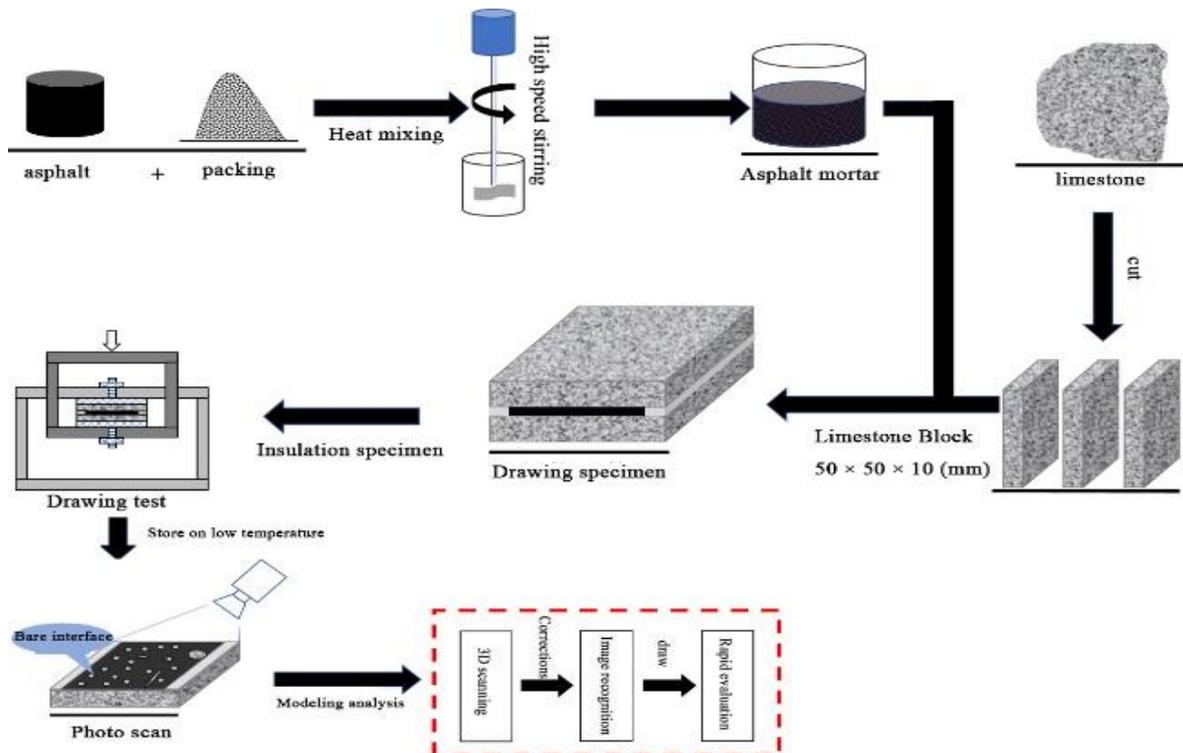
As graphically illustrated in Figure 5, some of the final steps of determining the spalling rate involved image processing, corrections, and measurement of the target objects. The specific procedural steps to obtaining the spalling rate of the asphalt mortar and aggregates interface using the Image-Pro Plus software [24] are as follows:

Figure 5. Flow chart for the complete process (i.e., specimen preparing, testing, imaging).

After image acquisition, the second phase of image processing, computational modeling, and analytical calculations was implemented. That is, after the spalling images of the fracture surfaces of the pull-out tested specimens were collected, the photographic parameters such as the spalling area of the asphalt in the image were intricately extracted to quantitatively evaluate the adhesion between the asphalt mortar and aggregates—which is discussed in the subsequent text. The complete experimentation process starting from specimen preparation through testing to modeling analysis, imaging, and analytical calculations is graphically and visually summarized in the flow chart in Figure 5.

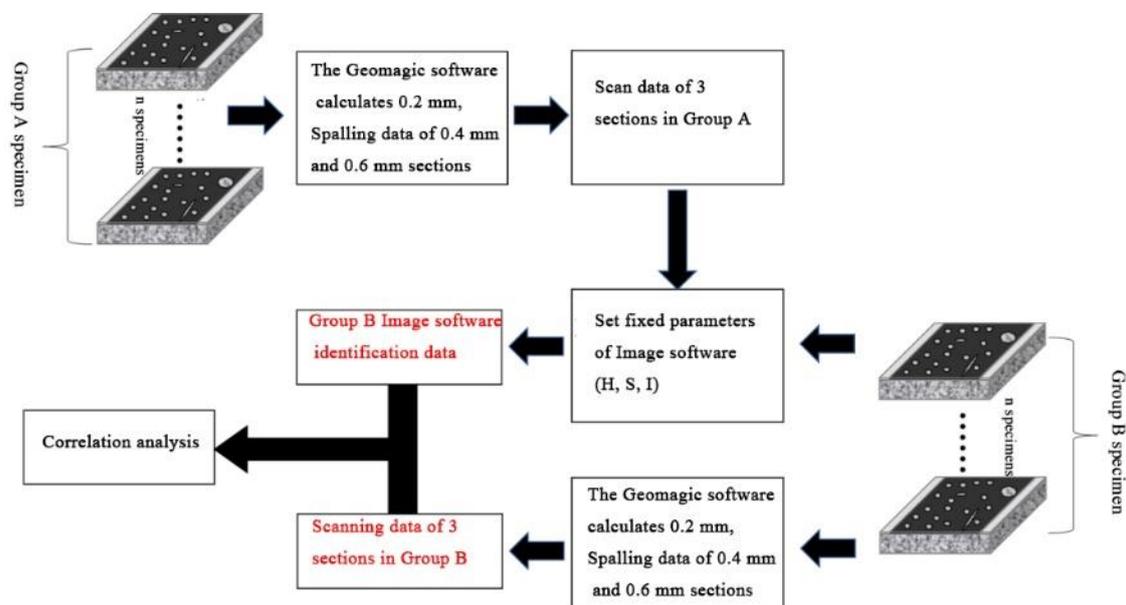
Pearson statistic correlation analysis [37–39] was performed between the multi-section peeling data obtained using structured light 3-D scanning [40] and the peeling rate obtained using the Image-Pro Plus software [23] to obtain more accurate peeling results. The parametric correction and correlation process are illustrated in Figure 6.

Figure 6. Parametric modifications and correlation process.

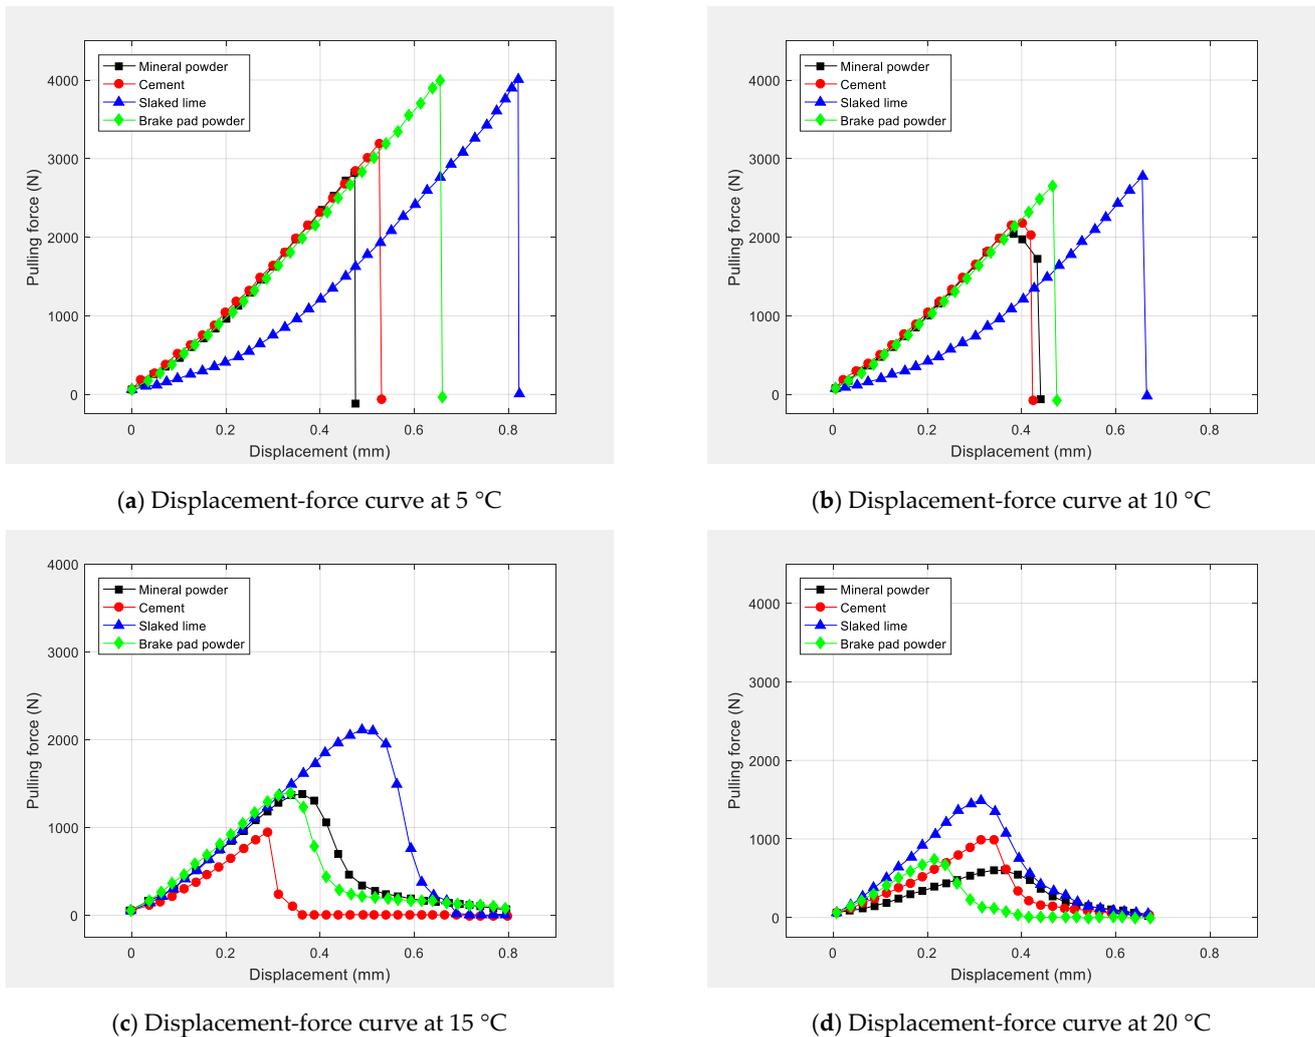
Figure 7. Force-displacement response curves of the asphalt mortar at different test temperatures.

It can be observed in Figure 7 that the tensile pulling force is inversely proportional to the test temperature and decreased with an increase in the test temperature. However, whilst the interfacial pull-out force decreased rapidly (i.e., instantaneous) within the first test temperature range of 5 to 15 °C, the decline was much slower for the 15 to 20 °C temperature range. Likewise, the viscosity (stiffness) of the asphalt mortar (due to the viscoelastic nature of the asphalt) was also observed to be inversely proportional to the test temperature [15,42,43]. That is the higher the temperature, the lower the stiffness and the lower the peak tensile failure load. During interfacial pull-out testing, instantaneous

fracturing of the asphalt mortar is thus more likely to occur at lower temperatures, making the interface failure to change from adhesive to cohesive as the temperature increases.

Furthermore, it was observed that under the low temperature conditions of 5 and 10 °C, the asphalt within the asphalt-mortar was more in the elastic phase with a relatively high stiffness, leading to brittle adhesive-fracture failure accompanied by an instantaneous load drop to zero—see Figure 7a,b. As evident in Figure 7c,d, this was not the case for 15 and 20 °C as the asphalt was shifting towards the softer viscous phase, with relatively low stiffness and peak loads that gradually reduced to zero—suggesting more of a ductile (i.e., cohesive-fracture) failure than brittle adhesive-fracture failure. When the test temperature was 10 °C, however, there was a transitional indication of both adhesive and cohesive failure of the asphalt mortar in the force-displacement response curves for mineral powder and cement—see Figure 7b. As photographically illustrated in Figure 8a, this suggests that brittle fracture failure predominantly occurs at low test temperatures such as 5 °C. At around ambient temperatures (i.e., 15 and 20 °C), the asphalt mortar interaction exhibits a cohesive mode of failure, with the resulting fracture interfaces exemplified in Figure 8c,d, respectively. By contrast, however, the fracture interfaces in Figure 8b visually indicates the simultaneous occurrence of both adhesive and cohesive failure occurred at 10 °C, which is synonymous to the limestone mineral powder and cement's response curves in Figure 7b. By and large, these interfacial photographs of the fracture interfaces in Figure 8 somewhat corroborates the graphical response trends of the asphalt mortar observed in Figure 7.

Looking at the magnitudes of the pulling tensile force and displacement in Figure 7, it is evident that slaked lime generally exhibited performance superiority over the other filler materials at all the test temperatures that were evaluated. At the lower temperatures (i.e., 5 and 10 °C), the limestone mineral powder performed the poorest with the least pulling tensile force and failure displacement, respectively. At 15 and 20 °C, the poorest performers were cement and brake pad powder, respectively.

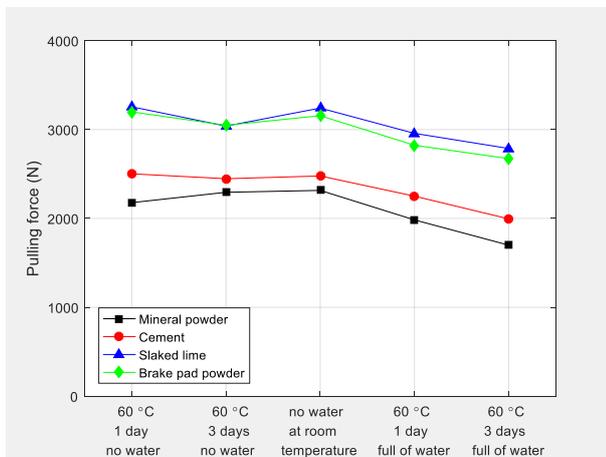
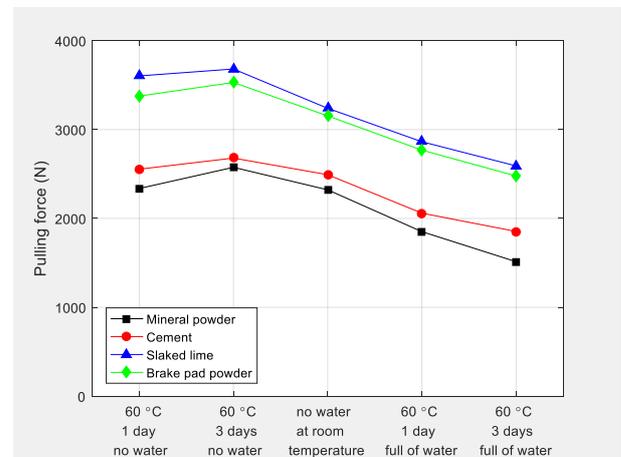
Figure 9. Pulling force results as a function of moisture (H₂O saturation) curing time at 0 °C and 60 °C.

(a) Force vs. moisture curing at 0 °C

(b) Force vs. moisture curing at 60 °C

In general, the graphical results in Figures 9 and 10 indicated a declining response trend with an increase in the moisture (H₂O saturation) curing period for the pulling force and vice versa for the pulling force loss rate. For all the filler types, higher forces

in magnitude and the least loss rates were conversely registered at 1 day curing period without water. As theoretically expected, the degree of force reduction and increase in the loss rate (i.e., damage) were also more distinctive at 60 °C than 0 °C curing temperature. Looking at Figures 9b and 10b at 60 °C for 1 day with full H₂O saturation, the pulling force exhibited a declining response trend with loss rates of about 20.4%, 17.3%, 11.6%, and 12.4% for limestone mineral powder, cement, slaked (whitewashing) lime, and brake pad powder, respectively. After 3 days of H₂O saturation at 60 °C, the force loss rates reached 34.9%, 25.5%, 20.1%, and 22.8%, respectively, with slaked lime registering the highest pulling force and lowest loss rate, respectively. That is the damaging impact of water was higher under the longer moisture conditioning period of 3 days with the H₂O at a higher temperature of 60 °C. Likewise, Figures 9a and 10a exhibited similar graphical response trends to Figures 9b and 10b, with slaked lime generally being superior to the other fillers. After 1 day of H₂O saturation at 0 °C, the force loss rates for the limestone mineral powder, cement, slaked lime, and brake pad powder were 14.7%, 9.3%, 8.4%, and 10.7%, respectively, whilst it was 26.9%, 19.6%, 13.9%, and 15.5% after three days of H₂O saturation at 0 °C.

From Figure 9, it was generally observed that the pulling force was higher in magnitude under dry (no water) high-temperature conditions and vice versa for the force loss rate in Figure 10. These observations suggest that dry high-temperature conditions are conducive for enhancing the adhesion of the asphalt mortar-aggregate interface, which could be partly attributed to the asphalt's viscoelasticity. This phenomenon was attributed to the intense activity of the asphalt molecules under the dry high-temperature conditions that caused the viscoelastic asphalt to shift towards the viscous phase and readily flow due to the temperature softening effects [44–46]. This probably allowed for better infiltration of the asphalt onto the aggregate pores/surfaces, enabled full contact with the aggregate, and adequate adhesion to the aggregate surfaces.

Under full H₂O saturation conditions, however, the pulling force exhibited a general decreasing response trend as the moisture curing time was increased from one to 3 days, particularly at 60 °C. As theoretically expected, an opposite increasing response trend was observed for the force loss rate, with the 60 °C H₂O saturated specimens enduring quantitatively more decay and loss rate (i.e., all exceeding 10%) than the 0 °C H₂O saturated specimens. This was partly because under H₂O saturated conditions, the tension associated with the water molecules is greater than in the asphalt. Therefore, the polarity of the aggregate will enhance the binding force between the water molecules and aggregate, with water ultimately playing a tearing role between asphalt and aggregates interactions [47]. This phenomenon is further exacerbated if the water is hot at high temperatures such as 60 °C. With more hot H₂O intrusion, the asphalt film potentially de-bonds and falls (i.e.,

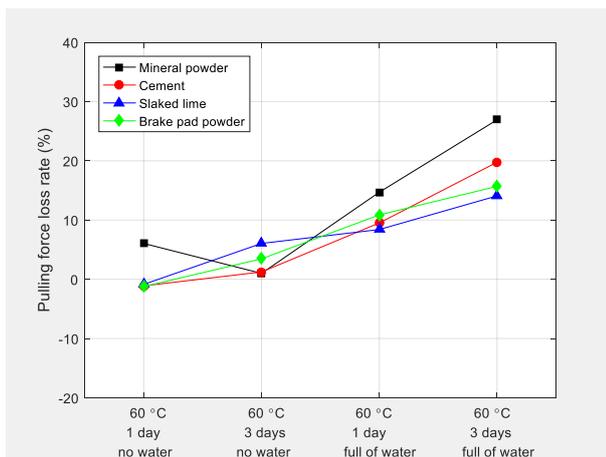
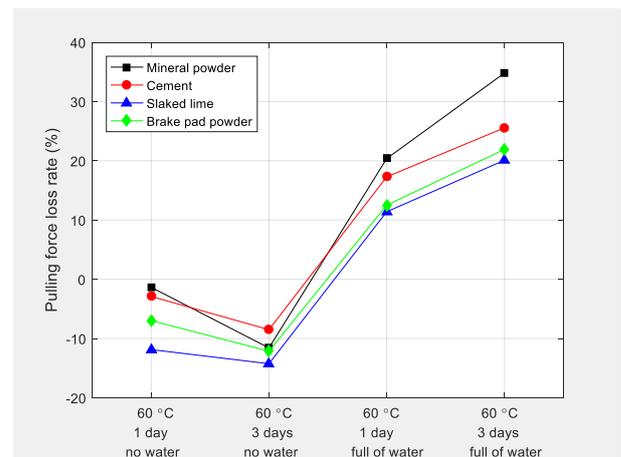
Figure 10. Force reduction rate as a function of moisture curing (H₂O saturation) time at 0 °C and 60 °C.

(a) Loss rate vs. moisture curing at 0 °C

(b) Loss rate vs. moisture curing at 60 °C

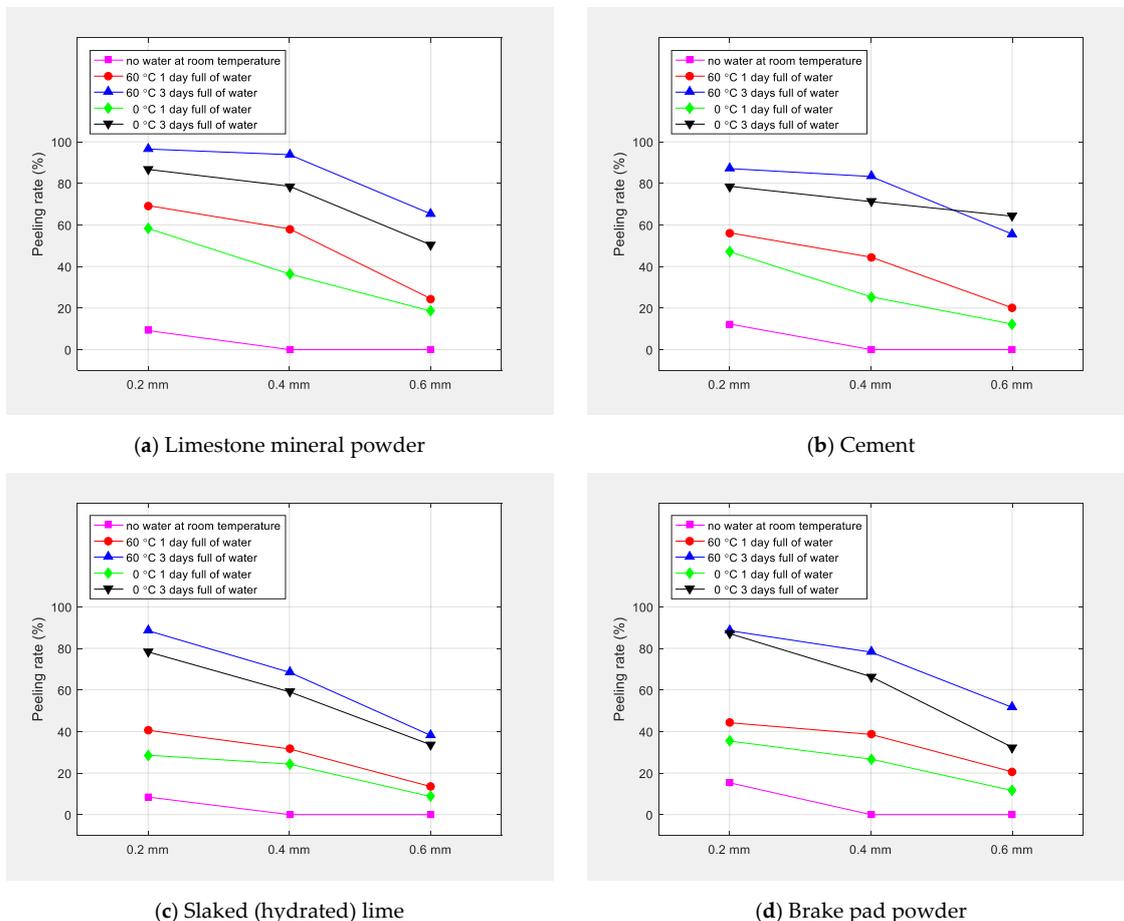
Looking at Figure 11, it can be observed that the variational response trends of the spalling sections with different spacings is basically the same, with the spalling rate decreasing with an increase in the spacing. For the different curing (H₂O saturation) conditions that were evaluated, the spalling rate showed an increasing tendency, particularly with the prolongation of the water saturation time to 3 days. This is partly because as the diffusion rate of the water molecules increased with the extension of the water immersion time, the interface phase between the asphalt and aggregate began to become weakened by the invading water molecules [48–50]. The net result is that the asphalt on the aggregate surface was replaced by the water molecules, and hence, a decay in the asphalt-aggregate adhesion. From Figure 11, it is also apparent that this phenomenon, as theoretically expected, was further exacerbated by the high 60 °C saturation/curing temperature with the invading water molecules inherently being more energized.

Figure 11. Peeling rate results before and after water saturation using the Geomagic Wrap software.

For the asphalt mortar with different fillers as exemplified by the 0.4 mm spalling section, the peeling rates of the slaked lime and brake pad powder after 60 °C moisture (H₂O saturation) curing for one day were 31.6% and 38.6%, respectively. This was significantly lower than the peeling rates associated with the mineral powder and cement fillers. After three days of 60 °C moisture (H₂O saturation) curing, the observed peeling rate relations were as follows: limestone mineral powder (93.8%) > cement (83.3%) > brake pad powder (78.2%) > slaked lime (68.5%). From these results, it is obvious that after 60 °C of H₂O saturation, the spalling rate associated with the cement filler was smaller than that of the limestone mineral powder but greater than the brake pad powder. This suggests that the anti-spalling property of the asphalt mortar can be effectively enhanced by substituting the limestone mineral powder with an equivalent volume of cement.

In Figure 11, the spalling (peeling) rate of the mortar with slaked (hydrated) lime before and after water saturation was the lowest, which indicated that its moisture tolerance and water damage resistance were significantly better than the other three fillers. At one day 0 °C moisture (H₂O) saturation condition, the spalling rate (0.4 mm) of the limestone mineral powder, cement, slaked lime, and brake pad powder were 36.4%, 25.4%, 24.3% and 26.7%, respectively. With the extension of the H₂O saturation time to 3 days, however, the spalling rates of the fillers showed noticeable differences—a phenomenal response trend that was consistent with the previous pull-out test results. Overall and as previously inferred, the results in Figure 11 further suggests that the anti-spalling properties of the asphalt mortar with cement and slaked lime fillers are basically the same in the initial stages of low-temperature moisture (H₂O saturation) curing. With time, however, slaked lime exhibited superiority over cement filler.

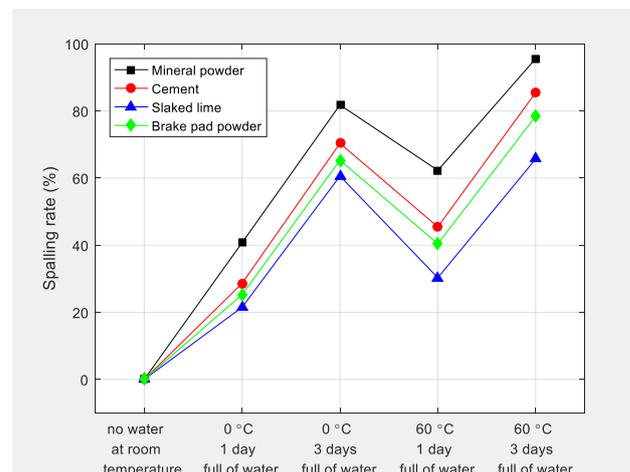
Figure 12. Spalling rate results determined using the Image-Pro Plus software.

Looking at Figure 12, it can be observed that the graphical response trends of the spalling (peeling) rate determined using the Image-Pro Plus software yielded similar results to the structured light 3-D scanning results in Figure 11. Under dry (without water) room temperature conditions, the interfaces were all stable with no flaking off and a spalling rate of zero percent (i.e., 0%). After H₂O saturation, however, the interfaces produced different degrees of flaking off and peeling effects, with varying spalling rates and almost nearing 100% in the case of the limestone mineral powder after 60 °C moisture conditioning for three days. This was largely attributed to the minimal occurrence of microscopic cohesive failure

of the asphalt mortar at room temperature without water. But with moisture conditioning (i.e., H₂O saturation), however, the moisture has the inherent effects of tearing, displacing, interface weakening, and gap pressurizing between asphalt mortar and aggregate. This makes the asphalt mortar to peel off from the aggregate surface, with the occurrence of adhesive failure.

At elevated temperatures, the effects of water on the asphalt mortar were more obvious. From dry room temperature conditions to H₂O saturation 60 °C for one day, the spalling rates of the limestone mineral powder, cement, slaked lime, and brake pad powder increased to 62.3%, 45.4%, 30.3% and 40.4%, respectively, and continued to rise with the extension of saturation time to three days. For all the curing conditions, the spalling rate generally increased with an increase in the temperature, with more spalling occurring at 60 °C than 0 °C. This can be explained by the fact that at ambient and higher temperature, the asphalt (due to its viscoelastic nature) plays a huge role [51]. When the temperature is about and/or higher than the softening point of the asphalt, the activity of the asphalt molecules is intense, with the asphalt potentially flowing due to temperature softening [48–50]. Likewise, the activities and the movement of the invading water molecules are highly energized at elevated temperatures. Thus, compared with the low temperature curing conditions, the highly energized water molecules are more easily infused within the inside of the asphalt mortar at elevated temperatures. This inherently accelerates and exacerbates the impact of water on the asphalt mortar, with a resultant degradation in the adhesion of the asphalt-aggregate interface [47].

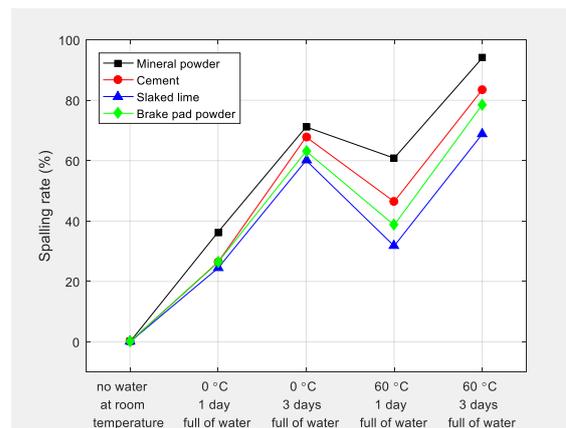
At R² = 99.9%, it can be seen in Table 4 that the correlation coefficients for the 0.4 mm interface were the highest, which is more consistent with the actual peeling surfaces. Therefore, the parameters of the Image-Pro Plus 6.0 software [23] were corrected and modified using the 0.4 mm peeling interface as the reference datum. This aided to quantitatively express the moisture sensitivity and water damage resistance of the asphalt mortar with different fillers more accurately. The results of these correlation analyses and the corrected spalling rates are shown in Figure 13.

Figure 13. Corrected spalling rates.

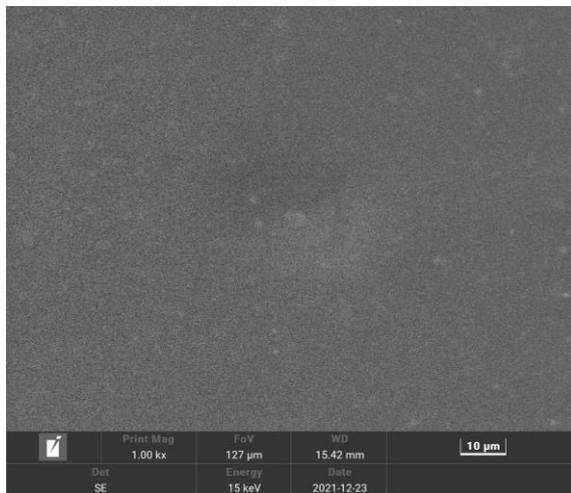
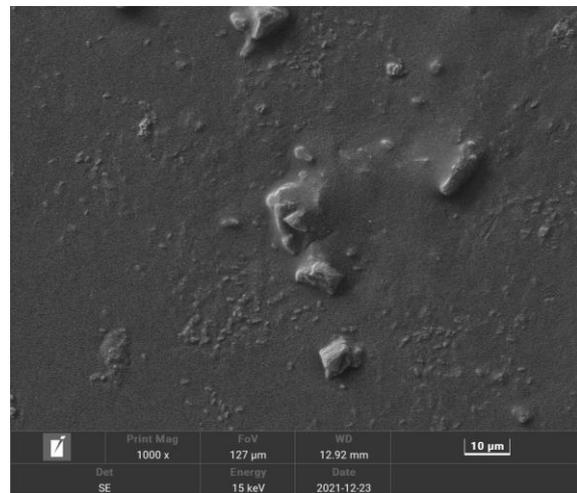
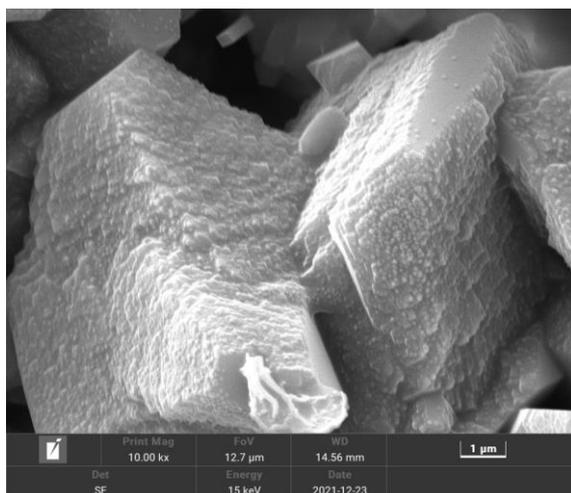
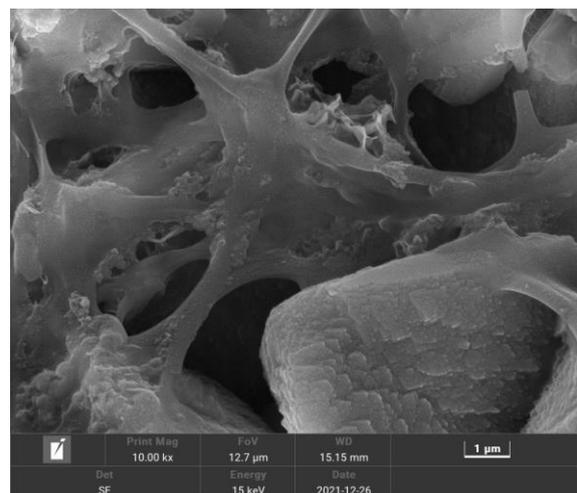
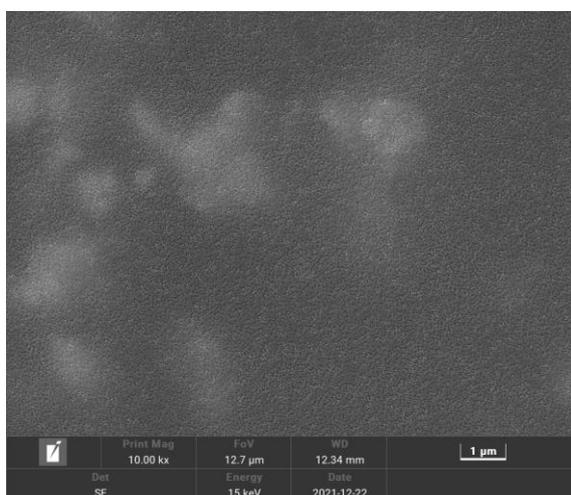
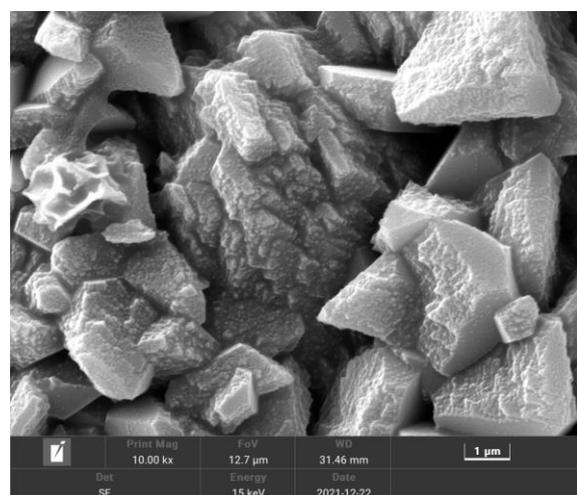
Figure 14. Cont.

Under dry conditions, the limestone mineral powder get immersed within the asphalt, forming a layer of dense asphalt membrane or film with a high cohesive bonding force that is visually exemplified in Figure 14a. After full water saturation at 60 °C, as the moisture diffuses and infiltrates through the asphalt membrane, part of the limestone mineral powder particles shown in Figure 14b get exposed on the outside of asphalt and consequently weakens the interfacial bond. And this partially contributes to the ultimate decay and degradation in the interfacial adhesion.

As shown in Figure 14e, when the asphalt mortar mixed with slaked (hydrated) lime is not H₂O saturated, the lime particles get wrapped by asphalt with laterally no visible interfacial zone. However, after the slaked lime is saturated with water, the products of the chemical reaction between the lime and asphalt along with the unreacted slaked lime particles form more stable block structures exemplified in Figure 14f. This is because calcium hydroxide, the main component in the slaked lime, gets into contact with the carboxylic acid and SARA (namely Saturate, Aromatic, Resin, and Asphaltene) in the asphalt [53]. This fundamentally leads to chemical reactions that produce products with strong absorbability with the potential to firmly adhere to the aggregate surface without

(a) Limestone at room temperature with no water

(b) Limestone saturated H₂O at 60 °C for 3 days

(c) Cement at room temperature with no water

(d) Cement saturated with H₂O at 60 °C for 3 days

(e) Lime at room temperature with no water

(f) Lime saturated H₂O at 60 °C for 3 days

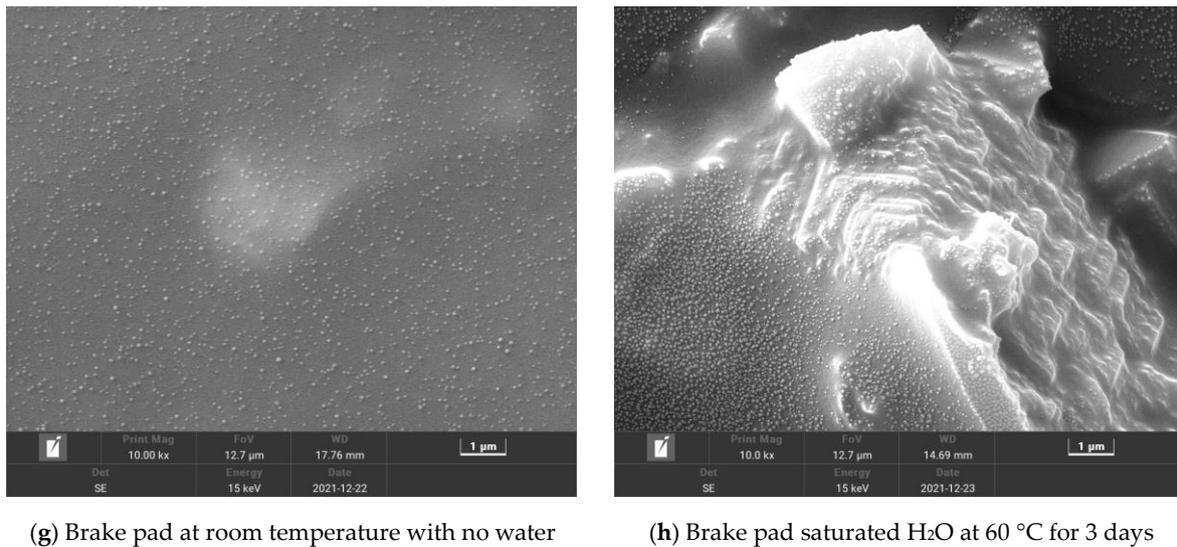
(g) Brake pad at room temperature with no water

(h) Brake pad saturated H₂O at 60 °C for 3 days**Figure 14.** SEM microscopic morphology of asphalt mortar before and after water saturation.

Compared to other filler materials, the thickness of the asphalt film becomes thinner when the brake pad powder is saturated with water—see Figure 14g,h. Concurrently, because it contains more calcium oxide, it induces a hydration reaction with water and generates stronger adsorbable products that to some degree enhances the anti-spalling performance of the asphalt mortar [30]. Because cement, slaked lime, and brake pad powder have stronger chemical reactions in water, their corresponding asphalt mortar water stability is better than that of the mineral powder (limestone) asphalt mortar. Furthermore, the chemical reaction products of slaked lime, brake pad powder, and water interacts better with the asphalt, and so, the water stability of the asphalt mortar is better than that of the cement asphalt mortar. Compared to slaked (hydrated) lime, brake pad powder has more impurities with relatively lower pure alkali-containing substances. So, the resultant water stability of its asphalt mortar is correspondingly lower than that of the slaked lime asphalt mortar. Overall, the brake pad powder was ranked second best performer after slaked (hydrated) lime. The poorest performer at the bottom-most rank was the limestone mineral powder.
