# A Reasoned Diagnostic Procedure to Support the Restoration of the 17th Century Stucco Altar Dedicated to St. Michael the Archangel in Barbarano Romano (Viterbo, Italy)

## Abstract

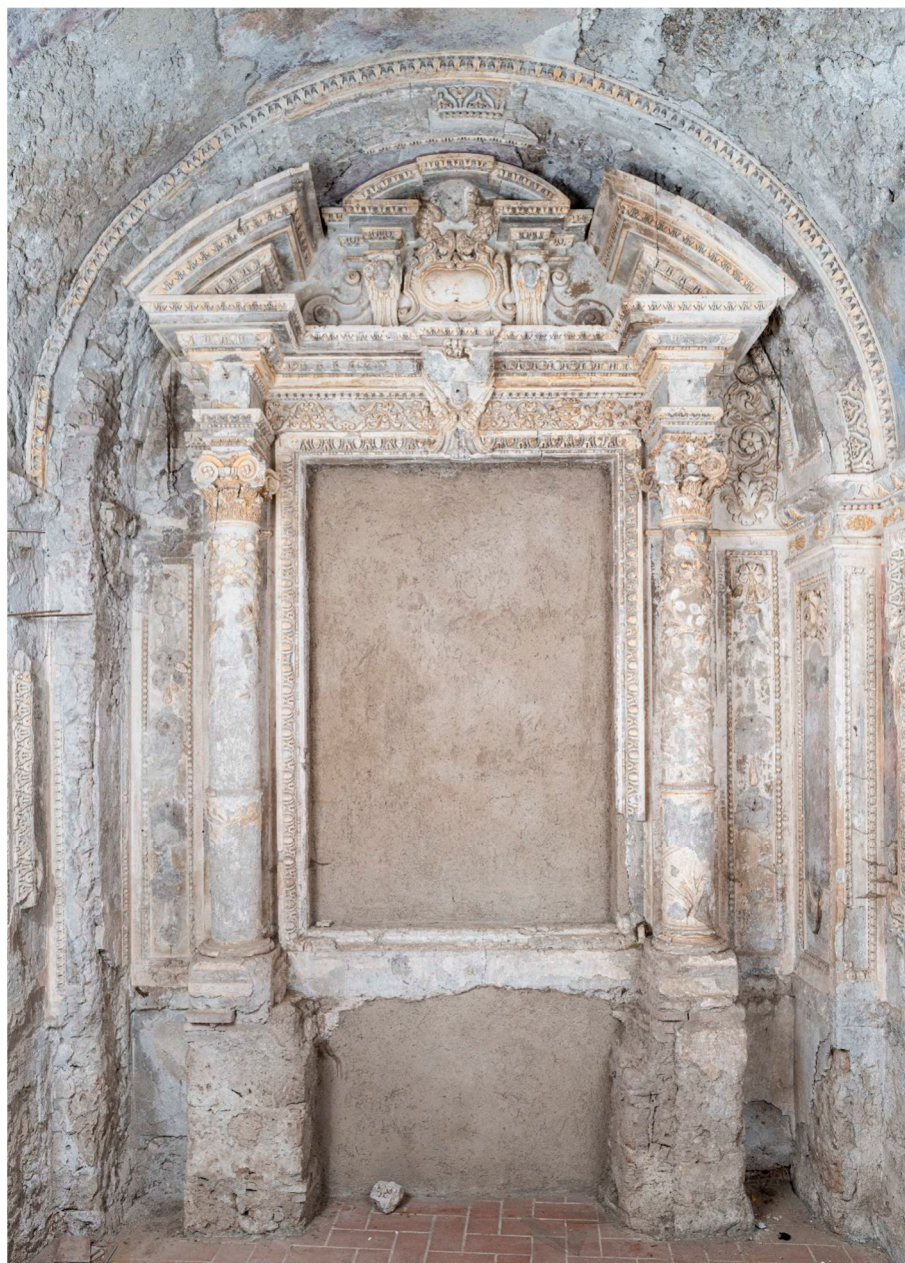
**Figure 1.** A photograph of the stucco altar before the restoration and the positioning of the scaffolding necessary for the various operations (Credits: Gaetano Alfano, University of Tuscia).

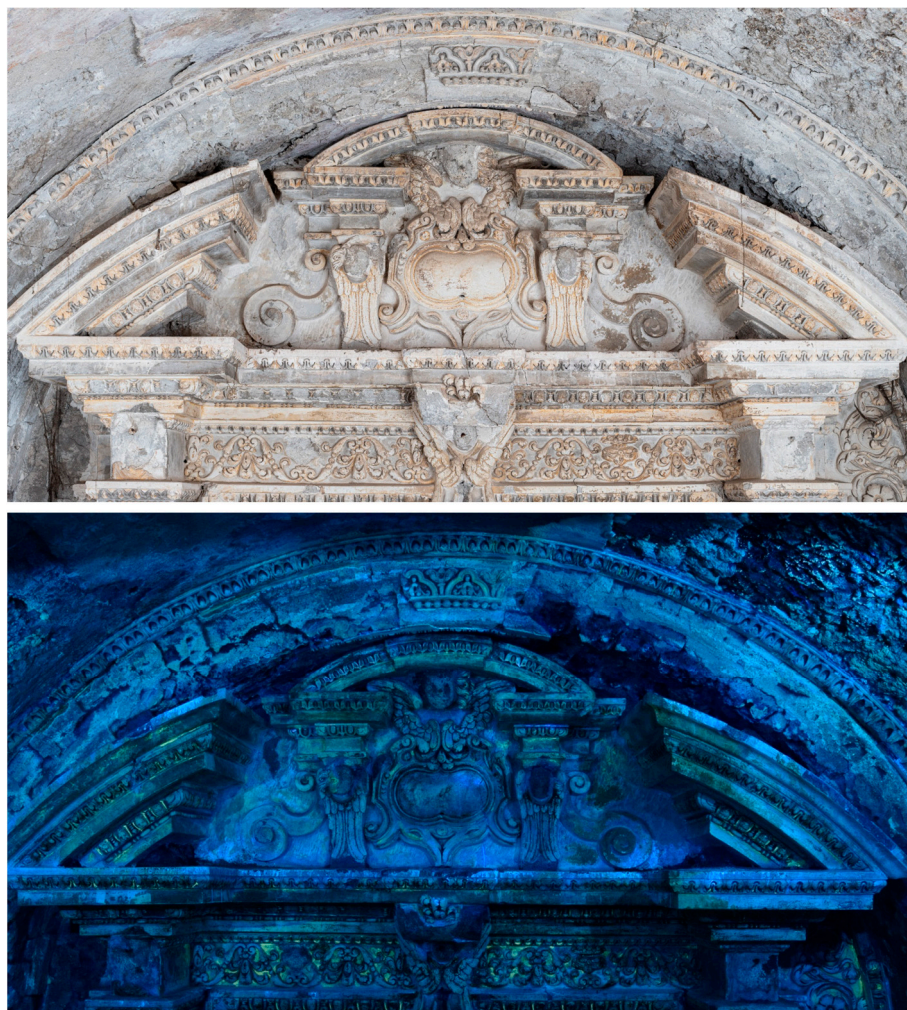
**Figure 3.** Comparison between RGB (**upper**) and UVF (**lower**) images of the upper part of the stucco altar. A complete acquisition of the altar was not possible due to the presence of the scaffolding positioned at the beginning of the restoration activities.

A first investigation of the stucco surfaces was performed using UVF photography. It is a fundamental technique in restoration since it gives information about the state of conservation [20–23]. The UVF images confirmed the bad state of conservation of the stuccoes, as observed by restorers from the scaffolding at the beginning of the work, and showed a diffused blue fluorescence due to the main constituting materials of the stuccoes, i.e., gypsum and probably organics. Moreover, an unexpected yellow fluorescence was observed non-homogeneously on the surfaces (Figure 3).

The yellow fluorescence seemed associated with a superimposed white layer partially interconnected, in some zones of the altar, with a dark or light grey surface color. This last appeared anomalous and was interpreted as a probable deposit of carbonaceous material, plausible if considering the presence of worshippers and lit candles in the chapel. The presence of soot in places of worship such as churches and chapels is common due to the use of candles (lit for devotion) that produce black deposits on surfaces [34–38]. However, in some zones, the grey layer was characterized by the presence of brushstrokes, indicating a possible intentional application, whereas in others it was completely absent (right side). This was quite puzzling, as also hinted in the Introduction, and had to be solved before proceeding with the cleaning operation.
