Article

The Use of Triboemission Imaging and Charge Measurements to Study DLC Coating Failure

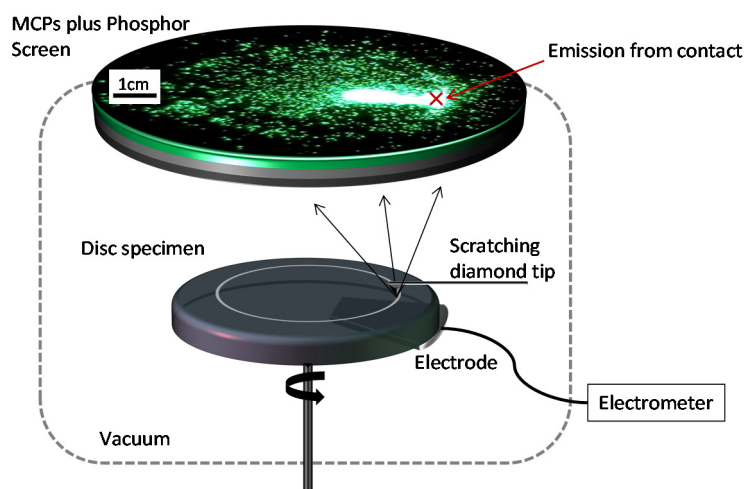
The tribometer used to conduct the study is represented schematically in Figure 1 [17,22]. It consists of a system of microchannel plates (MCPs, i.e., arrays of electrons multipliers), coupled with a phosphor screen (Photonis Inc., Sturbridge, MA, USA). The two circular MCPs, in a chevron arrangement with an active diameter of 75 mm, are located 10 mm above and parallel to the disc specimen (note: the centre of the circular MCPs are located directly above the centre of rotation of the disc). This setup allows us to obtain spatially resolved images of the triboemission, with 1:30 magnification due by the divergence of emitted electrons. The emissions detected and visualised through this system were recorded by a high speed camera (Phantom Miro eX, Vision Research Ltd., Bedford, UK) with a Fujian 35 mm f1.7 lens located above the experimental setup. The sliding contact was produced by loading a diamond tip of radius 100 μm (Synton-MDP Ltd., Port, Switzerland) against the rotating disc specimen. The rotation of the disc was recorded by the supplied PCS Instruments encoder device. In addition, an electrometer (Model: 6517b, Keithley Instruments Ltd., Bracknell, UK) coupled with a 10 mm \times 5 mm metal sheet electrode attached underneath the specimen was used to inductively measure the charge of the surface, simultaneously with the emission detection. The tests were conducted in vacuum conditions at a pressure of $\sim 10^{-5}$ Torr.

Figure 1. Schematic of the tribometer.

The triboemission measurements were conducted in negative particle detection mode, i.e., 10%–85% of 0.01–50 keV electrons were detected [25], with the voltage applied to the input MCP, output MCP and the phosphor screen being ground, applying 1.5 kV, and 5 kV, respectively. The speed of the rotation of the disc was 4 Hz giving a sliding velocity of 50 mm/s. The deadweight load applied to the scratching tip on to the disc was 0.5 N. The frame rate of the high-speed camera (exposure time 8 ms), the encoder and the electrometer acquisition were synchronised at 125 Hz. At the end of the test, the cleaning procedure previously described was repeated and the topography of the wear track was recorded using the Veeco Wyko NT9100 optical profiler (Veeco Instruments Inc., Plainview, NY, USA).

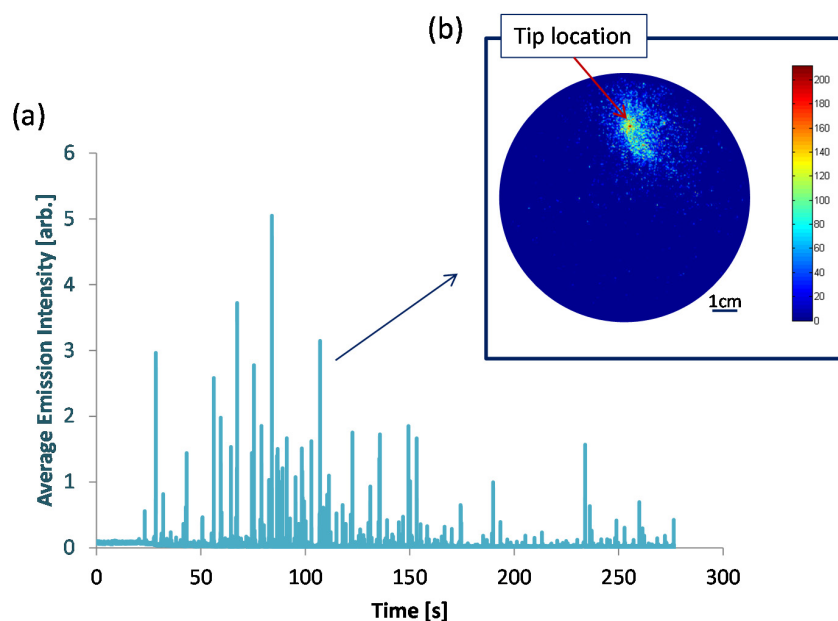
Figure 2a displays the average (spatial) intensity of each phosphor screen image plotted as a function of time, throughout the entire sliding test. In addition, Figure 2b shows an example of an emission event as viewed on the phosphor screen. The emission event is localised at the tip location suggesting that it is due to wear. In Figure 2a, a decrease in emission intensity is also evident during the second half of the test.

Figure 2. (a) Average Emission Intensity (spatial average of each phosphor screen image) vs. time, (complete test); (b) Phosphor screen intensity of a single emission event.

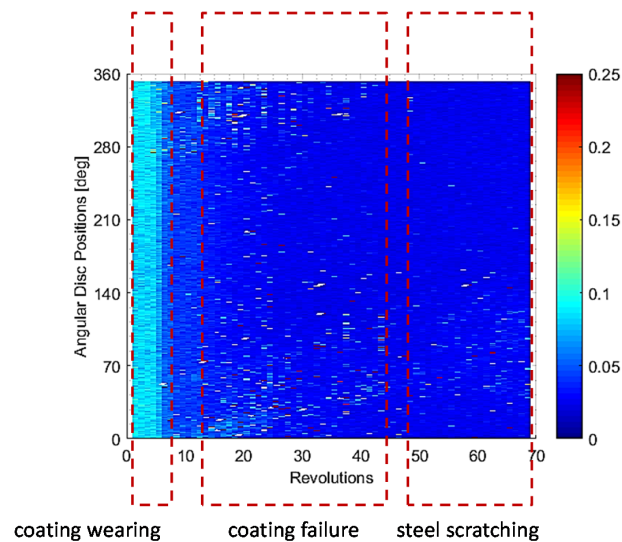
An alternative way to display the same phosphor screen intensity data is to plot the average emission intensity as a function of the cycles and the angular disc position of the stylus relative to the disc, as shown in Figure 3 (with each coloured square representing the average phosphor screen intensity). Here, the spatial evolution of the emissions can be visualised and divided into three regions.

Initially, there is a moderate level of emission indicated by the pale blue rectangular section at the start of the test. Towards the end of this period, the first and highest intensity peak in emission occurs, and the low-level baseline emission transitions into the second stage of the test (shown by the background colour becoming dark blue). From this point onwards, sporadic high intensity peaks occur, although their intensity is lower than that of the first event. Eventually, the frequency and magnitude of these peaks reduce, as shown by the mostly uninterrupted dark blue region.

Figure 3. Average phosphor screen intensity as a function of time and disc position.

It is hypothesised that this observed behaviour is attributed to the following mechanism. The initial area characterised by a constant, low level intensity (the light blue colour) defines the emission generated by the wearing of the non-conductive coating layer as shown by the optical microscopy scan in Figure 4a. This is in accordance with previous studies on non-conductive materials [17]. The following high intensity emission event indicates the moment at which the coating fails resulting in a wear trace characterised by both surface cracks and partial delamination (Figure 4b). This is in accordance with previous studies that suggest that emission is due to the high energy generated during the damage of the surface, in particular crack formation [17,19,31,32]. The third region shows relatively few high emission events, occurring due to wearing of the remaining coating. The baseline emission (shown by the dark blue colour) is at a low level due to the scratching of the metal substrate, which can conduct away charge and hence prevents emission. This is in agreement with the fact that the triboemission intensity is greater for materials with high electrical resistivity [33].

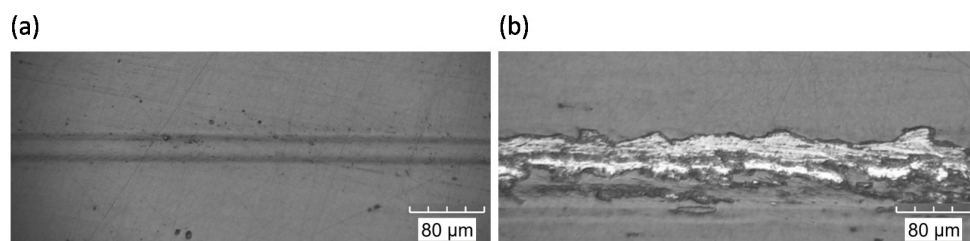
Figure 4. Optical Microscopy scans of the wear trace during (a) coating wearing phase; (b) coating failure phase.

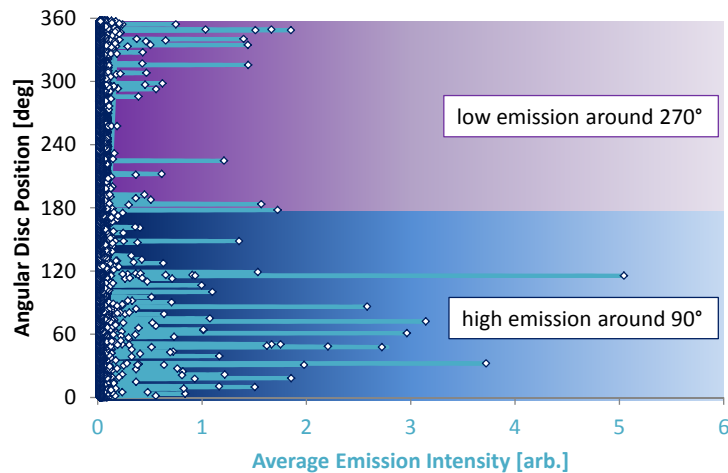
Since the angular position of the disc is recorded and synchronised with the camera acquisition, the average emission intensity can be plotted as a function of the angular position of the disc as shown in Figure 5. Here, it is evident that the highest intensity emissions are localised around 90° and the

lowest intensity emission are around 270° of disc rotation. Visual inspection of the disc revealed that the depth of wear around the track was not uniform. It was therefore hypothesized that the area of the disc characterised by high intensity emission events corresponded to the diamond tip contacting the non-conductive coating. Conversely, the area characterised by low emission events corresponded with the tip scratching the conductive steel.

Figure 5. Average of phosphor screen intensity as a function of emission intensity and disc position.

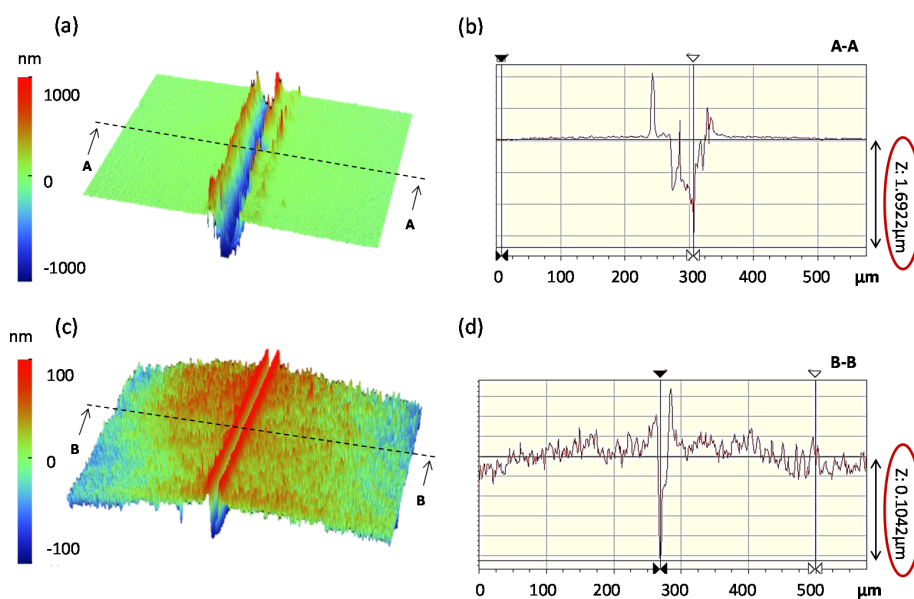
After the test, a Veeco optical profilometer analysis of the surface was conducted to evaluate the depth of the wear track in the two areas under consideration. Results are shown in Figure 6. It can be seen that the wear track at the angular position of 270° is $1.69 \mu\text{m}$, which is deeper than the thickness of the coating layer (Figure 6b). In the region of the disc surface around the 90° location, the depth is only $0.1042 \mu\text{m}$, which is less than the thickness of the coating layer, as shown in Figure 6d. This proves that, around the 90° location, the coating was not removed so that the tip scratched the coating generating an emission in accordance with triboemission measurements for non-conductive materials. However, around 270° , the tip scratched the metal substrate and the intensity of the emission was reduced in accordance with previous emission measurements for conductive materials.

Figure 6. Veeco analysis of the surface at disc regions of low and high emission, (a) 3D profile at 270° ; (b) section depth at 270° ; (c) 3D profile at 90° ; (d) section depth at 90° .

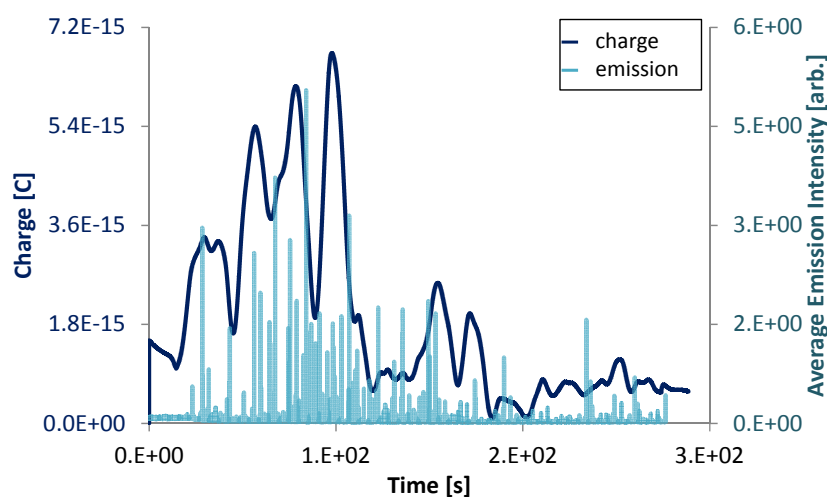
The release of the emission was then compared with the evolution of the charge on the disc surface. To do this, instantaneous measurements of charge on the surface and the average of the emission intensity are plotted as a function of time in Figure 7. There is a clear correspondence between the emission intensity and the charge accumulation for the DLC surface (a local regression smoothing method was applied to the charge measurement data for a better comparison). In the first part of the test, there is a clear correspondence between the negative emission peaks and the positive charge peaks. This suggests that the surface charges positively, at least partly due to electrons leaving the surface. At around 100 s, the reduction of the emission intensity and the charge can be attributed to the failure of the coating. It is suggested that this reduction is caused by: (i) the scratching of a reduced area of coating (part of the coating is removed during the first 100 s of the test); (ii) the exposure of the metal substrate which switches the contact from being diamond/DLC to being diamond/steel, preventing the accumulation of opposite charge on each of the two counter bodies which would otherwise lead to emission; and (iii) the exposure of the steel substrate which may absorb charge, preventing the generation of emission.

Figure 7. Instantaneous values of average phosphor screen intensity and surface charge vs. time.

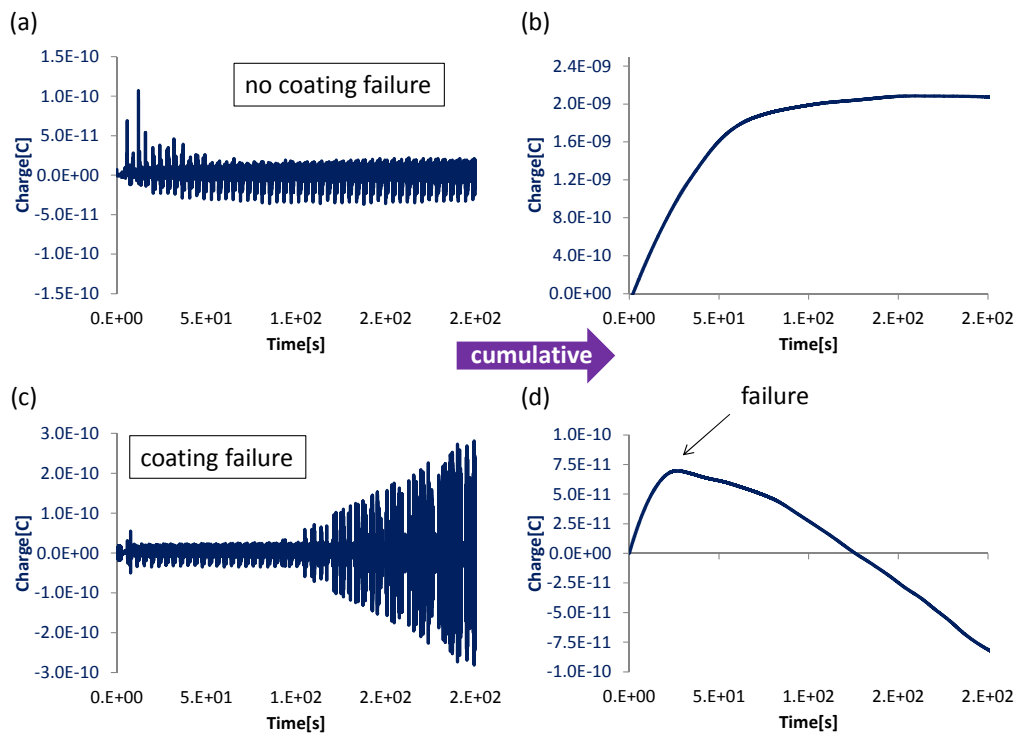
Additional measurements were assessed to compare the differences in charging behaviour between tests in which coating failure either did or did not occur (Figure 8). The curves of instantaneous charge values show a fluctuation for both no failure and failure tests—see Figure 8a,c, respectively. Figure 8a shows that, in the case of no coating failure, the charge fluctuates around 10 pC for the entire test. However, the cumulative values in Figure 8b show positive charges accumulating on the surface, as also reported by previous studies [34], until a saturation value is reached, from which point onwards the charging remains stable. In the case of coating failure, the instantaneous charge curve fluctuates around 10 pC until the point failure, after which it increases, as shown in Figure 8c. The cumulative curve in Figure 8d shows that, after failure, the surface started to accumulate negative charge. This is suggested to be caused by the reasons outlined above.

This comparison clearly shows the differing charging behaviours in the case of failure and no failure of the coating. The accumulation on the surface of positive particles due to the emission of negative particles is affected in the case of failure.

Figure 8. Surface charge vs. time: (a) no coating failure—instantaneous; (b) no coating failure—cumulative; (c) coating failure—instantaneous; (d) coating failure—cumulative.

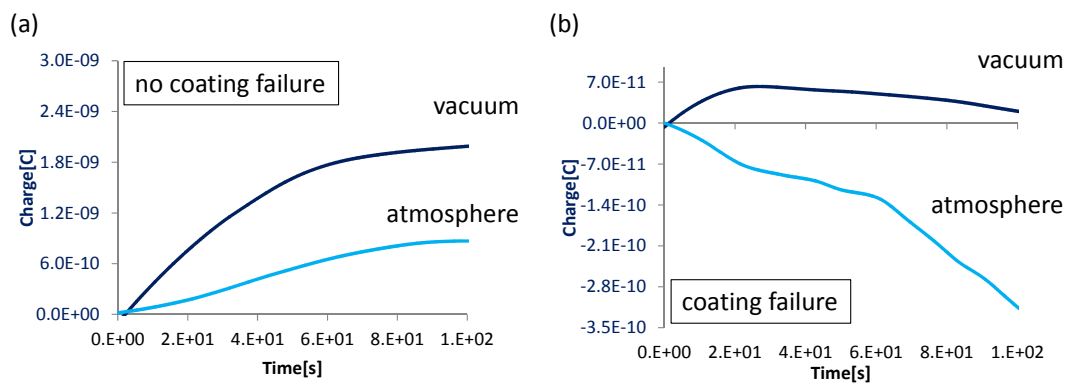
The final investigation was aimed at comparing the charging of the surface in both vacuum and atmospheric conditions. A comparison for the charge measurements when failure did and did not occur is reported in Figure 9. When the coating remains intact, the surface charges positively in both vacuum and atmospheric conditions, as shown in Figure 9a. In the case of failure, the surface charges negatively as soon as the metal substrate is exposed, as reported in Figure 9b. In each case, the value of the charge in the atmosphere is lower compared to that under vacuum conditions. This may be due to increased electrical breakdown due to the presence of air. Specifically, when the electric field due to the accumulation of charge on components exceeds a threshold determined by the dielectric field strength [35] of the surrounding gas (30 kV/cm for air [36]), breakdown can occur through a Townsend discharge process. Furthermore, some evidence suggests that corona discharge limits the formation of charge during contact electrification [37,38].

Figure 9. Surface charge vs time in vacuum and atmosphere: (a) no coating failure—cumulative; (b) coating failure—cumulative.

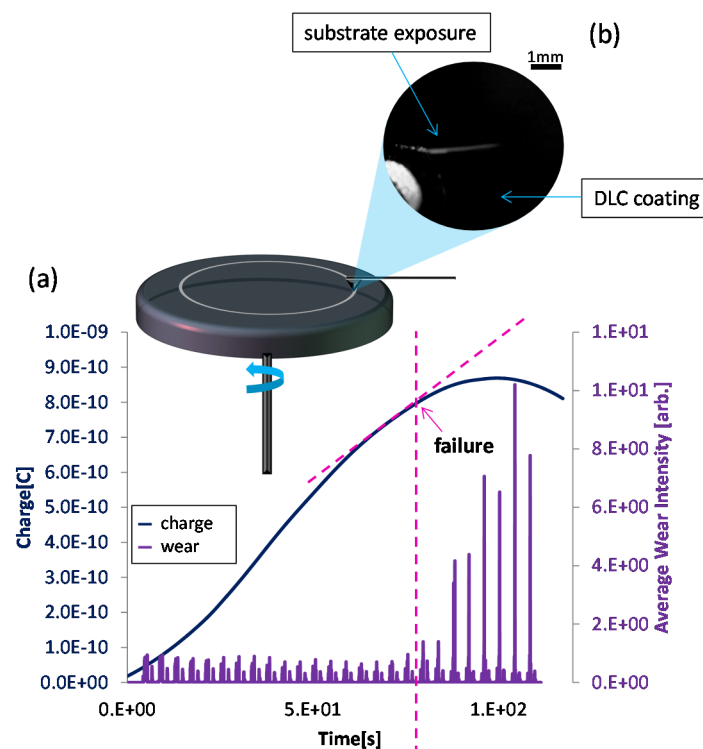
The charge measurements in atmosphere were accompanied by standard optical microscope video recordings of the wear track. This gave an in situ indication of the instantaneous coating integrity on the specimen surface during sliding, by acquiring and averaging the colour intensity of pixels recorded at the exit of the contact. The increase in the intensity indicates the exposure of the metal substrate, since steel has a higher reflectivity compared to DLC coating. The average of the intensity at the exit of the contact and the measured surface charge are plotted against time in Figure 10a. This plot shows that, when the tip wears the coating without failure, the surface charges positively. However, as soon as the coating fails (the moment of the failure is indicated by the dashed line) the metal substrate is exposed, as show in Figure 10b, and the surface charge begins to decrease towards negative values in accordance with previous results.

Figure 10. (a) Average wear track intensity and surface charge vs. time; (b) example of $5\times$ magnification wear track tip outlet.
