# The CRATI Project: New Insights on the Consolidation of Salt Weathered Stone and the Case Study of San Domenico Church in Cosenza (South Calabria, Italy)

**Abstract:** This paper presents the results of a laboratory experimentation carried out on stone materials in the framework of the CRATI project (Knowledge and Restoration through Advanced Integrated Technologies) aimed at testing new products with consolidating properties by means of an integrated methodological approach. After the preliminary characterization of stone materials collected in the pilot site, the second stage of the activities within the project were focused on the formulation and testing of products for the conservation of the same materials against decay, especially salt crystallization, one of the most aggressive and common degrading processes. The San Domenico Church, located in the old town of Cosenza (Calabria, Southern Italy) has been chosen as the pilot site and for the in situ tests. Several specimens with the same features of the stone materials used in San Domenico church were collected from a historical quarry near the city of Cosenza. These specimens were treated and then artificially degraded by

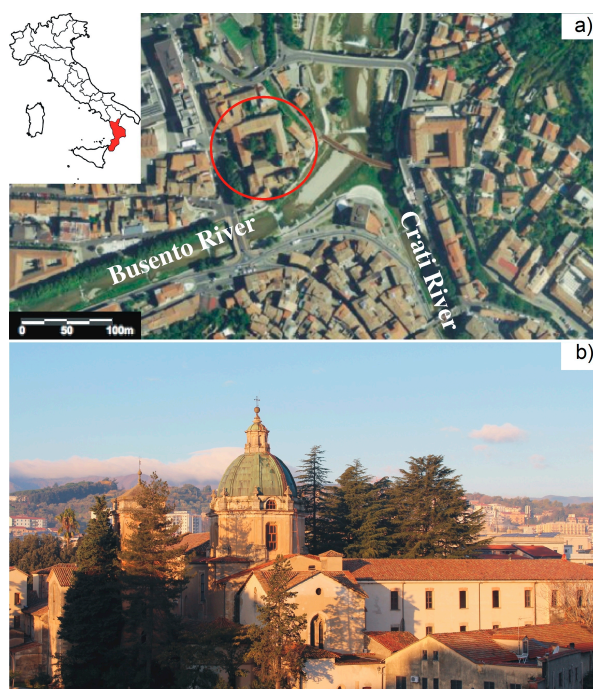
**Figure 1.** (a) Cosenza city map: red circle indicates the San Domenico church; (b) panoramic view of the San Domenico church.

This historical monument is located in the old town of Cosenza (Calabria, southern Italy) and belongs to a Dominican complex dating back to the fifteenth century. Geographically it is placed to the left-side of the Crati river, near its confluence with the Busento river (Figure 1). This complex represents one of the most important historical buildings of the city, with an initial Gothic architectural influence that has undergone stylistic changes over time, especially during the Renaissance and Baroque periods. The church, as the central unit of the whole complex, reflects the typical features of the mendicant orders with a single rectangular room covered by a wooden ceiling and a quadrangular choir overhung by a ribbed vault [14,15]. The façade is composed of three parts: (a) the pediment (no longer visible) with the tympanum, (b) the rose window and (c) the prothyrum with a sixth-acute arch and denticular cornice. The main portal, which, along with the prothyrum was selected as the case study (Figure 2), is made up of calcarenite and characterised by a sixth-acute arch composed of large trapezoidal ashlars, with the exception of the triangular-shaped ashlar-key, and springers with a rectangular section. The arch is framed by a geometrical molding, alternating with shaped bands of rod, strip and inverted throat [14,15].

An exhaustive sampling of the San Domenico building stones was performed, with the assistance of the Superintendence of Archaeology, Fine Arts and Landscape for the Provinces of Catanzaro, Cosenza and Crotona, who retrieved small samples in different representative areas of the pilot site (Figure 1).

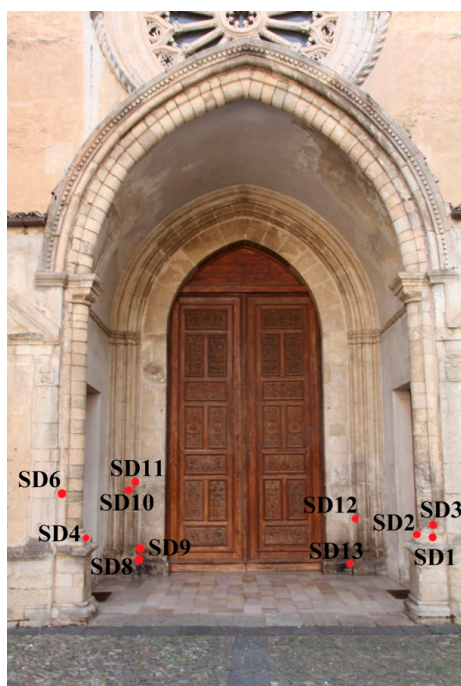
**Figure 2.** Portal of San Domenico Church (Cosenza, Italy) and details of the sampled areas.

Specifically, the prothyrum and the main portal, both attributable to the original building of the Dominican complex, were selected as cases study. Before sampling, a preliminary survey aimed to verify the state of preservation of the portal was carried out. In particular, the main detected forms of degradation are characterised by surface deposits (accumulation of dust, soil, etc. due to outdoor exposure), black crusts, erosion (mainly diffused in the lower part of the portal and in the areas concerned with black crusts' presence), chromatic alteration (distributed over large areas), loss of material (mainly diffused in the lower part of the portal) and biological patinas.

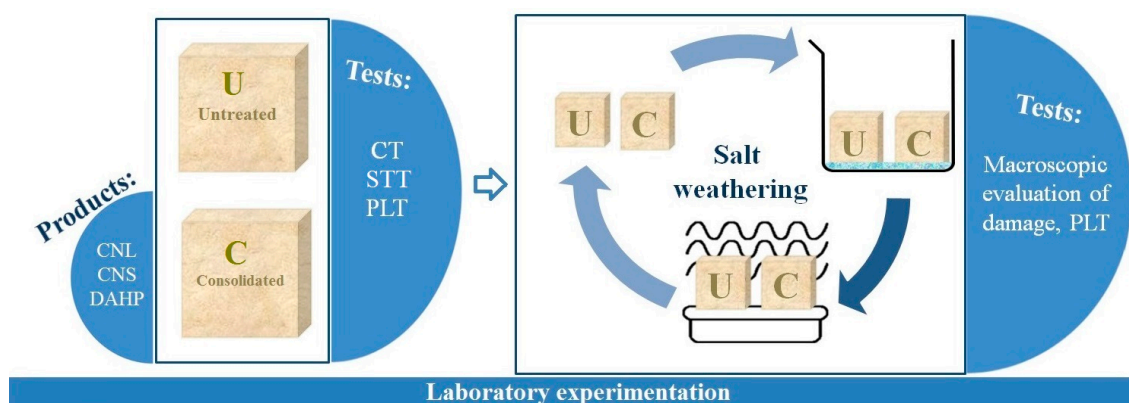
**Figure 3.** Scheme illustrating the experimentation workflow.

The workflow of the whole laboratory experimentation reporting the specimens list along with details on formulations and used methods is summarized in Table 2 and Figure 3. The experimentation consists of several phases: (a) specimen consolidation, (b) characterization of the formulations after application on the specimens, (c) salt weathering test on untreated and treated specimens to evaluate resistance to salt crystallization.

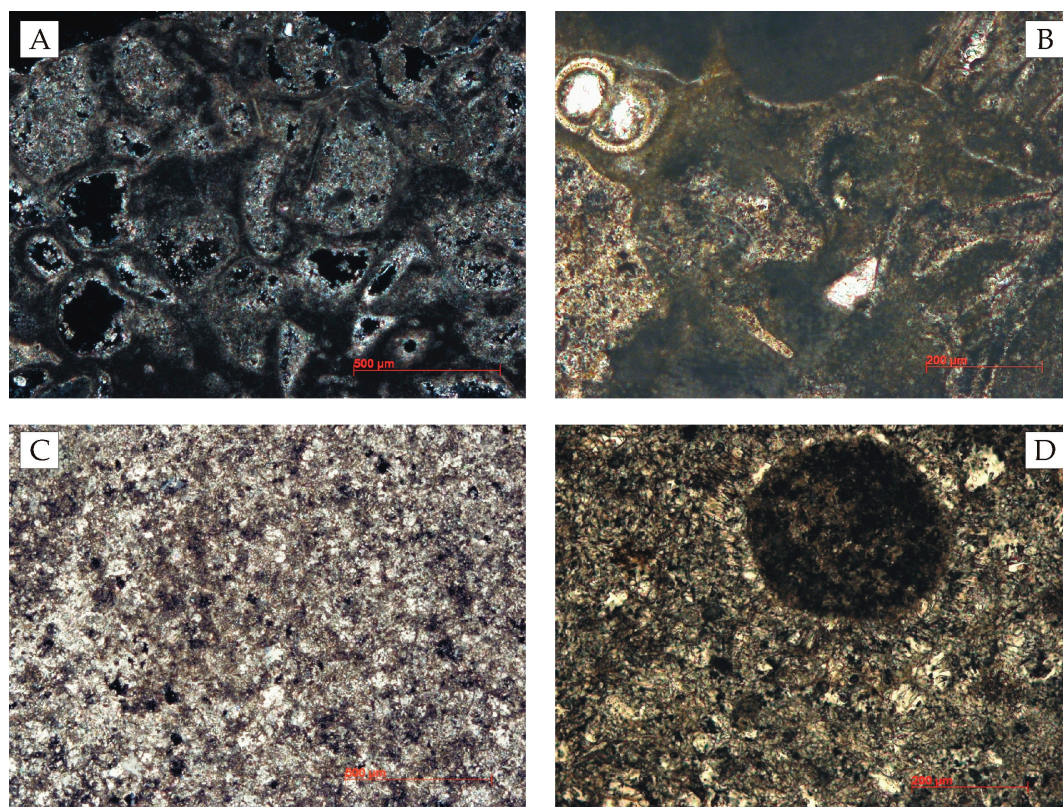
**Figure 4.** Representative photomicrographs by POM showing some textural features of biomicrites samples (A,B) and biosparites (C,D).

Petrographic observations of the thin sections under optical microscope reveal that samples show similar compositional features. Specifically, they can be classified as biomicrites or packstone/grainstone (Figure 4A,B) [26,27] with the exception of the samples SD11 and SD12 which are biosparites (Figure 4C,D) and SD1 showing biosparitic/micritic properties. The framework components are bioclasts dominated by fragments of molluscan shells, bryozoans, foraminifera and echinoderms 1–2 mm in size. The most abundant accessory clasts are mainly siliciclastic and they are monocrystalline quartz, biotite, muscovite, K-feldspars, plagioclase and chlorite with grains ranging from 0.1 to 0.2 mm in size. Rarely, plutonic and metamorphic rock fragments occur, and the micritic matrix is not well represented within these samples. Cementations of these rocks include, on the basis of crystal morphology, small prismatic calcite cement and locally developed meniscus cement at grain contacts. Grain size distribution is quite heterogeneous, and it is composed of at least by two secondary modes and one principal mode that fall into the coarse-grained sand (microfossils). All samples show predominantly intergranular macroporosity with cavities demonstrating a variable and irregular shape, ranged in size from 0.2 to 5 mm.

A brownish and superficial layer up to 800 µm thick is often present on the substrate. The level is related to the alteration forms macroscopically observed, with variable colours, morphologies and thicknesses. Superficial layers appear, many irregularly shaped, constituted by microcrystalline gypsum with sporadic grains of calcite (from the substrate) and carbonaceous particles.

Deterioration layers that developed on biomicrites or packstone/grainstone show variable thickness and different degree of adherence to the substrate. In particular, the adherence is very weak, especially in those areas where subefflorescences made of soluble/hygroscopic salts are present. Furthermore, the morphology of black crusts on these surfaces follows approximately the profile of the underlying building material with episodic deeper penetrations of the alteration products along pore walls in the stone.

On substrates composed of biosparites, black crusts seem to grow homogeneously with a lesser thickness showing also a stronger adherence to the substrate.

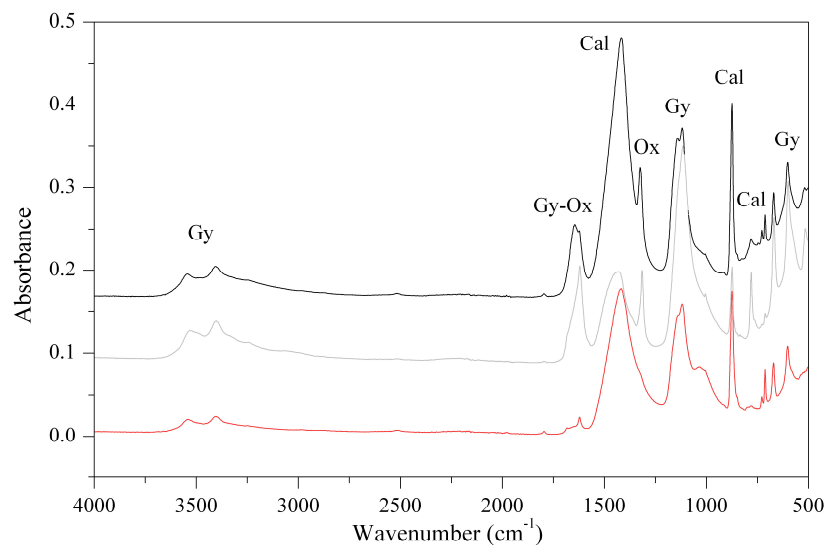
**Figure 5.** Representative FTIR spectra of some samples showing superficial alteration forms.

Spectra from the samples SD4, SD9, SD10 and SD12 revealed a variable amount of gypsum ( $\text{CaSO}_4 \cdot 2\text{H}_2\text{O}$ ), showing the typical vibrational bands centred at 1109, 669, and  $596 \text{ cm}^{-1}$  as well as the

stretching vibrations of calcite ( $\text{CaCO}_3$ ), peaked at 1409, 875, and  $711\text{ cm}^{-1}$  [28] and quartz peaked at 1094 and  $457\text{ cm}^{-1}$ .

Calcite and quartz occur due to substrate, while the presence of gypsum can represent a degradation product. In fact, if calcium carbonate is attacked by sulphuric acid generated by the sulphur compounds in the polluted atmosphere, it is transformed into gypsum [29–34]. Spectra of the samples SD8, SD11 and SD13 exhibit all the previous bands; and in addition, those related to the presence of the characteristic bands of weddellite (calcium oxalate) peaked at around 1643, 1330 and  $783\text{ cm}^{-1}$ . The presence of this mineral is indicative of an alteration product [30,31,35,36]. Representative IR spectra are shown in Figure 5.

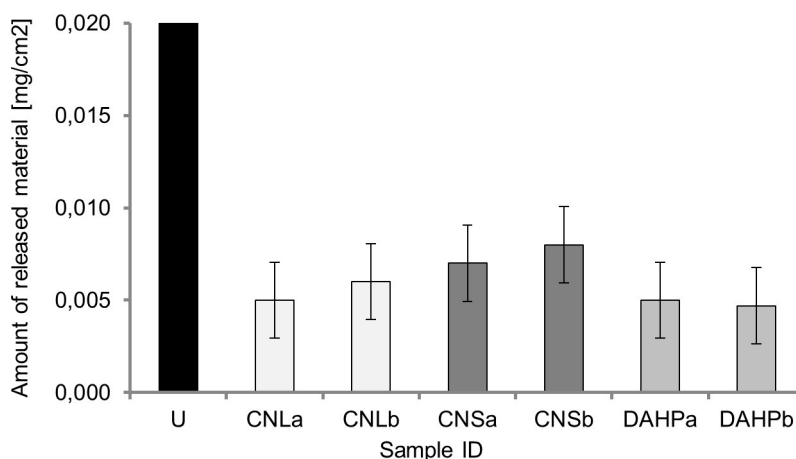
Figure 7. Scotch tape test on untreated and treated specimens.

The Scotch tape test (SST) was performed to provide information on the superficial cohesion of stone in order to investigate better the mechanical features of treated samples and to correlate them with those untreated. The results are reported in Figure 7. Treated specimens show a decrease in released material compared to untreated specimens, achieving an improvement in their superficial cohesion. Also, specimens treated with greater quantities of product give a better result. In more detail, a greater efficacy in terms of increased cohesion properties was observed in the samples treated with a mixture of nano calcium-hydroxide and diammonium hydrogen phosphate.

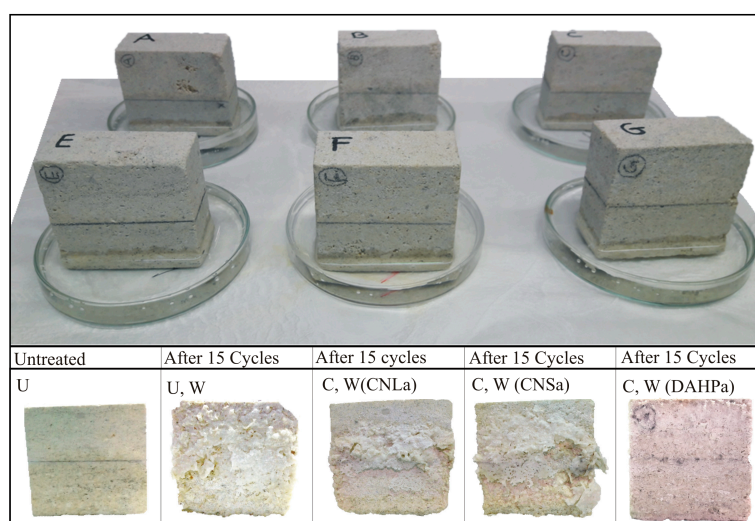
**Figure 8.** Salt weathering of some representative “San Lucido” stone specimens. Note: U, untreated; C, consolidated; W, weathered; CNL, CaLoSiL®; CNS, Nano Estel®; DAHP, Mixture of  $\text{Ca}(\text{OH})_2$  and diammonium hydrogen phosphate.

At the 15th cycles specimens suffered just rounding and loss of very small fragments, mainly at the edges. None of the samples suffered a break (Figure 8). Based on the results, and in accordance with [5], weight variations could be due to both the development of efflorescence and subefflorescence, and to the loss of material, although minimal, observed along the edges of the samples.

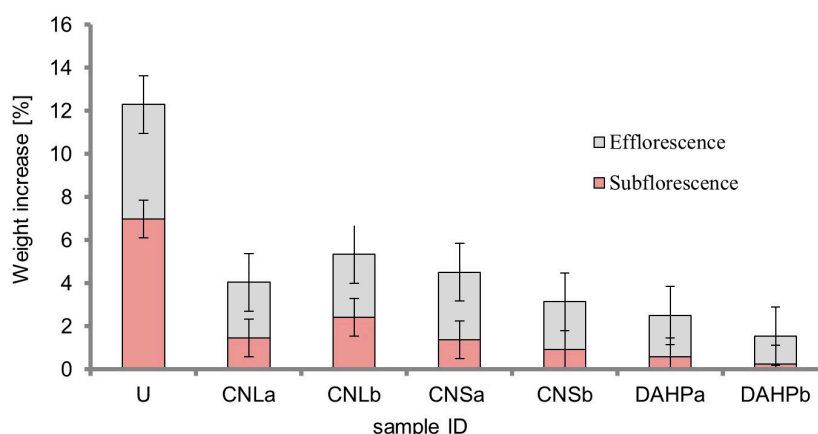
**Figure 9.** Weight increase (%) after salt crystallization test with evidence of the contribution of efflorescence and subefflorescence.

Considering the weights at each cycle and removing the efflorescence from each sample, the contribution of the subefflorescence was then evaluated. This occurs because, the longer the saline solution remains within the porous media, the worse the damage can be produced [42,43]. Figure 9 shows the increase in weight (%) that the specimens have undergone up to the 15th cycle, emphasizing the contribution made by the efflorescence compared to that made by the sub-efflorescence.

The difference between the consolidated and untreated samples is remarkable, both in terms of weight variations (at the end of the 15th cycle) as well as the growth of efflorescence and sub-efflorescence. These differences suggest that nano calcium-hydroxide mixed with diammonium hydrogen phosphate give a better response against salt crystallization decay process.
