Article

External Strengthening of Corrosion-Defected Beam–Column Members Using a CFRP Sheet

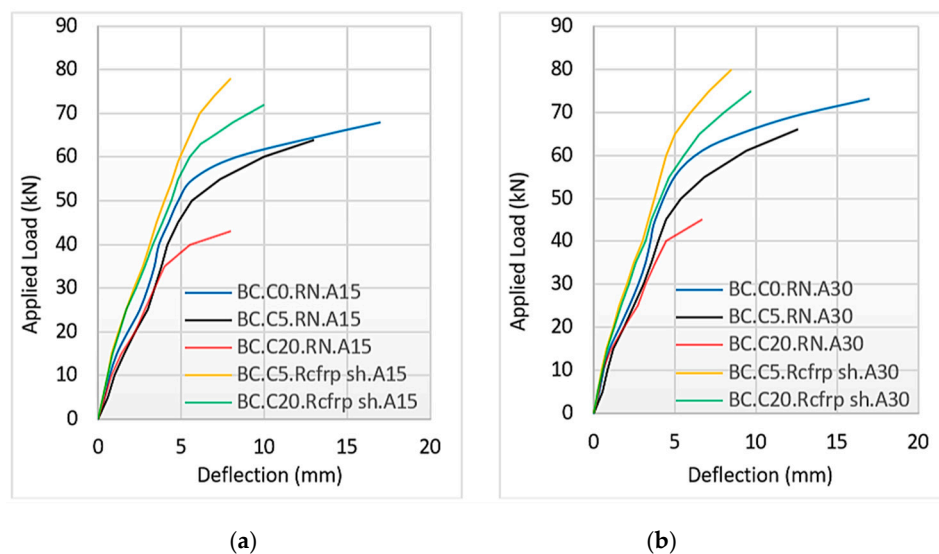
**Figure 5.** Comparison of load deflection response for each group. (a) Group A; (b) Group B.

The experimental study was performed under constant axial compressive force and transverse four-points load up to failure. The experimental results recorded in this study were the ultimate transverse load up to the peak load and service mid-span deflection for the tested specimens in addition to the allowable limit of service deflection according to the American concrete institute (ACI) code. These results are illustrated in Table 3. A comparison of the load-deflection response for each group is given in Figure 5.

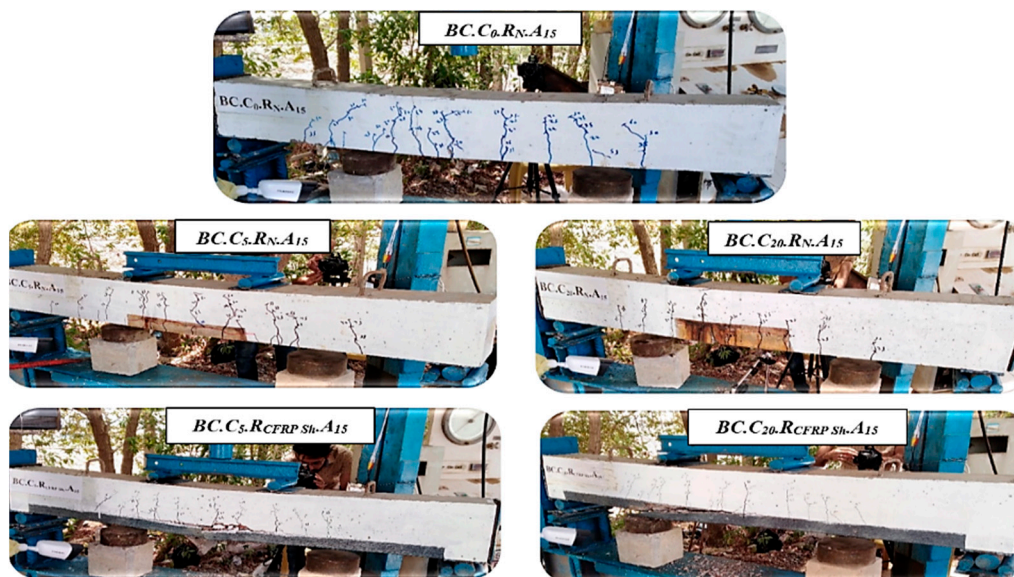
Five specimens (BC.C₀.R_N.A₁₅, BC.C₅.R_N.A₁₅, BC.C₂₀.R_N.A₁₅, BC.C₅.R_{CFRP sh}.A₁₅, and BC.C₂₀.R_{CFRP sh}.A₁₅), as shown in Figure 6 were tested under a constant axial force of 15 kN, and we gradually applied a transverse load up to failure. Horizontal corrosion cracks appeared before testing due to internal pressure from the corrosion product. First, flexural cracks appeared in the middle third span of the tension face and started to propagate and widen. Then, inclined flexural shear cracks were shown. A flexural yielding followed by a concrete crushing failure occurred for the control and low corrosion specimens. A premature rupture of the corroded bars or a sudden rupture of the CFRP sheet were shown for high corrosion or strengthening specimens, respectively. A significant reduction in the ultimate flexural strength and serviceability was recorded with an increased level of corrosion degree in addition to a lower stiffness in all stages of load-deflection response. An improvement in defected/rehabilitated specimens was noticed in the behavior and increase in the ultimate strength by 22% for low corrosion level and 67% for high corrosion level with respect to corresponding defected specimens. Serviceability in terms of mid-span deflection was restored to the allowable limit of the American concrete institute (ACI) code.

Figure 6. Cracks pattern at failure for specimens in group A.

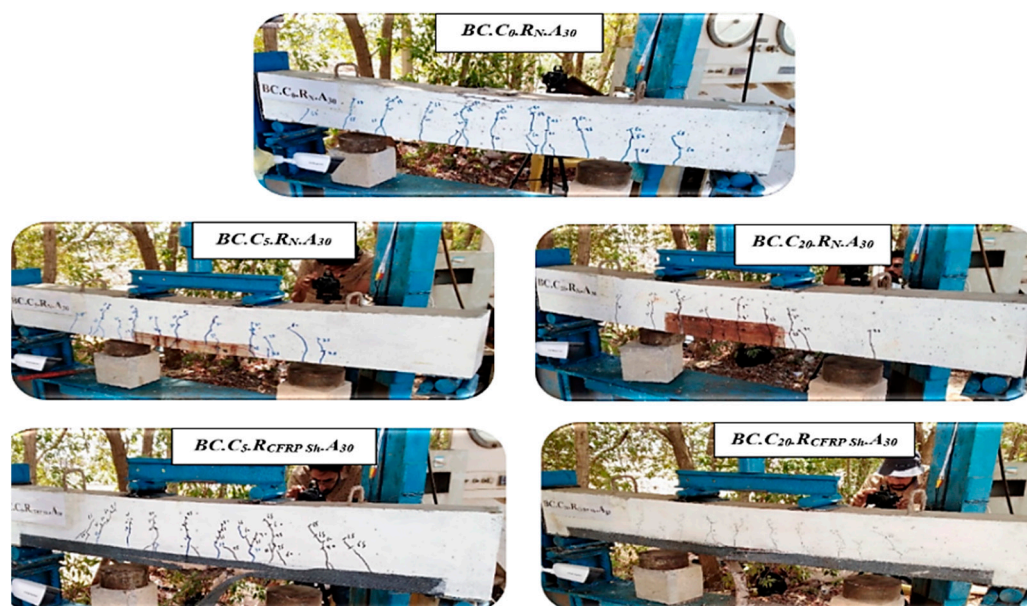
Further, five specimens (illustrated in Figure 7) were tested under a constant axial force of 30 kN, and we gradually applied transverse loading up to failure. The crack patterns were similar to those of the previous group with more propagation of the flexural crack. A flexural yielding followed by concrete crushing failure occurred for the control and low corrosion specimens, a premature rupture of corroded steel bars occurred for high corrosion specimens, and a sudden rupture of CFRP sheet failure for strengthening specimens were modes of failure. An improvement was noticed in the behavior and increased in ultimate strength by 14% for the low corrosion level and 56% for the high corrosion level with corresponding defected specimens. Also, the serviceability in term of mid-span deflection was restored to the allowable limit of the ACI code. Compared with the specimens in Group A, the increase of the axial force was recorded to be a positive effect on the ultimate strength, as well as the service deflection and stiffness. This effect was evident in the corrosion-defected specimens by decreasing the adverse effect of corrosion.

Figure 7. Cracking patterns at failure for specimens in group B.

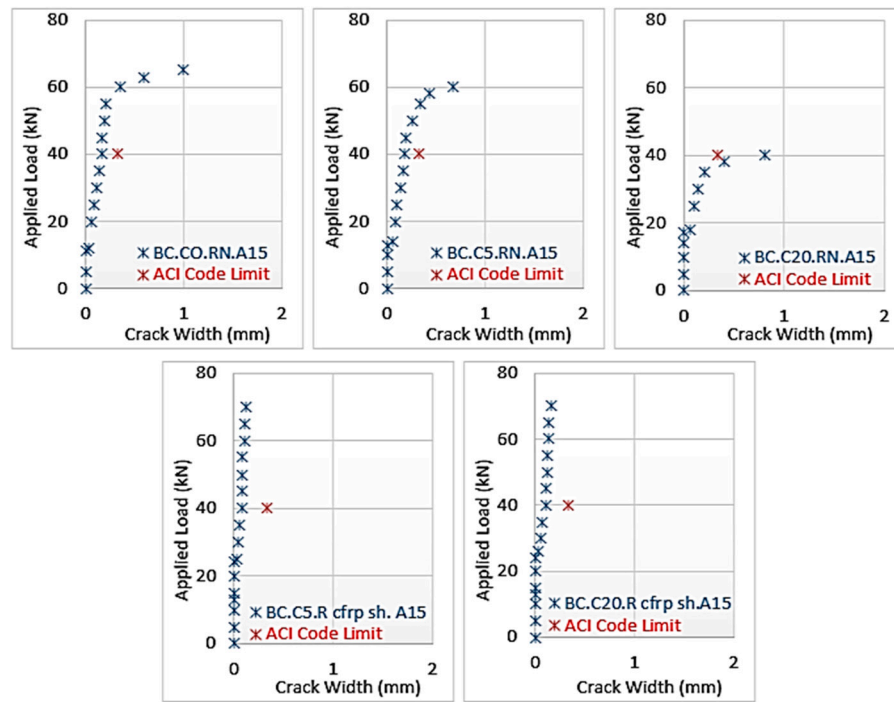
During testing, the maximum crack width was recorded for flexural cracks in critical sections (maximum moment and corrosion region), as illustrated in Figure 8.

Figure 8. Maximum crack width for specimens in group A.

As shown in Figure 8, there are two effects on the maximum flexural crack width. The first effect was the corrosion effect, so one can notice that the maximum crack width at the same service load level increased by about (12.5% and 400%) when the corrosion level increased from 5% to 20% respectively, as compared with the non-corroded control specimens. That effect occurs because of the reduction of the cross-section area of corroded steel bars, which reduces its ductility. The maximum crack width for the specimen with a high corrosion level exceeded the allowable limit of the ACI code. Using the CFRP sheet to repair the defected specimens showed a significant decrease in the maximum crack width, which then restored the allowable limit.

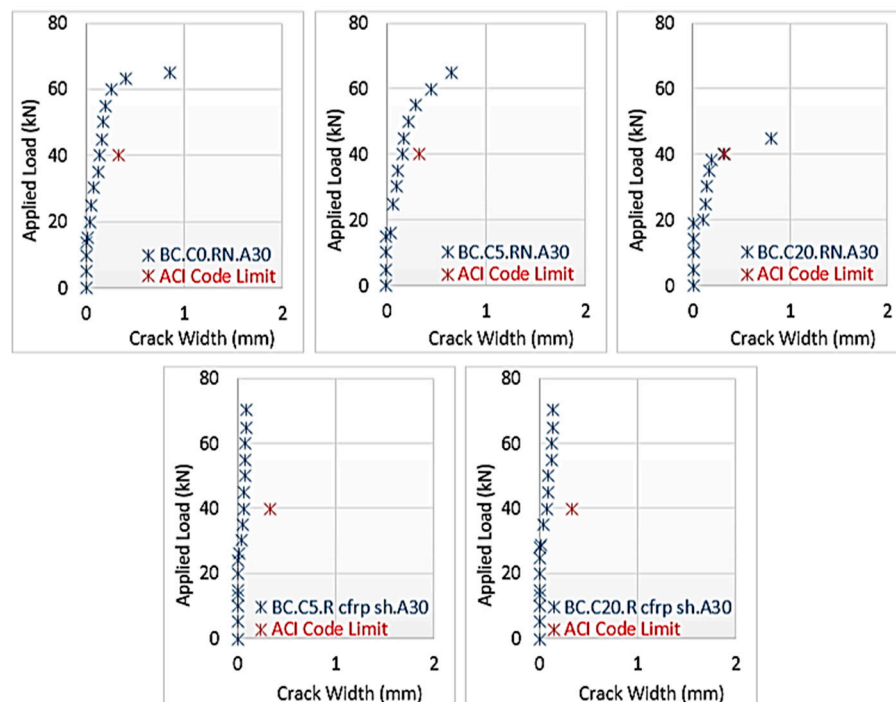
Moreover, the maximum crack width was recorded for the flexural crack in the critical section, as illustrated in Figure 9. The results of the maximum crack width in this group showed an effect of corrosion that was similar to those in group A, the maximum crack width at the same service load level increased by about 8% and 120% when the corrosion level increased from 5% to 20%, respectively, and compared with non-corroded control specimen. Also, the effect of increasing the axial force was shown by decreasing the maximum flexural crack width at the same load level, which is due to the reverse effect of the compression stress of the axial force.

Figure 9. Maximum crack width for specimens in group B.
