# Natural and Geomorphological Response of the Small Lowland River Valley for Anthropogenic Transformation

**Citation:** Ogłęcki, P.; Ostrowski, P.S.; Utratna-Żukowska, M. Natural and Geomorphological Response of the Small Lowland River Valley for Anthropogenic Transformation. *Resources* **2021**, *10*, 97. <https://doi.org/10.3390/resources10100097>

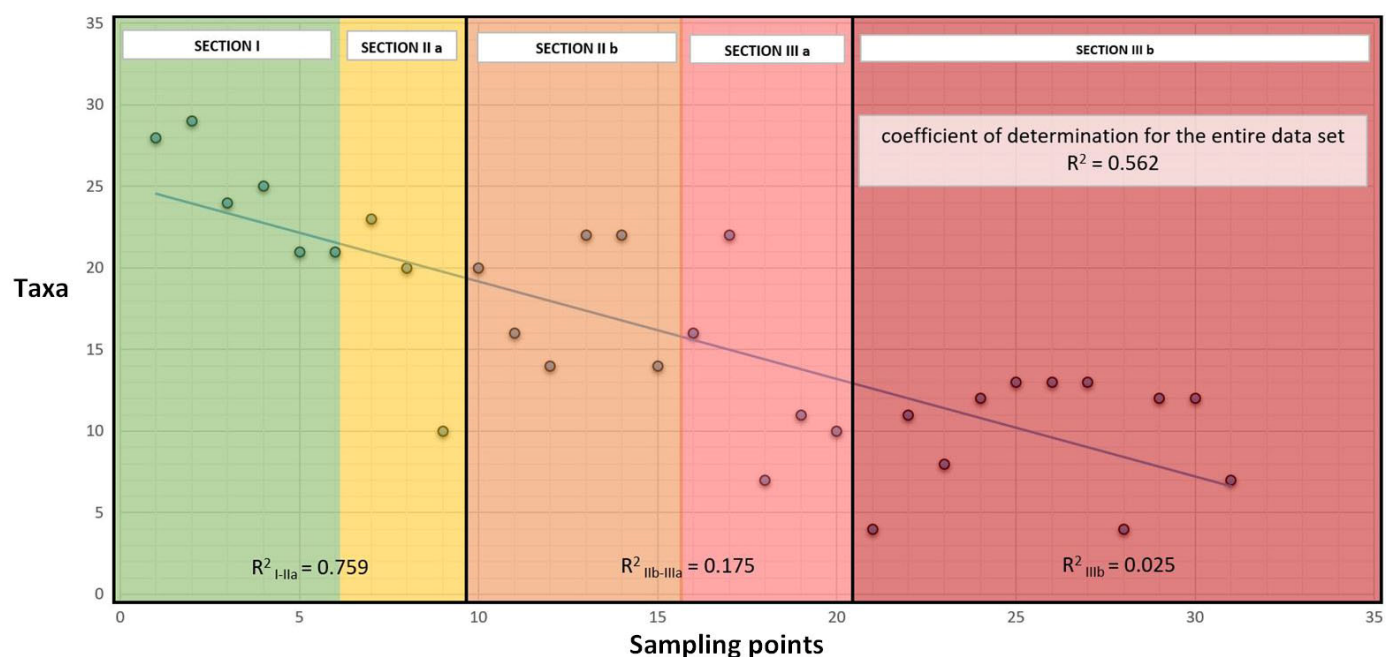
**Figure 6.** Graph of the dependence of the number of taxa on the distance from the mouth of the river, divided into distinguished sections.

When analyzing the obtained results, it can be seen that the relation between the number of observed taxa and the distance from the confluence of the Kraska River to the Jeziora River is quite visible (Figures 6 and 7). Despite the small number of sampling points, which made statistical analyses difficult, a correlation coefficient ( $r$ ) equaling 0.63 was obtained for all analyzed points, which can be considered satisfactory, even though the probability of error does exist [37]. However, in the case of joint analysis of Sections I and IIa, the value of the  $r$  coefficient increases up to 0.87. The analysis of the scanned section of the river itself (IIIa and IIIb) showed the lack of any statistical significance (the obtained coefficient values were close to zero).

It seems almost certain that the estuary section of Kraska is the reproduction ground for invertebrates from Jeziorka during the breeding period. Its role in this aspect is all the more important as it “has” suitable habitats for high water-dependent organisms. A similar role is played by the adjacent Section IIb for the sewerage section (Sections IIIa and IIIb). This is evidenced by the higher number of taxa present in Section IIIa than in Section IIIb and almost twice as high as the average number of taxa per harvesting point (Table 3). Hence, there is a very important aspect concerning regulation/maintenance of rivers: if it is necessary to interfere in the riverbed zone, the lower-most, confluence sections of small lowland rivers should not be regulated and care should be taken to keep it as accessible as possible for invertebrates (and also fish). It is also important that when regulating longer stretches of watercourses, they should be separated by even short unregulated stretches. At the same time, it is worth pointing out that, after the possible restoration of a part of the river, they could be inhabited relatively quickly by taxa with greater habitat requirements, which already have their “bridgeheads” in unregulated sections. The largest species variability in the unregulated section (Section I) and the smallest in the canalized section (Section III) should be considered to be in line with expectations, although the possibility of determining the scale of this phenomenon in the case of small lowland rivers seems important here (Figures 6 and 7; Tables 2 and 3).

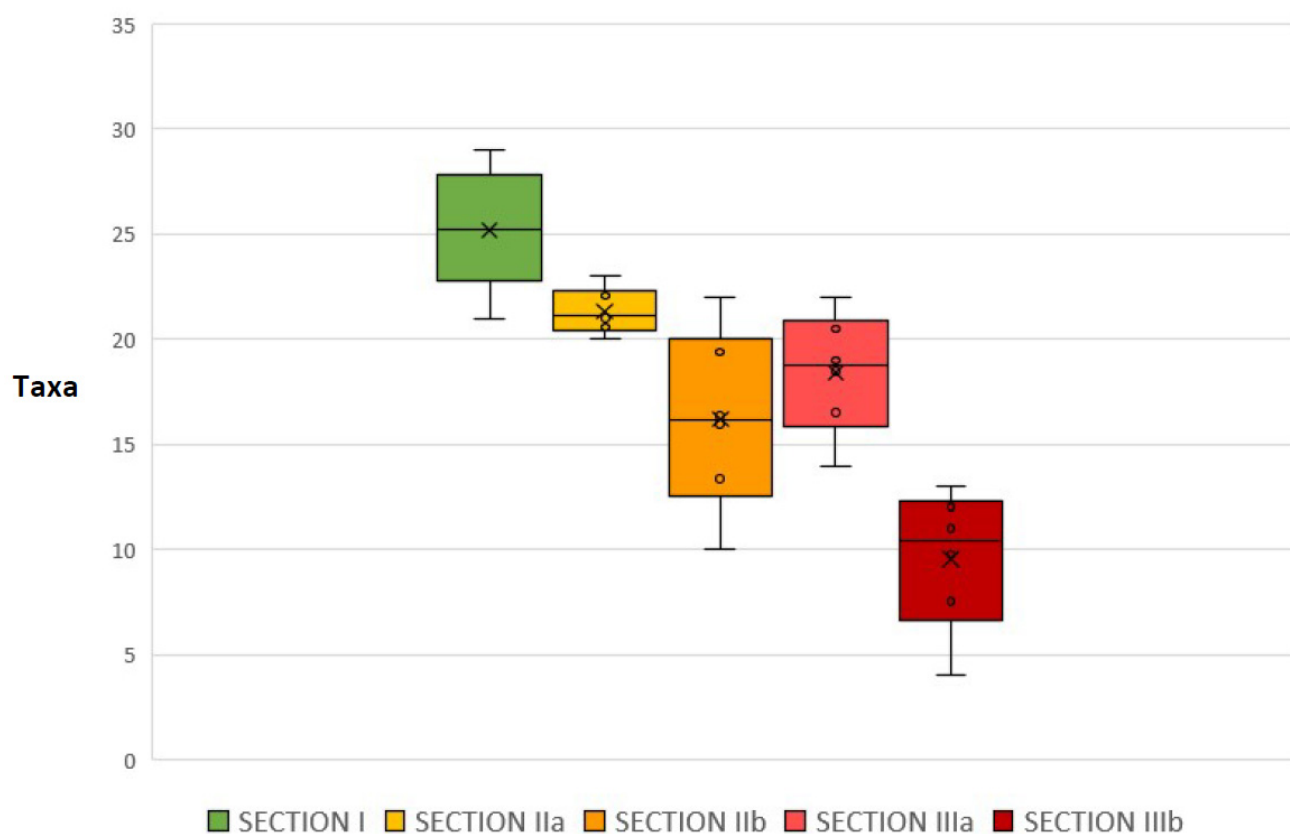
**Figure 7.** Box chart of the relationship between the numbers of existing taxa by section.

In case of the box diagram (Figure 7), due to the small number of measurement results, it was not decided to separate extreme and outlier observations. For Sections I and II the graph looks roughly symmetrical. Section IIa is characterized by the smallest scattering of results but one should keep in mind that it is the shortest section among the analyzed sections of the Kraska. Section IIb is the most diverse in this respect, which indicates a large variation in the number of taxa observed at individual measurement points. In the case of the whole Section III, a clear left-handed asymmetry can be observed—in this case, there were single points with a very small number of observed taxa. The high difference between the mean value and the median can also be noticed for Section IIIb.

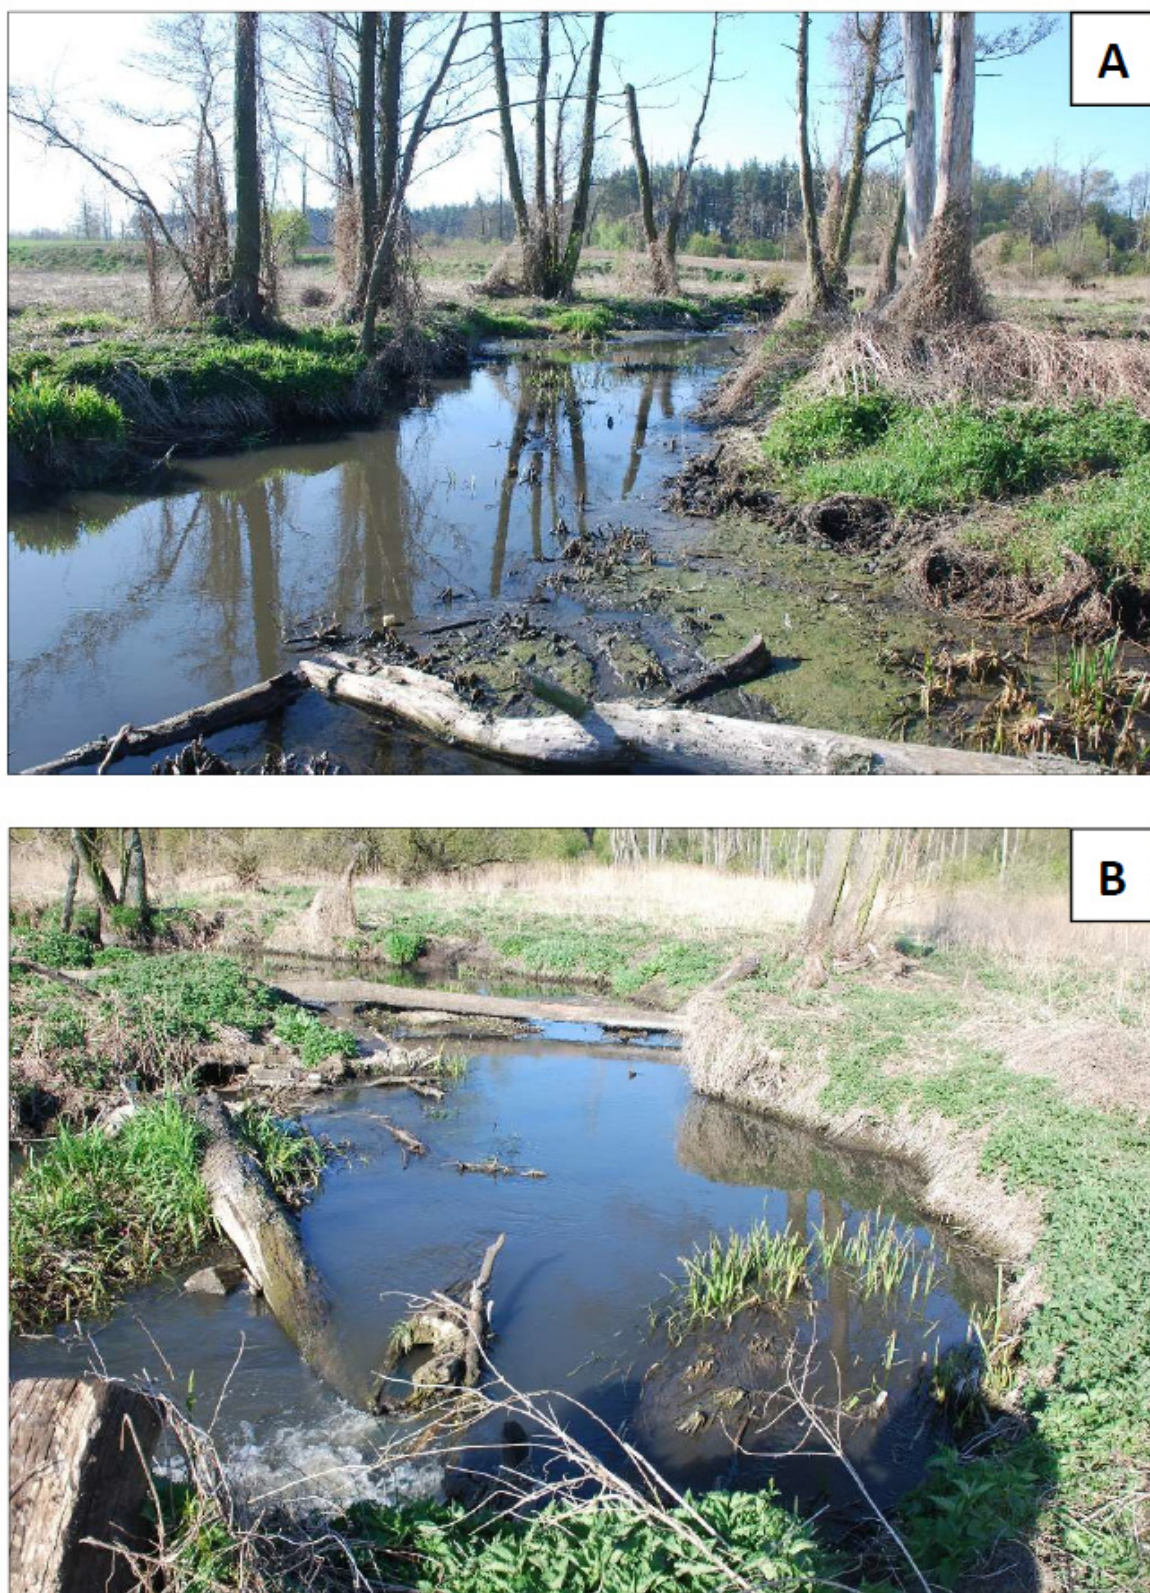
**Figure 8.** Relief differentiation (habitat richness) of the Kraska riverbed zone in Sections IIa (A) and IIb (B); traces of the regulation of the riverbed made in 2002/2003 are difficult to notice.

However, the most interesting results were obtained for the transitional Sections IIa and IIb, which was regulated in 2002/2003. From the geomorphological point of view, it did not differ significantly from Section I and contained many elements characteristic for watercourses with a high degree of naturalness (Figures 3, 4B,C and 5). In only about 18 years, the morphogenetic processes conditioned by natural factors led to the restoration of the original relief and thus the habitats in the riverbed and floodplain (Figures 8 and 9). In this case, the most important factor should be considered the cyclic congestion and related to it long-lasting extra-riverbed flows [13], usually determining the relief of the trough and floodplain. The surprisingly fast rate of renaturation in the case of Kraska was possible, as it seems, thanks to the technology used in the regulation, which was not very durable (earthworks secured only with fascia fortifications). Such tendencies to the natural course of morphodynamic processes, often resulting in the destruction of regulation devices, are also quite commonly observed on large rivers of the Polish Lowlands, such as the Vistula [22,47,48]. The geomorphological changes in Section II have also confirmed the results of trapping invertebrate fauna (Figure 6 and Tables 2 and 3), i.e., slightly lower number of taxa present than in Section I. A comparison of Sections I and IIa, which are characterized by the same valley bottom morphology, seems particularly interesting here (Figures 2 and 3). If it had not been made 18 years ago, the adjustment of the channel could have been treated as one section. The number of registered taxa in Sections I and IIa is similar (Figure 6 and Table 2). It is connected with their differentiated and very similar sculpture of the channel zone influencing the habitat richness. The similarity of these sections is also confirmed by the high value of the coefficient of determination (0.76).

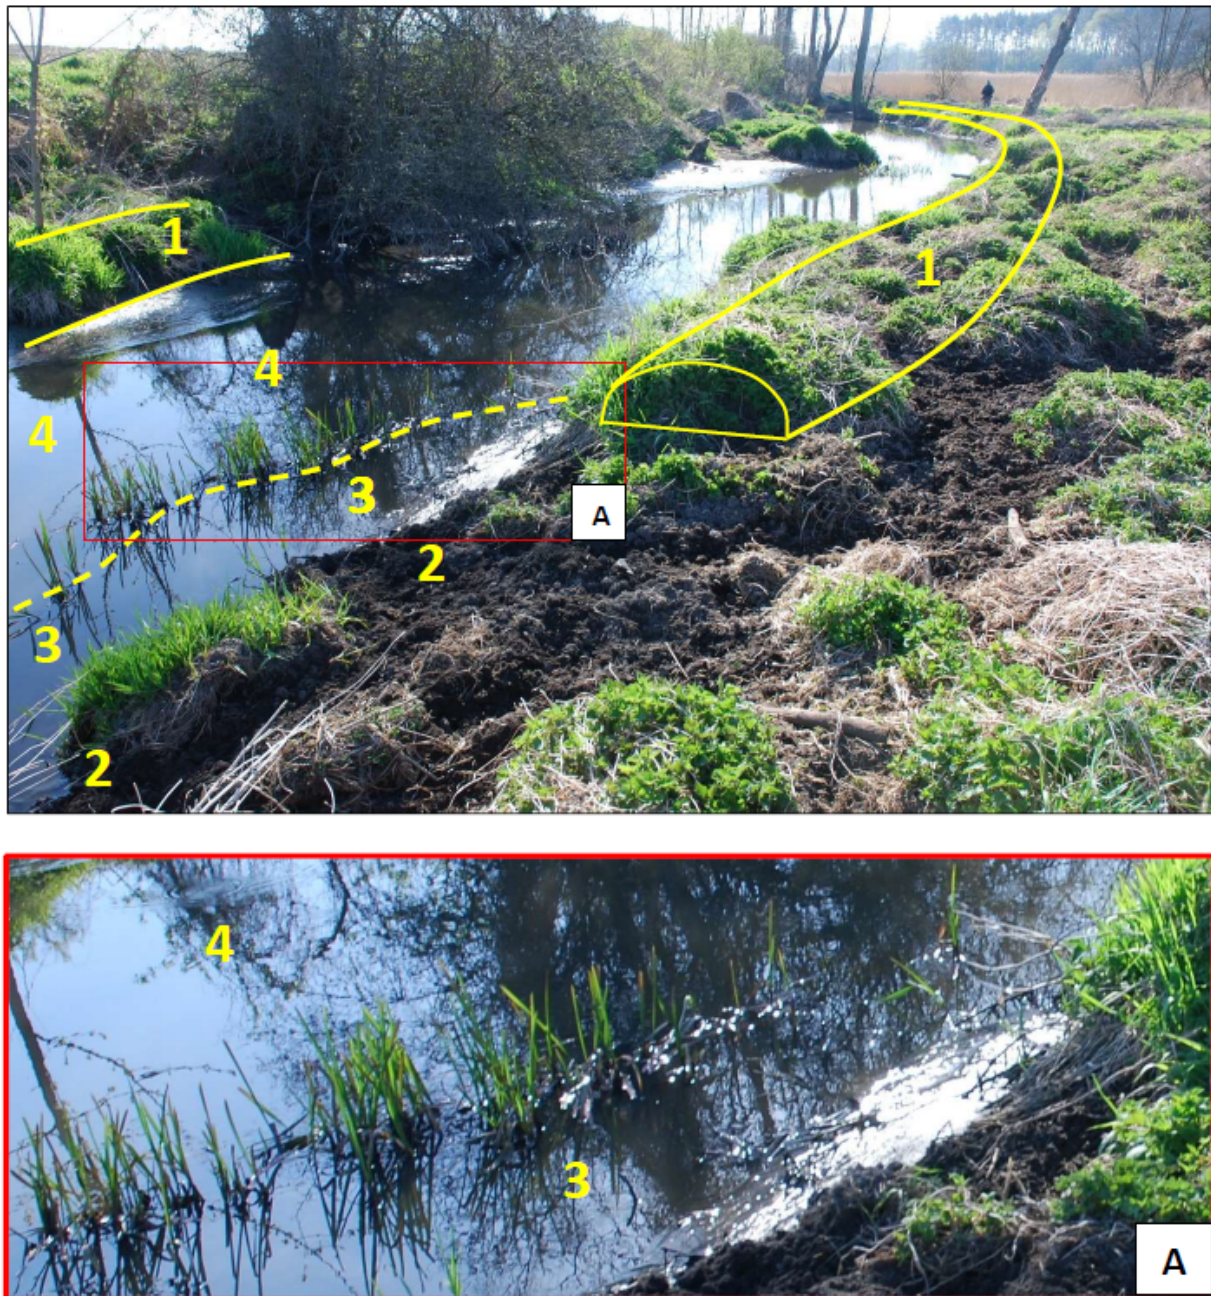
**Figure 9.** Features of natural morphodynamics/relief in the Kraska riverbed zone visible 18 years after the regulation (Section IIb); 1—reconstructed natural levee, 2—levee destruction site, 3—organic silt deposition zone and 4—erosion zone in the channel.
