Article

Wheeled Robot Dedicated to the Evaluation of the Technical Condition of Large-Dimension Engineering Structures

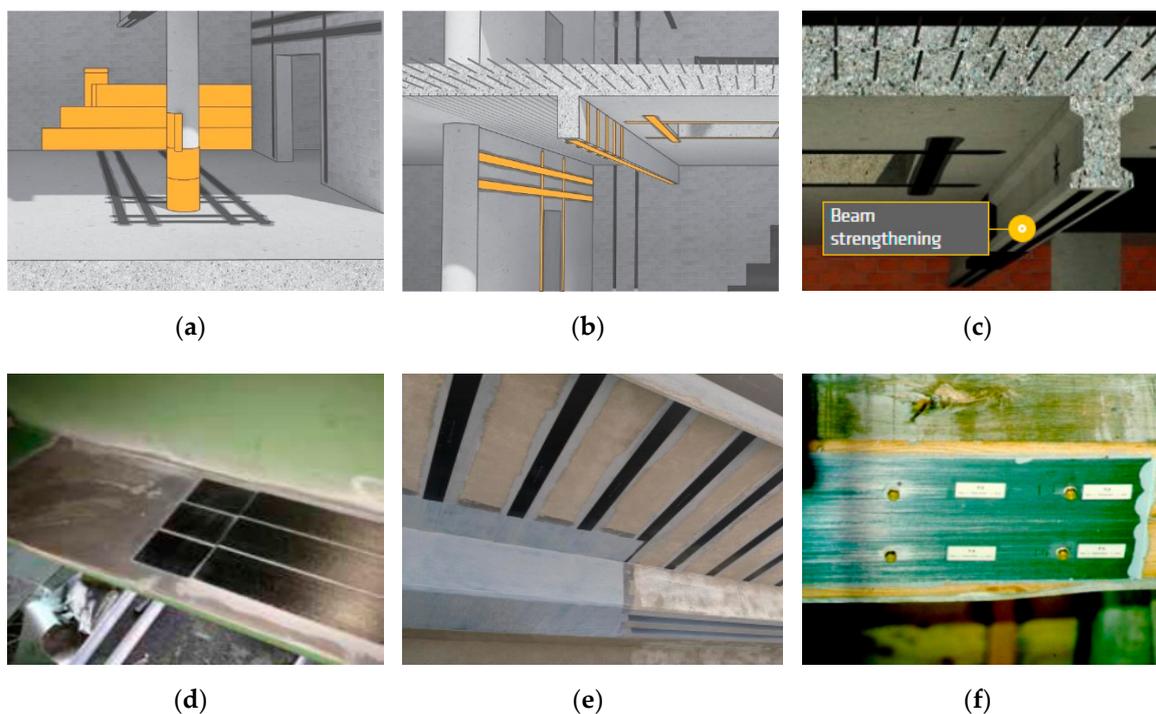
Figure 1. Examples of structural elements reinforced with composites (a–c) inside the building, (d–f) strengthening bridges [3].

Fiber Reinforced Polymer (known as FRP) technique invented in EMPA, Switzerland in the 1980s [2] basing on externally glued high-performance precast, very light element made of fiber has become the most popular method of structural strengthening recently, mainly due to the ease of its use, reasonable price for high reliability and efficiency of this solution. Examples of contemporary composite reinforcements are shown in Figure 1 [3].

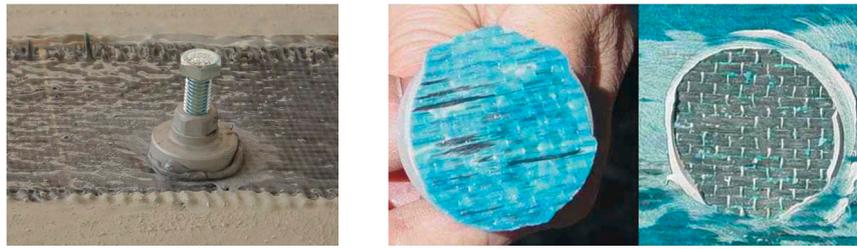
Figure 2. Pull-off method for diagnostics of reinforcements [3].

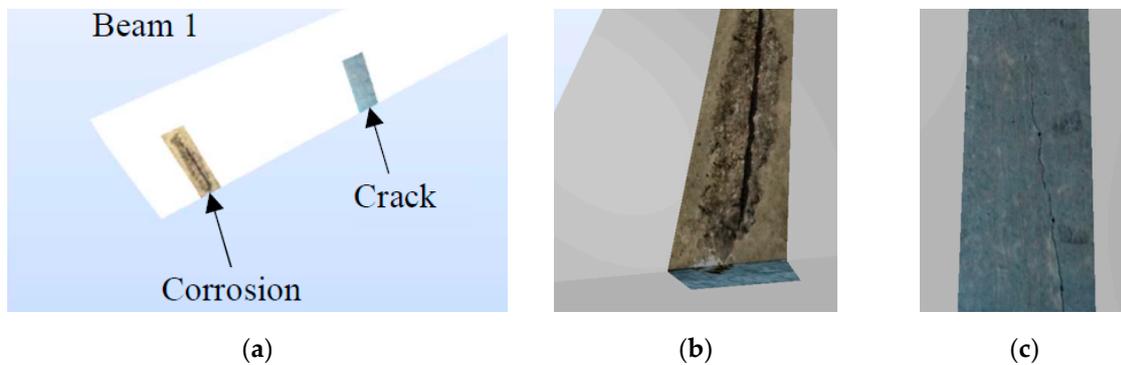
Figure 3. 3D view of a model including the defect location and texture: (a) defect view, (b) close-up view of spalling, (c) close-up view of crack [4].

Due to life cycle problems, new non-destructive diagnostic solutions have recently been sought. Work was directed into two paths. The first consists of the diagnostics of the surface of structural elements, their automated identification and implementation. One such solution based on photogrammetry is shown in Figure 3. The photographic documentation was automatically analyzed and imposed on the existing model [4]

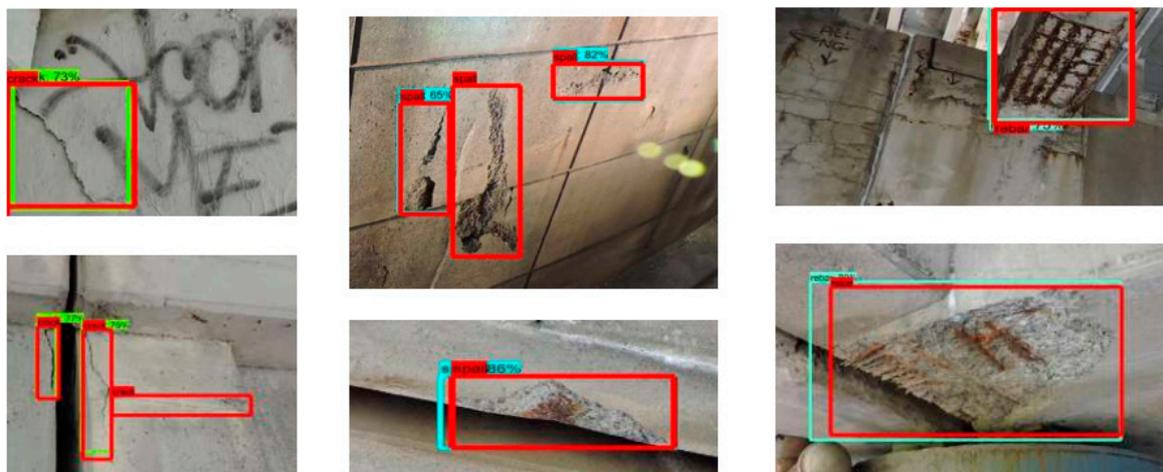
Figure 4. Examples of possible surface damage identification [5].

Currently, this method finds commercial applications, such as the Thornton Tomasetti T2D2 application. A drone equipped with a set of cameras takes an inventory of the object, as photogrammetric images. The application then detects damage and presents a report along with the locations of the damages (Figure 4).

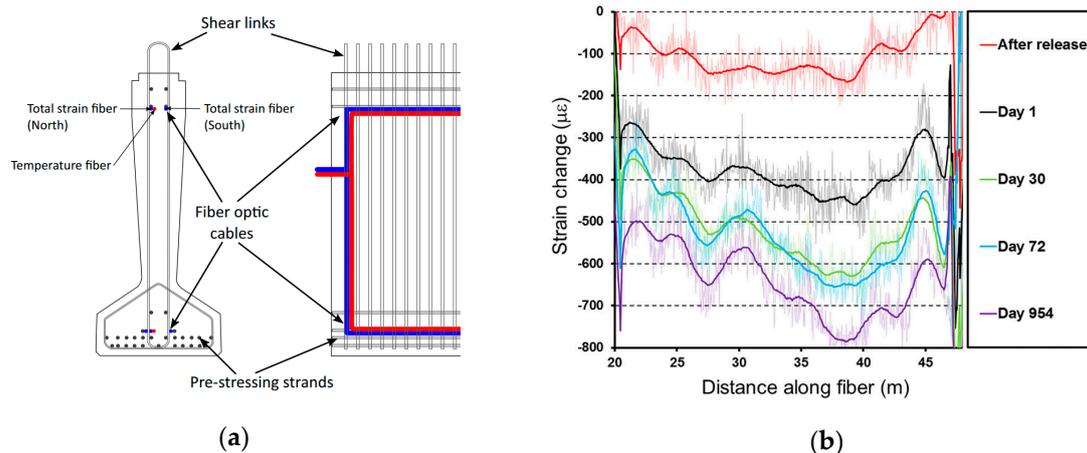
Figure 5. (a) Beam cross-section showing fiber optic cable locations, (b) strain plot for beam [6].

Most of the structural elements become unavailable after the construction process, so this method often cannot be used. Also, it does not allow direct assessment of the load capacity of this element. Therefore, a second direction of searching for solutions enabling object diagnostics from inside is necessary. The method, which in recent years has found many practical applications, including the use of optical fibers for monitoring. It was used mainly in reinforced concrete structures, and its use must be planned already at the execution stage. Optical fibers should be placed in the vicinity of the main reinforcement (Figure 5a), which means that their strain will be equal to the strain of steel, and thus allow to determine the stresses in the structure directly. It allows for tracking stresses in real time (Figure 5b) [6].

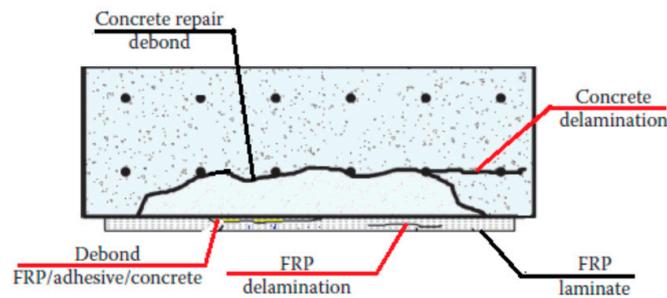
Figure 6. Location of potential degradation in fiber-reinforced polymer (FRP)-strengthened structural member [12].

None of the above methods gives full information on the condition of the structure (Figure 6). Therefore, a well-designed and managed constructions require the use of various forms of monitoring. In the case of reinforced concrete structures strengthened with FRP, this will be monitoring reinforced concrete deformations using the fiber-optic method and analysis of the strengthening over time based on thermographic testing.

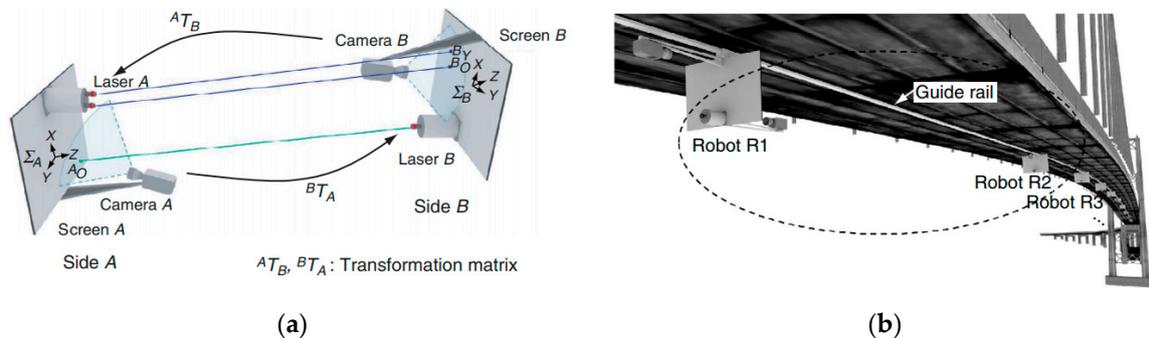
Figure 7. (a) schematic diagram of paired structured light (SL)-based robot module, (b) deformation measurement system using paired SL-based robots [16].

The autonomous inspection robots are increasingly used in industry [13–15]. They are particularly useful for working in places inaccessible or dangerous to experts. Nowadays, the inspection robots are used, for example, measuring the air parameters, visualization of a mining excavation, pipelines inspection, assessment of technical condition and many others. Robots and drones used in the diagnostics of building structures are also one of the groups. This group can be divided into universal devices that can be used in many different facilities and dedicated to a specific structure. An example of a first group may be a modular robot system for structural health monitoring (SHM) of large structures (Figure 7). To develop an SHM system that directly measures the deformation of the structure using a low-cost sensor, a paired structured light (SL)-based modular robot system is proposed. The proposed module which uses one or two actuated lasers and a camera in pair is inexpensive to implement; it can directly measure the accurate relative deformation between any two locations on the structure.

The proposed paired SL-based robot can be used to monitor the structural health of civil infrastructure. In this system, each modular robot installed with one or two lasers and a camera measures the deformation between two sides and a multi-robot that moves along a guide rail is used to measure the deformation of the whole area of the structure.

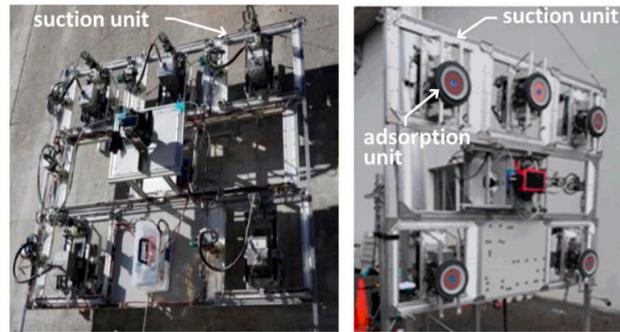
Figure 8. Suction unit of diagnostic robot system (ALP) [17].

The second one (Figure 8) is the diagnostic robot system (ALP) for a detailed inspection of concrete structures at elevated heights [17]. ALP uses a vacuum suction pad improved by testing on real structures as a moving mechanism. ALP is also fitted with a measurement system that consists of a high-resolution camera, an electromagnetic wave radar and a hammering sound diagnostic device.

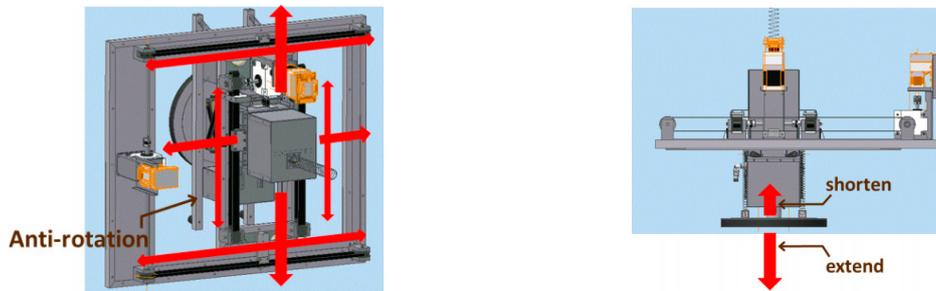
Figure 9. Suction/travel mechanism [17].

ALP can adsorb to rough and irregular wall surfaces such as weathered concrete and tiled surfaces with shallow joints with little air leakage. To maintain the adsorption power, the adsorption unit seal was sophisticatedly designed to adapt to wall surfaces. The result is a highly capable self-propelling inspection system that can carry out detailed inspections of infrastructure in difficult-to-access locations, such as high places (Figure 9).

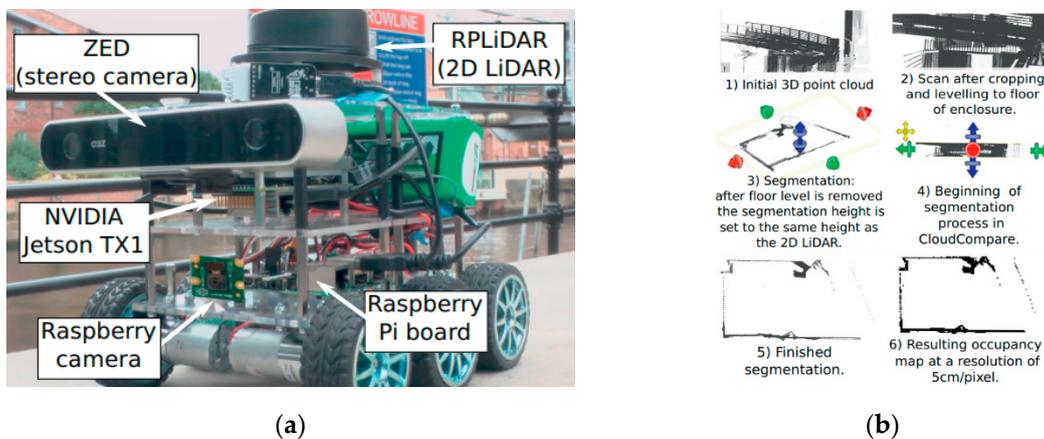
Figure 10. (a) Robot equipment and (b) stages of point cloud processing [18].

An excellent example of trying to emphasize the development of modern autonomous tools in construction is the bridge bearing inspection robot. The platform used in this solution is a commercial product called something DiddyBorg [18], the robot is equipped with LiDAR visible in Figure 10a, the next steps of processing the three-dimensional point cloud are shown in Figure 10b. The authors of the study also point to various difficulties for teleoperation since bridge bearings are located in hard-to-reach places where other obstacles limit the field of vision.

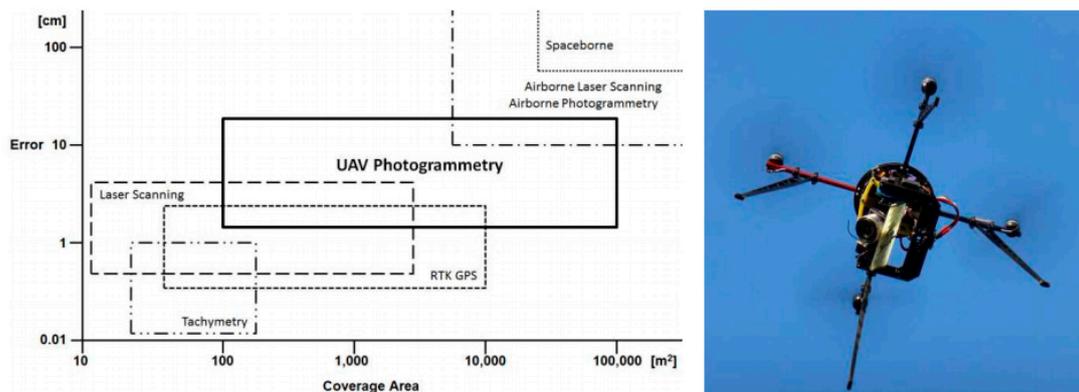
Figure 11. Unmanned aerial vehicle (UAV) and the scope of the device's applicability [19].

Another group is the so-called UAV—unmanned aerial vehicles. This series solution can have its place not only in civil engineering but also here it has a vast potential associated with the preparation of technical documentation at various stages of the object's life cycle. It must be added that UAVs can be used in certain conditions—both legal and environmental (too strong wind may prevent measurements). The range of applicability depending on the error and the size of the survey area is shown in Figure 11.

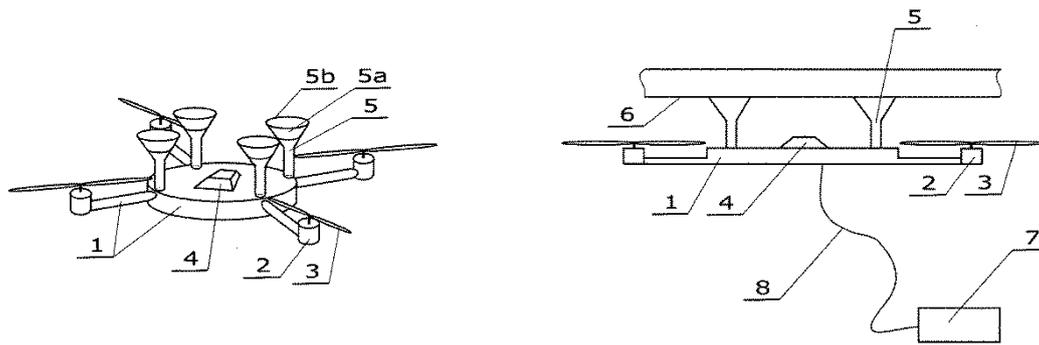
Figure 12. General scheme of the unmanned aerial vehicle [20].

The unmanned aerial vehicle with a module of suction cups (5) is capable of vertical takeoff and landing from a small area, getting to the hard-to-reach places and adhering to the other objects (6). After adhering to the surface (6) it is possible to switch off the motors (2) of the aerial platform, which allows eliminating the vibration of the supporting structure (1) caused by the operation of the motors (Figure 12). In conventional solutions, the vibrations of the supporting structure (1) bring about a lot of functional problems, e.g., measuring problems, especially at the time of hovering in place. The proposed solution eliminates that problem. Specific properties of the surface (6) to which the aerial platform adheres imposes a necessity to select dedicated modules of pneumatic suction cups (5) with a system of filters. The applied module of suction cups (5) with bellows (5a) and a sealing lip (5b) provides the possibility of controlling the suction force and adhering to the surface (6) of various texture: e.g., uneven or porous one. Activation of the pneumatic system located in the ground-based flight control station (7) connected with the unmanned aerial vehicle through an elastic pneumatic conduit (8), generates vacuum pressure in the module of suction cups. As a result, the unmanned aerial vehicle adheres to the surface (6).

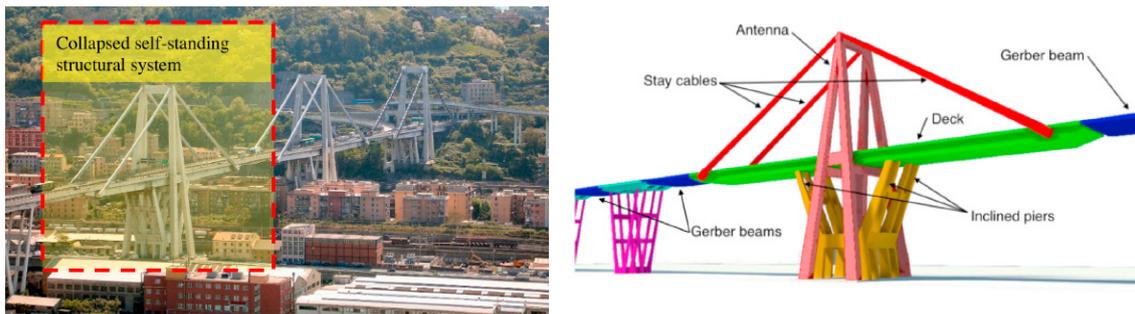
Figure 13. Construction of the Polcevera Bridge in Genoa (the marked part has collapsed) [23].

Diagnostics of large-scale engineering structures allows assessment of the safety and serviceability state of a given building. Periodic diagnostics of the structure allows for proper use of the building as well as prevents construction failures. The famous example of a construction disaster was the collapse of the Polcevera bridge in Genoa (Figure 13). This viaduct was designed as a cable-stayed concrete bridge. As investigated in [23] a combination of adverse factors such as corrosion degradation and very-high-cycle low-amplitude fatigue contributed to collapse one of the self-standing structural systems. It has been proven that the aggressive environment has significantly accelerated the degradation of the structure.

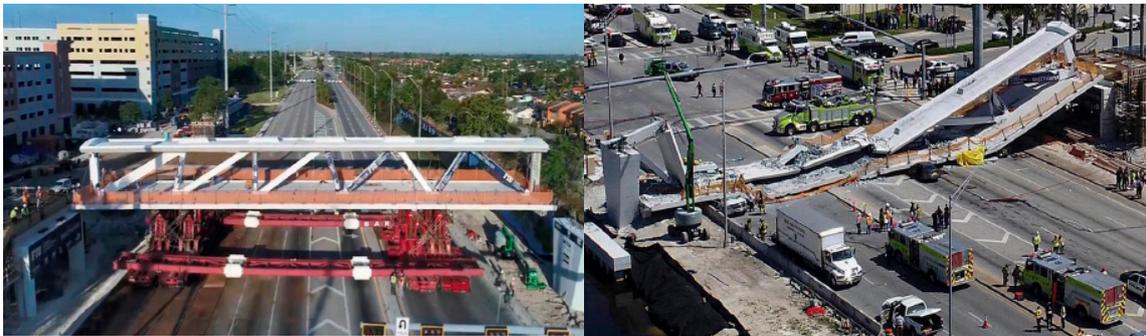
Figure 14. Transportation of the pedestrian bridge and collapsed structure [24].

Another well-known building that collapsed on 15 March 2018 was a pedestrian bridge at the University of Miami (Figure 14). The structure weighed about 930 tons and consisted of a single concrete truss and piers. Expert opinion showed that hours before collapse Engineer of Record failed to recognize that the bridge was in danger of collapsing. The bridge's structure was characterized by numerous wide and deep structural cracks jeopardizing the integrity of the bridge [24].

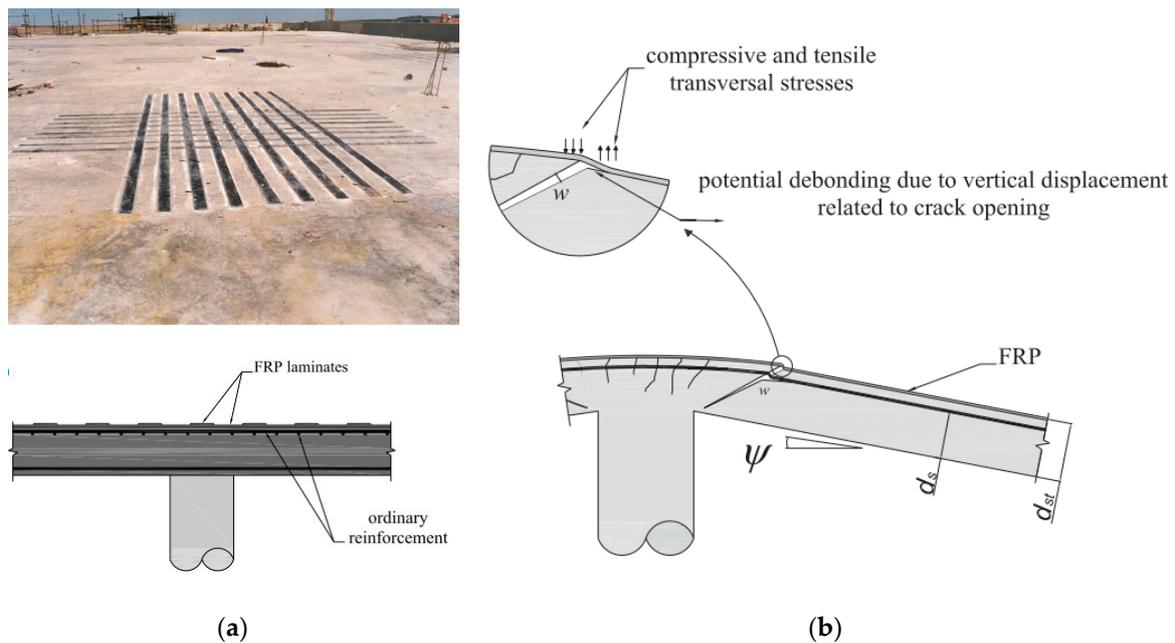
Figure 15. (a) Practical application of bonded FRP's for slab strengthening. (b) debonding in the vicinity of the shear crack [25].

The mechanism of overloading reinforced concrete structures leads to cracking in the place where the highest stresses occur (Figure 15a). FRP applications often occupy a significant area of the slab and even wholly covering its surface. Therefore, most cracks develop under FRP-strengthening (Figure 15b), leading to potential debonding, thus preventing a visual diagnosis of the structure.

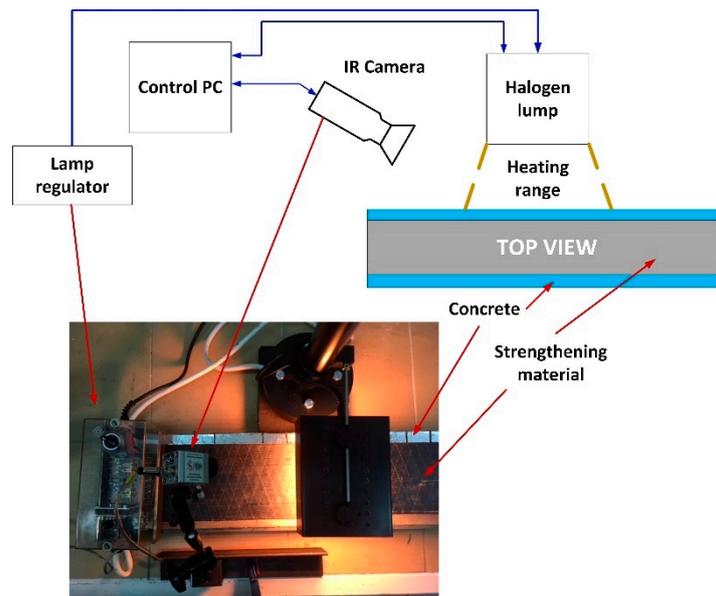
Figure 16. Laboratory test rig configuration [8].

After many years of using this strengthening technique, it is also required to use efficient methods of quality assessment of connections between a strengthened member and composite not only during the construction stage but also during periodic inspections of existing structures [26]. It is especially important for structures under long-term loads. Connections between composite and surface of structural member prepared in a regardless way can lead to hidden defects or voids as well as discontinuities in the bonding layer. Even more severe situation is met while the assessment of old strengthening where debonded areas may be caused by aging, rheology, materials corrosion or overloading. As a consequence, it can result in local delamination of material which means that composite connection does not meet the required criteria anymore. The proposed diagnostic method bases on thermal diagnostic [8] and it was installed on the robotic platform. The test procedure involves even heating of the element, followed by observation of the surface cooling process (Figure 16).

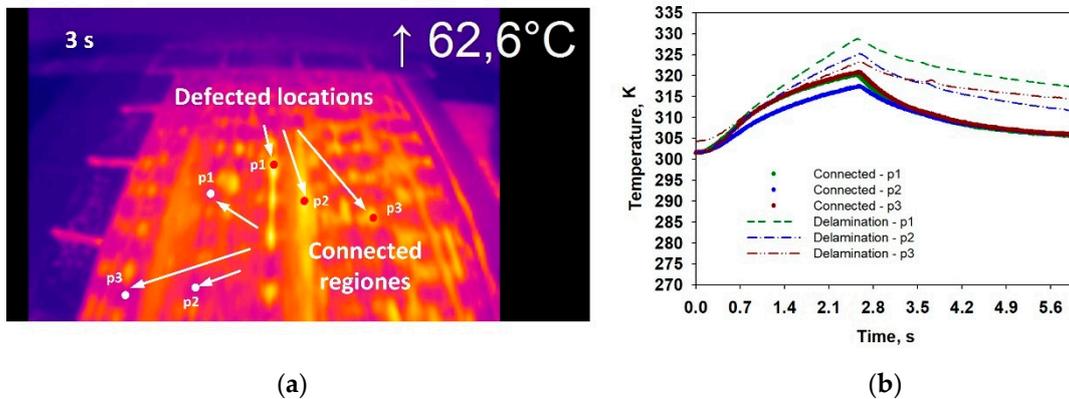
Figure 17. The exemplary result of thermal diagnostic: (a) selected location for retrieving thermal resistance of the connection layer, (b) temperature profile recorded at selected locations [8].

Such an approach allows the detection of zones of a faulty composite FRP with a concrete substrate. Properly made reinforcements through a good connection with the ground allows for better heat transfer to the structure (concrete). Based on the tests already carried out (Figure 17) algorithms for interpreting the video image will be developed for the automatic detection of defects.

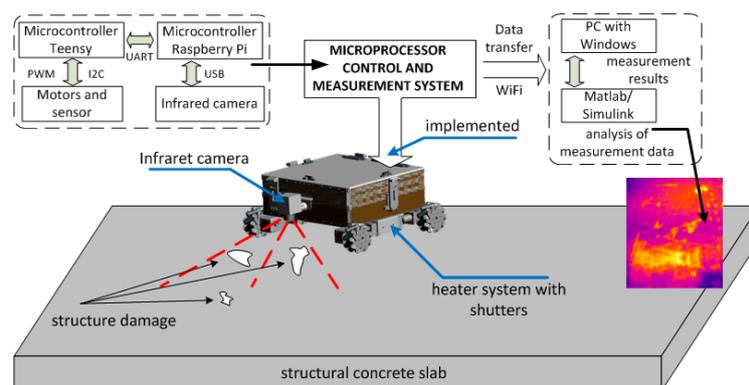
Figure 18. The scheme presenting the idea of the operation of the mobile platform robot dedicated to the evaluation of the technical condition of building large structures using thermographic techniques.

- light modular frame,
- thermal module for heating the tested surfaces with the heating power not less than 2 kW,
- microprocessor control and measurement system consist of distance sensors, infrared camera, microprocessor drive control system, microprocessor system for archiving, visualization and wireless transfer of measurement data,
- drive system equipped with Mecanum wheels driven by DC motors with encoders.
- The idea of the inspection mobile platform dedicated to the evaluation of the technical condition of large-dimension engineering structures using thermographic techniques is presented in Figure 18.

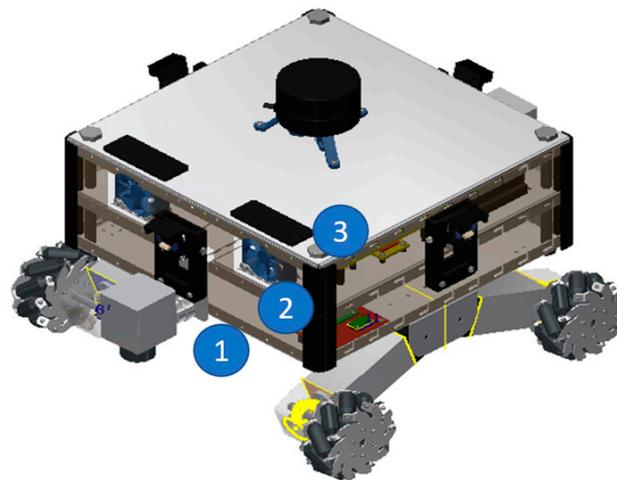
Figure 19. The main frame of the mobile platform (CAD model): 1,2,3—first, second and last module (floor).

The prototype of the frame of the mobile diagnostic platform was designed in a modular way. The main frame made from aluminum (the lightweight aluminum frame allows the use of lower power drive motors) and was divided into three main modules. The first one (robot's first floor) located at the bottom of the mobile platform is the basis for the thermal module and suspension of the robot integrated with the drive system. The second module (robot's middle floor) is located between the first and third modules. In that part of the robot frame, the heat removal system and electronics were installed. The last module located at the top of the robot (robot's last floor) is the basis for the LIDAR system (light detection and ranging). The LIDAR system is useful for integration obtained results with a numerical model of the structure within BIM. A CAD model of the robot's main frame is shown in the picture below (Figure 19).

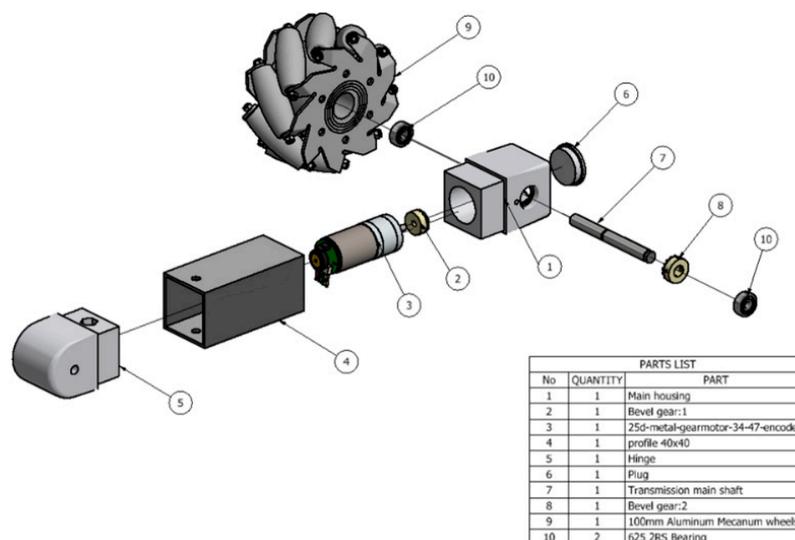
Figure 20. The platform suspension—CAD model.

- four Mecanum wheels (marked by number 9 in Figure 20),
- four DC motors integrated with magnetic encoders and planetary gears (marked by number 3 in Figure 20),
- four bevel gears with ratio equal 1 (marked by numbers 2 and 8 in Figure 20).

The use of the Mecanum wheels allows minimizing the number of moving parts (in the robot’s suspension system) and allows moving the platform in any direction without a steering system. In addition, the control algorithm of this type of drive system is much simpler than traditional systems with a steering axle.

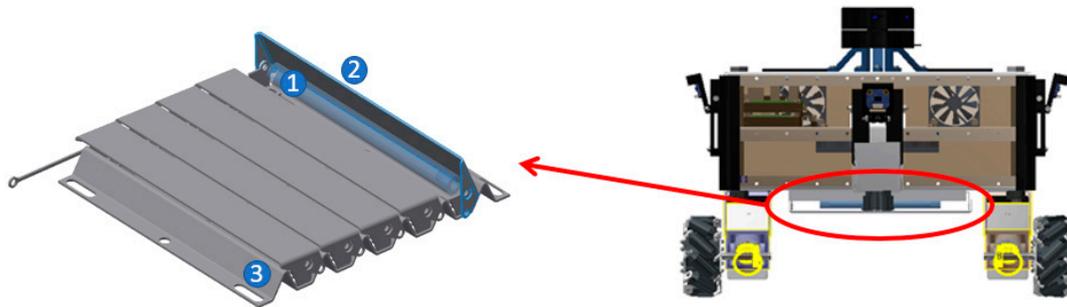
Figure 21. The heating module (CAD model) and its location, where: 1—a halogen lamp, 2—a shutter, 3—a reflector.

provides 1632.67 counts per revolution of the gearbox's output shaft. The motors are fixed to the Mecanum wheels by using bevel gears and integrated with the suspension of the mobile platform. The CAD model of the platform suspension is shown in Figure 21 in a detail way.

The thermal module consists of five halogen lamps with total power equal 2500 W. The heating unit is equipped with a metal reflector and the metal shutters (Figure 21). The shutters are used for insulation of the heat source from the tested surface (after the heating process) during the measurement process using an infrared camera. The negative impact of the thermal module during the measurement process is visible in Figure 29a. The shutters eliminate this problem. The servo motor is used for opening and closing the shutters. The thermal module is powered with 230 V alternating-current (AC) via a solid-state relay.

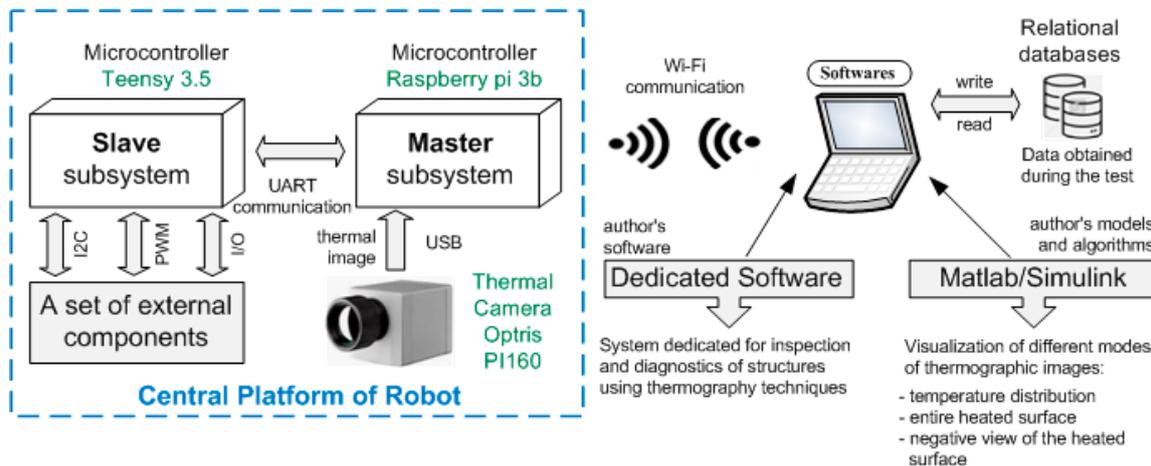
Figure 22. Main block diagram of the control and measurement system.

Control of a wheeled robot dedicated to the evaluation of the technical condition of building large structures is implemented using a microprocessor-based control and measurement system. The system block diagram is presented in Figure 22. The microprocessor control and measurement system consist of three main subsystems:

- the master subsystem implements wireless Wi-Fi communication with dedicated software on a PC and exchanges data with the slave subsystem using UART communication. The central unit of the master subsystem is the Raspberry Pi 3B+ microcomputer, which is additionally connected to an infrared camera Optris PI160 with using a Universal Series Bus (USB) [28].

- the slave subsystem directly controls a set of external components, reads data from the sensors mounted on the robot platform and controls motors groups. Communication between the slave subsystem and the master is carried out using universal asynchronous receiver–transmitter UART.
- dedicated PC software written in C#.

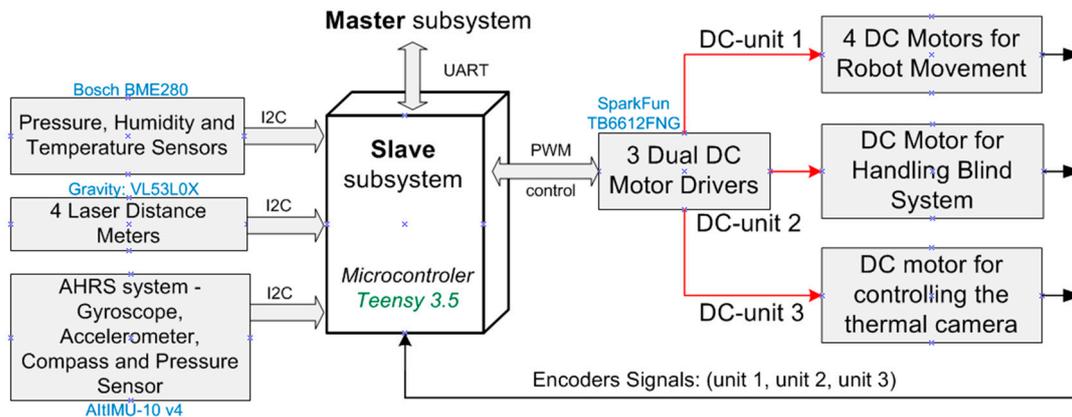
Figure 23. Connection diagram of the slave subsystem with a set of external components of the robot platform.

The connection diagram of the slave subsystem with a set of external components of the robot platform is presented in Figure 16. The robot platform was equipped with a set of extended external components, sensors and motors with encoders:

short circuits in the winding. This function, which is called in every iteration of the program, sets the motor shaft even after its displacement from the set position. During the tests, there was a problem with reaching the set position with PWM signal fill values lower than 200, during small displacements of the motor shafts caused by external interference. For this reason, the PWM signal fill was set to the maximum value. Connection diagram of the slave subsystem with a set of external components of the robot platform is shown in Figure 23.

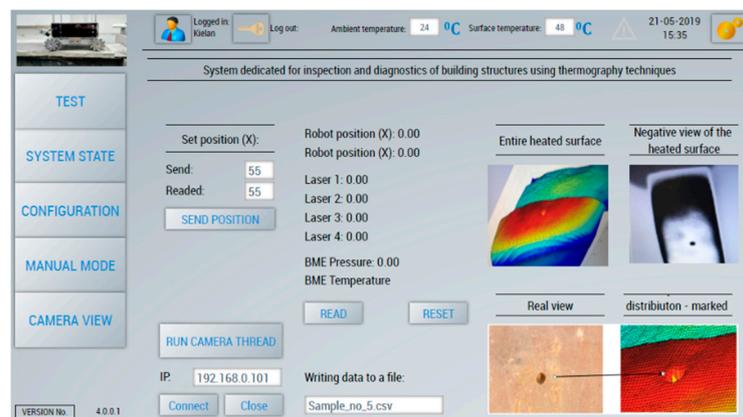
Figure 24. The real view of the control software panel—system dedicated for inspection and diagnostics of structures using thermography techniques.

The dedicated PC software (Figure 24) allows to:

- remotely establish communication with the master subsystem—the central unit integrated with the robot platform;
- realization of a given research program, remote execution of the temperature distribution measurement of the tested surface and save the samples;
- stores the measurement data in a relational database to enable further analysis of captured images thermography;
- visualization of different modes of thermographic images: (temperature distribution, entire heated surface—negative view of the heated surface).

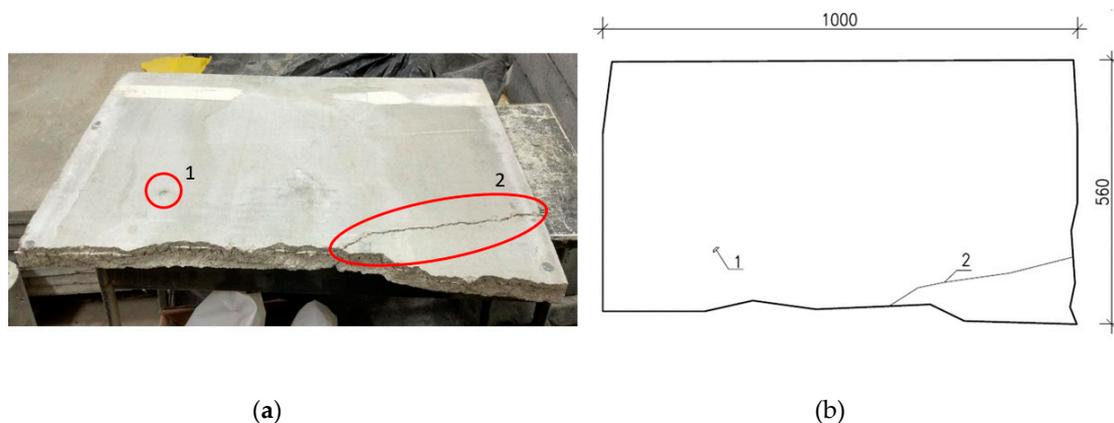
Figure 25. The concrete slab (without FRP-strengthening) used for tests: (a) real view, (b) the damages shown in illustratively way.

The laboratory tests of the mobile diagnostic platform were performed using a reinforced concrete slab with dimensions 100 cm × 56 cm × 4 cm. The concrete slab had been reinforced with rebar grid made of non-metallic fibers embedded at a depth of ~8 mm. The selected for tests slab had one defect in the concrete surface structure and contained one longitudinal crack that simulated possible real damage of the concrete elements as a result of overloading. This type of concrete surface is often strengthened by the FRP systems.

For research purposes, additional damages of different geometry were made (Figure 25).

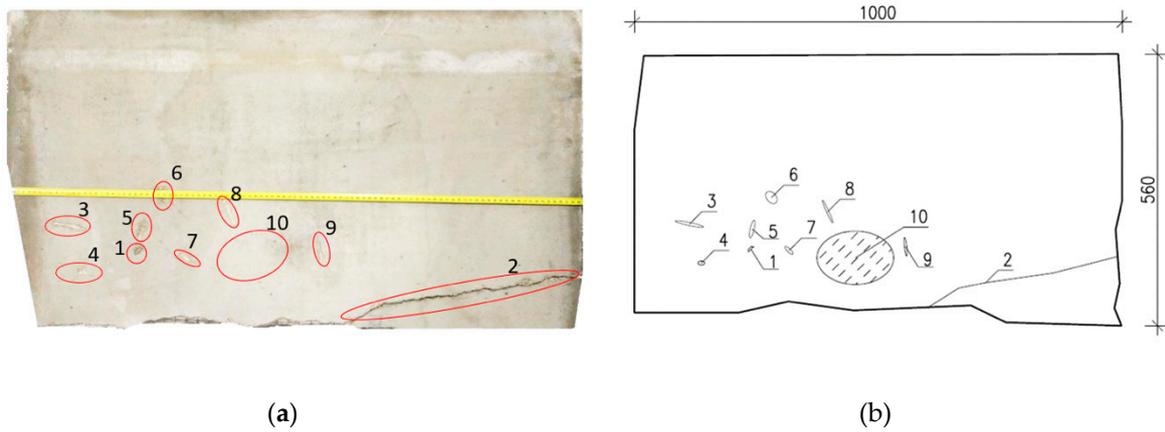
Figure 26. Concrete slab (without FRP-strengthening, with additional damages) used for tests: (a) real view, (b) the damages shown in illustratively way.

The tested concrete surface can be divided into three parts. The first of them contains damages marked by numbers 1–7 (grouped damages), the second—damages marked by numbers 8, 9, 10 (area with incorrectly fixed FRP tape) and the last one has the longitudinal crack.

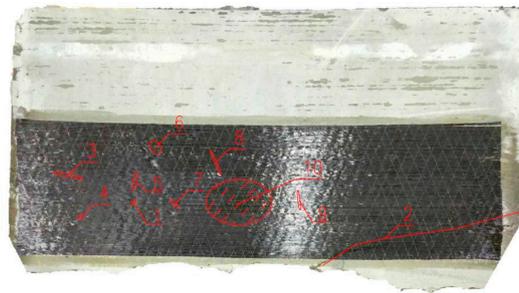
Figure 27. The concrete slab (with FRP-strengthening) used for tests.

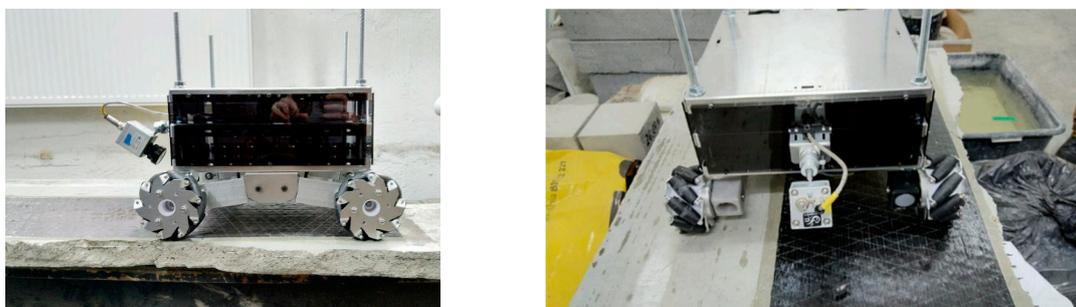
Figure 28. The real views of the mobile platform during laboratory tests.

The real view of the mobile diagnostic robot during tests is shown in the picture below (Figure 28).

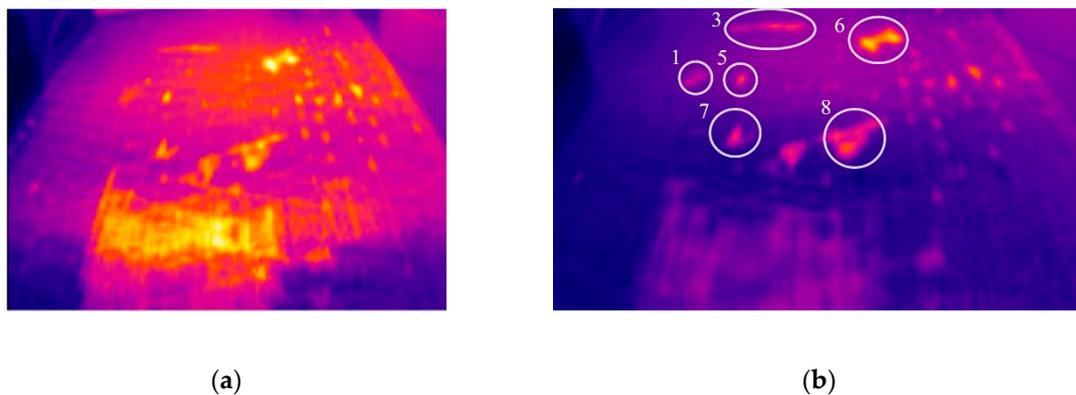
Figure 29. Thermographic image of the tested area number 1: (a) view during heating process, (b) view after heating process completion.

Figure 29a shows a thermographic image saved during the heating process, is visible the negative impact of the heating lamps on the identification of damages. In Figure 29b shown results obtained for the same area after heating process completion. In the thermographic image (Figure 29b) the damages marked with numbers 1, 3, 5, 6 and 7 are visible. The cracks in number 5 and 6 are the most visible. In the foreground, the damage in number 8 is additionally visible. The results obtained for the second area are shown in Figure 30.

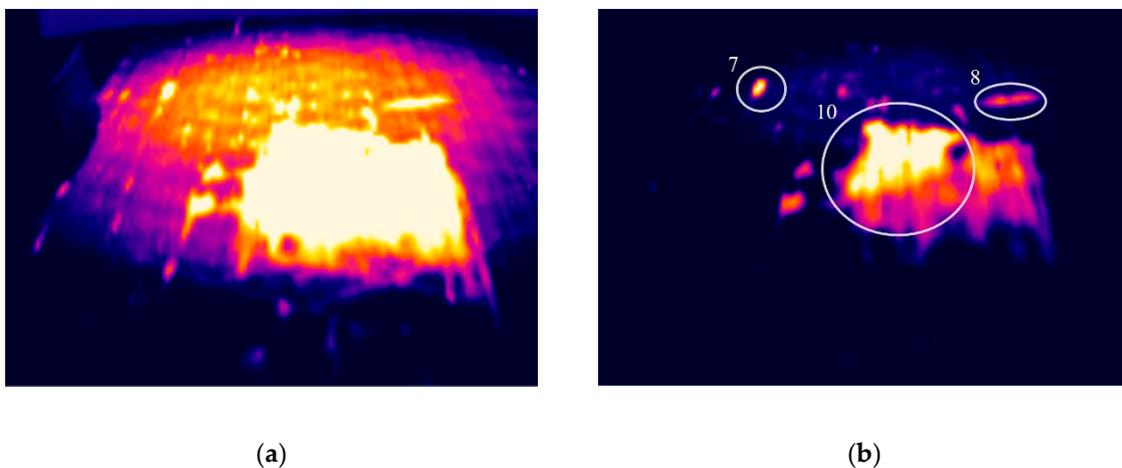
Figure 30. The thermographic image of the tested area number 2: (a) view during heating process, (b) view after heating process completion.

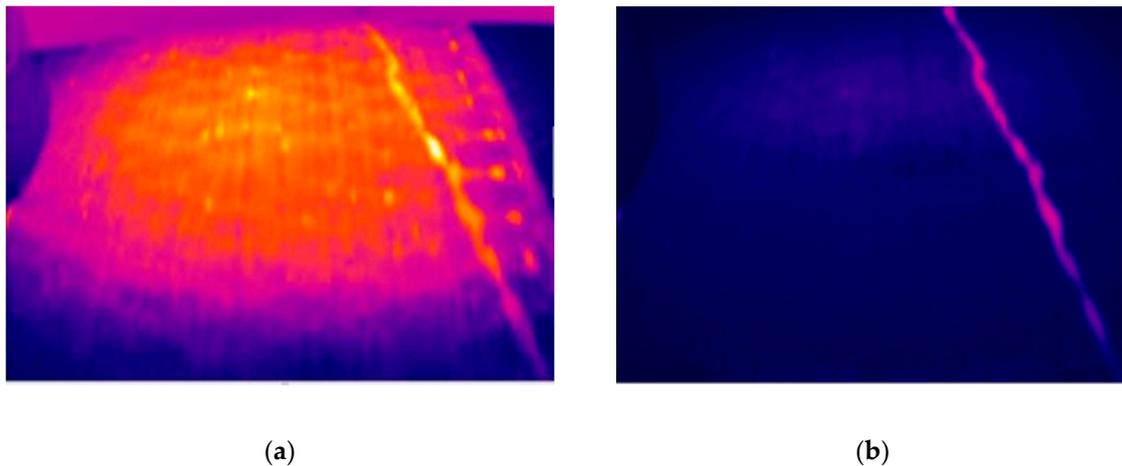
Figure 31. The thermographic image of the tested area number 3: (a) view during heating process, (b) view after heating process completion.

In the same way, as for the first area, the two thermographic images were recorded: the first one (Figure 31a) during the heating process and second after this process (Figure 31b). In the recorded images, the cracks in number 8 and 7 (in the background) and the area with the incorrectly fixed tape (marked by number 10 in Figure 30 are clearly visible.

For the last area, the longitudinal crack is well visible on both recorded images (during and after the heating time—see Figure 31).
