Field Geological Investigations and Stability Analysis of Duanjiagou Landslide

Abstract: This paper analyses the stability of the Duanjiagou landslide on the Bazhong to Guangan Expressway K134–K135 segment in China. The Duanjiagou landslide took place on 4 November 2015. In order to discover the cause of the landslide, we carried out field geological investigations. The indoor physical property experiments were performed by taking the undisturbed soil sample from the borehole cores. To study the strength of the soil, we carried out a saturation direct shear test and saturation residual shear test on sliding zone soil samples. According to the physical properties of soil and the saturated shear strength parameters of sliding zone soil, the stability was analyzed by the landslide force transmission method and numerical simulation method. The results showed that in the initial sliding stage, the safety factor obtained by using the average value of saturated shear strength parameters was in good agreement with the field observation situation. The landslide was at an unstable state. The softening of soil and roadbed excavation at the foot of the slope are the main reasons for landslide

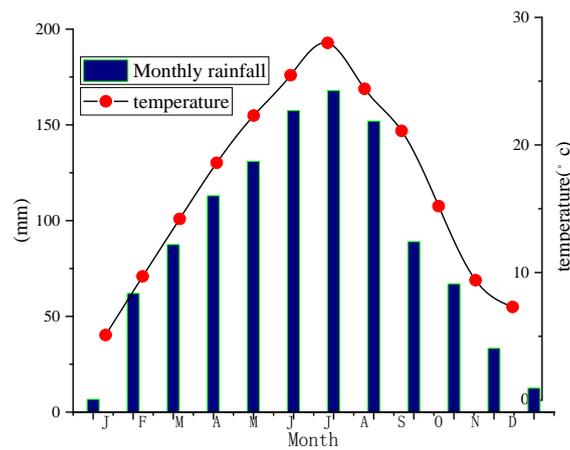
Figure 2. Rainfall and temperature distribution in the Yingshan County.

The average annual temperature is 17.3 °C and the monthly averages range from 5 (January) to 28 °C (July). The highest temperatures occur in July and August, and are characterized by abundant precipitations (Figure 2). Rainfall is not evenly distributed in all seasons, accounting for 45% of the whole year in summer, 25% in spring and autumn, and 5% in winter.

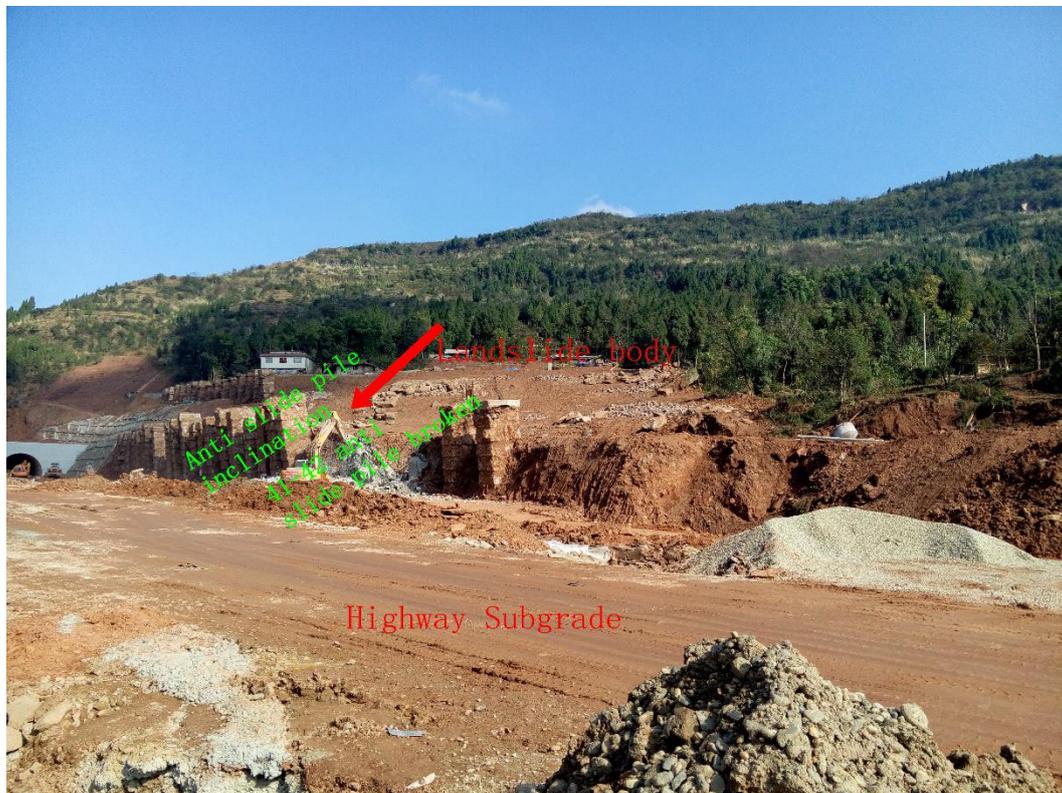
Figure 3. Fracture and inclination of the anti-slide pile.

The anti-slide pile is 2 m long and 1 m wide, and the long side direction is parallel to the sliding direction of the landslide, with a depth of 30 m. Due to the excavation on the foot of the slopes, a vertical free surface is formed at the foot of the slope. The slope had a serious sliding deformation on the morning of 4 November 2015. Severe cracking of houses and rural roads in the slope, the No. 40[#] and 41[#] anti-slide piles collapsed and broke and the No. 42[#] and 43[#] anti-slide piles inclined substantially. The adjacent anti-slide piles against No. 40[#] and 43[#] also showed different degrees of deformation (Figure 3). After the landslide, the construction unit backfilled the excavated roadbed to prevent the landslide from further development.

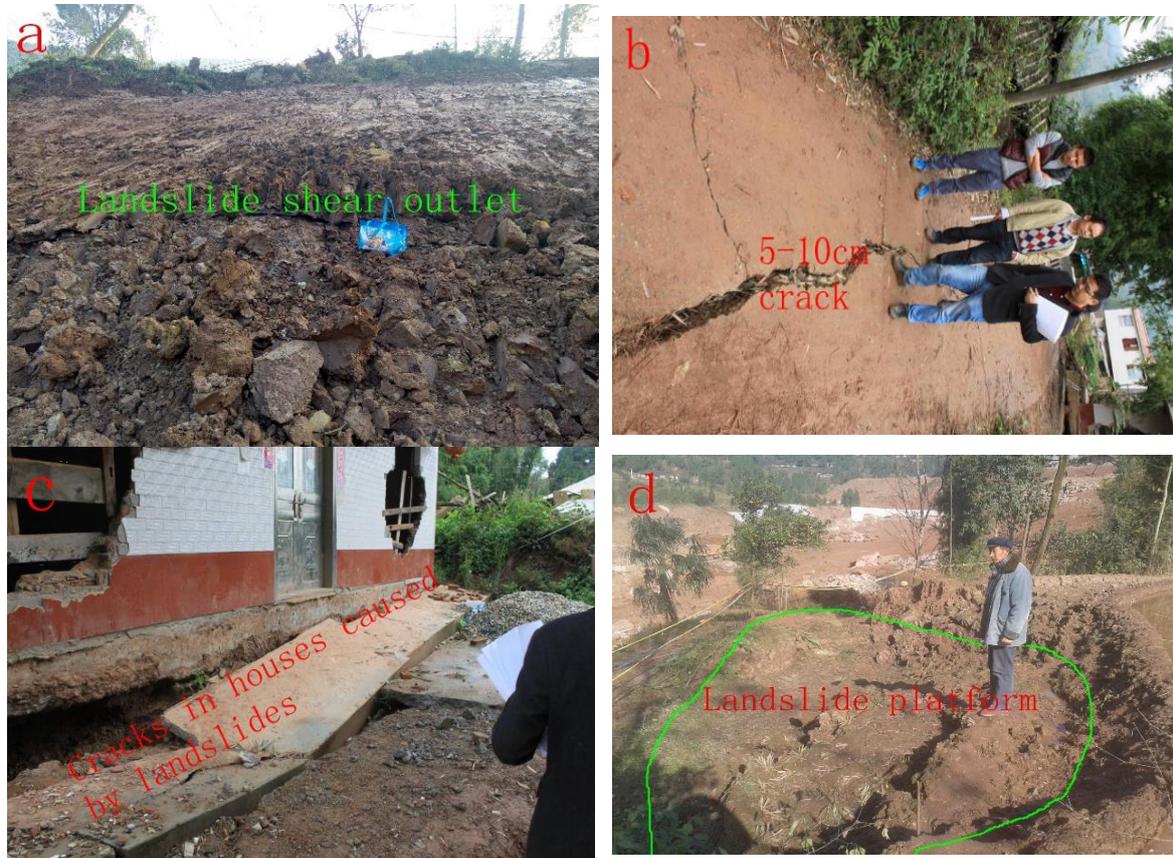
highway roadbed, and an obvious shear outlet can be seen (Figure 4a). The landslide had clear borders and the left side was located in the gully. From the overall shape, the landslide was in the shape of a circle chair.

Figure 4. (a) Shear outlet in front of landslide, (b) rural road cracks on the back of the landslide, (c) cracks in the building foundation on the boundary of the landslide, (d) landslide platform on slide body.

Tensile cracks are developed on the rural road and the upper slope at the back edge of the landslide. Fracture zones are formed with a width of about 1–2 m in local areas, the width of ground cracks varying from 5 to 10 cm (Figure 4b). The house near the boundary was badly cracked (Figure 4c). Due to the deformation, the landslide platform was formed locally with a height of 1 m. (Figure 4d).

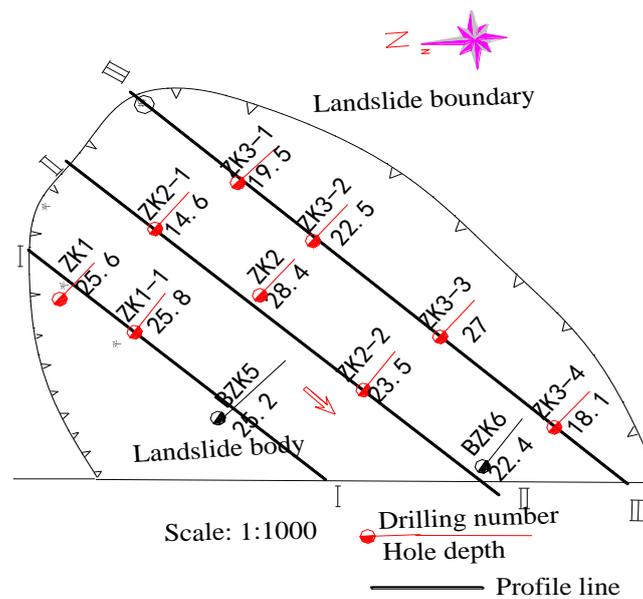
Figure 5. Plane distribution of boreholes.

In order to understand the landslide situation better and provide geological data for the slope treatment, we carried out detailed engineering geological investigations. In the landslide survey, three profile lines and nine boreholes were set up, and BZK5, BZK6 boreholes were added to understand the geological conditions in detail. Locations are shown in Figure 5.

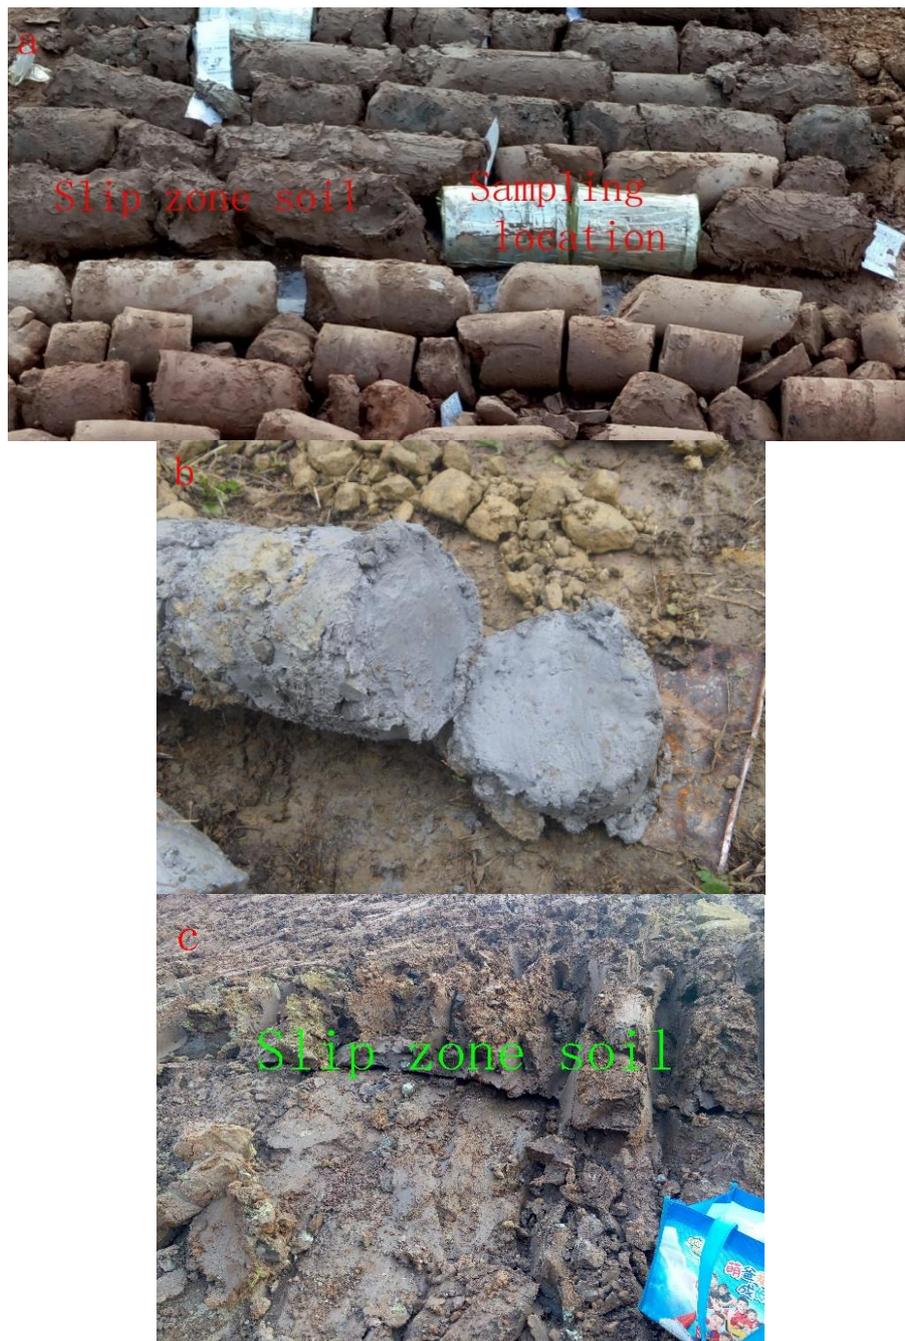
According to field geological survey data and drilling holes, the slip zone soil was silty clay (Figure 6a), with a thickness of 30–70 cm, mostly yellow-brown, partly reddish-brown and grey-green (Figure 6b), saturation and plastic-soft plastic state. Scratches and folds of the landslide could be seen from the boreholes and shear outlets of the sliding zone soil. (Figure 6c).

Figure 6. (a) ZK1-1 borehole sliding zone soil, (b) ZK2-2 drilling sliding surface soil, (c) sliding zone soil.

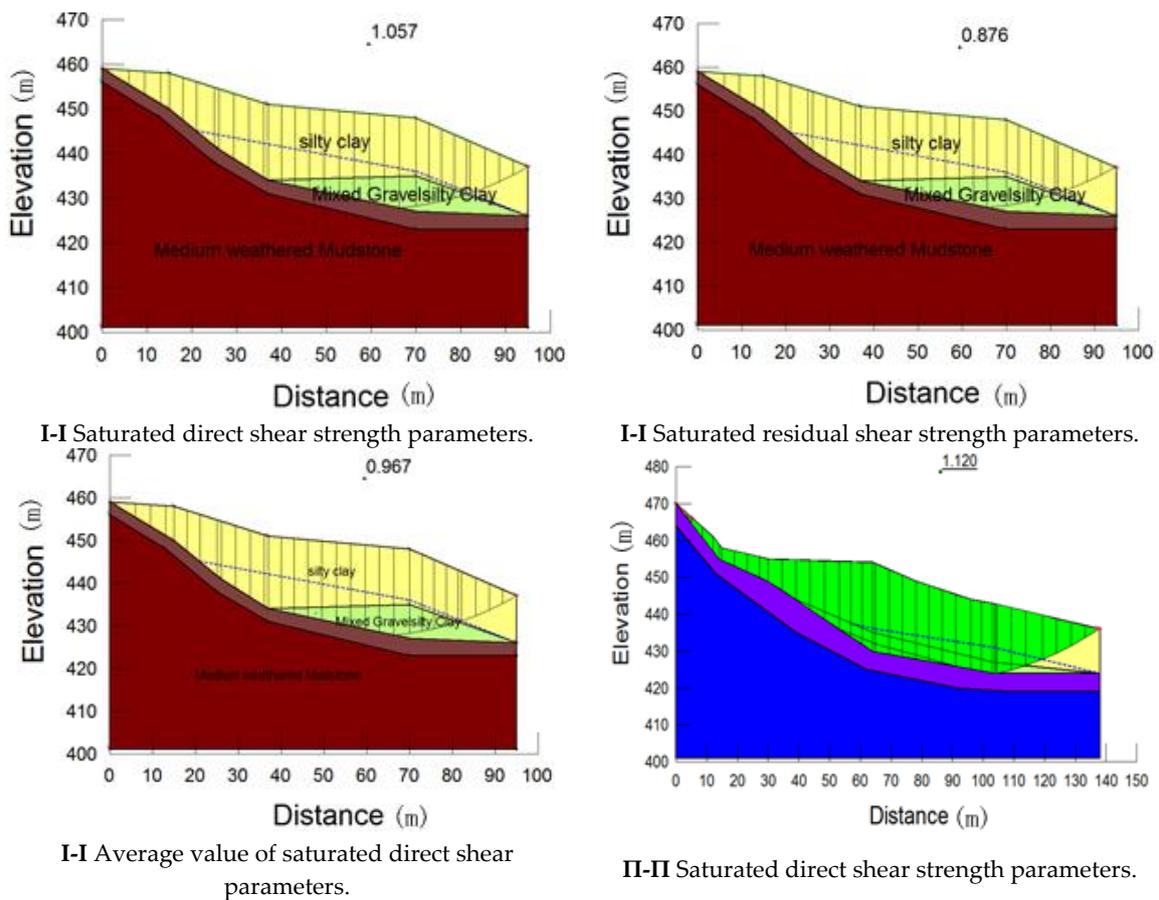
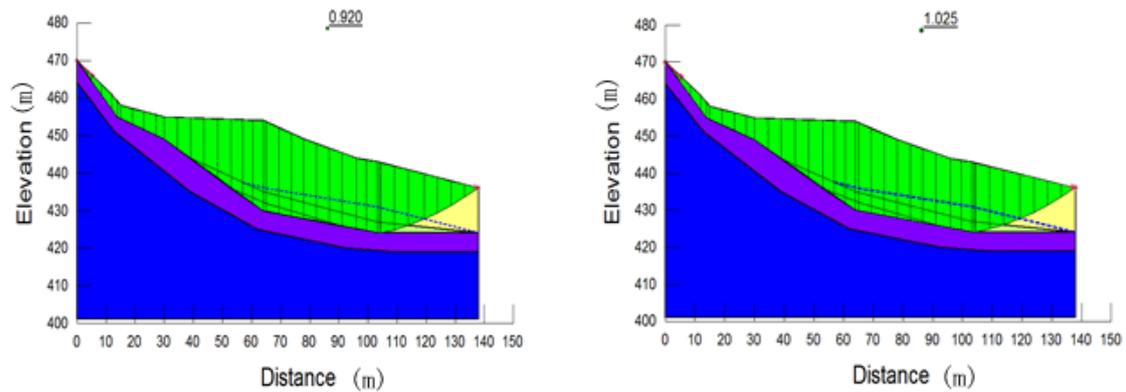
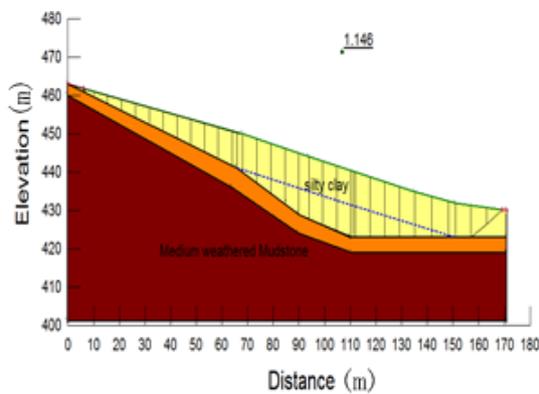
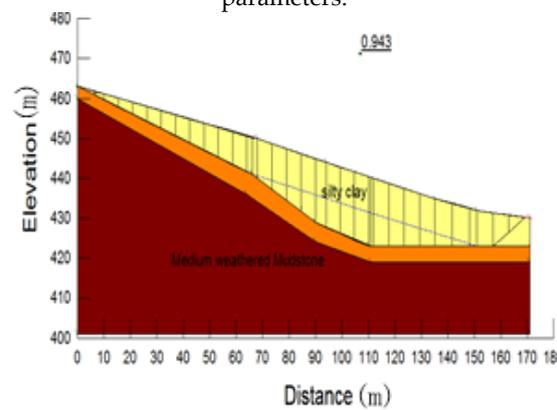
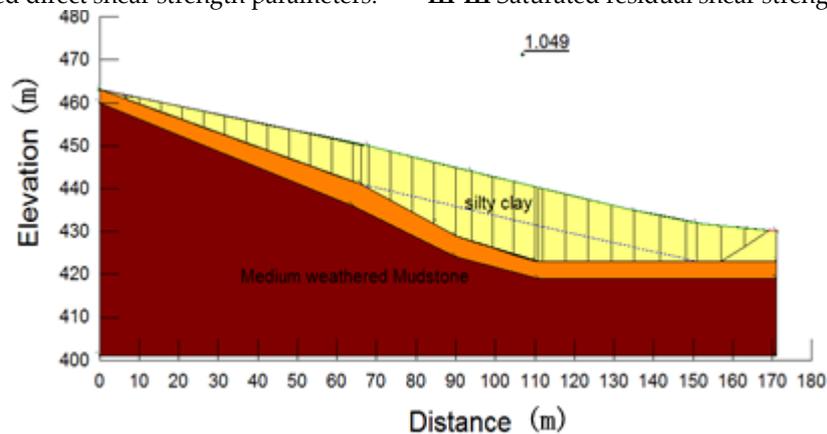
Figure 7. Numerical simulation of landslide stability.

The stability was analyzed by GeoStudio-SLOPE/W, based on the Morgenstern—Price approach of limit equilibrium. According to laboratory test results and parameters of saturated direct shear test, saturated residual shear test and average shear strength, numerical simulation of landslide stability was carried out. The numerical simulation figures are shown in Figure 7.

II-II Saturated residual shear strength parameters.

II-II Average value of saturated direct shear parameters.

III-III Saturated direct shear strength parameters.

III-III Saturated residual shear strength parameters.

III-III Average value of saturated direct shear parameters.

The safety factor (F_s) of different profiles were simulated. The numerical simulation results are shown in Table 5.

Comparing Table 4 with Table 5, the difference between landslide force transmission method and numerical simulation results was small. The safety factor of the three profiles were different.

When the saturated direct shear parameters were used to calculate the stability, the safety factor was between 1.05 and 1.146, and the landslide was basically stable. When the saturated residual shear parameters were used to calculate the stability, the safety factor was between 0.876 and 0.95, and the landslide was in sliding state. When the average value of saturated shear parameters was used to calculate the stability, the safety factor was between 0.96 and 1.049, and the landslide was in an unstable or lacked a stable state.

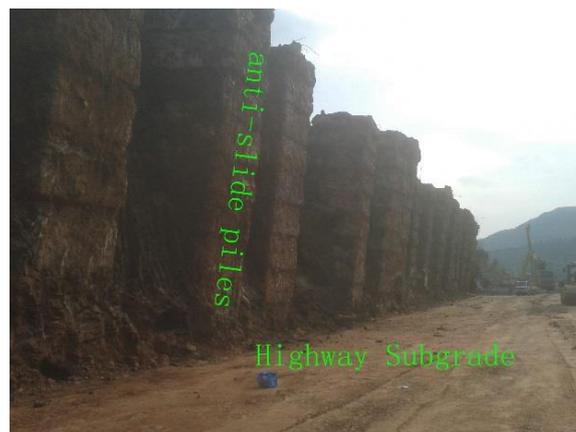
Figure 8. Anti-slide pile.

Before the construction of the anchor frame, the construction company excavated the soil in front of the anti-slide pile, which reduced the anti-sliding force and produced a vertical free surface (Figure 8). This was the main reason for the formation of the landslide.

- At present, the landslide is in the unstable or lack of stability state. If the upper surface water of the slope and atmospheric precipitation continue to seep down, and the soil in the sliding zone is saturated and softened, the landslide will accelerate the decline and cause adverse effects.
- The landslide is harmful to the highway under construction and the residents nearby. Considering the importance of slope stability and landslide prevention, we have suggested that drainage combined with anti-slide pile anchor should be taken in time.

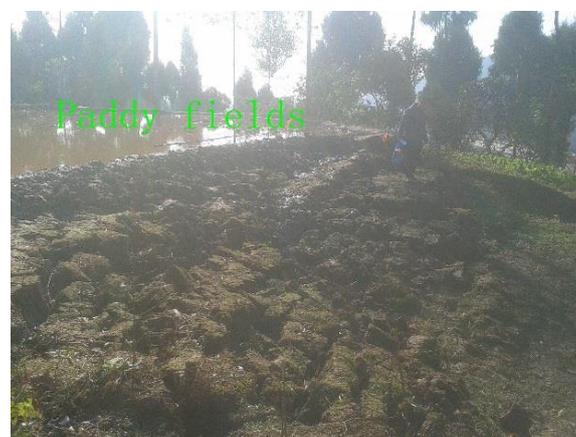
Figure 9. Paddy field in upper landslide.

Rainfall is abundant in landslide areas, and there are a large number of paddy fields above the slope. Because a large amount of surface water infiltrates downward, soil properties are poor (Figure 9).

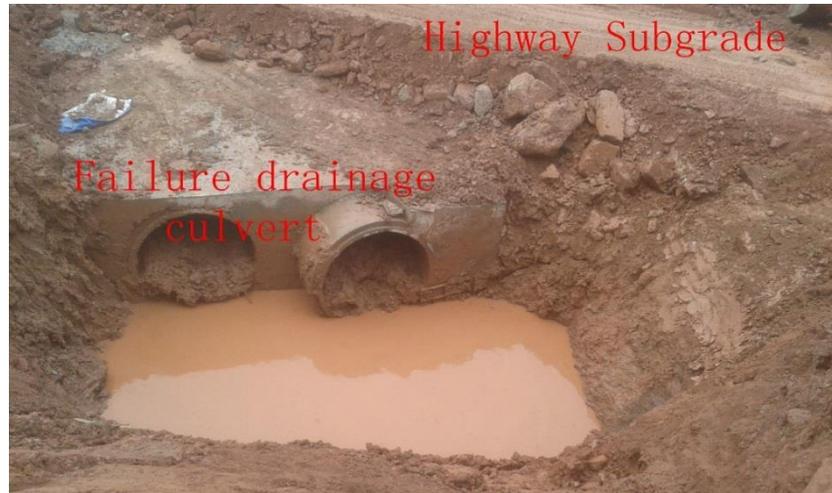
Figure 10. Drainage culvert failure at foot of slope.

Surface water and groundwater were developed in the slope. The drainage culvert of section K134 + 930 could not drain effectively, which made groundwater gather at the foot of the slope. (Figure 10). The saturation and softening soil gradually reduced the strength of the soil, which caused the failure of the anti-slide piles. The failure of No. 40[#]–43[#] anti-slide pile further aggravated the development of the landslide.
