# Correlation of Infrared Thermal Imaging Results with Visual Inspection and Current-Voltage Data of PV Modules Installed in Kumasi, a Hot, Humid Region of Sub-Saharan Africa

**Abstract:** In this study, a photovoltaic (PV) modules site installed from 1997 to 2017 (20 years of outdoor exposure) in the hot, humid region of Kumasi, Ghana in Sub-Saharan Africa was selected in order to study the aging phenomenon and rate of degradation due to long-term exposure. The main purpose of this work was to correlate the performance of 14 PV modules using data from infra-red thermal imaging (hot spot tests), current-voltage (I-V) tests and visual inspection. The modules were first visually inspected followed by electrical performance tests using an I-V curve tracer. Hot spot testing of each module was performed to enable further characterization. The results of the visual inspection using the United States National Renewable Energy Laboratory (NREL) checklist did not show any major observable defects. The results also show that the higher the temperature difference in the hot spot tests, the higher the rate of power degradation. Eleven modules failed the hot spot tests according to the criteri

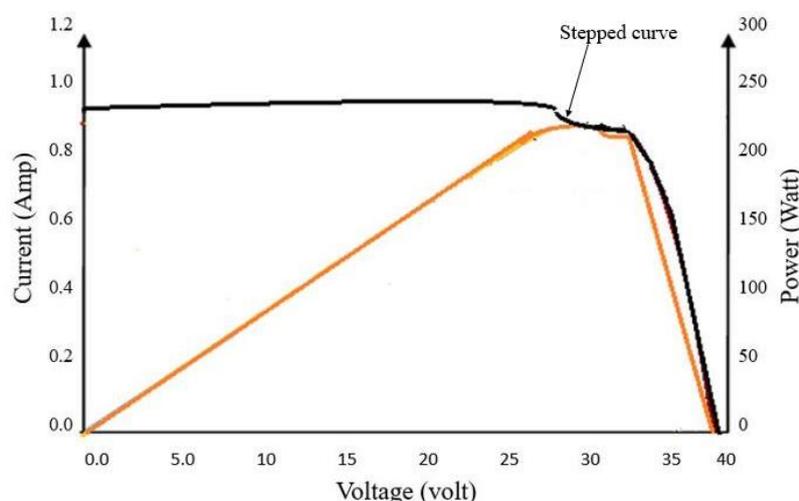
One of the deviations in I-V curve tracing is the production of stepped curves. This may occur when bypass diodes activate and allow current around cells that do not receive enough light or have been weakened. Possible causes may include shading, soiling of damaged cells, etc. Roumpakias et al. [11] have reported that in a string of modules, this deviation can lead to a drop in the recorded current. Figure 1 shows typical arrays, with a stepped curve as a result of cell shading.

**Figure 1.** Step curve due to shading.

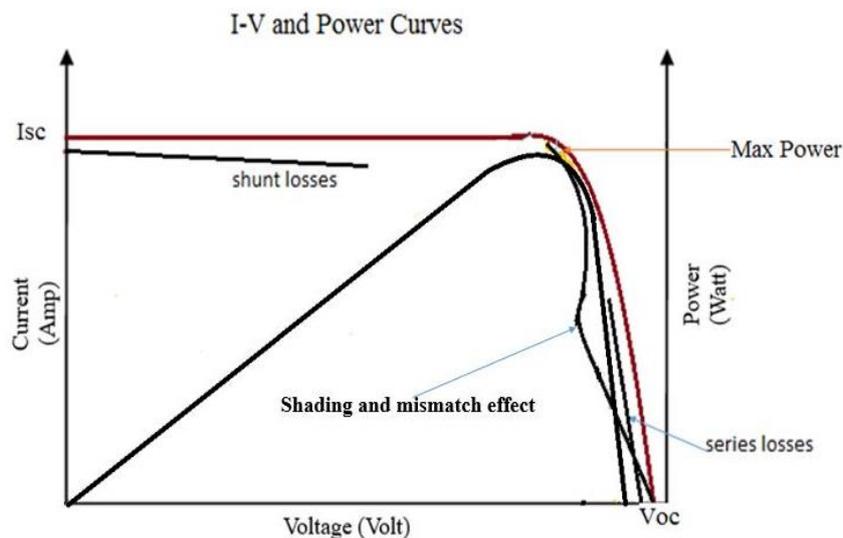
Another deviation occurs where slopes along the I-V curve appear steeper than the manufacturer's curve. For steeper curves, reduced shunt resistance is a possible cause. Shunt current is a current that bypasses the solar cell junction without producing power, short circuiting a part of a cell or module. Some amount of shunt current within a solar cell is normal, although higher quality cells will have a higher shunt resistance and hence lower shunt current. Shunt current is typically associated with highly localized defects within the solar cell, or at cell interconnections. Infrared imaging of the PV module can usually identify minor shunt current hot spots since a temperature rise of 20 °C or more is common. Factors that lead to a reduction in shunt resistance may include shunt paths existing in PV cells, shunt paths existing in the PV cell interconnects and module  $I_{SC}$  mismatch. In the work presented by Solmetric [13], it is reported that the overall effect is the reduction in the fill factor of modules. Figure 2 shows various losses that can exist within I-V curves. These losses greatly affect the overall power output of modules as reported in the literature [11,13].

Figure 2. Possible losses within PV modules.

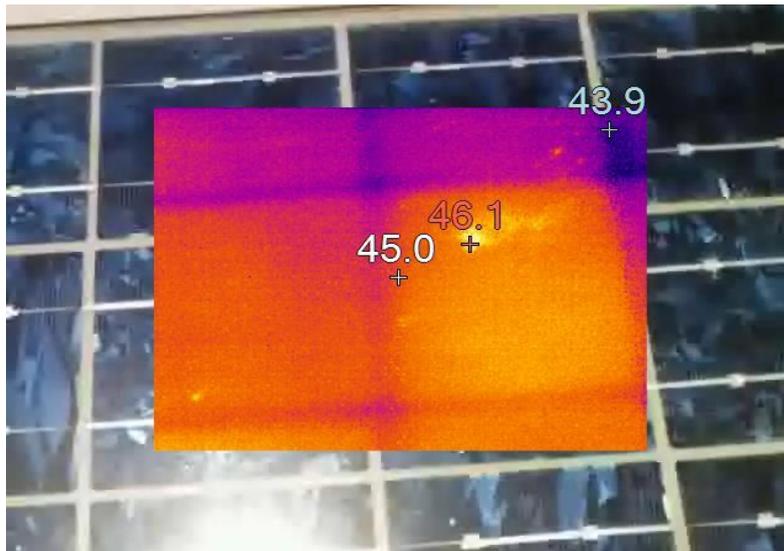
Figure 3. IR thermal image of a cell.

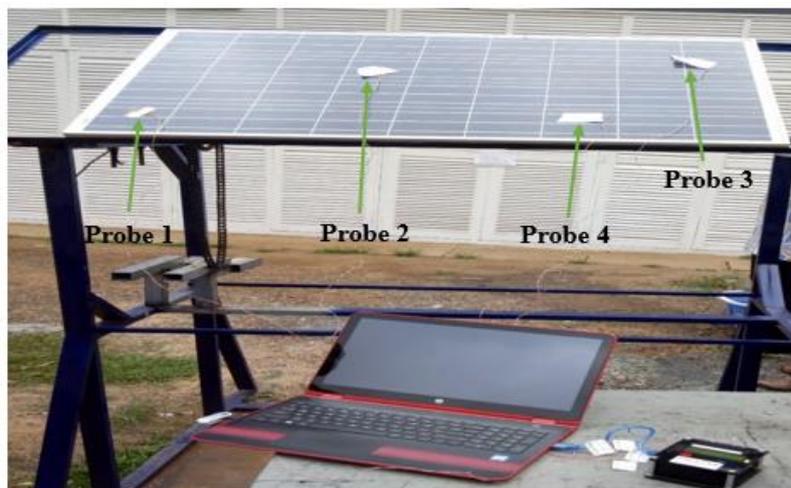
short-circuited. The purpose was to observe temperature distribution over the surface of the PV module. Two temperature points (hottest and coldest) were noted by moving the scanner across each cell of the modules. The measurements were taken during a period of good insolation (around  $1000 \text{ W/m}^2$ ) in a clear sky. Hoyer et al. [22] and Acciana et al. [23] have classified hot spots as either a light hot spot, where power losses are about 4% due to a  $10 \text{ }^\circ\text{C}$  temperature difference, or a strong hot spot, where power losses are about  $18 \text{ }^\circ\text{C}$  in the cell's surface. The accuracy of the infrared (IR) temperatures was verified using contact temperature probes. Figure 4 shows the experimental setup used to collect data to compare the IR imager and temperature probe readings. Table 1 shows the data taken from the IR imager and the four temperature probes. The results indicate that the data from the two measurement instruments compare favourably well.

Figure 4. Setup for comparison of IR imager and temperature probes.

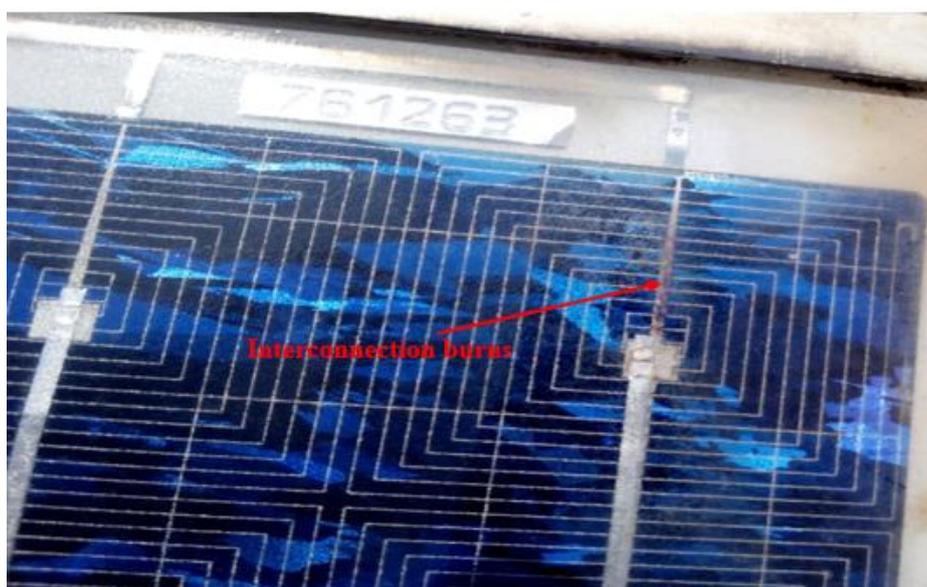
Component	Observation (s)
Cell gridlines	Gridlines on modules indicate browning and corroding effect. These corrosion effects were observed clearly on some gridlines of Modules 1, 5, 6, 12, 13 and 14 as shown in Figure 5 for Module 12
Backsheet	Minor discoloration on front glass—this might be due to moisture ingress. No wavy texture was observed, no chalking, burn marks or other damage was visible
Wires/connectors	no embrittlement or burns was observed
Delamination	Minor delamination was observed on Modules 1, 5, 6 and 7
Cell Gaps	All modules cell gaps showed minor brown discoloration, affecting encapsulations slightly
Frames	Frames of all modules show minor discoloration, there was no evidence of corrosion of metal joints
Metallization	Bus-bars and cell interconnects showed no burns, discoloration or corrosion
Junction box	No damage was observed on the junction boxes. No adhesion losses
Interconnect Ribbons	Module 10 shows a minor burn along a ribbon (Figure 6)

**Figure 6.** Module 10, indicating interconnection burns.

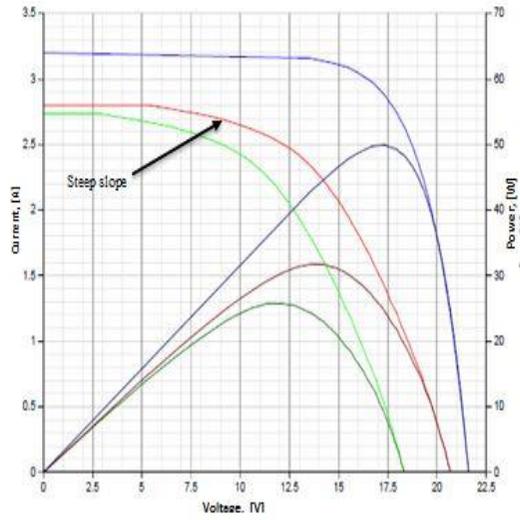
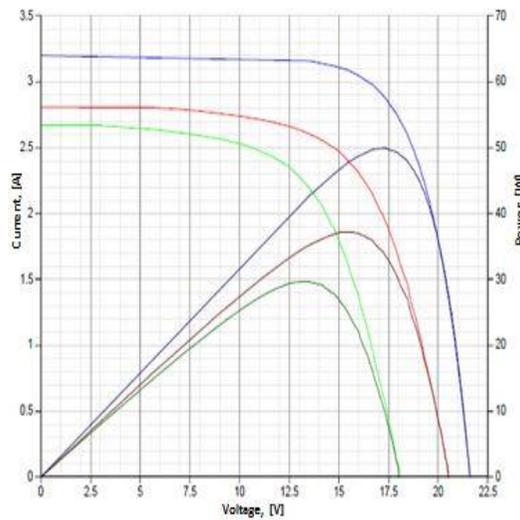
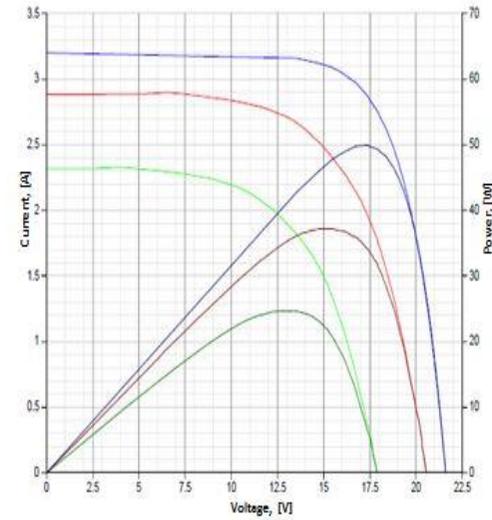
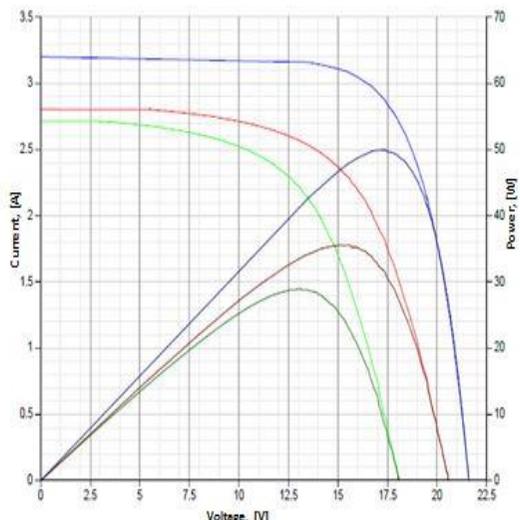
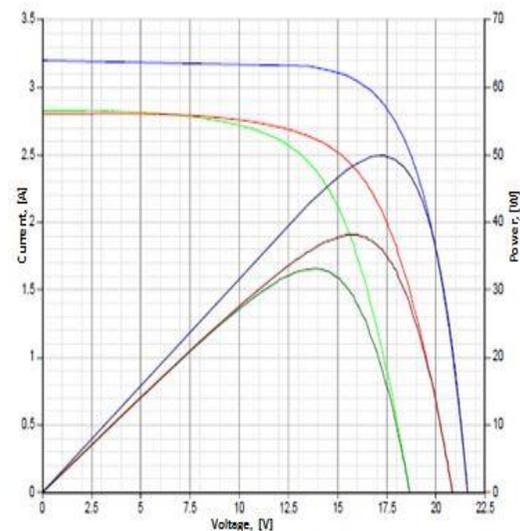
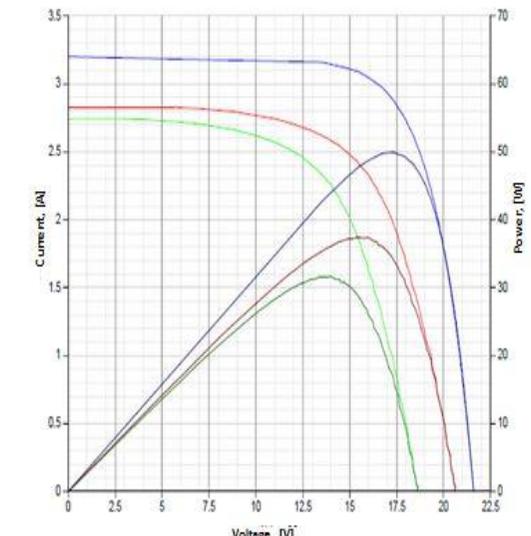
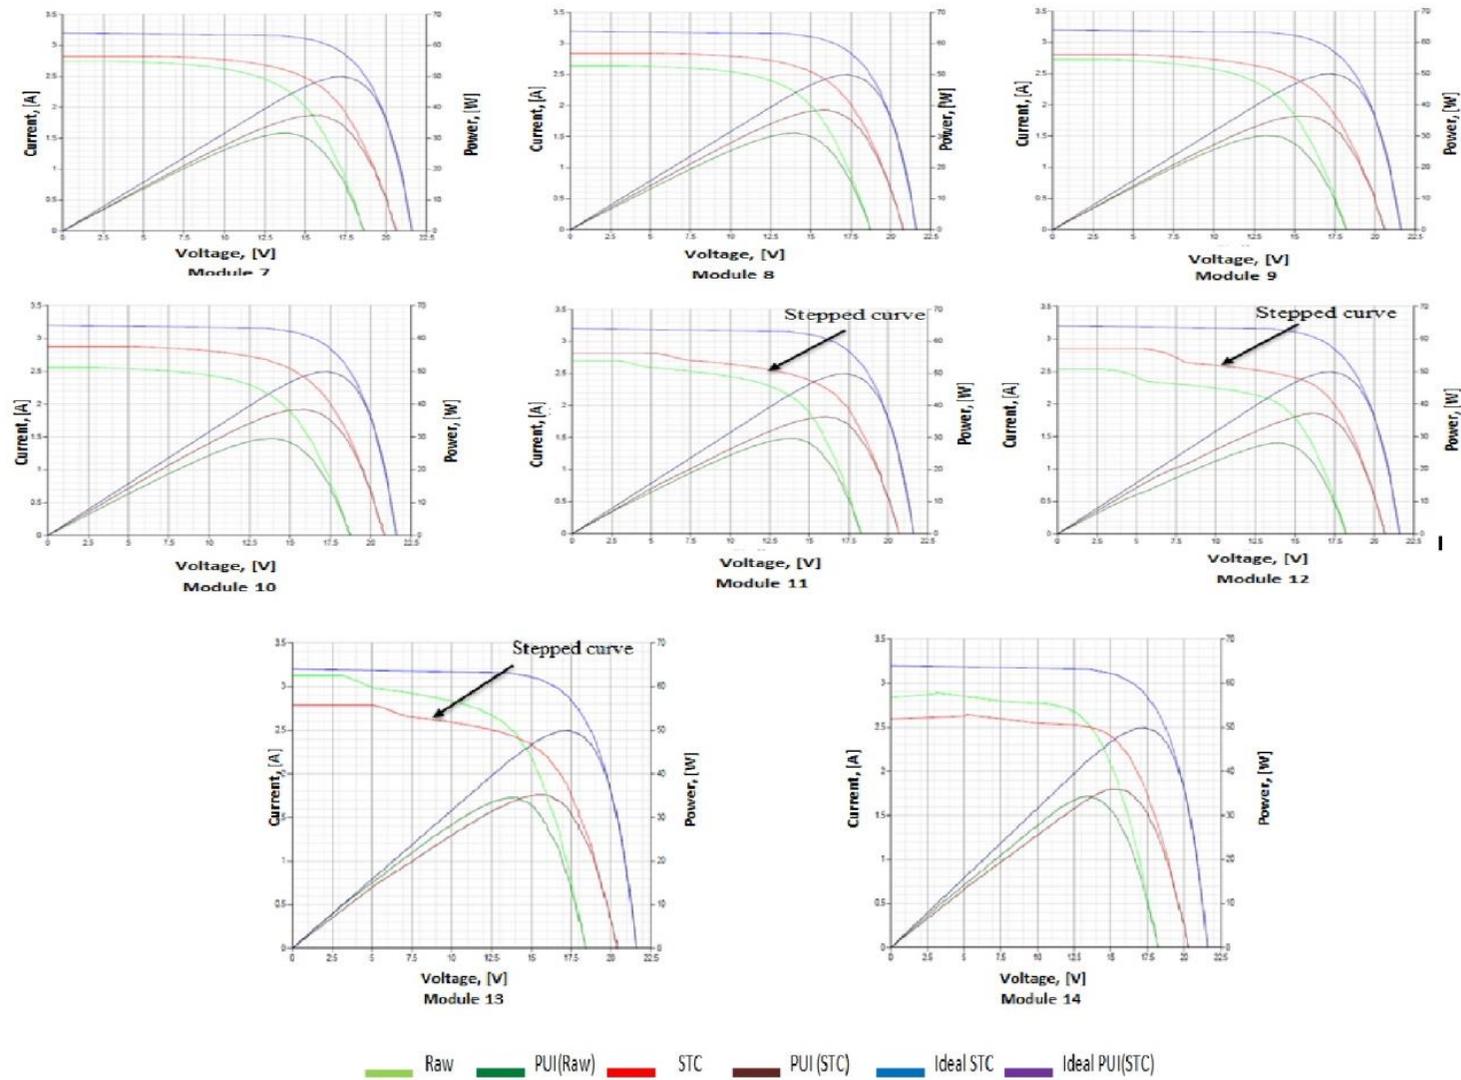
As indicated earlier in Section 2 (Methodology), all recorded data were extrapolated to STC conditions that will be used in the analysis. Figure 7 (Modules 1–14) shows curves traced from all 14 modules.

Figure 7. I-V and power graphs showing raw, extrapolated and manufactures' Curves (Modules 1–14).

Module 1 in Figure 7 shows a steep slope deviating sharply from the ideal plots than the manufacturer's plot. The effect has manifested in the reduction in the fill factor values (see Table 3). It is not clear the reason for this observed behaviour. The results also show a decrease in  $V_{OC}$  and  $I_{sc}$  values as compared with the manufacturer's curves. This is an indication of degraded modules.

From Figure 7, it can be observed that Modules 11–13 show stepped I-V curves, a deviation from the manufacturer's ideal curve. Factors such as damaged PV cells or a short-circuited bypass diode may be the cause, according to the literature [13]. This is indicated by the significant drop in power (27 watts, 26 watts and 30 watts, respectively), as shown in Table 4. Inspections conducted on these PV modules indicated no physical defect except for a semi-permanent dirt deposit around the sloppy edges of the modules.

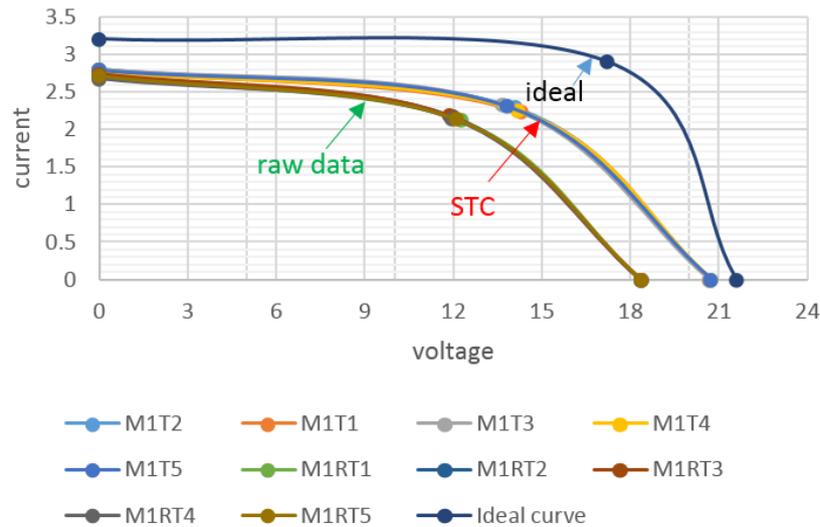
Figure 8 shows the I-V curves of five experiments taken for Module 1 in order to test for repeatability. It shows the various plots indicated as M1T1–M1T5 (experiments 1–5 for Module 1) for the manufacturer's data, STC condition and raw data (blue, green and red plots, respectively, shown in Figure 7). The plots show repeatable data.

**Figure 8.** I-V curves of Module 1 to test for repeatability.

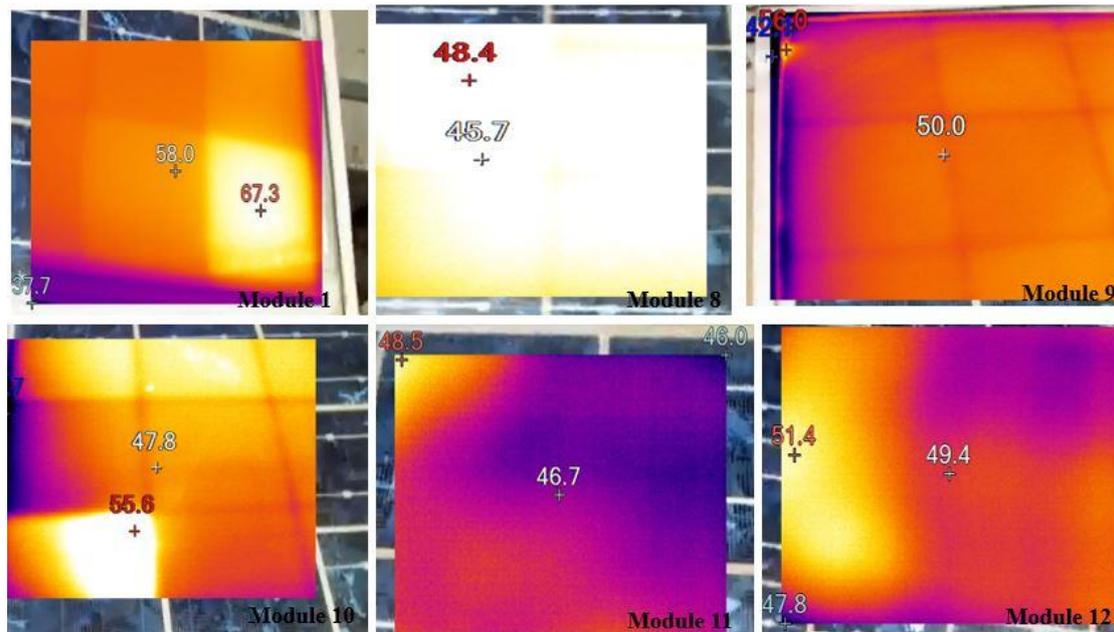
Figure 9 shows that portions of select modules (1, 8–12), as captured by the IR thermal imager, show temperature hot spots. In the IR imaging tests, the coldest and hottest parts of the module were recorded and the difference determined, as shown in Table 3. A temperature difference of 10–20 °C or more indicates a hot spot of an area.

**Figure 9.** Thermal images of selected modules showing temperature hot spots.

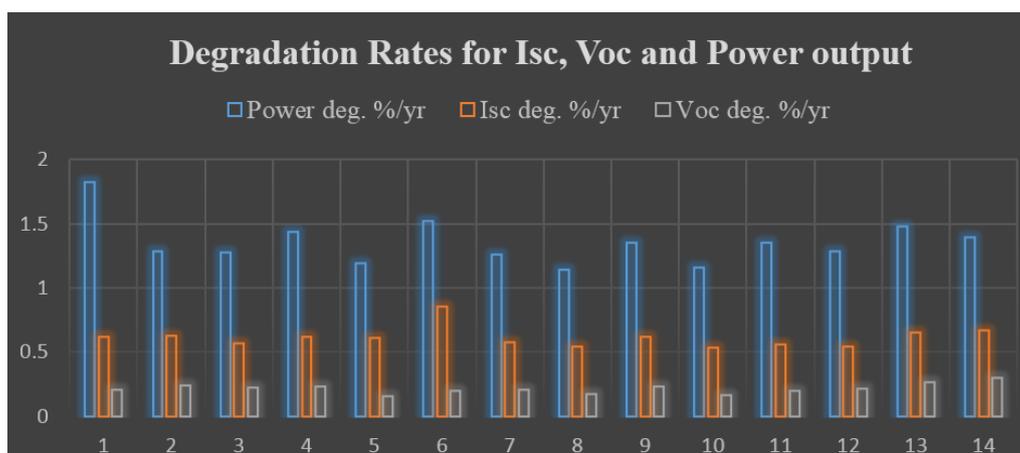
From Table 4, the module power degradation using the manufacturer's rated data (50 watts) instead of the actual data at the time of installation (zero age) ranges between 1.19% and 1.823%/year, which is higher than the industry-accepted rate of 0.7%/year reported in the literature [6] or 1%/year in earlier years reported in the work by Sample [28]. This indicates that all the modules tested fell outside the acceptable range of 0.7–1.0% degradation rate. Module 1 recorded the highest degradation rate of 1.82%. The range of power performance factor (PPF) is 63.54–76.76% after 20 years of operation. This also indicates that all the modules' power output performance fell below the average 80% standard set by most manufacturers for modules operating within a 25-year warranty. These factors indicate an overall higher degradation rate for all modules. Figure 10 shows the graph of degradation rate against number of years in operation. The graph also shows Module 1 with the highest degradation rate.

**Figure 10.** Degradation rates of 14 PV modules.

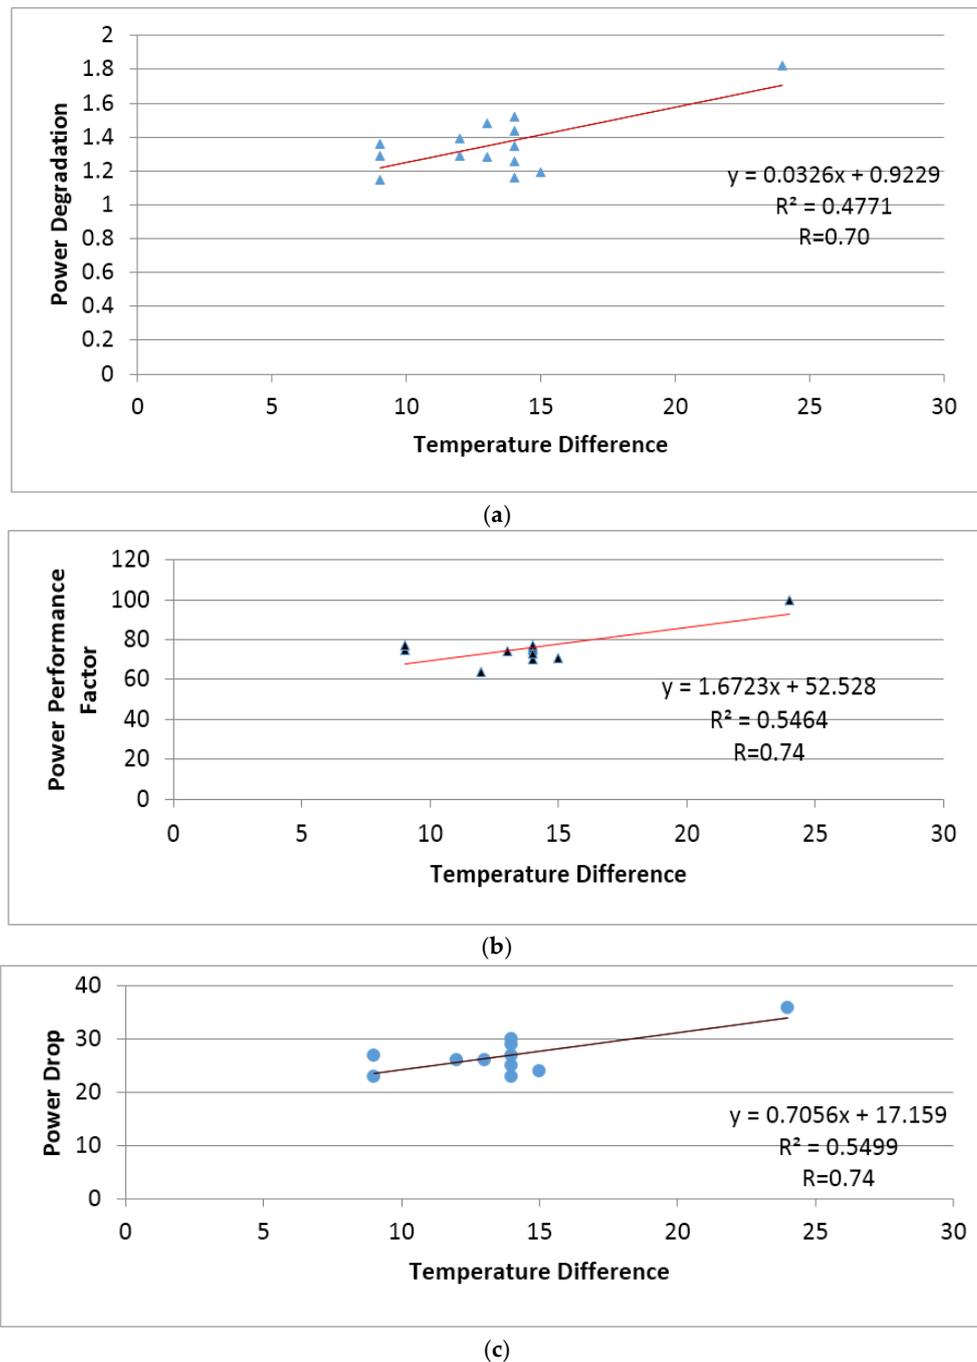
Figure 11a–c shows the plots of temperature difference against  $P_{deg}$ , PPF and  $P_{drop}$ , respectively. The results show positive correlations, although not strong ones (R-values of 0.7, 0.74 and 0.74) between temperature difference and the performance parameters:  $P_{deg}$ , PPF and  $P_{drop}$ . The three

plots also show Module 1, separated from all other modules with the bulk of the data points concentrated around the same area near the best fit line.

**Figure 11.** Graphs of temperature difference vs.  $P_{deg}$ , PPF and  $P_{drop}$ . (a) Temperature difference vs.  $P_{deg}$ ; (b) temperature difference vs. PPF; (c) temperature difference vs.  $P_{drop}$ .
