# Defects Classification of Hydro Generators in Indonesia by Phase-Resolved Partial Discharge

**Abstract:** This paper proposed a phase-resolved partial discharge (PRPD) shape method to classify types of defect generator units by using offline partial discharge (PD) measurement instruments. In this paper, the experimental measurement was applied to two generators in the Inalum hydropower plant, located in North Sumatera, Indonesia. The recorded PRPD using the instrument MPD600 can illustrate the PRPD patterns of generator defects. The proposed PRPD shape method is used to mark auxiliary lines on the PRPD patterns. Moreover, four types of defects refer to the IEC 60034-27 standard, which are microvoid (S1), delamination tape layer (S2), slot defect (S3), and internal delamination (S4) and are used to classify the defect types of the generators. The results show that the proposed method performs well to classify types of defect generator units.

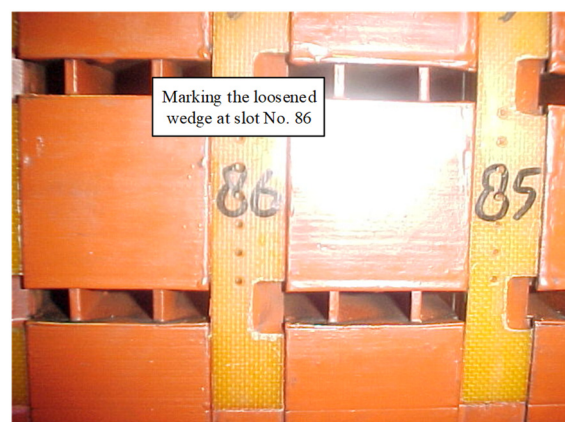
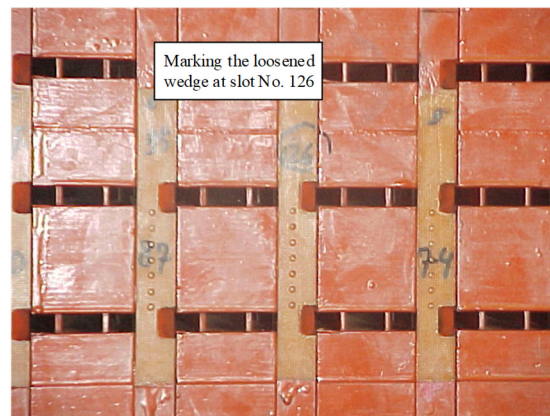
Based on inspection experience as evidence, slot discharges in generator stator coil units 2 and 3 at TNP were found, as shown in Figures 24 and 25. Maintenance treatment is carried out for the stator coil as countermeasures after conducting the inspection, such as

- (1) Checking the wedges of the stator coil for each stator slot as shown in Figures 24a and 25a, overheating areas for units 2 and 3, respectively;
- (2) Marking the loosened wedges for every slot so that they can be replaced by appropriate new wedges as shown in Figure 24b, wedge at slot no. 86, and Figure 25b for units 2 and 3, respectively.
- (3) Inspecting and marking the loosened wedges for every slot number of the stator coil, as shown in Figure 24c, wedge at slot no. 126, and Figure 25c, wedge at slot no. 47 for units 2 and 3, respectively.

**Figure 24.** Visual checking on stator slot of generator unit 2. (a) Engineer checking the wedge by gauge pressure. (b) Loosening of the wedge in slot no. 86. (c) Loosening of the wedge in slot no. 126.

Loose and wounded wedges were found during the routine maintenance work on 27 January 2016. In the inspection procedure, pressure meters were used to obtain the pressure magnitude to realize the status of wedges, as shown in Figures 24a and 25a for units 2 and 3, respectively. In the measurement, loose and wounded wedges were found at slot nos. 126 and 86, as shown in Figures 24b and 25b for units 2 and 3, respectively. Meanwhile, other loose and wounded wedges were inspected at slot nos. 126 and 47 as shown in Figures 24c and 25c for units 2 and 3, respectively. The locations of the wedges are almost similar with the locations of the conductor partial discharge nearby.

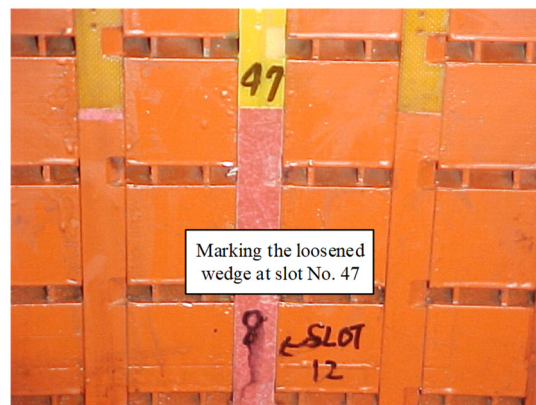
**Figure 25.** Visual checking on stator slot of generator unit 3. (a) Engineer checked and found marking such as overheating. (b) Marking the loosened wedge. (c) Loosening of the wedge in slot no. 47.
