# Exploratory Research on Drainage Structure of Highway Tunnel Based on Reducing the Risk of Crystallization Blockage

**Abstract:** Crystal blockages of tunnel drainage systems severely undermine the tunnel lining structure and operation safety. In order to reduce the risk of crystal blockages of tunnel drainage systems, the distribution of highway tunnel defects was identified through a field survey, indoor test, and literature analysis, and an optimization method of tunnel drainage structures was proposed. The research suggested the following: (1) Lining water leakage and construction joint water leakage were the most common defects in the tunnel drainage system of Renhua–Xinfeng Expressway and Yingde–Huaiji Expressway in Guangdong Province, accounting for 60% and 32% of total defects, respectively. The number of defects that occurred in the drainage system of the tunnel was larger in the granite formation, with the number of road seepage and inspection chamber crystallization incidents reaching 2.5/km and 2.8/km, respectively. (2) The groundwater was mainly alkaline with a pH value of 8–12,  $\text{Ca}^{2+}$  (107 mg/L) was the cation with the largest ion concentration, and  $\

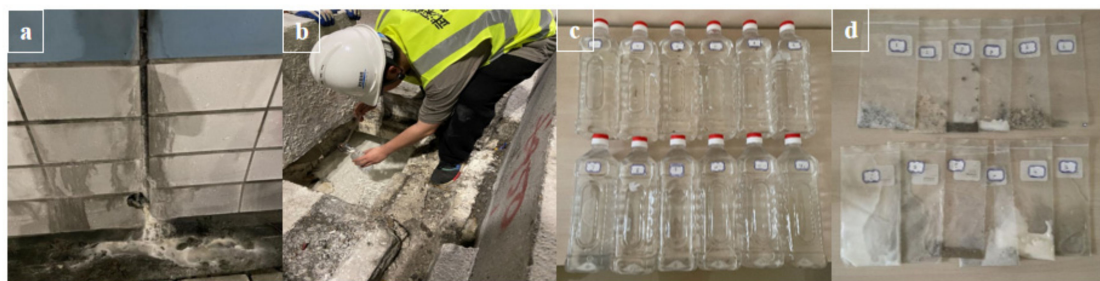
**Figure 2.** Tunnel site investigation ((a): Tunnel disease; (b): Site sampling; (c): Groundwater sample; (d): Crystal sample).

By investigating the crystal blockage of the tunnel drainage system of Renhua–Xinfeng Expressway and Yingde–Huaiji Expressway in Guangdong Province (Figure 2), we identified the type, distribution form, and number of crystal blockages of the tunnel drainage system, performed a causative and factorial analysis on the defects of the tunnel drainage system, and provided suggestions for the prevention and control of crystal plugging of the tunnel drainage system. The survey locations were primarily distributed across the tunnel emergency parking zone, tunnel entrance, side wall, and crosswalk, and the rocks of the surveyed tunnel were largely slate, sandstone, granite, and quartzite. Table 1 shows the name of the tunnel and the specific survey locations.

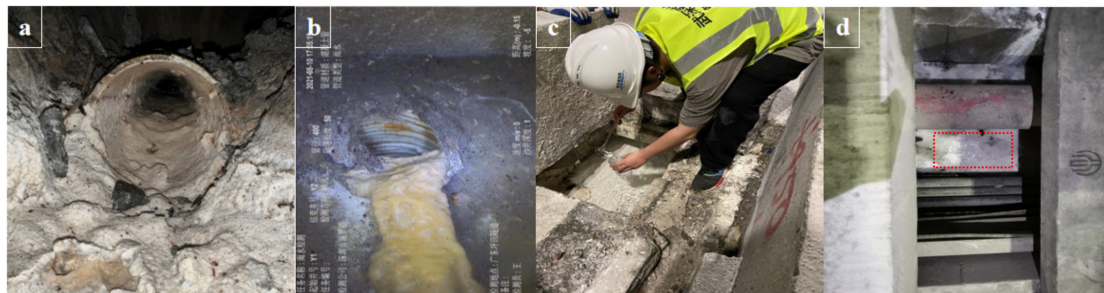
**Figure 8.** Crystal disease of tunnel drainage structure ((a): longitudinal drainage pipe; (b): transverse drainage pipe; (c): roadside underdrain; (d): cable trench).

Through the field survey of the tunnel drainage structure of the Renhua–Xinfeng Expressway and the Yingde–Huaiji Expressway, it was learned that crystal blockages were not only found in the longitudinal drainage pipe (Figure 8a), transverse drainage pipe (Figure 8b), and roadside blind drainage ditch (Figure 8c) behind the lining, but also in the cable trench (Figure 8d). The crystal plugging of the tunnel drainage structure gradually gave rise to a number of defects, such as inspection chamber overflow, lining cracking and leakage, and construction joint water leakage. Therefore, drawing on relevant research results, this paper optimized the sites where crystal plugging of the tunnel drainage structure could take place to prevent crystallization, and thus reduce the maintenance costs of the tunnel drainage system.
