Case Report

The Strange Case of a Broken Periodontal Instrument Tip

Manuela E. Kaufmann , Alex Solderer, Deborah Hofer and Patrick R. Schmidlin *

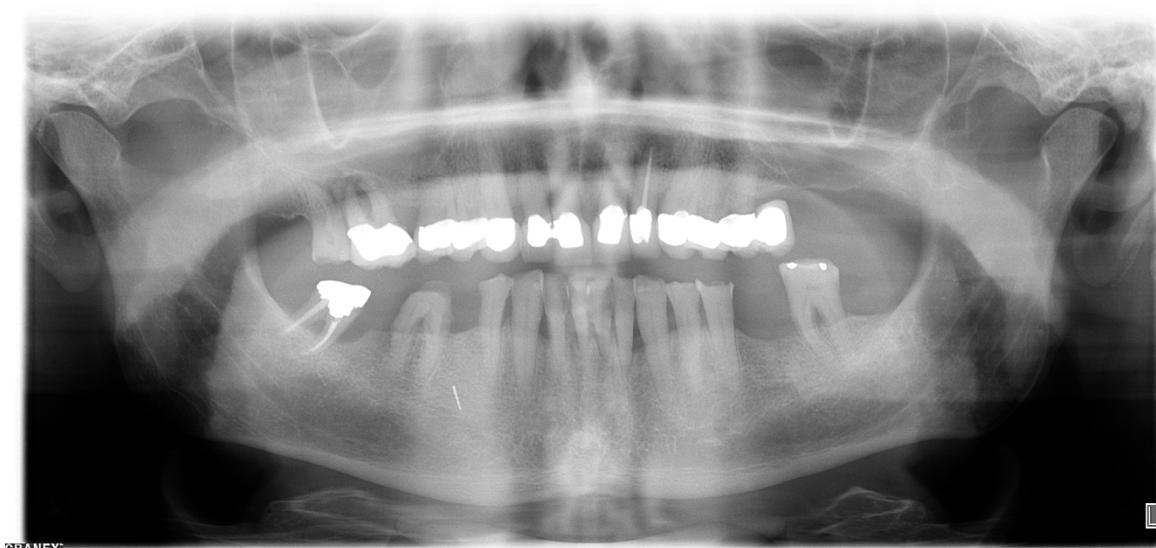
Region 45 showed a thin cylindrical, approximately 5 mm (coronal-apical) metallically dense opacity in the OPT (Figure 1).

Figure 1. Orthopantomogram taken in October 2019.

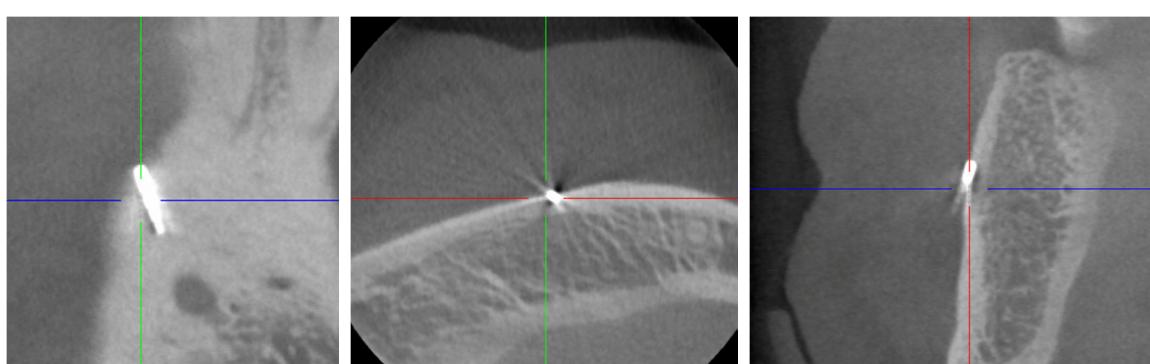
For the presurgical planning, a three-dimensional imaging using cone-beam tomography (CBCT) was made (Figure 2), using a MORITA 3D Accuitomo 170 (MORITA Europe, Jordi Röntgentechnik AG, Münchenstein, Switzerland) with a spatial resolution (voxel edge length) of 0.08 mm. The recording time was 17.5 s at 90 kV and 5 mA (pulsed).

Figure 2. Cone-beam tomography showing the metallic opacity compatible with a broken tip of a periodontal probe. No close relationship to the mental nerve canal or supplying vessels was evident.

An opacity corresponding to the findings described in the OPT, but buccally perforating the cortical bone, was found. The shape, which was typical for a periodontal probe of the type AE P OWB (Michigan O with Williams Markings), led us to suspect that it was a broken periodontal probe tip made of medical steel. A possible differential diagnosis could be excluded with certainty, despite some artefacts.

may be sufficient. The tube-shift method is also often used for the intraoral localization of an object. Whenever possible, simpler techniques with less exposure to radiation should be first applied. In our case, due to the unfavorable location of the fragment close to the *foramen mentale* and the fact of greater detecting-sensitivity using CBCT than with two-dimensional imaging techniques [16,17], CBCT was employed.

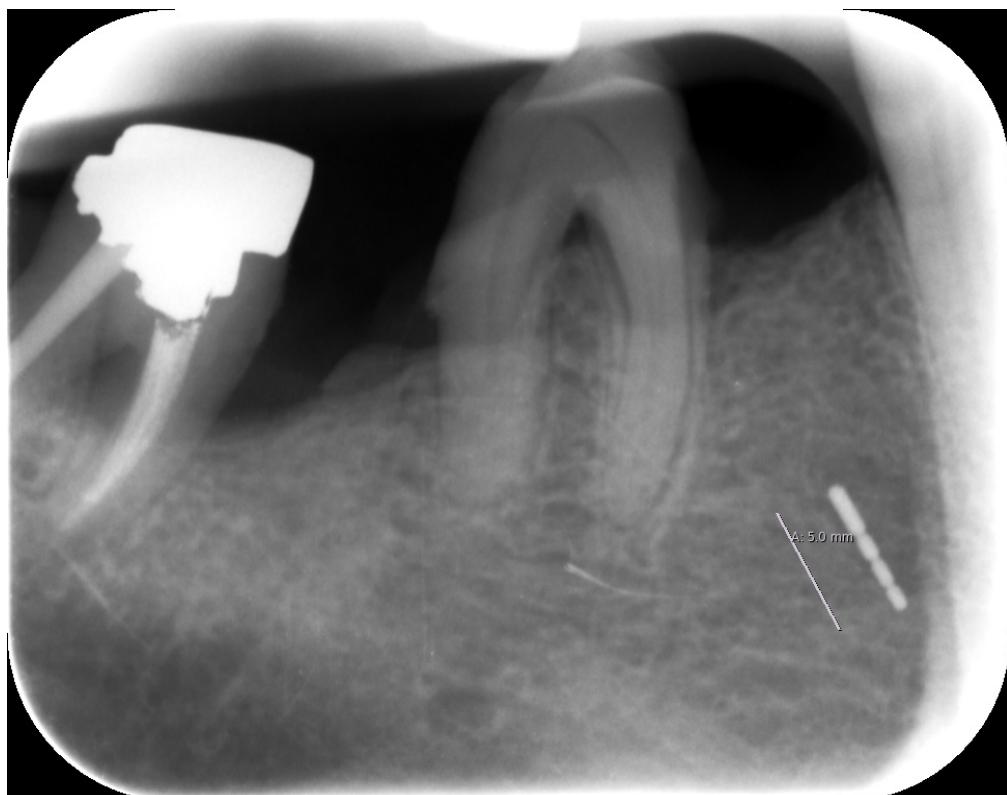
Unfortunately, no older X-rays were available. The single tooth X-ray taken in our clinic in December 2019 clearly identified the broken periodontal probe in two dimensions (Figure 3).

Figure 3. Periapical X-ray with the broken periodontal probe.

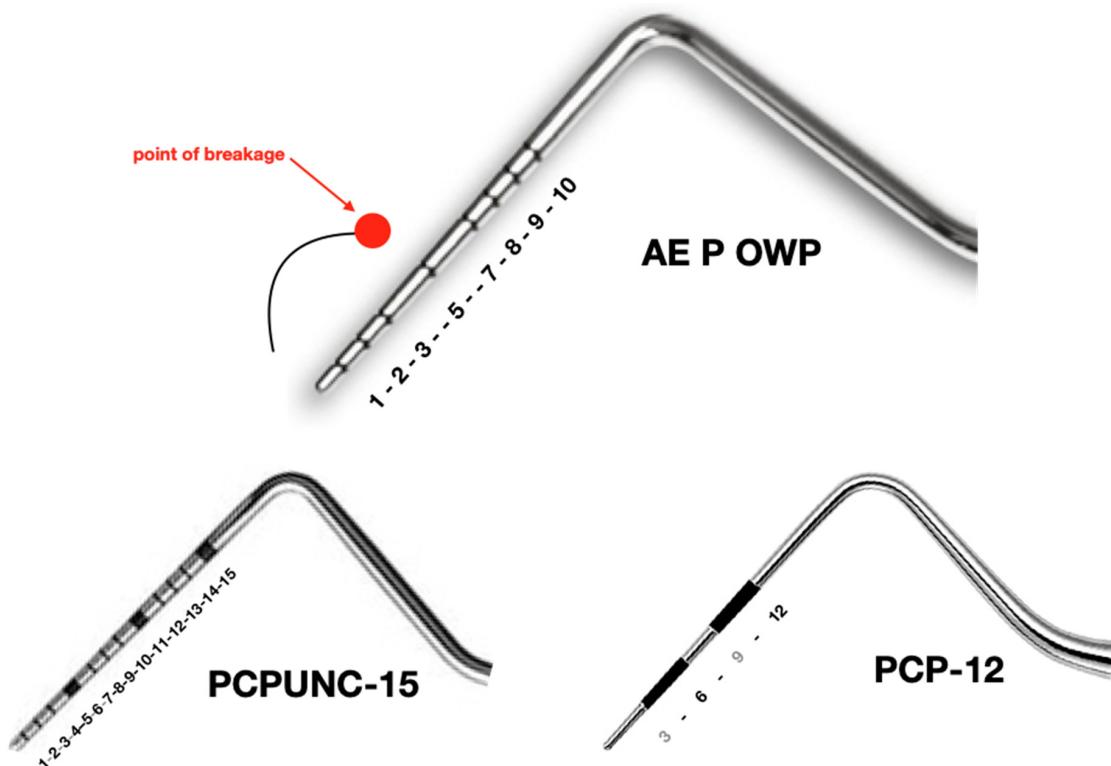
Based on the X-ray findings and visible markings on the metal object, we surmised that this was a broken periodontal probe tip. It appeared to be either a PCPUNC-15 or AE P OWP, both of which are similar, although the latter is shorter and does not have a 4 mm marking (Figure 4). The definitive identification could only be made after removal when we were able to measure and assign the fragment tip accordingly (Figures 5 and 6). Details and photographs of the patient's oral status can be found in the Supplementary File.

Figure 4. Comparison of the periodontal probes AE P OWP, PCPUNC-15 and PCP-12 (mm markings).

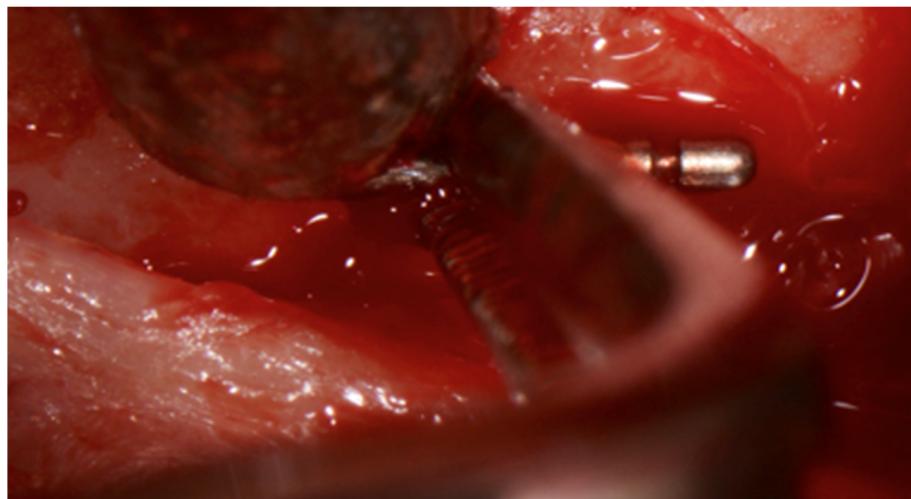
Figure 5. In situ image showing the removal of the broken periodontal probe tip from buccal, which was removed with pliers after careful luxation.

In December 2019, region 45 was operated and the fractured instrument tip removed (Figures 5 and 6).

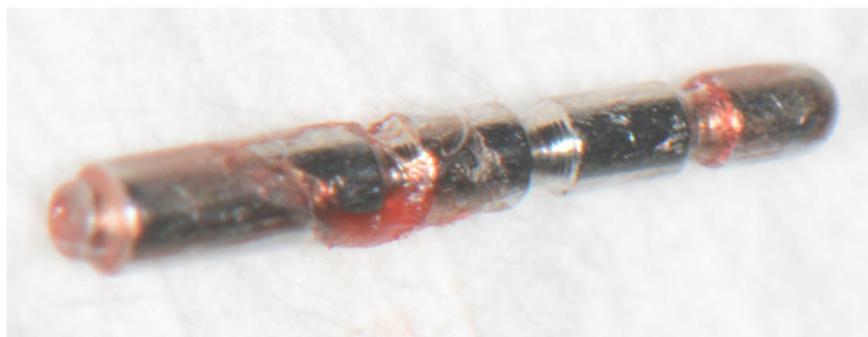
Figure 6. The surgically removed fragment tip of a periodontal probe type AE P OWP.
