# Experimental and Numerical Calculation Study on the Slope Stability of the Yellow River Floodplain from Wantan Town to Liuyuankou

**Keywords:** floodplain; slope; scour; flume experiment; numerical calculation

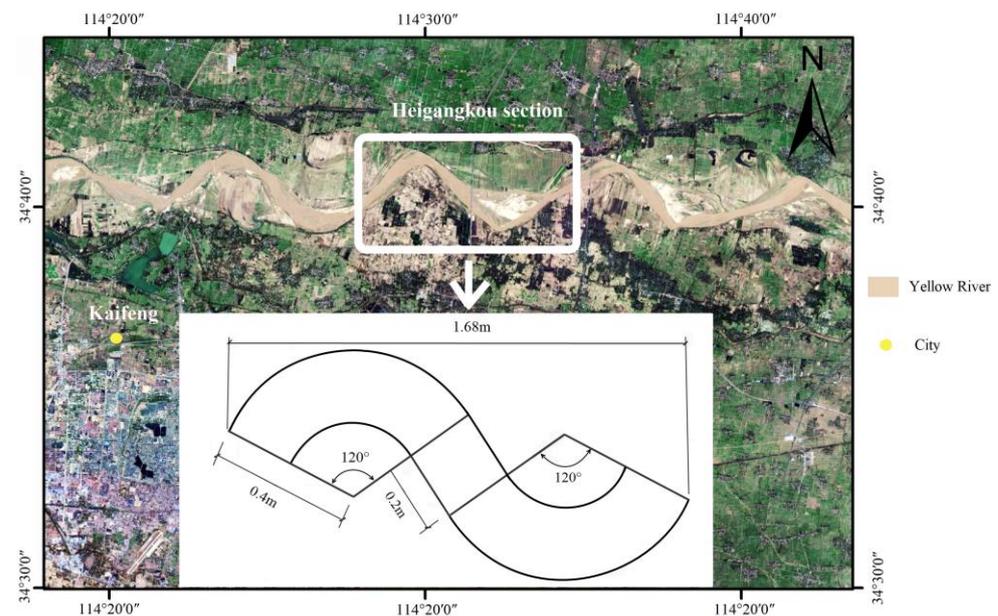
The collapse of the floodplain slope directly threatens the safety of the Yellow River levee. Additionally, Heigangkou is located in Kaifeng, where levees have repeatedly broken in the past. The S-shaped flume following the actual bank size of the Heigangkou section was used to simulate the erosion process of the convex, concave, and straight banks, to study the failure pattern and mechanism of the floodplain slope (Figure 2).

**Figure 2.** Schematic diagram of flume size.

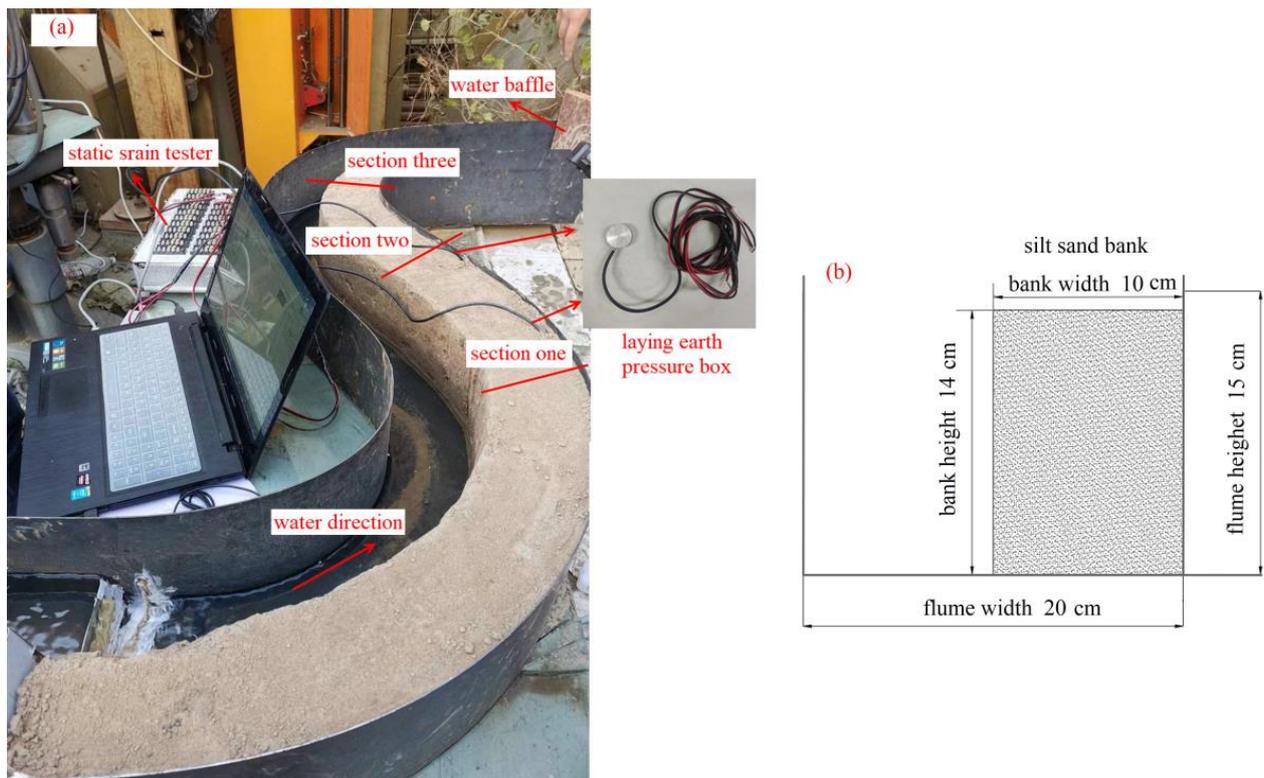
Three profile positions were selected in this experiment, as shown in Figure 3a. A camera was set up on the convex, concave, and straight banks to capture the failure process. Earth pressure sensors were buried at the bottom of the concave and straight banks, and the measuring accuracy of the earth pressure box is 0–0.4 MPa. To prevent water from scouring the start and end of the slope, gravels were paved in the water inlet and outlet of the flume (Figure 3). The water outlet of the flume was provided with a water baffle which was used to control the water level height by changing its position at the same time (Figure 3a). The detailed description of the experiment equipment is shown in Table A2.

**Figure 3.** Actual diagram of the scouring experiment: (a) the layout of the scouring experiment; (b) side views of the flume.

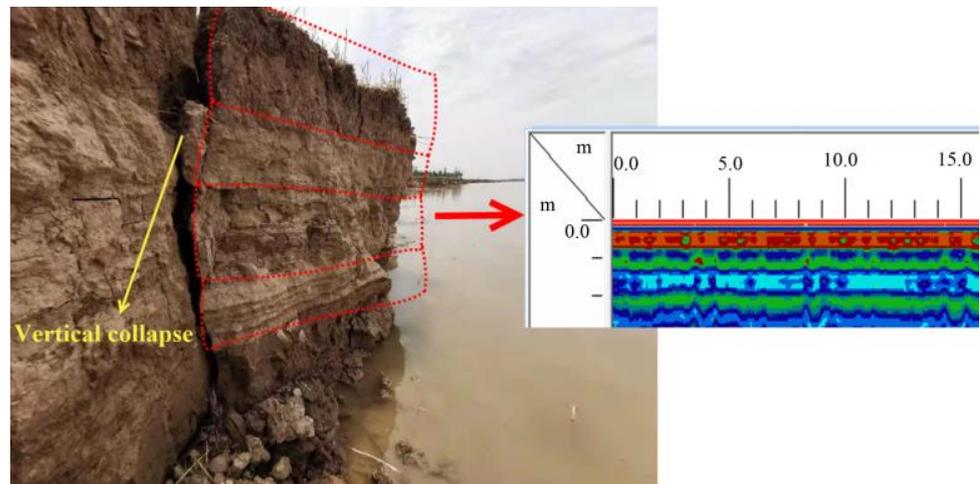
The bank presents a vertical stratified structure, and bank soil is roughly divided into brown and yellow soils (Figure 4). A scan result in Wantan Town is presented on the right side of Figure 4. Because different soils correspond to individual conductivity properties, nearly all the scan results of 18 sections showed a vertically layered structure.

Figure 4. The scan result of a section in Wantan Town.

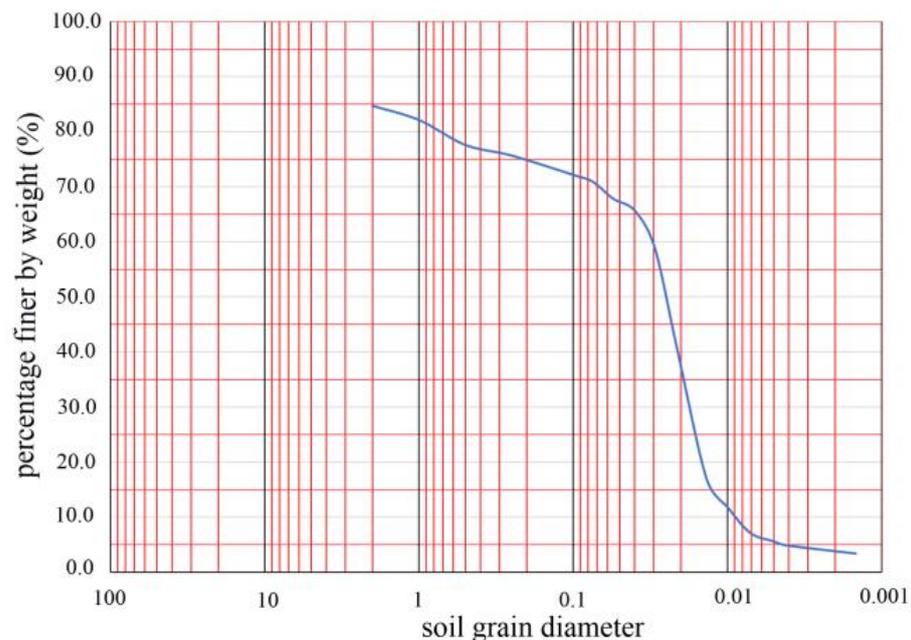
Owing to the plasticity indexes above 17 (shown in Table 2), the soil was classified as clay in combination with relevant classification standards [67]. The yellow soil was first subjected to a sieving test, and then the particle gradation of the soil with particle size below 0.075 mm was determined by the densitometer method. Finally, the drawn particle gradation curve is shown (Figure 5). The particle size greater than 0.075 mm and smaller than 0.005 mm did not exceed 50% and 10% of the total weight, respectively. The plasticity index obtained from the liquid–plastic limit test was less than 10, so this soil was classified as silty sand according to the standard [67].

Figure 5. The particle gradation curve of the soil, whose scan color is blue.

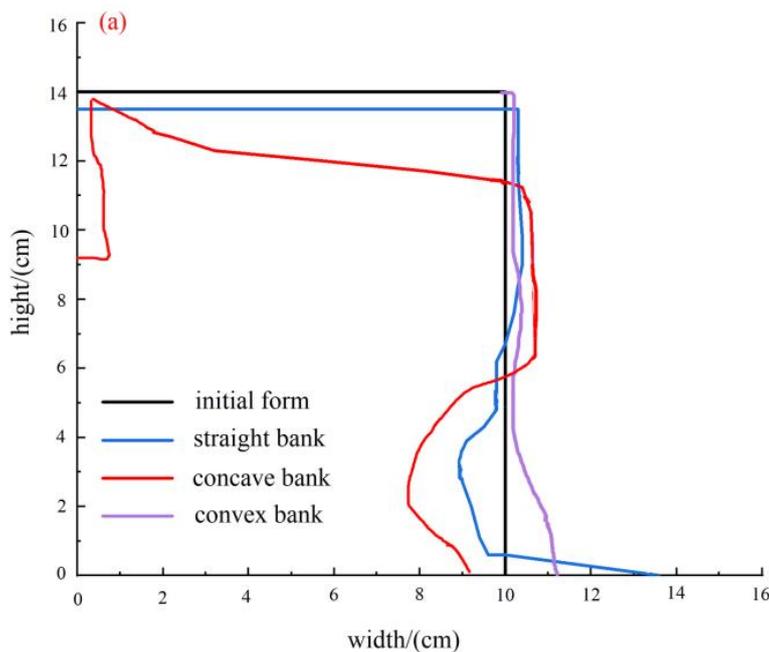
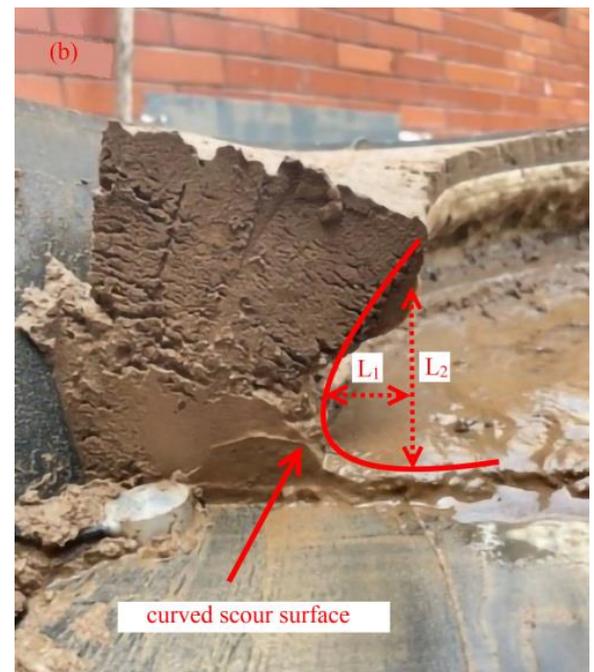
Figure 6a shows the bank failure schematic diagram of concave, straight, and convex banks under working condition 2. The erosion degree of the concave bank is greater than that of the straight bank and the convex bank, and the convex bank is silted. According to Figure 6b, it can be found that the slope toe was scoured to form an arc-shaped scouring surface, which was attributed to the presence of clay and the pseudo-cohesion of silty sand. To further understand erosion characteristics under the different variables and compare with previous studies, the scour height, L<sub>1</sub> and width, L<sub>2</sub>, accurate to millimeters, were introduced.

**Figure 6.** Bank failure pattern: (a) failure schematic diagram of slopes under working condition 2; (b) actual diagram of the concave bank under working condition 2 (L<sub>1</sub>: the scour height, L<sub>2</sub>: the scour width).

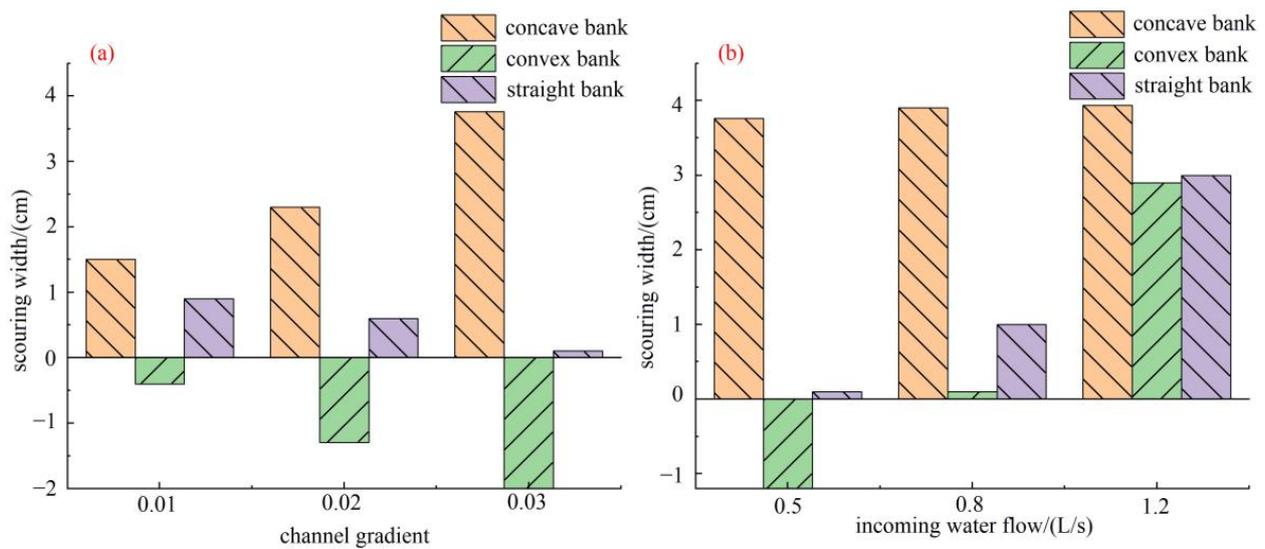
Figure 7a shows that when the channel gradient equaled 0.01, the concave and straight banks were all eroded because of the weak circulation intensity caused by the low water velocity. As the channel gradient increased from 0.01 to 0.03, the scour width of the concave bank gradually enhanced. On the contrary, the convex bank which kept depositing from the channel gradient equaled 0.03.

Figure 7b shows that with the increase in incoming water flow, there was no deposition in the straight and convex banks. Wang found that when the water flow increased to a certain extent, the straight and convex banks were eroded [68].

**Figure 7.** (a) The scour width varies when the channel ratio is a variable. (b) The scour width varies when incoming water flow is a variable.

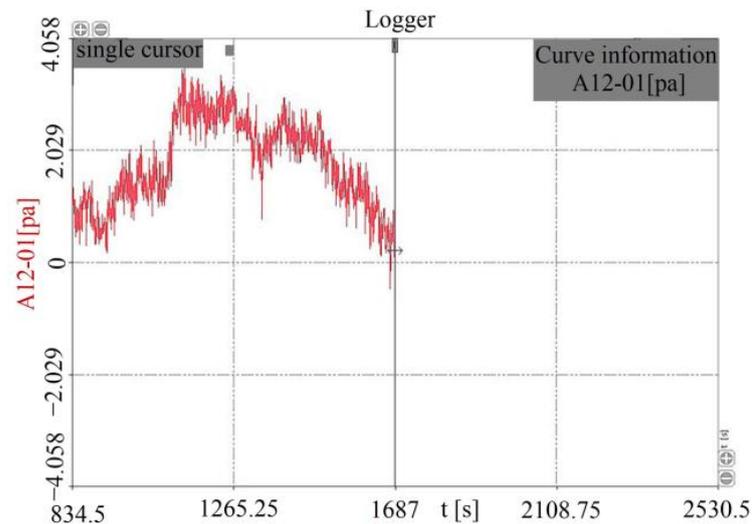
The change of the internal earth pressure from the experiment’s start to the experiment’s end is shown in Figure 8. Two factors affect earth pressure in the experiment process; earth pressure increases with an increase in soil water content, but water erosion decreases earth pressure. The earth pressure increased first and then decreased (Figure 8). This appearance indicated that the water content in the early stage had a more significant impact than water flow erosion. In the later period, the earth pressure decreased when the water content changed very little. In combination with the video recorded for the experiment, the slope collapsed when the earth pressure was less than before the experiment.

**Figure 8.** Earth pressure curve.

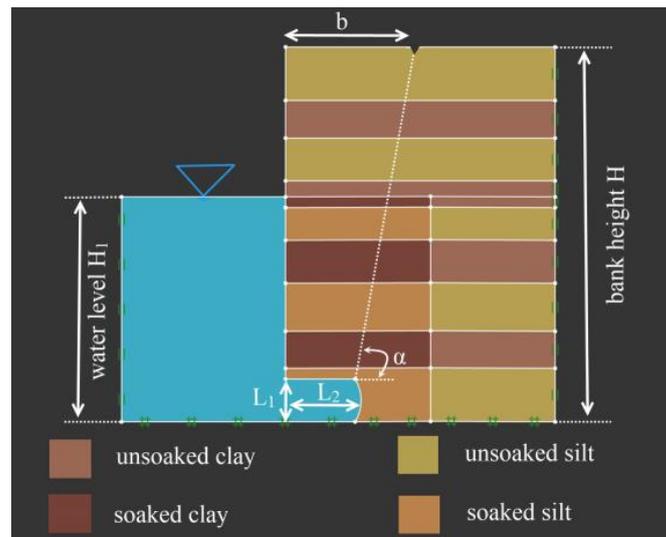
According to the flume experiment, the vertical slope formed an arc-shaped suspended layer under water flow scour. An equal proportional slope model, based on the size of the arc-shaped suspended layer, was established using OptumG2. A generalized model of slope collapse was established, wherein  $H$ ,  $H_1$ ,  $b$ , and  $\alpha$  represent bank height, water level, the length of the failure surface to the bank edge, and the failure surface angle, as seen in Figure 9.

**Figure 9.** Generalized model of the bank collapse.

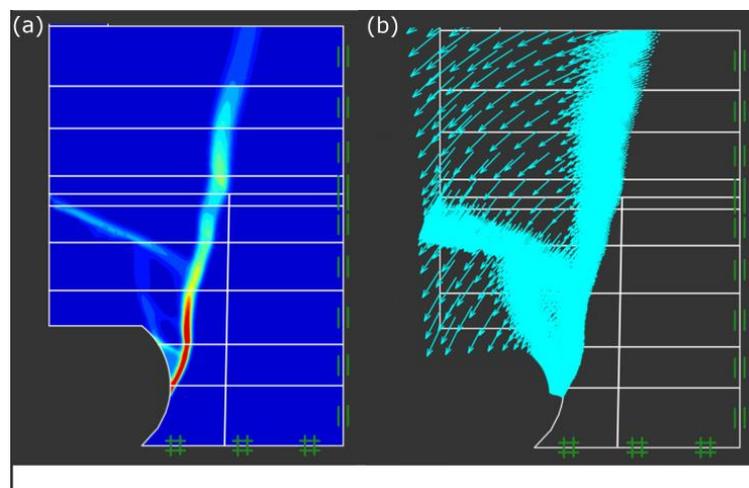
The failure pattern of a straight bank after scouring (under test condition 5) was selected for validation using the OptumG2. The erosion height and width equal 0.39 and 0.29 m of the slope model in Figure 9, and the simulation results are stated in Figure 10.

**Figure 10.** Validation result of the straight slope after scouring (under working condition 5): (a) the bank failure surface; and (b) displacement vector map.

The failure surface of the slope was almost vertical in Figure 10a. The simulated result was very similar to the failure mode of the scouring experiment; the upper suspended soil rotated and fell into the water under the action of gravity in Figure 10b.

The slope was scoured to form an arc-shaped scouring surface under the action of water scour (Show in Figure 10), and the overhanging soil, broken through by the fissure, toppled when the bank slope was washed to a certain extent. Zhang summarized the failure pattern of single-layer bank slope and surmised that the length from the top failure surface to the bank edge is about twotimes of the scour width [70], which is smaller than the results of this paper (2.5 times). This difference may be caused by the clay layer in the stratified bank studied in this paper, which increases the integrity of the bank and makes the failure range of the top of the bank larger.

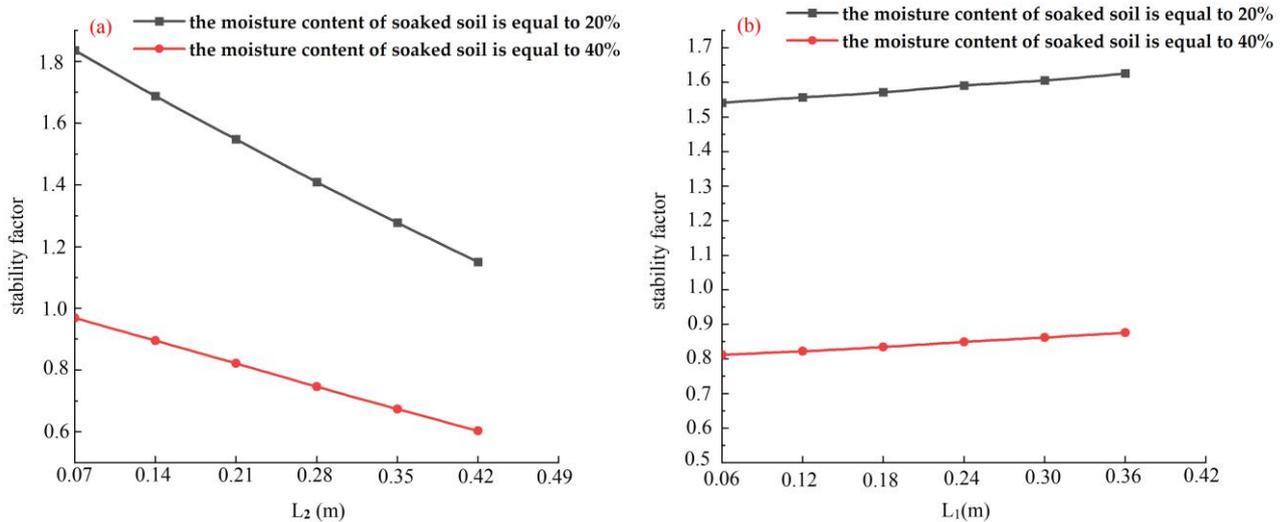
**Figure 11.** The effect of the scour degree on the bank stability: (a) the influence of the scour width on the stability coefficient; and (b) the effect of the scour height on the stability coefficient.

The stability coefficient of the bank decreases significantly with an increase in the scour width in Figure 11a. This was consistent with the scour experiment in that banks first collapsed with large scour width when the scour height was almost the same. Contrary to the scour width, the stability coefficient of the bank increased slightly with an increase in the scour height (Figure 11b). The bank soil strength significantly declines when the water content increases from 20% to 40% (Table 4). The bank stability coefficient decreases rapidly under the dual effects of an obvious decrease in the soil strength and an increase in scour width (Figure 11a).

According to the experimental observations, scouring is an important cause of bank failure. Numerical simulation results show that the bank stability coefficient decreased with the scour width increasing (Figure 11a). However, the stability coefficient of the bank increased slightly with an increase in the scour height. Zhang performed a systematic study on the failure of single-layer overhanging slopes and concluded that bank stability first decreases and then increases with an increase in erosion height [70]. This is because the stability of the sandy soil slope is poor, and the slope stability decreases rapidly after being soaked in water.

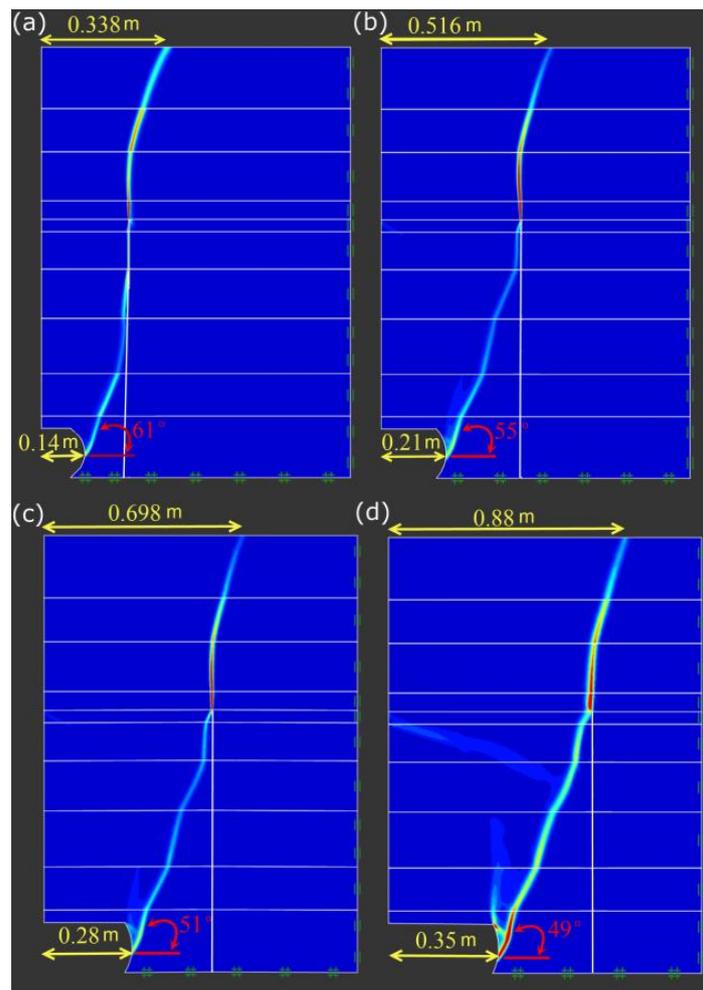
When the scouring widths are 0.14, 0.21, 0.28 and 0.35m, respectively, the failure surface of the river bank is as shown in Figure 12. With an increase in the scouring width, the failure distance *b* of the shore top becomes larger, and the failure surface angle  $\alpha$  gradually decreases. The processing results of *b* and  $\alpha$  under six scour widths are shown in Figure 13. It is clear that  $\alpha$  is negatively correlated with *L*<sub>2</sub>, and *b* is about 2.5 times that of *L*<sub>2</sub>.

**Figure 12.** Variation of slope failure surface under four scour widths: (a) scour width is equal to 0.14 m, (b) scour width is equal to 0.21 m, (c) scour width is equal to 0.28 m, and (d) scour width is equal to 0.35 m (a).

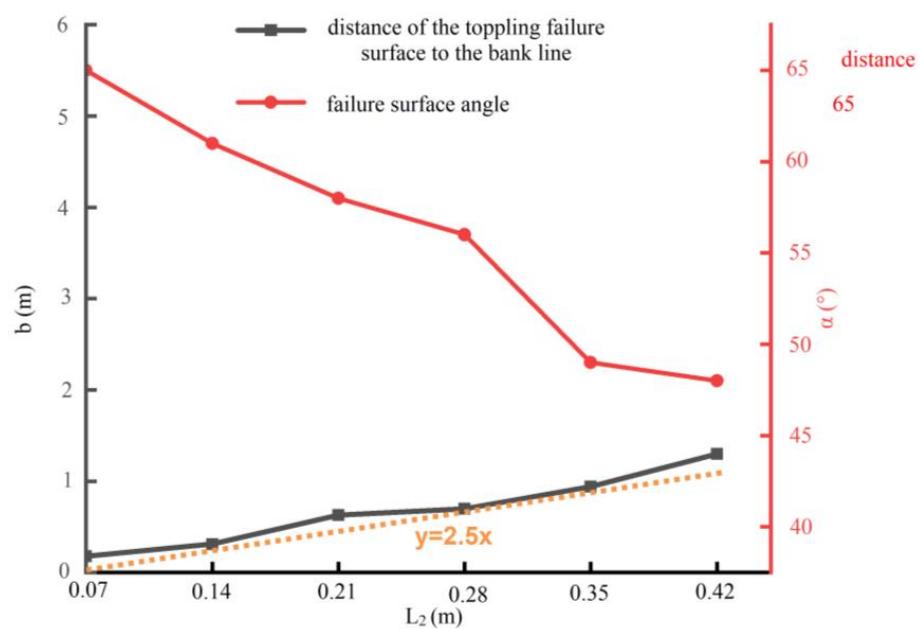
**Figure 13.** Variation in the angle of the failure surface and the length from the top failure surface to the bank edge with changes in scour width.

The failure depth of the bank top is greatly affected by the scour width. It is found that the distance from the failure surface of the bank top to the edge,  $b$ , is about 2.5 times the scour width. Meanwhile, the failure surface angle diminishes with an increase in scour width.

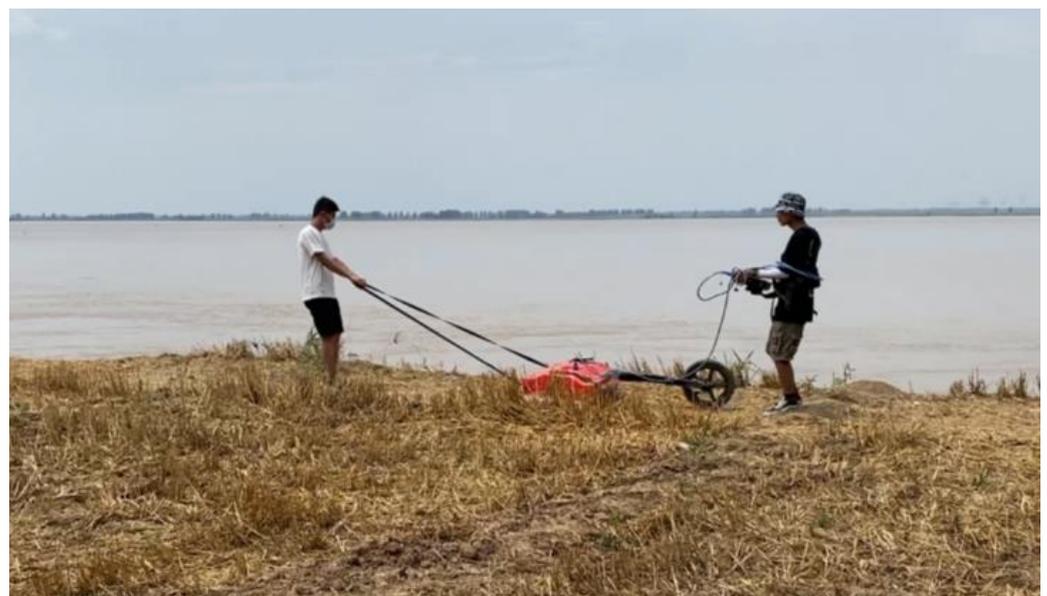
**Figure A1.** Scanning the floodplain in Wantan Town using the geological radar.
