Monitoring and Quantifying the Fluvio-Geomorphological Changes in a Torrent Channel Using Images from Unmanned Aerial Vehicles

Geomorphology Edaphology and Riparian Areas Laboratory (GERi Lab), Department of Forestry and Natural Environment Science, International Hellenic University, 66100 Drama, Greece

Hydrology **2022**, *9*, 184. <https://doi.org/10.3390/hydrology9100184>

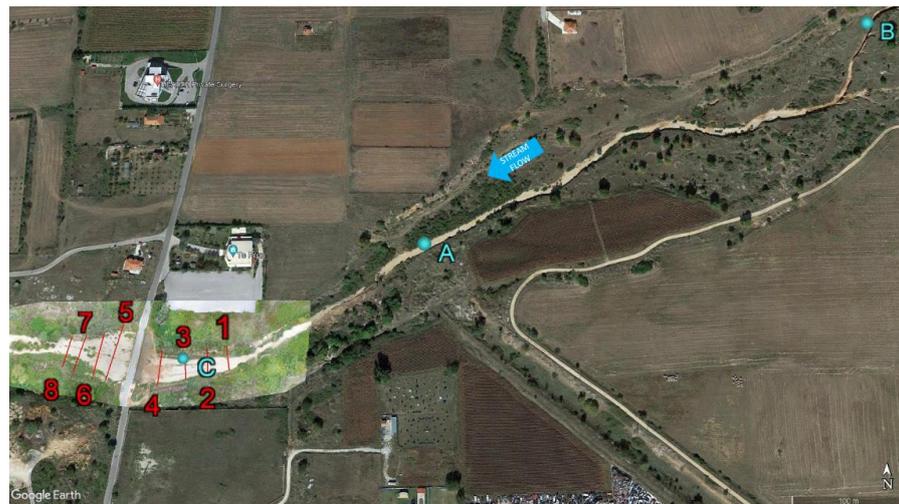
Figure 2. The eight cross-sections (red lines) and three erosion pins plots (blue dots) as located on studied reach of Kallifitos torrent, Drama, Greece. Between cross-sections 4 and 5 is an Irish bridge. The light color area indicates the area that was captured by the drone during the six flights.

Two field methods were utilized: (a) cross-section survey (CS) [62] and (b) erosion pins [63]. Both methods were used to validate the results from the analysis of the UAV's images. Eight cross-sections of the torrent were recorded in order to compare the dimension and any change among different events (Figure 2). Four of the CSs (1–4) were upstream from the Irish bridge and the other four (CS5–8) downstream to assess the potential impacts of the anthropogenic structure. The GPS/GNSS (Global Position System/Global Navigation Satellite System) RUIDE PULSAR R6P (Guangzhou, China) was selected to record the real coordinates (in WGS 84) of the eight cross-sections. Surveying channel cross-sections is a standard method to analyze and measure changes in stream channel geometry, such as stream bank and bed erosion and depositions [64].

The eight cross-sections (see Figure 2), produced based on the field measurement (using the GPS), were compared with those produced from the drone images flown in the six different periods along the study’s stream reach. In this comparison, the left bank is the north bank and the right bank is the on south (see Figure 2). Firstly, the GPS cross-section

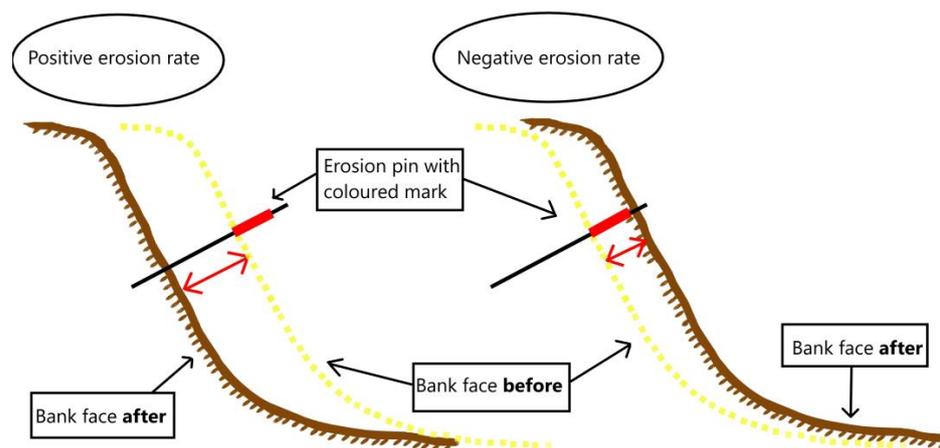
Figure 3. Erosion pins installed and measurements after erosion (left) and deposition (right) events.

The erosion pin method (Figure 3) was selected due to its practicability for short time-scale investigations and its results have high accuracy (up to 5 mm) [65]. The length of the pins was 80 cm, because erosion rates of up to 50 cm per erosion event were witnessed in similar-sized streams [66]. A pin diameter of 1 cm was selected because it was small enough to cause minimum disturbance to the banks but large enough to not bend under most high-discharge events [67]. A total of three erosion pins was installed. One of the plots was within the area captured by the drone flights while the others were upstream.

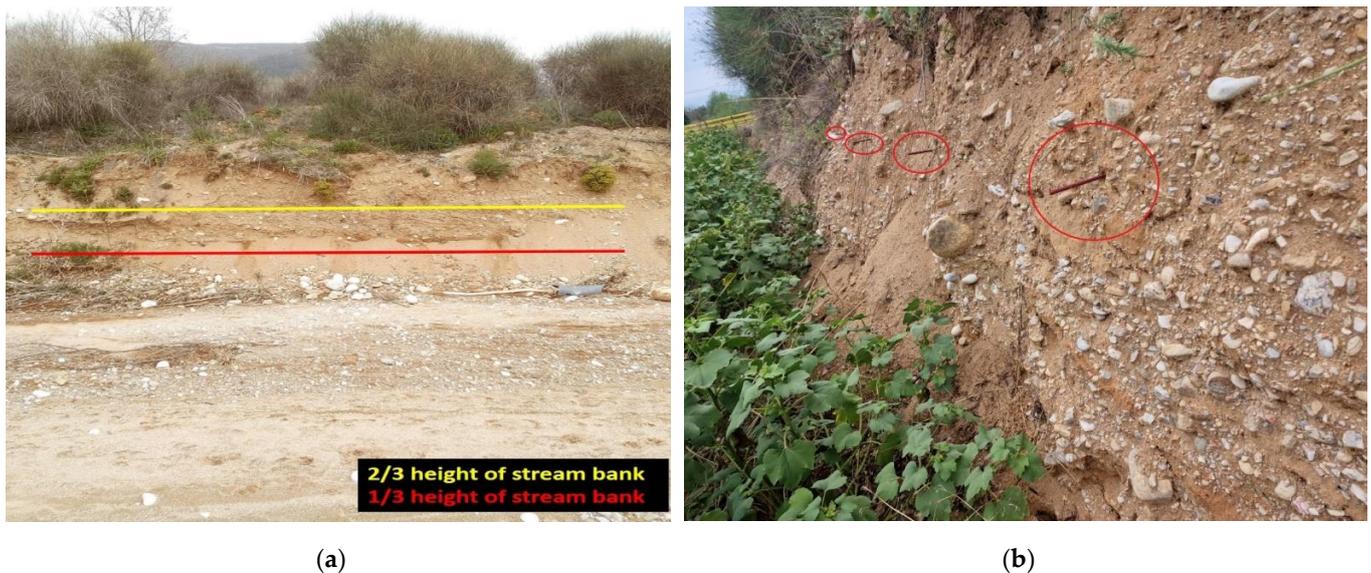
Figure 4. (a) A representative stream bank of the Kallifitos torrent with the upper erosion pins (2/3) in the yellow line and the lower erosion pins in the red line; (b) a representative stream bank of the Kallifitos torrent with erosion pins (red circles) installed at the upper part (2/3) while the lower part (1/3) was covered by soil deposition.

Each erosion pin plot included two horizontal rows of five pins each (Figure 4) installed on bare banks. Pins within these rows were placed 1 m apart for a total length of 4 m. To consistently place the pins in similar bank positions among the streambanks, the horizontal rows were placed at 1/3 and 2/3 of the height of the bank. The Kallifitos torrent has three erosion pin plots, specifically A: X:514557,150 Y:4554900,600, B: X:515011,382 Y: 4555136,200 and C: X:514334.900 Y:4554791.400 (see Table 1) in three different locations of the torrent (Figure 2). The specific reach (captured by the drone) includes only one pin, plot C. The measurement period is during the last winter (specifically the pins were installed in November 2021 and measured in March 2022 and June 2022).

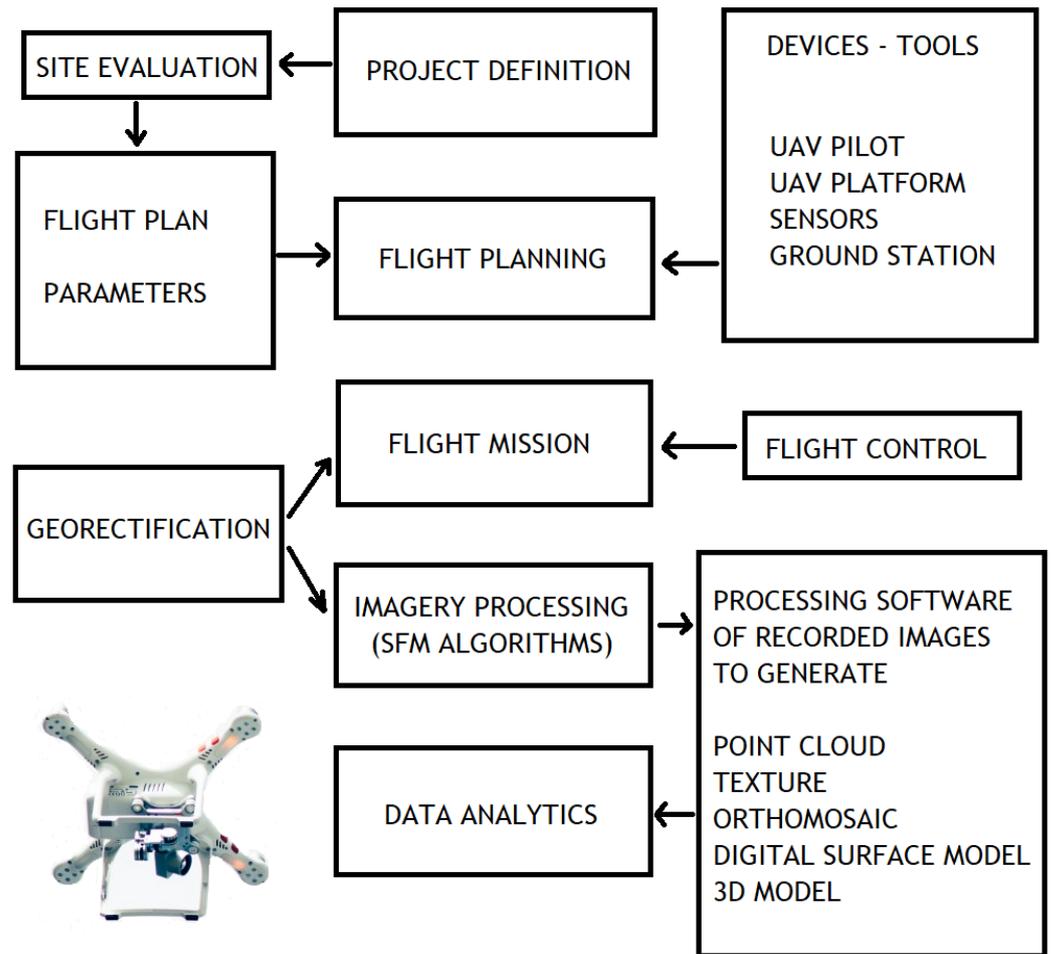
Figure 5. The typical steps followed for UAV-based photogrammetric studies.

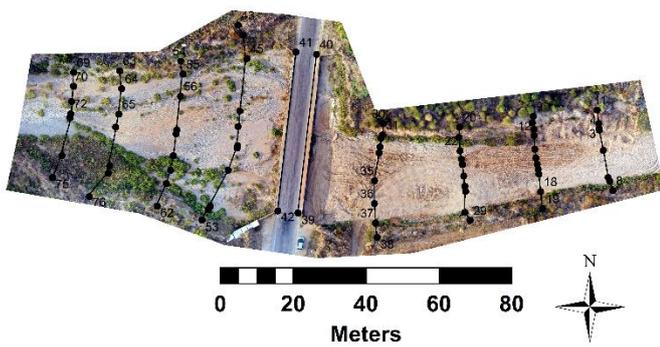
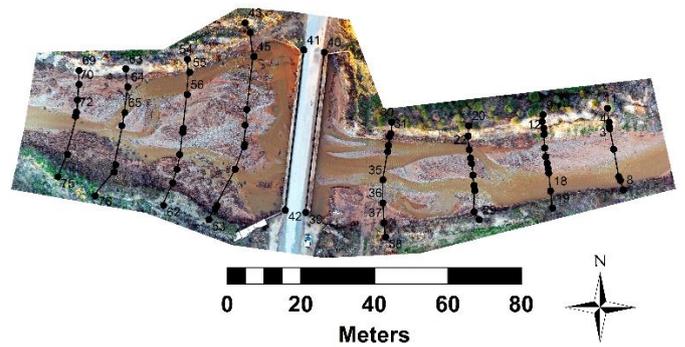
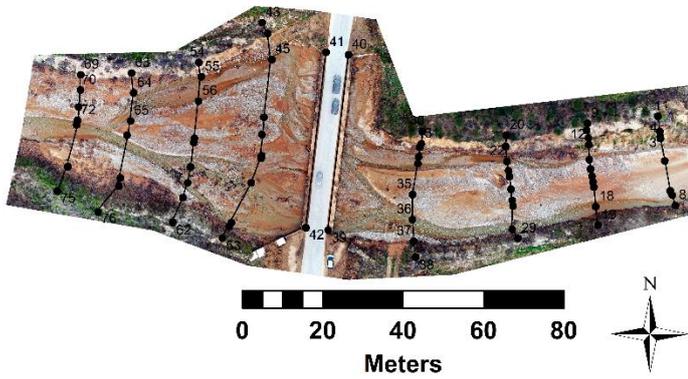
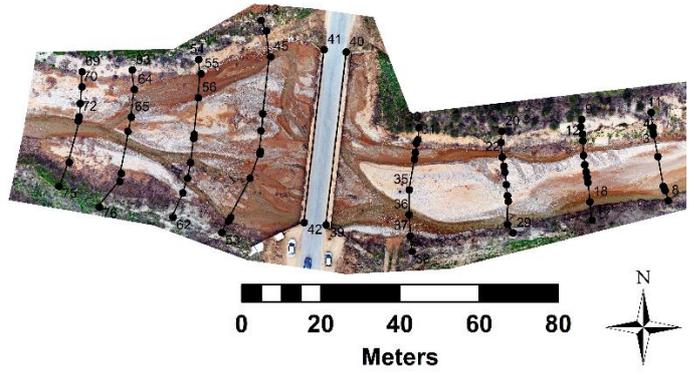
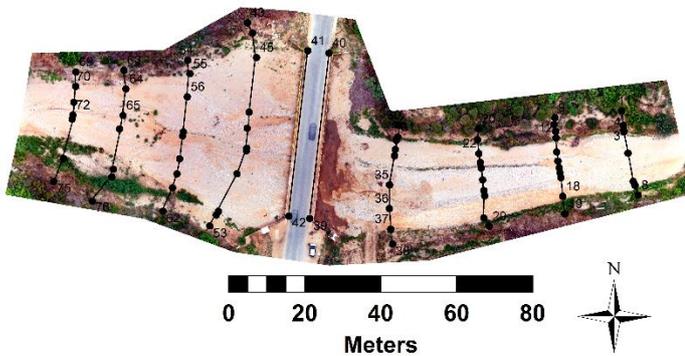
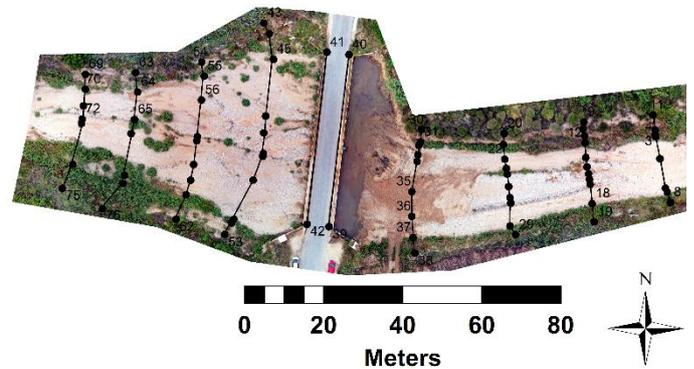
Figure 6. The produced orthomosaic for each UAV flight: (a) 24 September 2020, (b) 5 January 2021, (c) 11 January 2021, (d) 18 March 2021, (e) 18 June 2022 and (f) 24 August 2022. In addition, the field cross-section survey based on the GPS/GNSS is also depicted in each orthomosaic.

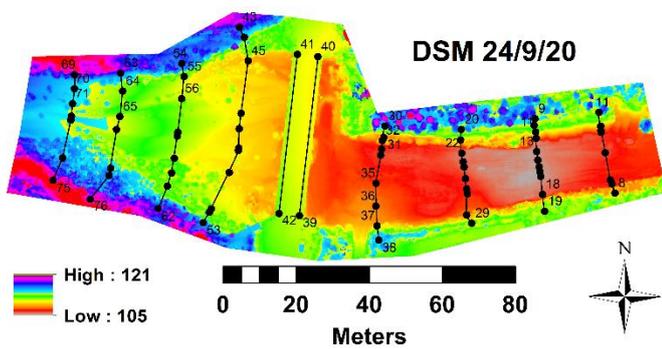
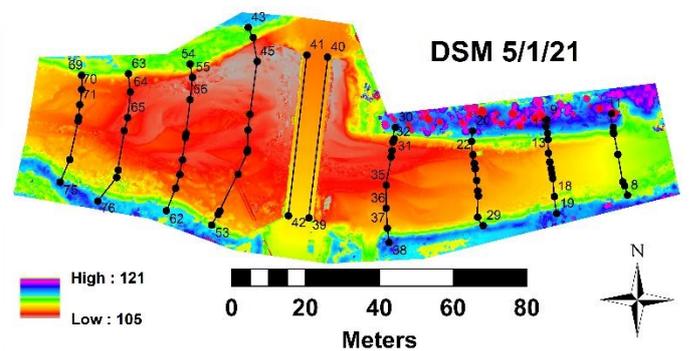
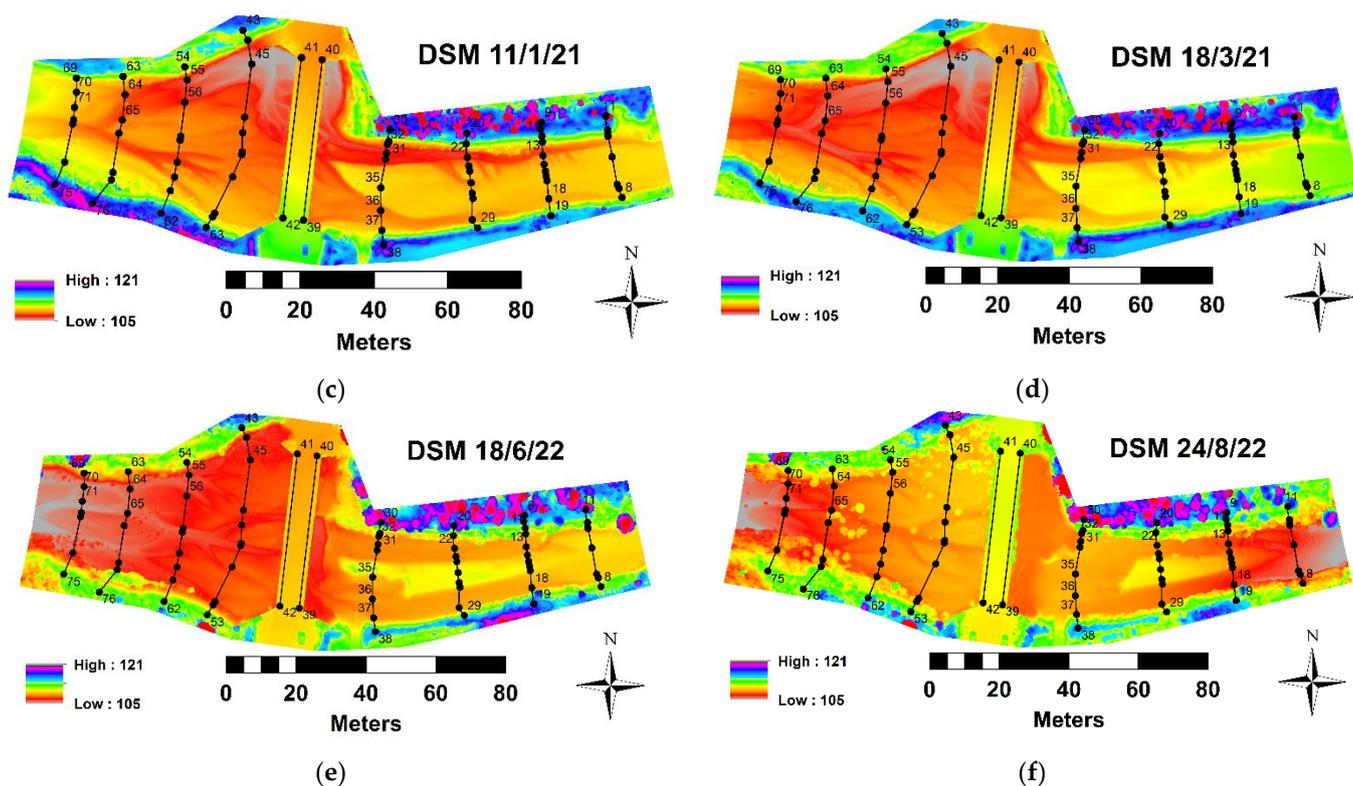
Figure 7. The produced DSMs for each UAV flight: (a) 24 September 2020, (b) 5 January 2021, (c) 11 January 2021, (d) 18 March 2021, (e) 18 June 2022 and (f) 24 August 2022. In addition, the field cross-section survey based on the GPS/GNSS is also depicted in each DSM.

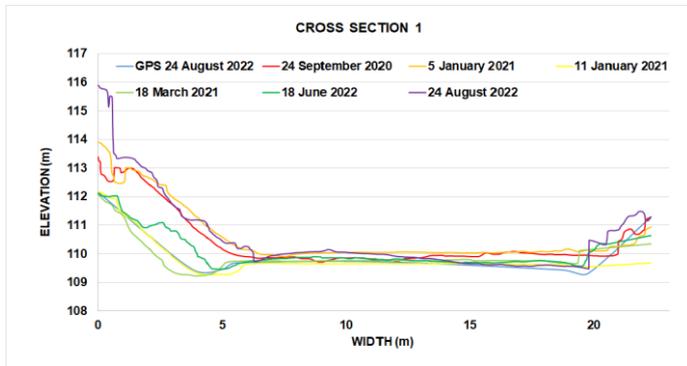
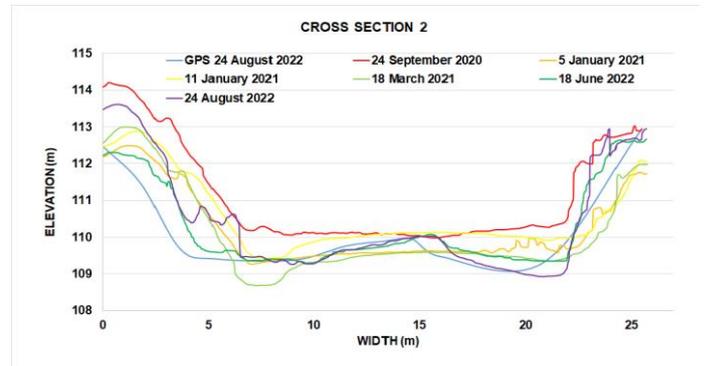
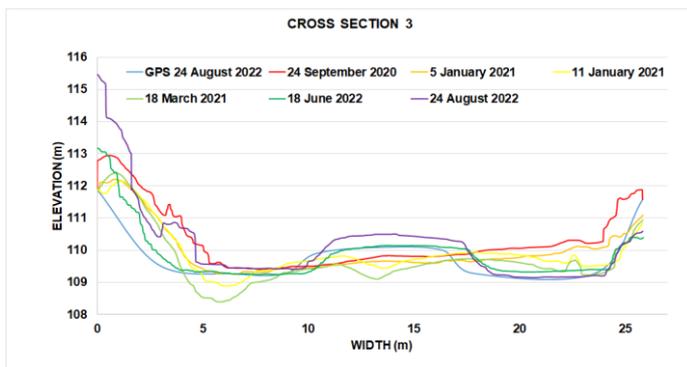
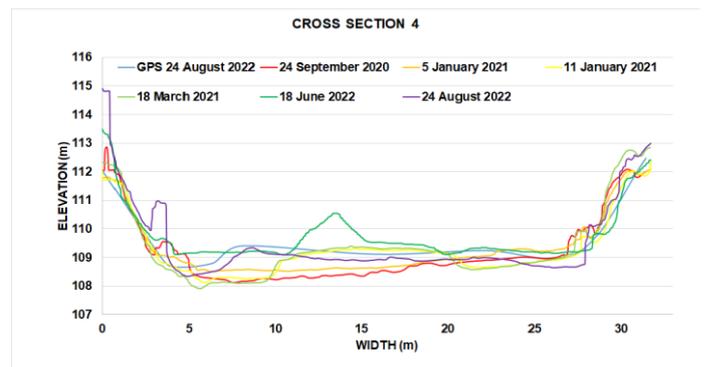
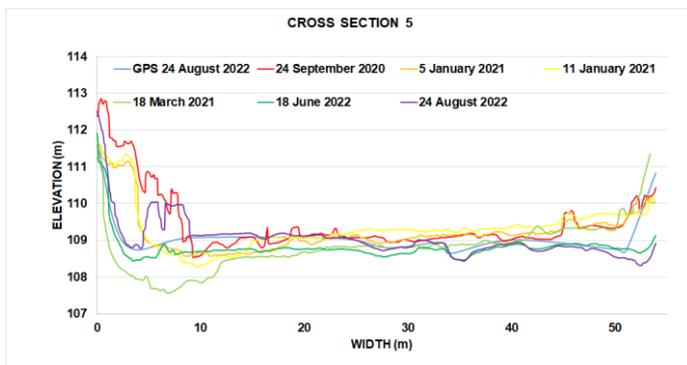
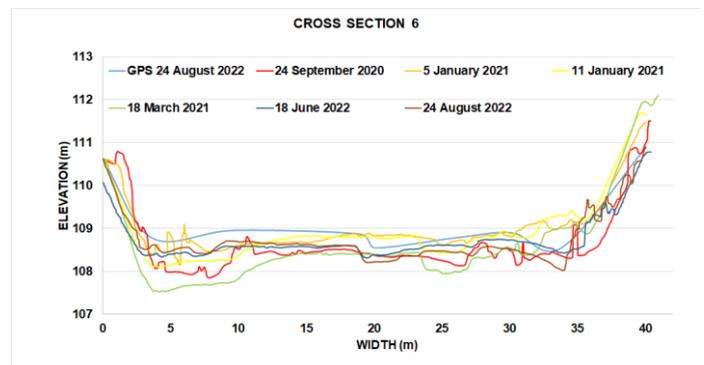
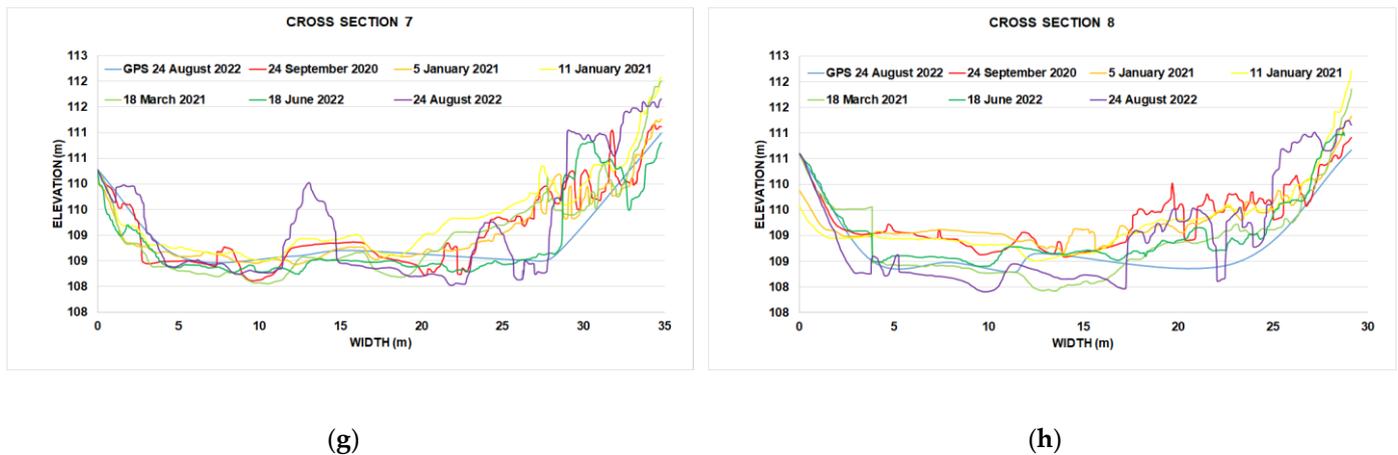
Figure 8. The produced profile of the cross-sections developed by the six UAV flights and the GPS field survey for each cross-section: (a) cross-section 1, (b) cross-section 2, (c) cross-section 3, (d) cross-section 4, (e) cross-section 5, (f) cross-section 6, (g) cross-section 7, (h) cross-section 8.

was compared to the cross-section produced by Flight 6 that took place on the same day as the GPS measurements. The GPS lines are blue and the drone lines are purple (Figure 8). Comparison of all eight cross-sections showed an almost identical match along the stream bed but there were small deviations on the left and right banks as a result of the presence of the riparian vegetation (Figure 8).

Figure 8 also includes the drone cross-section produced from the five other flights: (a) Flight 1 (red line), (b) Flight 2 (orange line), (c) Flight 3 (yellow line), (d) Flight 4 (light green line) and (e) Flight 5 (green line). Following is a comparison of all six flights together. When comparing the cross-sections, starting from CS1, we can identify the almost identical match on the stream bed and on the right bank. However, on the left bank, we can see slight deviation in the slopes. That should be expected since there is a lot of tall and dense vegetation that induces those errors on the DSM products (Figure 8a). For CS2, there was a small deviation again on the left slope because of the vegetation's presence. In the stream bed, there is a small fluctuation in the elevation's values between the different flights. This is a result of depositional events at this cross-section (Flights 3–5). These deposits were collected by the municipality's excavators (Flight 1) (Figure 8b,c). There is a match at approximately 90% of the different flights at the CS3 (Figure 8c). An increase is observed in the bed elevation between the bed width distance 10 to 17 m (Flights 5,6) due to deposition and the water moving around the island developed in the middle of the stream bed due to the excessive deposition. At CS4 (Figure 8d), the GPS and the three flights (Flights 3,5,6) have the same elevation. Flights 2 and 4 (red and yellow line) are 70 cm lower than the previous cross-section due to the municipality's excavator works, which removed the deposited material. This removal is a significant disturbance to the riverine ecosystem but is a necessity because, otherwise, even small-scale floods can overflow the Irish bridge and cause traffic jam problems. At CS5 and CS6 (Figures 8e and 8f, respectively), the elevation and slopes are the same at approximately 95% of the produced cross-sections. In cross-section CS7 (Figure 8g), in the middle section of the stream bed, the elevation of the drone images increases approximately by 1 m and that is because of the riparian vegetation found in the area. This vegetation appeared taller and denser during the growing season. The right bank also shows steeper slopes due to the vegetation. Finally, for the last cross-section, CS8 (Figure 8h), a few small changes were detected only on the right bank, again because of the density and height of the vegetation.

In the following paragraphs, comparisons of successive pairs of flights for each cross-section are described. In these comparisons, when the slope profile distance from the stream centerline increased, we considered erosion occurring (from this point on, mentioned as "increased"). In contrast, when the slope profile distance decreased from the stream centerline (from this point on, mentioned as "decreased"), we considered deposition occurring. In regard to the stream bed, when it is elevated, it indicates deposition, while when it is lowered, it indicates degradation (erosion).

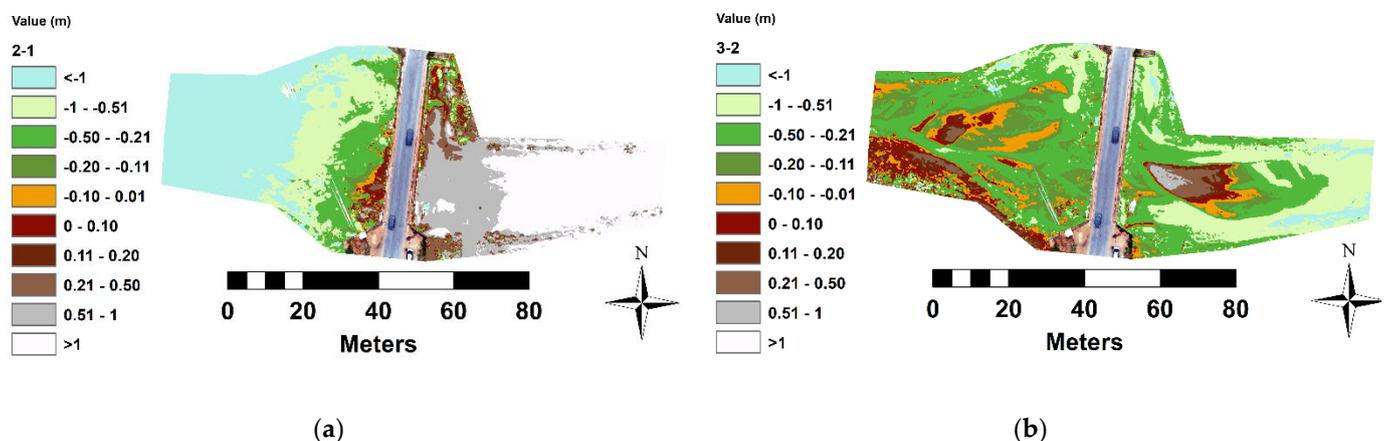
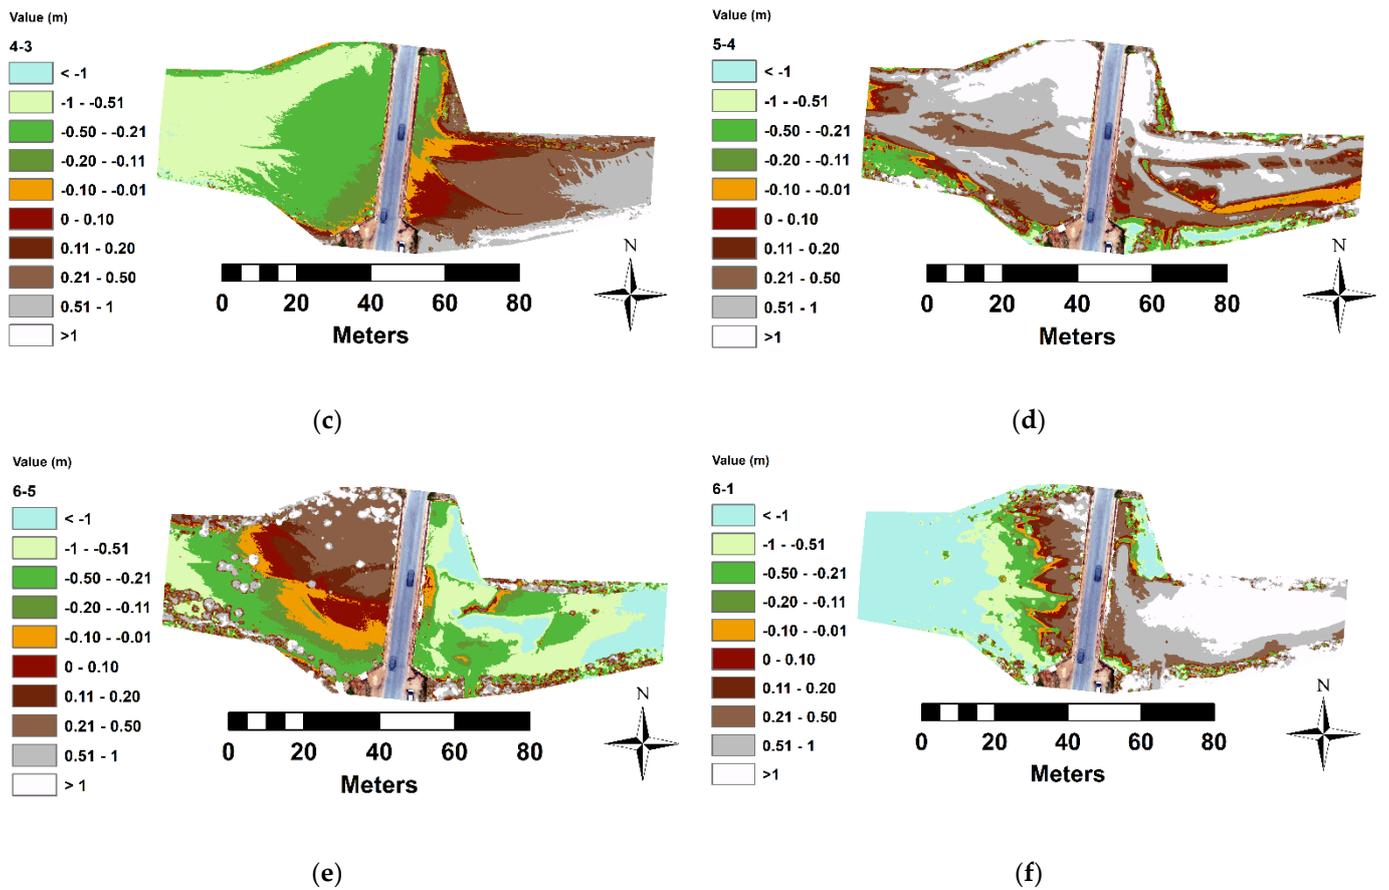
Figure 9. The produced DoDs extracted when comparing the DSMs for different flights: (a) 2–5 January 2021 with 1–24 September 2020, (b) 3–11 January 2021 with 2–5 January 2021, (c) 4–18 March 2021 with 3–11 January 2021, (d) 5–18 June 2022 = with 4–18 March 2021, (e) 6–24 August 2022 with 5–18 June 2022 and (f) 6–24 August 2022 with 1–24 September 2020.

The GCD tool enabled us to compare the different DSMs created by the drone flights (Figure 9). More specifically a ten-level scale ranging from <-1 to >1 was developed. For the positive value scale, the categories were: (a) $>0-0.10$ low deposition, (b) $0.11-0.20$ moderate deposition, (c) $0.21-0.50$ high deposition, (d) $0.51-1$ very high deposition and (e) >1 severe deposition. For the negative values, the categories were (f) $0-(-0.10)$ low erosion, (g) $(-0.11)-(-0.20)$ moderate erosion (h) $(-0.21)-(-0.50)$ high erosion, (i) $(-0.51)-(-1)$ very high erosion and <-1 severe erosion. In Figure 9a, when comparing the DoD from Flights 1 and 2, it is evident that upstream from the bridge, we have a deposition ranging from 50 cm to 1 m in the center of the stream bed. For the period between Flights 2 and 3, upstream had erosion on the left and right bank, ranging from 20 to 50 cm, and deposition at some points along the stream bed, ranging from 20 to 100 cm (Figure 9b). Increased deposition at the upstream section of the torrent from the bridge with moderate erosion downstream was also found when comparing the DoDs of Flights 3 and 4 (Figure 9c). Severe deposition upstream and downstream on the stream bed was found for the DoD based on Flights 4 and 5, especially near to the north bank of the torrent. The results of the DoD also match the results from the pins that were installed upstream (see Figure 2). Specifically, erosion pin plot C recorded erosion greater than 50 cm (see Table 1) and in Figure 9d, on the north bank, where the pins are placed, the erosion captured is $0.51-1.00$ (gray color) or greater than 1.00 m (white color). In Figure 9e (Flights 5 and 6), the upstream reach has high erosion while the downstream has high deposition, especially near to the north bank. Comparing Flight 6 (the last) with Flight 1 (the first) (see Figure 9f) showcases severe deposition on the upstream and some deposition immediately downstream from the bridge but further downstream, it has erosion. Finally, when comparing the DoD from Flight 6 with the DoDs from other Flights (2–4), the same trend is present with high deposition upstream, especially near to the north slope and moderate erosion in the middle section of the stream bed. Downstream, there is severe deposition in the middle section of the stream bed and to the north bank and high deposition from the south bank to the middle section of the stream bed. The results from the DoDs seem to be highly validated in comparison to the field measurements (erosion pins and cross-sections) during the examined periods. The torrential character of Kallifitos reach is depicted in Figure 10, with different events of sand extraction (Figure 10a,b,h) deposition (sediment and other material) (Figure 10c,d,g) and flooding (Figure 10e,f). The extraction from the streambed was performed using heavy vehicles (trucks and excavators) to remove the debris, which fills the culverts of concrete pipes under the bridge (Figure 10g,h).

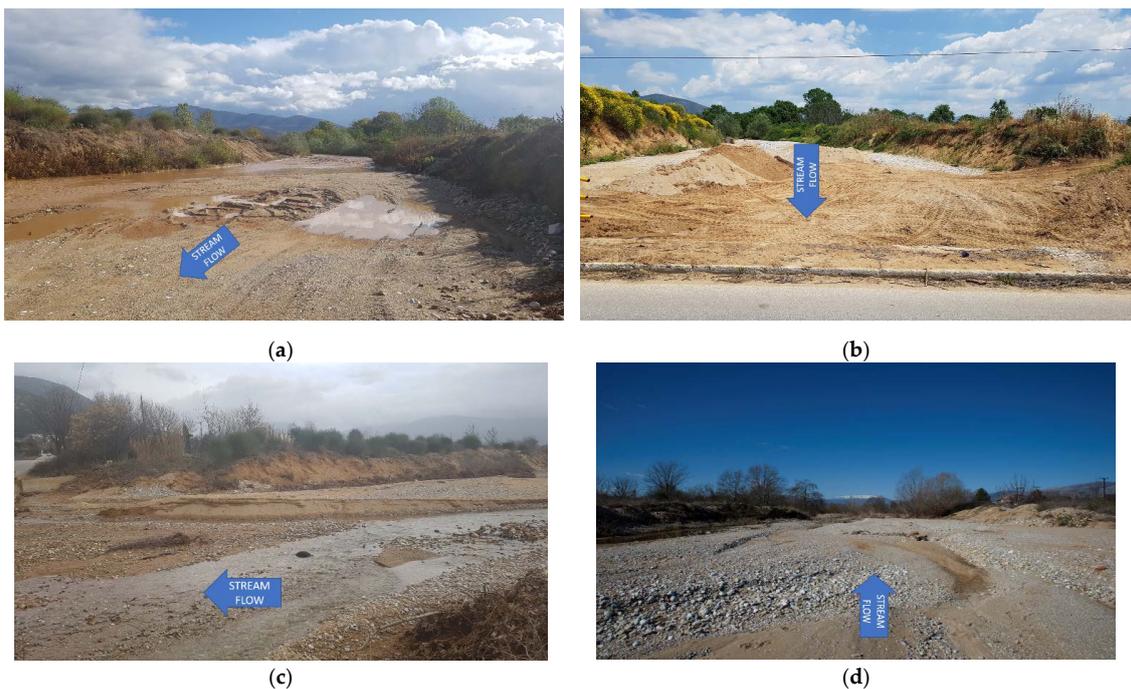
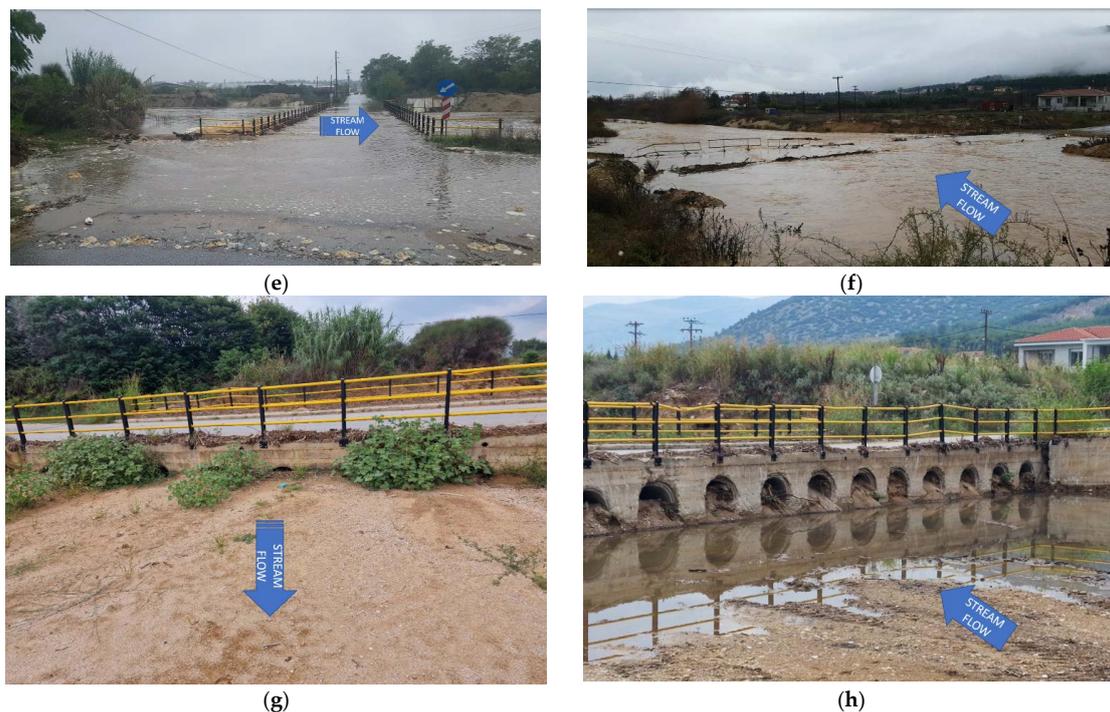
Figure 10. The Kallifitos torrent: (a) a field of view from the bed of the excavated material on 13 October 2020, (b) a field of view from the bed of the excavated material on 2 June 2022 (tire tracks are also visible), (c) a field of view from the bed of the deposition material on 8 February 2021, (d) a field of view from the bed of the deposition material on 5 November 2020, (e) a field of view from the road of the flooded area on 16 October 2021, (f) a field of view from the right bank of the flooded area on 12 January 2021 (the metal railings were destroyed), (g) a field of view from the bed of the deposition material at the bridge's culverts on 24 August 2022 downstream from bridge (h) a field of view from the bed of the deposition material at the bridge's culverts on 24 August 2022 upstream from bridge.
