Water Quality Assessment of Urban Ponds and Remediation Proposals

Abstract: Ponds are a common feature in urban parks to provide aesthetic and recreational functions, but also deliver a wide range of ecosystem services. The objective of this study was to assess the water quality of six urban ponds in the city of Lisbon, Portugal, to determine the factors that influence it and consider remediation measures for them. Besides that, our study aims to deliver data in order to support the best approach for a future monitoring program, toward more strategic and sustainable management. Floating treatment wetlands (FTW) were installed in three of the ponds during the study, where nutrient levels were higher. Water sampling was performed since 2016, with more intensive campaigns in 2020 and 2021. Average pH ranged from 7.9 to 9.0, average Chemical Oxygen Demand ranged from 36 mg/L to 90 mg/L and average Total Suspended Solids ranged from 7 to 93 mg/L. The main factors that contribute to these values were identified as the presence of waterbirds, vegetative debris that falls in ponds, and contamination with sewage. The FTW that were installed in some of the ponds could help to improve the wa

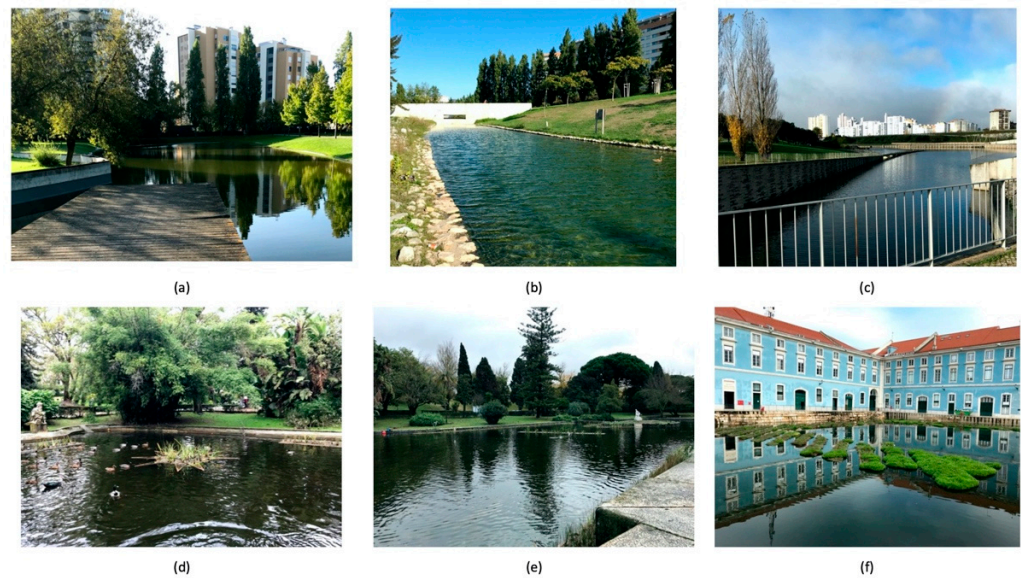
Figure 1. Urban ponds monitored in Lisbon: (a) Quinta das Conchas (QC), (b) Parque Oeste 3 (PO3), (c) Parque Oeste 5 (PO5), (d) Jardim da Estrela (JE), (e) Estufa Fria (EF) and (f) Doca da Caldeirinha (DC).

QC pond is integrated into a 25 ha garden (Figure 1a). It is a complex system of channels and a pond surrounded by grass areas with trees. In autumn, leaf debris fall in the water and accumulate in the bottom of the pond and channels. There is a large waterbird population that gathers in the pond and disturbs the bottom sediments, registered by observation. The water level in the pond was variable during the sampling period, increasing in the winter (maximum height of the pond, 1 m) and being very shallow in the summer (less than 0.5 m).

In Parque Oeste, pond PO3 is the smallest (Figure 1b) and PO5 is the biggest of the six ponds evaluated (Figure 1c). They provide an important function as a retention basin that collects and stores stormwater that can be used to irrigate the gardens surrounding the ponds, therefore, the water level also varied during the sampling period. Both ponds exhibit green water, fish, and large waterbird populations. According to Lisbon Municipality, pond PO5 was designed as a detention basin, and therefore stormwater flow is its main water source. However, in order to maintain a minimum water level groundwater is also pumped into the pond during dryer periods, when precipitation is not enough. It was also reported by the Municipality that there are occasional uncontrolled wastewater discharges from

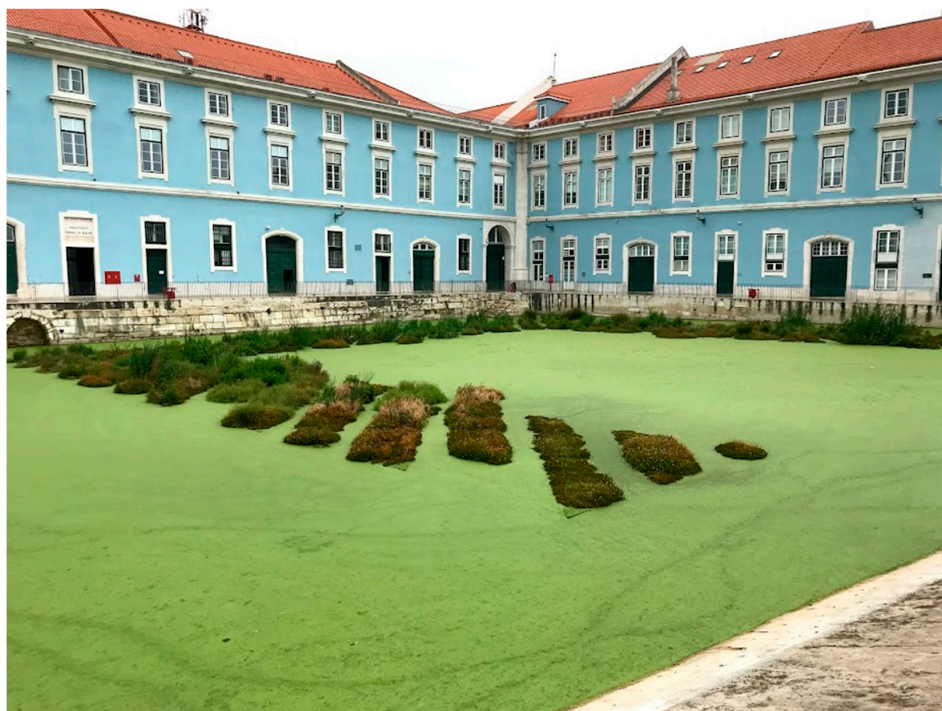
Figure 2. Algal bloom in the pond Doca da Caldeirinha (DC) (3 July 2021).

It is also worth noting that the algae bloom observed in June–July 2021 in pond DC (Figure 2) was not accompanied by relevant nutrient concentrations in the sampling that took place on April 2021 (<0.1 mg N/L for $\text{NH}_3\text{-N}$, 0.86 mg N/L for $\text{NO}_3^- \text{-N}$, 3.78 mg N/L for KN and 1.24 mg P/L for TP).

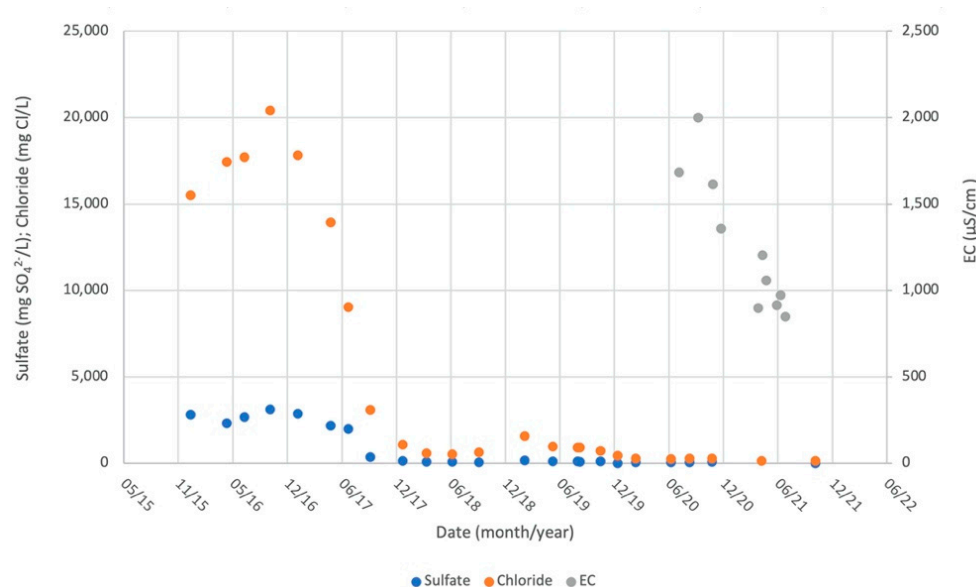
Figure 3. Chloride and sulfate concentration in the water pond sampled in Doca da Caldeirinha (DC), from January 2016 to October 2021.

Between 2020 and 2021, average EC values ranged from 300 µS/cm to 600 µS/cm in all ponds, being considered class II, medium salinity water [38]. Pond DC was an exception that exhibited the highest average values with 1255 µS/cm, most likely as a result of the sporadic hydraulic connection with river Tagus. This type of water is classified as class III, high salinity water [38]. Although there were no EC measurements in pond DC prior to 2020, the average values of EC in Tagus Estuary between 1999 and 2005 varied between 28,000 and 45,000 µS/cm [39]. It is worth noting that the water exchange with the river was significantly reduced in 2018, as can be observed by the chloride concentration shown in Figure 3.

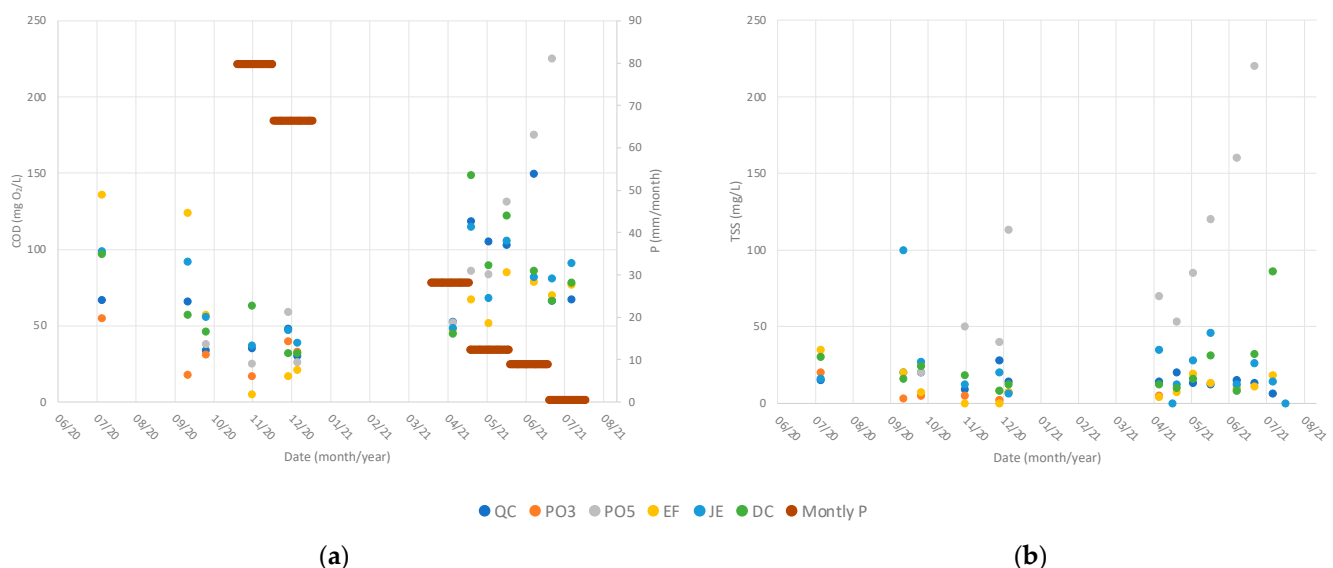
Figure 4. (a) Chemical oxygen demand (COD) and (b) Total suspended solids (TSS) concentrations in each pond water sampled and monthly precipitation (P) in Lisbon.

Average COD concentrations were similar between ponds, but concentrations seemed to decrease towards the winter and increase towards the summer, as can be observed in Figure 4a). Precipitation data was only available from November 2020 onwards, as such analysis was only made for the last year of sampling. In this period the higher precipitation levels in November and December 2020 are in line with the lower COD concentrations (5–63 mg O₂/L) observed in all ponds. The presence of animals that were observed in the area, such as ducks and birds, and the feeding by the visitors may also influence to some extent the organic loadings of the ponds [11].

Regarding TSS the large majority of the samples in all ponds had concentrations below 50 mg/L (Figure 4b) and average between 7 and 27 mg/L (Table 3). Pond PO5 was an exception, with an average TSS concentration of 93 mg/L. A steady increase in TSS was observed from 53 mg/L in May 2021 to 220 mg/L in 3 July 2021 (Figure 4b). This pond serves as a stormwater detention basin and its water is used for irrigation during the summer months. A decrease in the water level of the lake towards the summer of 2021

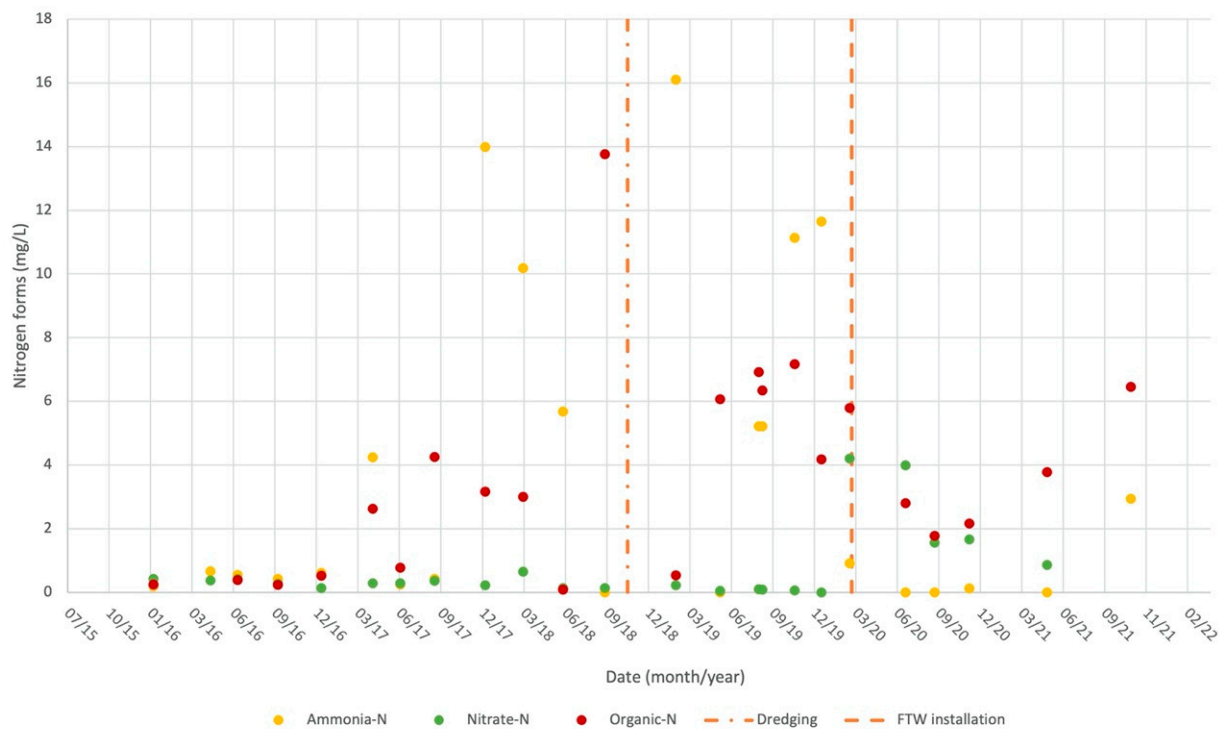
Figure 5. Nitrogen forms in water sampled in pond Doca da Caldeirinha (DC) from 2016 to 2021. (FTW: Floating treatment wetland).

The higher concentrations of nitrogen forms in pond DC had already occurred in past years. In fact, the sampling of nitrate parameters in DC started in 2016 and showed an increase in organic N and ammonia between 2017 and 2019 (Figure 5). From 2017 to 2019 ammonia concentration varied with values above 10 mg N/L observed mostly in cooler months (October to March). From 2020 onwards the ammonia concentration dropped below 1 mg N/L, except for October 2021 where 2.94 mg N/L was observed.

The overall concentration variations observed in Figures 5 and 6 seem to suggest that the introduction of FTW in March 2020 could have contributed to the reduction in nutrients

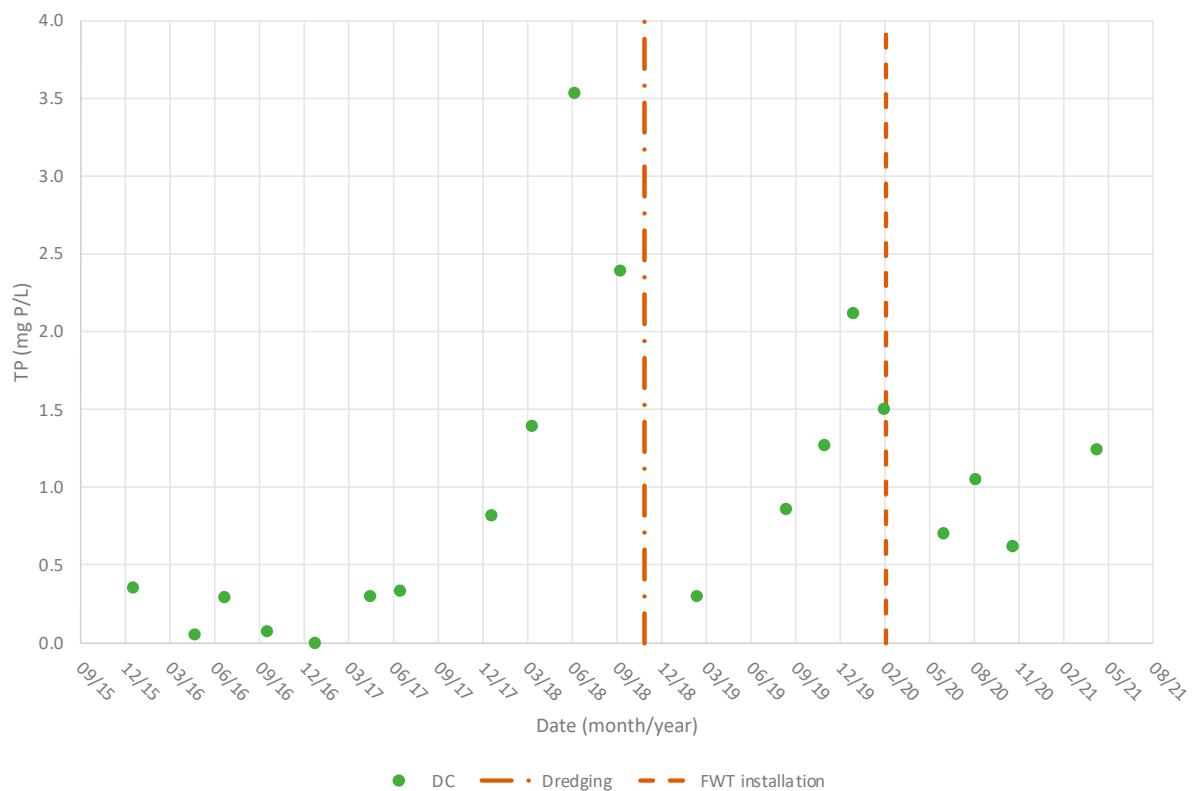
Figure 6. Total Phosphorus in water sampled in pond Doca da Caldeirinha (DC) from 2016 to 2021. Values below detection limit (0.13 mg P/L, n = 2) are not shown. (FTW: Floating treatment wetland).

Between 2020 and 2021 TP had an average value in pond DC of 1.09 mg P/L, which was higher than the average values of 0.14 and 0.2 mg P/L obtained in ponds EF and JE, respectively. TSS and TP non-point source pollution in lakes may be attributed in part to green space [41]. Total phosphorus sampling in pond DC started in 2016 with values lower than 0.5 mg P/L. From December 2017 onwards TP concentrations in pond DC were higher than 0.5 mg P/L. Dredging in this pond in November 2018 was followed by a reduction in TP concentrations, which remained below 2.5 mg P/L after that (Figure 6).

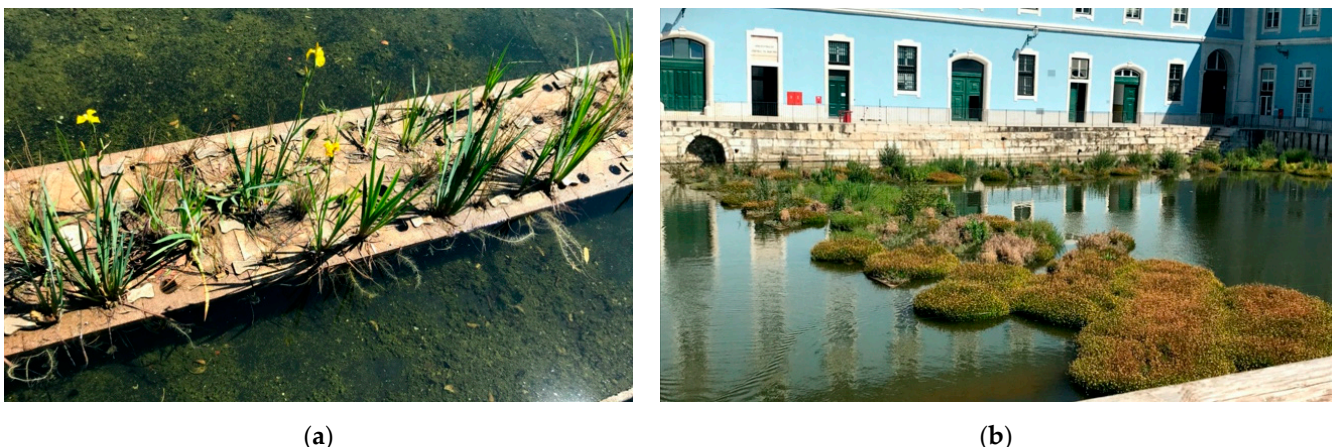
Figure 7. Photo taken in April 2021 showing plant growth differences in the floating treatment wetlands: (a) Estufa Fria (EF) and (b) Doca da Caldeirinha (DC).

In the present paper, three of the ponds under study had FTW installed at the end of 2019/beginning of 2020. Ponds JE and EF had different plants from pond DC, since the later had higher salinity and therefore received native plants from the river Tagus estuary. Based on visual assessment, different growth rates were observed, with the FTW in pond DC growing significantly more from July to December 2020 when compared to the other 2 ponds, where little to no changes were observed in the same time period (Figure 7). In accordance with Lisbon Municipality's FTW maintenance staff, waterbirds in ponds EF and JE kept feeding on plants from the cork platforms and so the plants had to be replaced multiple times, preventing their full development. If from one side FTW provide the creation of habitat for birds [43,44] they can also be damaged by them, especially new plantings, in certain circumstances [45].
