## Article

# Long-Term Monitoring of Crack Patterns in Historic Structures Using UAVs and Planar Markers: A Preliminary Study

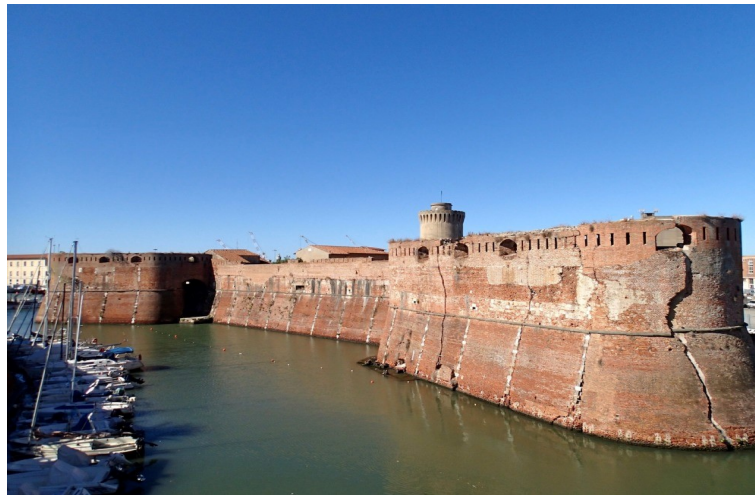
**Figure 1.** Fortezza Vecchia, Livorno, Tuscany (Italy). Evident structural defects can be noted on the walls of the ancient fortress.

Our conclusion is that it is possible and useful to use UAV for the long-term monitoring of crack patterns of architectural heritage, in order to prevent collapses or to schedule maintenance work. This is true especially when target environments are surrounded by water or challenging terrain as in Fortezza Vecchia in Livorno: UAV-based methods for structural monitoring may be practical and feasible even when the environmental and structural context makes it difficult or impossible to implement ground-based approaches usually adopted in Cultural Heritage, e.g., short-range laser-scanning.

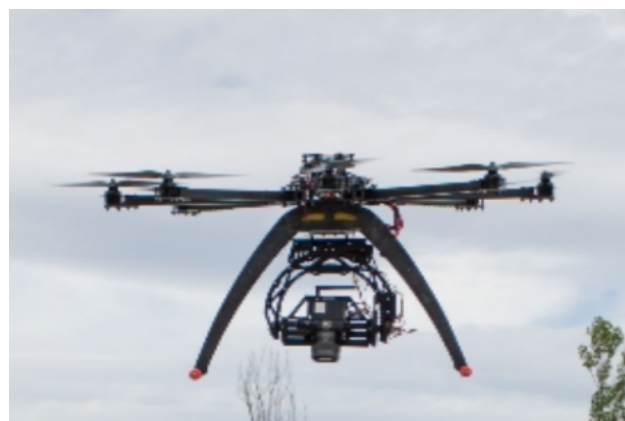
**Figure 3.** The ISTI-CNR drone: the digital camera is hosted by the gimbal, a mechanical support able to stabilize the image acquisition against vibrations or unexpected movements.

The data acquisition system is made up by several optical and electronic devices mounted on the custom ISTI-CNR drone: it is a Micro Air Vehicle designed and assembled in the Institute of Information Science and Technologies of the National Research Council of Italy. This drone has two flight modes: the usual free flight mode, controlled by the pilot, and the programmed flight mode, when the drone flight is based on a predefined set of GPS coordinates of way-points. The latter modality is quite interesting, for our purpose, as it allows for repeating the same flight over time; hence, it may support the creation of a large dataset of the site of interest over time. In the original setting on the bottom of the drone, there is a stabilized component, named gimbal, hosting a digital camera for video recording, as shown in Figure 3. The optical camera used is the Canon EOS M (Canon Inc, Japan), a 18 Mega-pixel mirror-less with a sensor APS-C of  $22.3 \times 15$  mm (aspect ratio 3:2). The maximum video resolution is of  $1920 \times 1080$  pixel at 30 fps. It weighs 298 g and has dimensions  $108 \times 66 \times 32$  mm. The focal length varies in the range 18–55 mm.
