# Spatial Potentials and Functional Continuity/Discontinuity in Ottoman-Turkish Hammams: Historical Peninsula, Istanbul

An architectural and cultural heritage analysis is performed in this study by systematically examining the social significance of historical hammams in today's Historical Peninsula of Istanbul, which symbolize washing–cleansing–hygiene activities and also have socialization–entertainment–economic dimensions, as well as reflecting urban development and change. Within this scope, 81 historic hammams listed as cultural heritage sites were researched using a multi-layered dataset that integrates on-site morphological studies and historical maps. The physical and intangible transformations of these hammams are analyzed based on a database of 24 examples documented through in situ observations of hammams still in active use, revealing the effects of changing cultural and historical contexts on these buildings. The other 19 examples, which are not currently operating as hammams but still exist as buildings, are assessed to determine their current purpose or whether they are undergoing restoration. The findings reveal the evolution of hammams and identify dominant archit

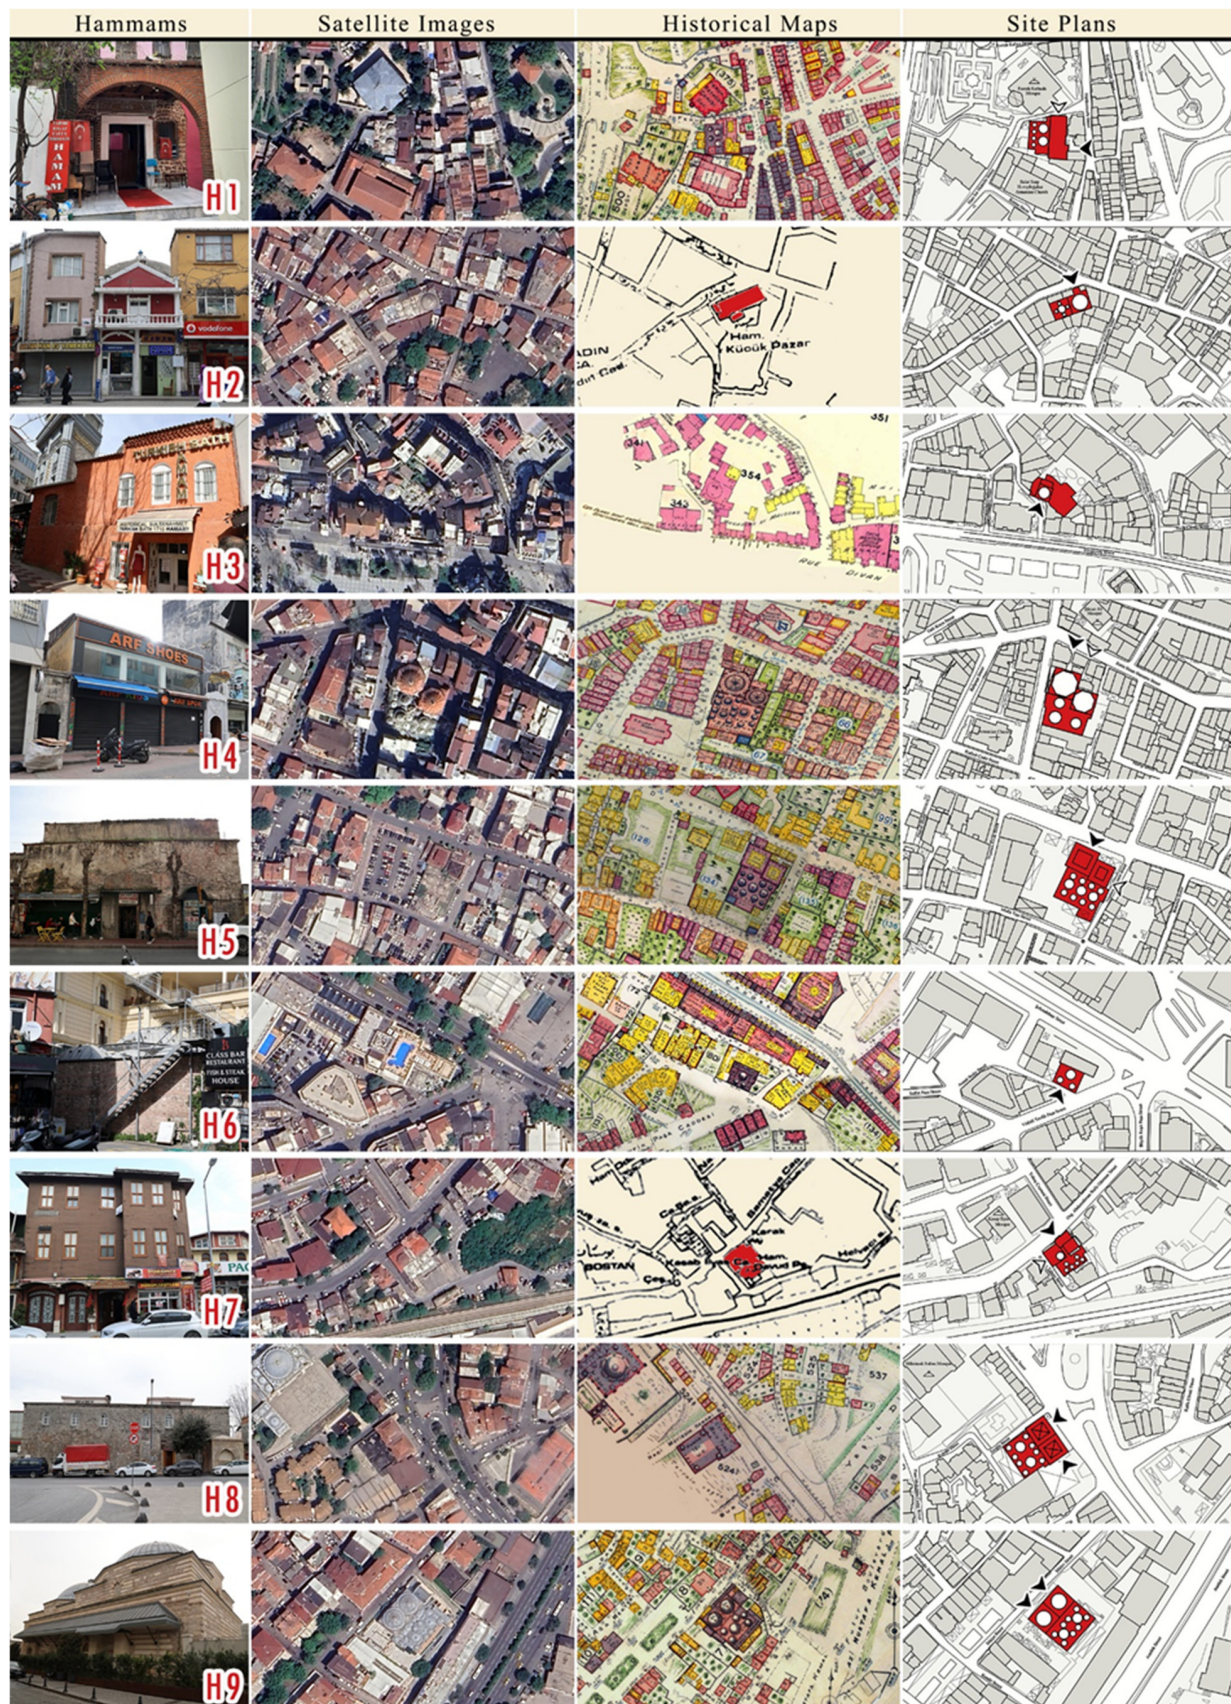
**Figure 4.** The main facade views, aerial photographs, locations on historical maps, and current locations (site plans) of hammams 1–9 (historical maps H1, H4–H6, H8–H9 [Pervititch]; H2, H7 [Ayverdi], H3 [Goad]; other documents created by the authors).

The 24 active hammams, along with their identifying numbers, photographs, aerial photographs, and locations (site plans) on historical and current maps, are shown in Figures 4–6. The Pervititch maps, as the most detailed historical maps, were used to compare the hammams’ current locations with their past locations. For the seven hammams excluded from the Pervititch maps (H2, H7, H17, H18, H21, H22, H24), the Ayverdi maps were consulted, and for two hammams (H3, H14), the Goad maps were consulted. Since the Ayverdi and Goad maps are not as detailed as the Pervititch maps due to their scale, it is difficult to track the changes to these hammams in the urban context. Comparison with the Pervititch maps reveals that some hammams (H8, H10, H23), once separated from the street and neighboring structures by gardens in the early 1900s, are now surrounded by new constructions, resulting in reduced visibility and altered relations with their surroundings.

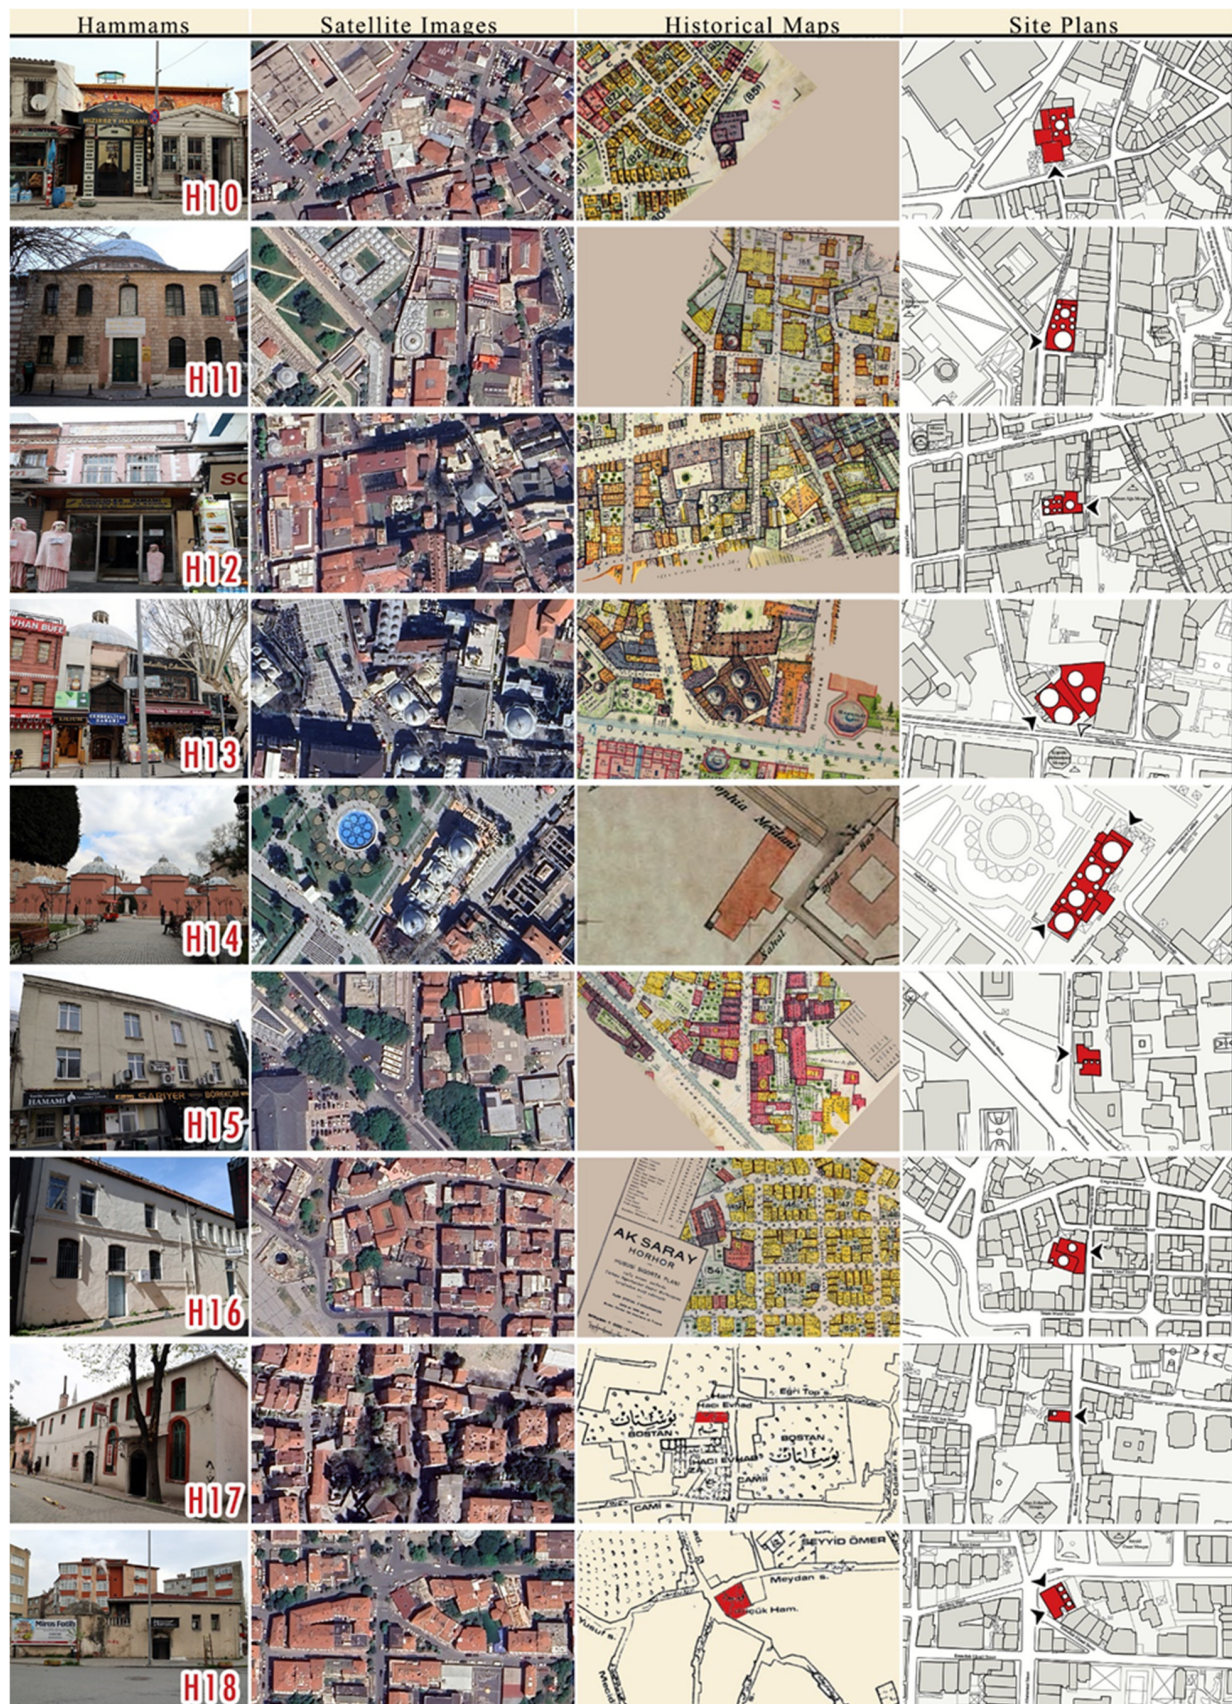
**Figure 5.** The main facade views, aerial photographs, locations on historical maps and current locations (site plans) of hammams 10–18 (historical maps H10–H13, H15–H16 [Pervititch]; H17–H18 [Ayverdi], H14 [Goad]; other documents created by the authors).

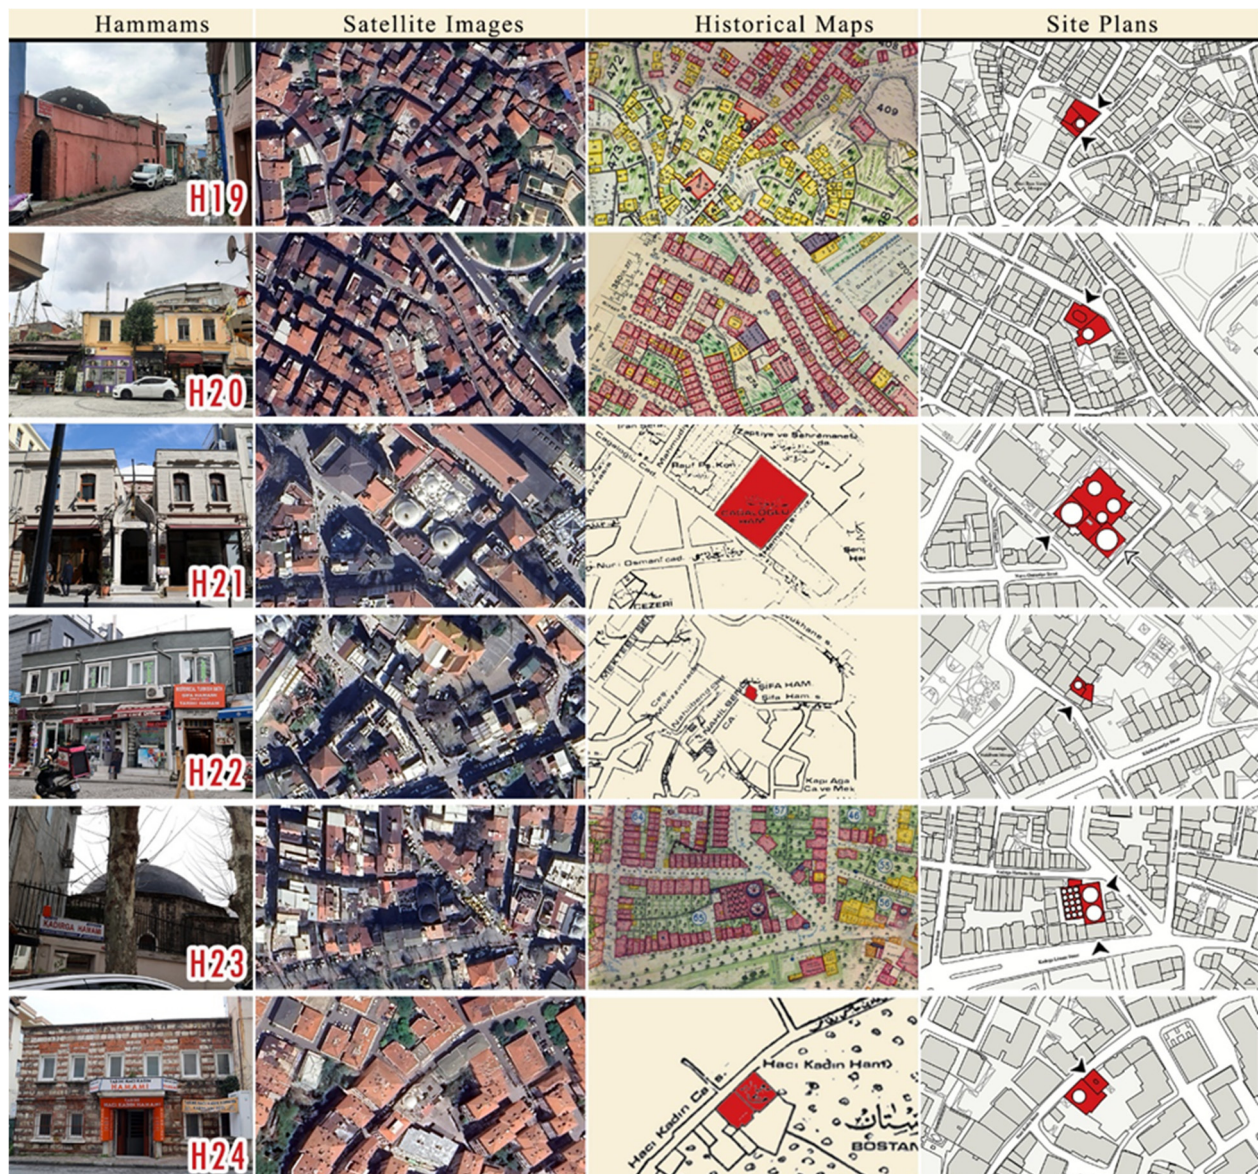
**Figure 6.** The main facade views, aerial photographs, locations on historical maps, and current locations (site plans) of hammams 19–24 (historical maps H19, H20, H23 [Pervititch]; H21, H22, H24 [Ayverdi]; other documents were created by the authors).

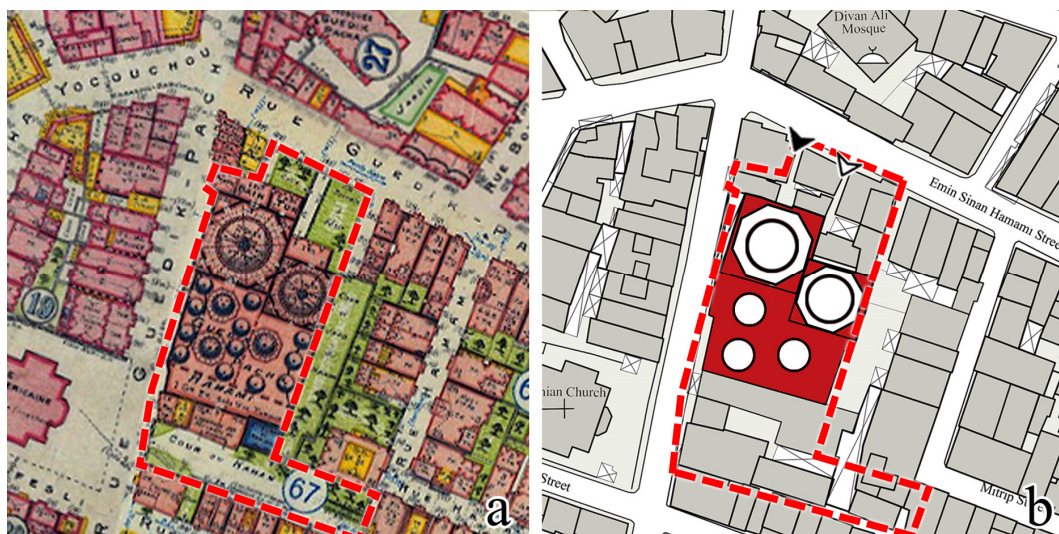
**Figure 8.** (a) The location of Gedikpaşa Hamam (H4) on the Pervititch Map (1925–1940). (b) The current site plan of Gedikpaşa Hamam (H4). The solid arrow on (b) indicates the entry still in use, the white arrow indicates the unused entrance. The area lined in red on both photos shows the dimension of the areas transformation and the hammam areas reduction in size over time. (created by the authors).

In 58.33% of the 24 active hammams, visibility was not restricted, while it was restricted by surrounding developments in 41.67% of them. An example of the increasing density of urban developments can be seen in the Pervititch Map (1925–1940), which shows the relationship between the Gedikpaşa Hammam (H4) and its surroundings. Although separated from the street by a wall to ensure privacy at that time, the hammam can be seen as a distinct mass within a garden (Figure 8a). Figure 8b, showing the current location of the same hammam, reveals that its visibility has been restricted over time due to the addition of commercial spaces replacing the gardens bordering the street. One reason for the restricted visibility is that hammam structures are generally extensive, outwardly closed masses, which allows for their surroundings to be closed off over time by new developments or advertising billboards.

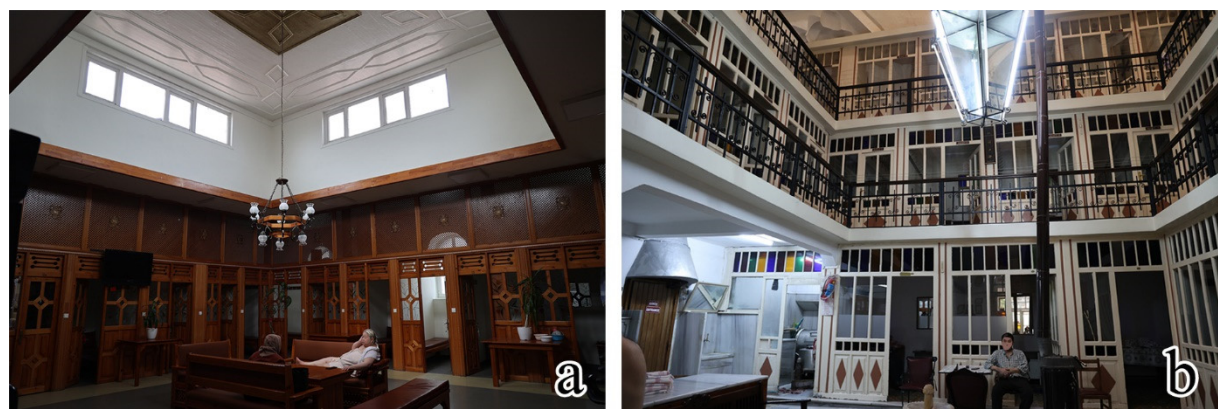
**Figure 9.** (a) Mihrimah Sultan Hammam (H8); view of the women’s frigidarium. (b) Kadirga Hammam (H23); view of the men’s frigidarium (photos by the authors).

exemplified by two cases: the Mihrimah Sultan Hammam (H8), designed by Mimar Sinan, serving mainly the local population on the periphery of the Historical Peninsula, and the Kadirga Hammam (H23), located near the touristic zone and serving both locals and tourists (Figure 9a,b).
